ATTENTION: Mr. Jason Brady Jason.Brady@greshamsmith.com **REPORT OF PRELIMINARY GEOTECHNICAL EXPLORATION** Subject: State Route 353 Emergency Bridge Replacement Washington County, Tennessee Bridge No. 90S238600011

State Route 353 Emergency Bridge Replacement

Bridge No. 90S238600011 Washington County, Tennessee

UES Project No. A24109.02271.000

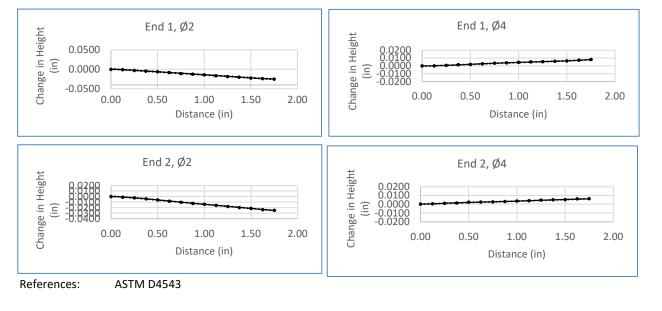
Rock Core Diametral Lines

End 1, Ø2 Best-Fit Straight Line Angular Slope:	-0.87	0
End 2, Ø2 Best-Fit Straight Line Angular Slope:	-0.85	0
End 1, Ø4 Best-Fit Straight Line Angular Slope:	0.26	0
End 2, Ø4 Best-Fit Straight Line Angular Slope:	0.20	0

The parrallelism tolerance is met when the max. angular difference between the opposing best-fit straight line on each specimen end is not more than 0.25° for spherically seated test machines.

Property	Pass / Fail		
Straigtness	Fail		
Flatness	Pass		
Parallelism	Pass		
Perpendicularity	Fail		
Best Effort Applied

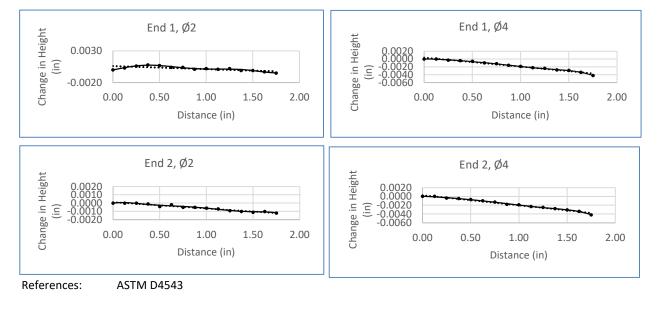
Rock Core Diametral Lines

End 1, Ø2 Best-Fit Straight Line Angular Slope:	-0.03	0
End 2, Ø2 Best-Fit Straight Line Angular Slope:	-0.04	0
End 1, Ø4 Best-Fit Straight Line Angular Slope:	-0.13	0
End 2, Ø4 Best-Fit Straight Line Angular Slope:	-0 13	0

The parrallelism tolerance is met when the max. angular difference between the opposing best-fit straight line on each specimen end is not more than 0.25° for spherically seated test machines.

Property	Pass / Fail		
Straigtness	Pass		
Flatness	Pass		
Parallelism	Pass		
Perpendicularity	Pass		
Best Effort Applied

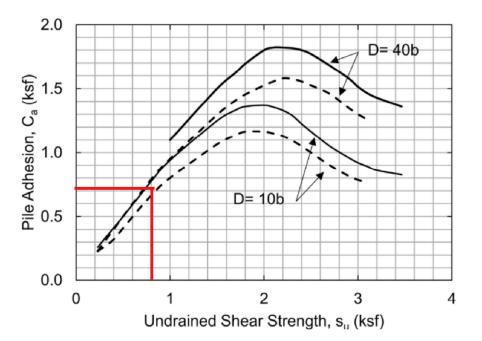
f_s = C_a = 0.70 based on graph

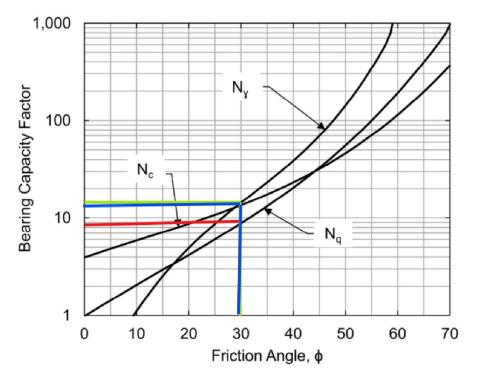
P_t = pile base factor of 0.8 for a square pile or 0.7 for a circular pile.N_c, N_q, and N_y are bearing capacity factors from Figure 7 – 22.

From Figure: $N_c = 15$, $N_q = 8$, and $N_{\gamma} = 8$

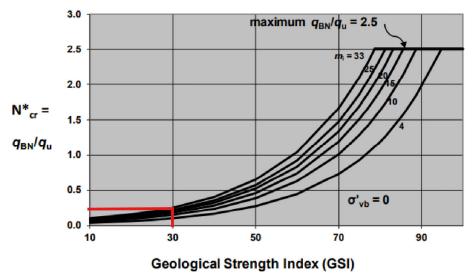
Figure 10-8 Bearing Capacity Factor N* er versus GSI for Base Resistance of Fractured Rock Mass

- q_u = 10, 000 psi
- Use Figure 10-8 to determine N_{cr}. Based Figure N_{cr} = 0.2

- $0.2 = \frac{q_{BN}}{10,000 \text{ psi}}$
- q_{BN} = 2,000 psi = 288 ksf
- Use 250 ksf

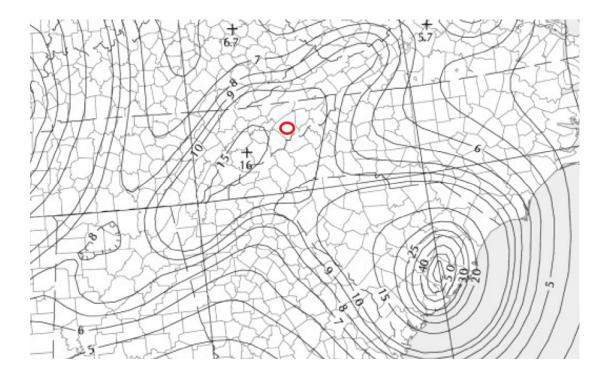
Use Figure 3.10.2-.1-1 From AASHTO Figure to determine PGA. The site contour is 0.14.

Structure	PGA (AASHTO Figure	Ss (AASHTO Figure	S1 (AASHTO Figure	Site Class
	3.10.21-1)	3.10.2.1-2)	3.10.2.1-3)	
SR 353 Emergency Bridge Repair – Washington County, Tennessee	0.21	0.384	0.151	D

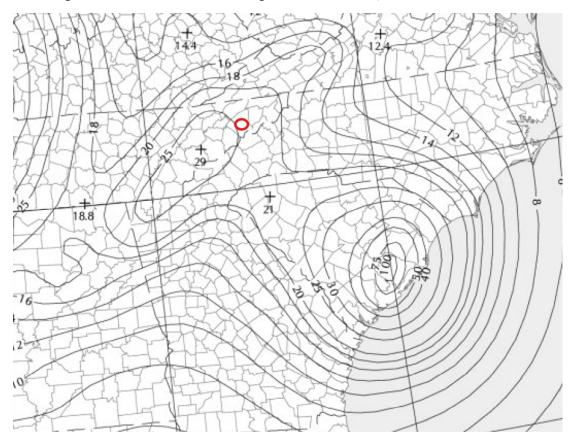
■ Use Figure 3.10.2-.1-2 From AASHTO Figure to determine S_s. The site contour is 0.24.

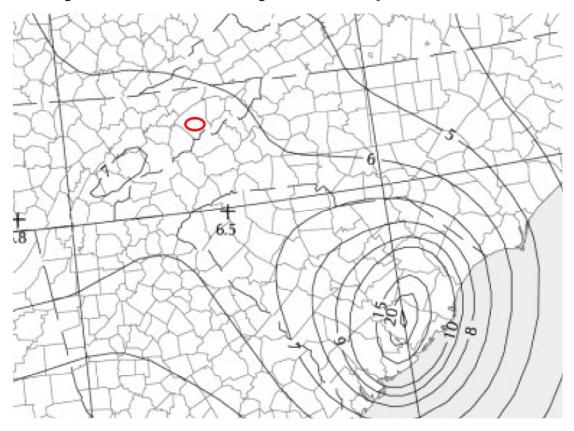
■ Use Figure 3.10.2-.1-3 From AASHTO Figure to determine S_s. The site contour is 0.63.
