GEOTECHNICAL DATA REPORT
I-40 BRIDGE REPLACEMENT / REST AREA TRUCK
PARKING
SMITH - PUTNAM COUNTY, TENNESSEE

FEDERAL AID PROJECT No. NH-I-40-5 (161)
TDOT PROJECT No. 80I040-S1-009
TDOT PIN 131552.01
TDOT GES No. 8001625

Date:
JUNE 18, 2025

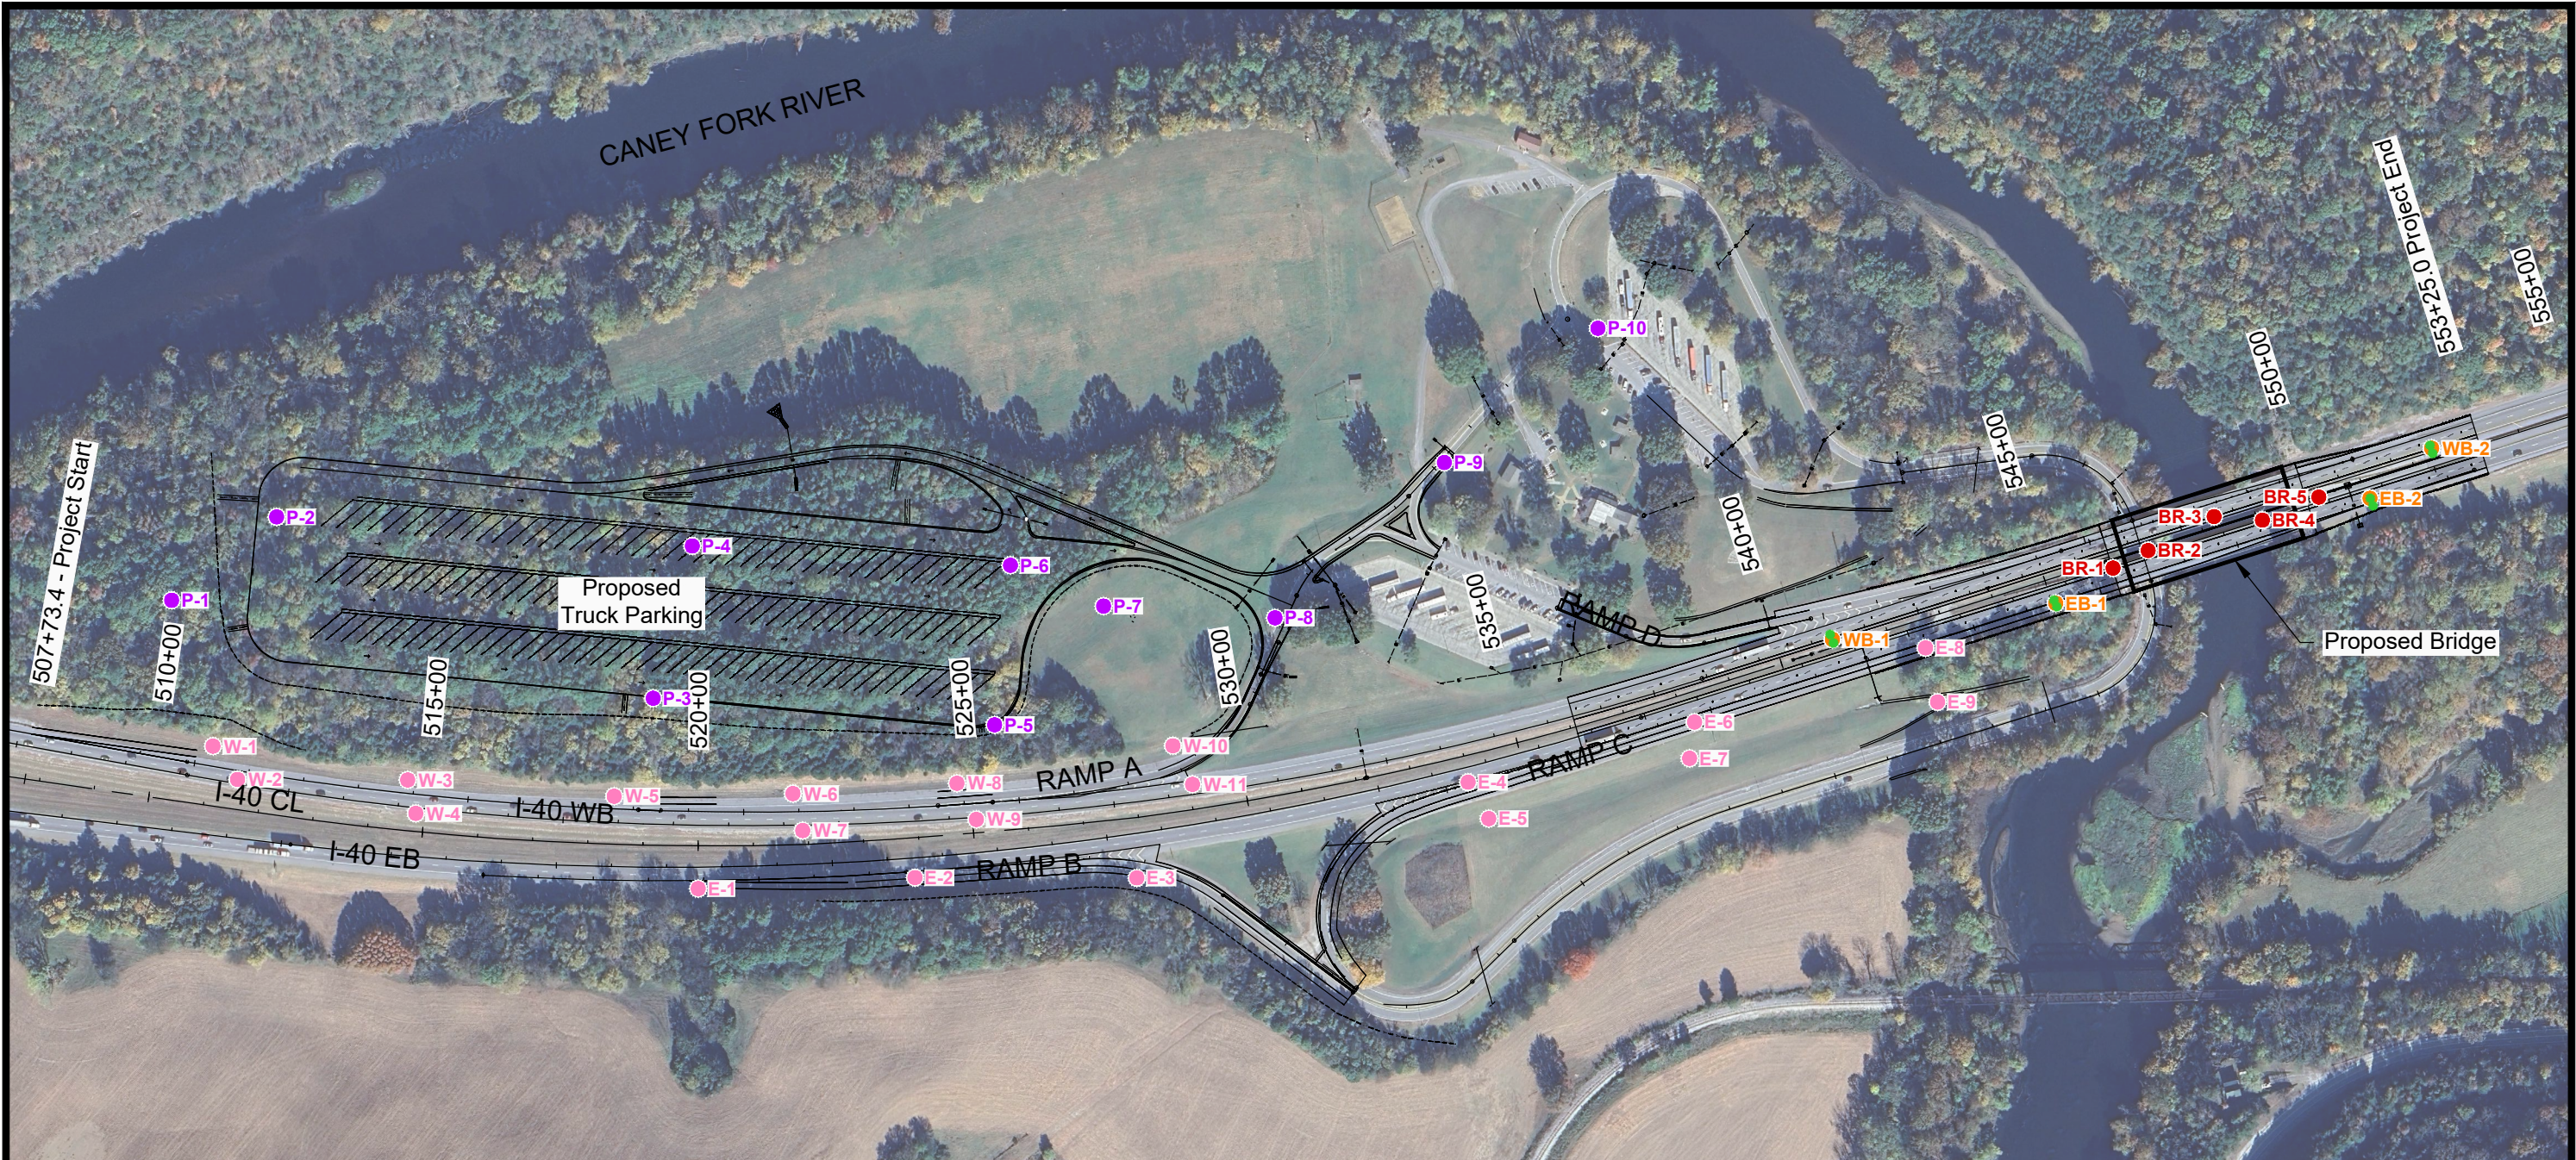
1. Plan adapted from a October 24, 2024 aerial photograph courtesy of Google Earth and a drawing set printed on May 8, 2025, titled "Smith - Putnam I-40 Bridge Replacement/Rest Area Truck Parking (L.M. 16.316/L.M.0.078)", prepared by State of Tennessee Department of Transportation Bureau of Engineering.
2. Boring locations were surveyed by the project surveyor.

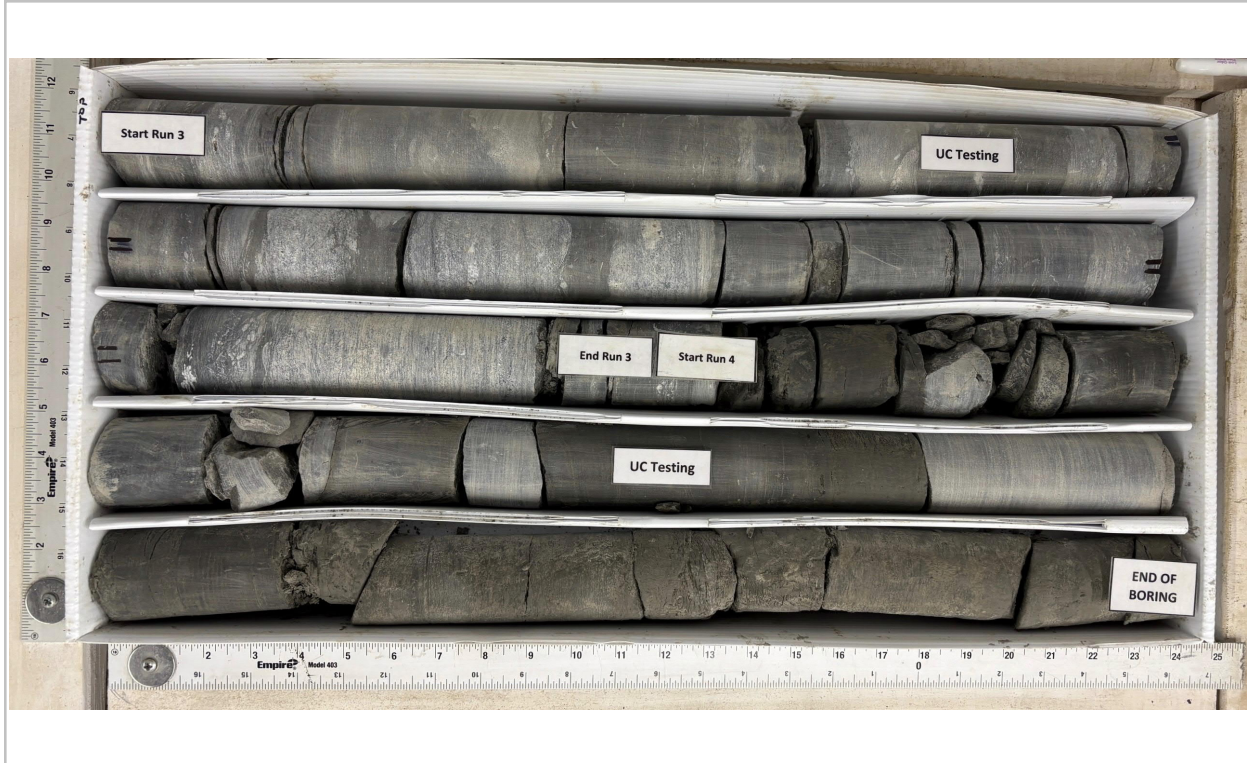
BORING BR-2

<u>RUN</u>	<u>DEPTH, FT</u>	<u>RECOVERY, %</u>	<u>RQD, %</u>
3	49.8 - 54.8	100	68
4	54.8 - 59.8	100	41

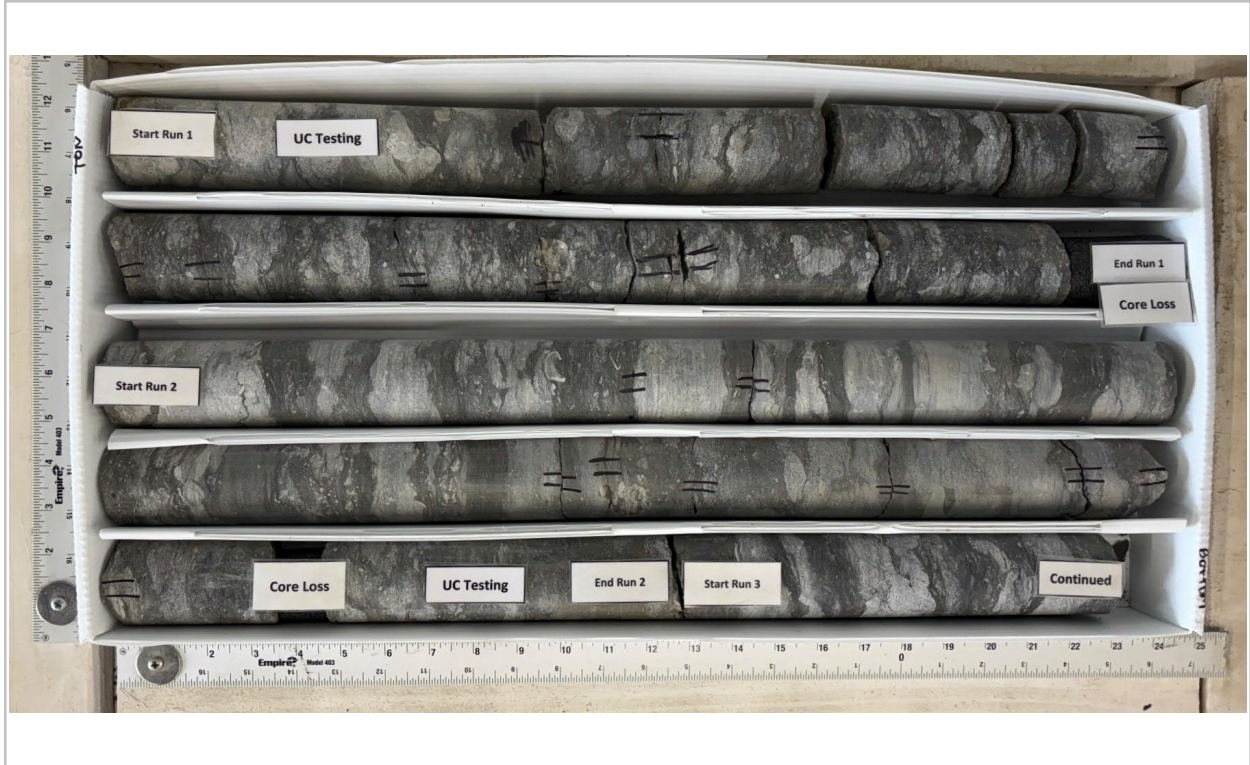
**BORING BR-3**

<u>RUN</u>	<u>DEPTH, FT</u>	<u>RECOVERY, %</u>	<u>RQD, %</u>
1	8.25 - 12.25	95	81
2	12.25 - 17.25	98	98
3	17.25 - Cont.	100	100

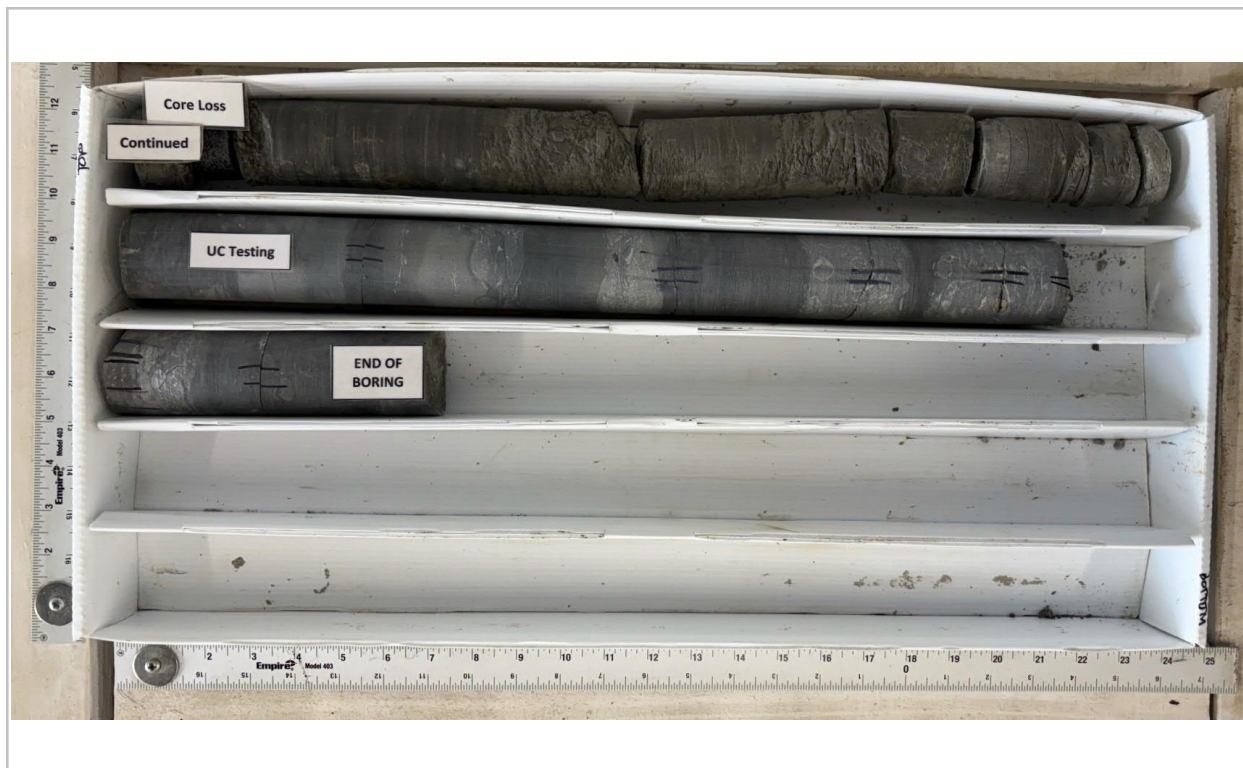
BORING BR-3

<u>RUN</u>	<u>DEPTH, FT</u>	<u>RECOVERY, %</u>	<u>RQD, %</u>
5	Cont. - 32.0	98	72

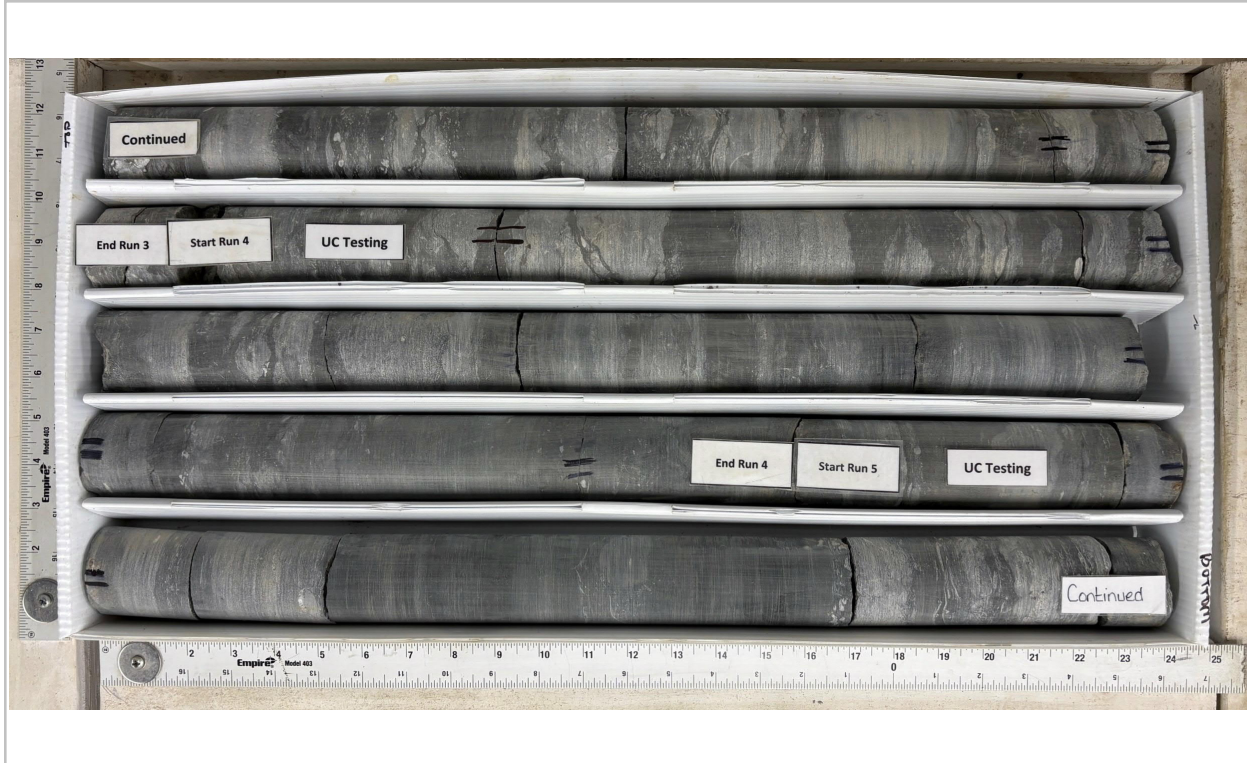
**BORING BR-4**

<u>RUN</u>	<u>DEPTH, FT</u>	<u>RECOVERY, %</u>	<u>RQD, %</u>
3	Cont. - 22.0	100	93
4	22.0 - 27.0	100	100
5	27.0 - Cont.	100	82

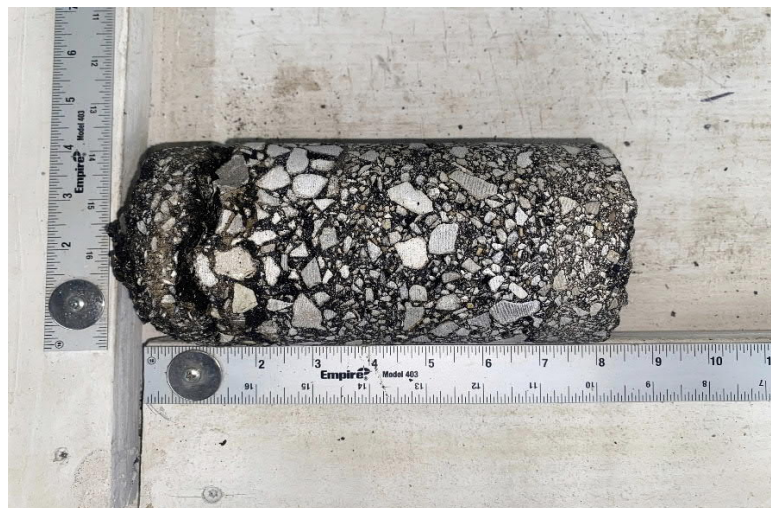
I-40 Bridge Replacement/ Rest Area Truck Parking Smith-Putnam County, Tennessee	
Boring EB-2 (Shoulder) 551+07.5 39.0 RT	
A24138.00136.001	Photograph 4
Description: 8 ½ inches of asphalt. Photograph taken on May 22, 2025.

The ground surface at the locations of the borings was covered with 3 to 15 inches of topsoil in landscaped areas and 4 to 25 inches of asphalt underlain by up to 38 inches of base materials in paved areas. The designation, location, and ground surface conditions encountered at the borings are presented in Table 4. It should be noted that due to the sample intervals and space between boring locations, the actual depth of base materials may vary between samples and borings.

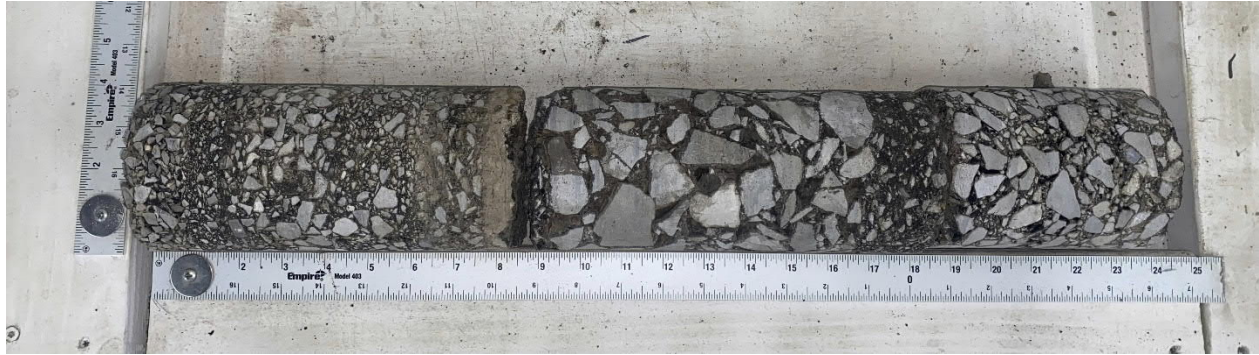
I-40 Bridge Replacement / Rest Area Truck Parking Smith-Putnam County, Tennessee	
Boring WB-1 (Lane) 541+01.5 14.5 LT	
A24138.00136.001	Photograph 5
Description: 24 ½ inches of asphalt. Photograph taken on May 22, 2025.

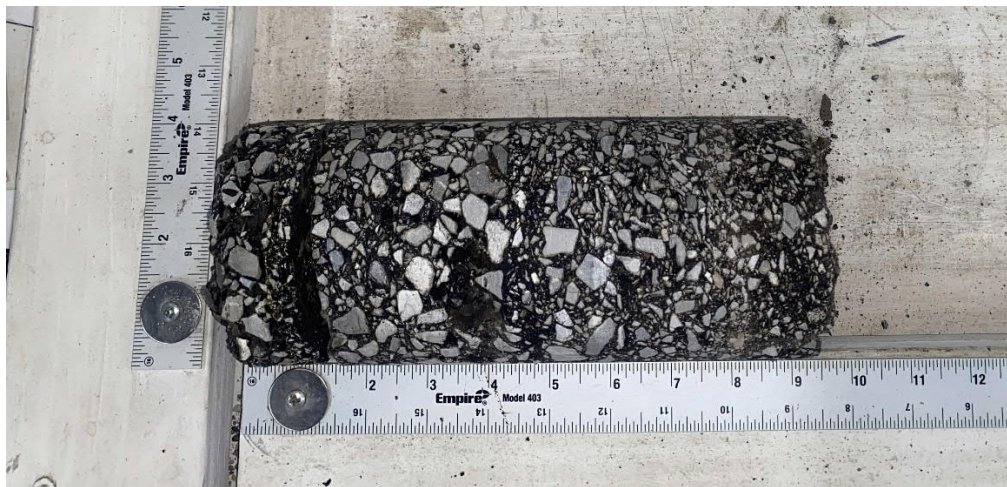
I-40 Bridge Replacement/ Rest Area Truck Parking Smith-Putnam County, Tennessee	
Boring WB-1 (Shoulder) 541+01.5 14.5 LT	
A24138.00136.001	Photograph 6
Description: 9 ½ inches of asphalt. Photograph taken on May 22, 2025.

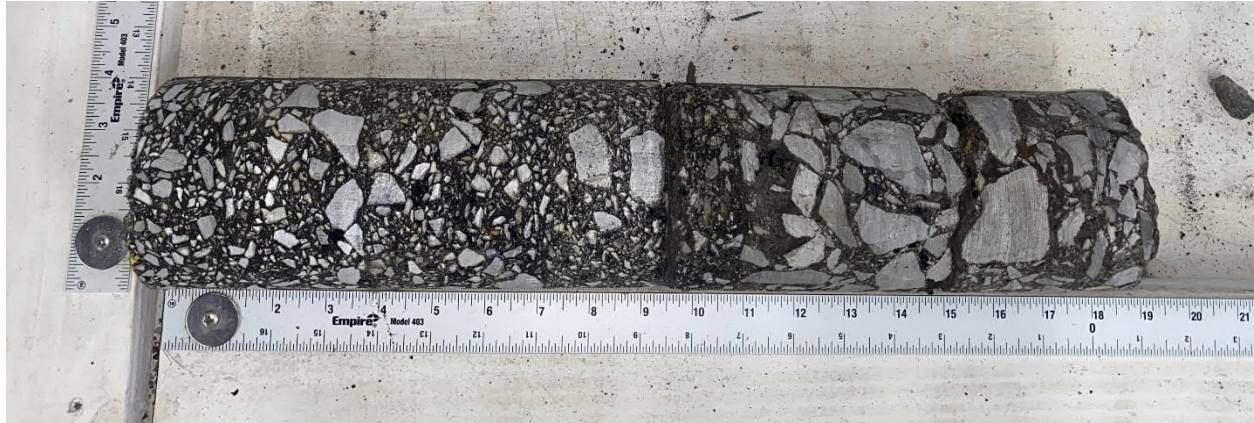
I-40 Bridge Replacement / Rest Area Truck Parking Smith-Putnam County, Tennessee	
Boring WB-2 (Lane) 552+41.5 13.5 LT	
A24138.00136.001	Photograph 7
Description: 18 ¾ inches of asphalt. Photograph taken on May 22, 2025.

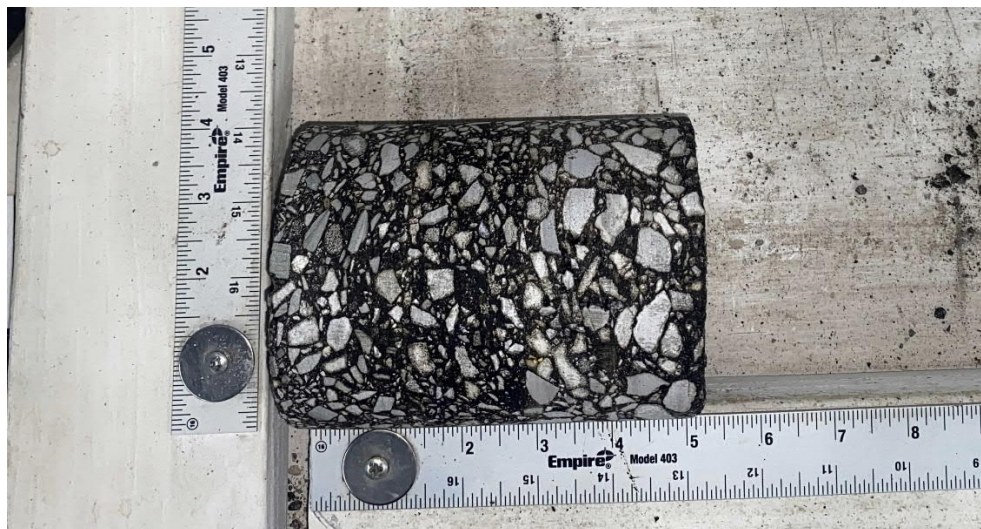
I-40 Bridge Replacement/ Rest Area Truck Parking Smith-Putnam County, Tennessee	
Boring WB-2 (Shoulder) 552+41.5 13.5 LT	
A24138.00136.001	Photograph 8
Description: 5 ¼ inches of asphalt. Photograph taken on May 22, 2025.
