# **C-List Categorical Exclusion**

Shellmound Road Bridge over I-24 Eastbound **Marion County** PIN 130902.00

The Tennessee Department of Transportation (TDOT), in cooperation with the Federal Highway Administration (FHWA), proposes to replace the Shellmound Road bridge over Interstate 24 (I-24) eastbound (Bridge ID#: 58I00240039) at log mile (LM) 1.36 in Marion County, Tennessee.

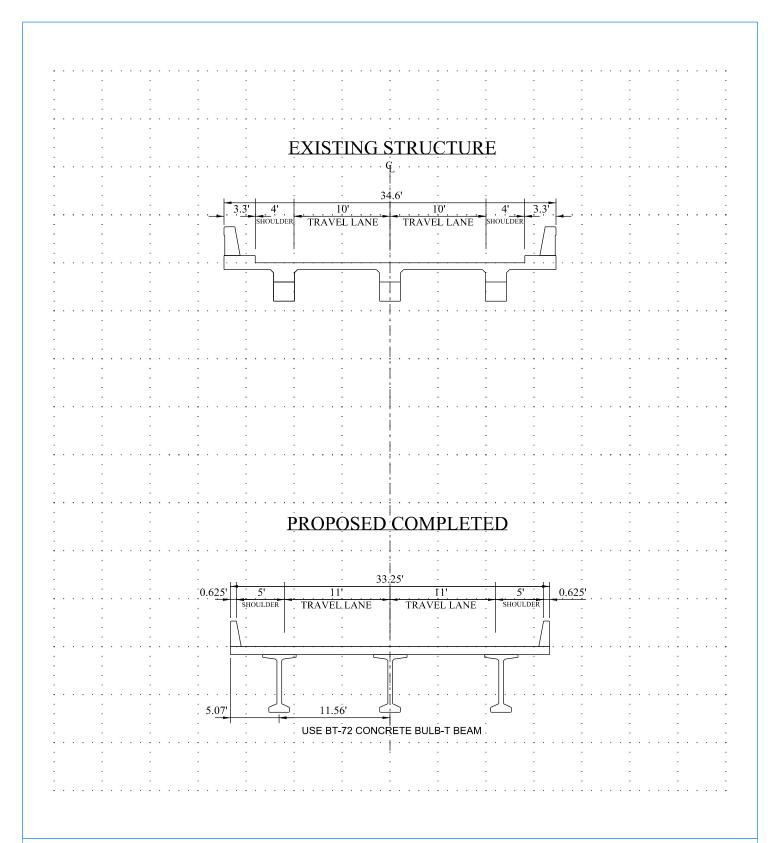
## **CROSS-SECTION DETAIL**

The proposed project is being developed through the TDOT Alternative Delivery Division. As indicated in the Concept Report (02/07/2023) and the Line & Grade Plans (05/21/2025), the proposed replacement structure would be a 154-ft long, concrete beam bridge with a single span, and have an out-to-out width of 33-ft 3-inches. The proposed bridge would be raised approximately 4-inches to increase the bridge clearance to 17-ft. The typical section of the proposed bridge would consist of two, 11-ft wide travel lanes and 5-ft wide shoulders.

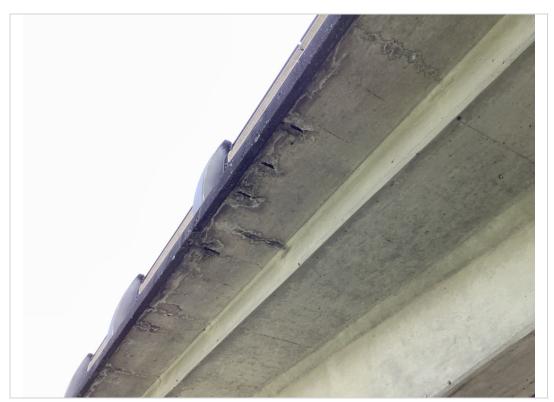
Typical delaminated areas in overhang

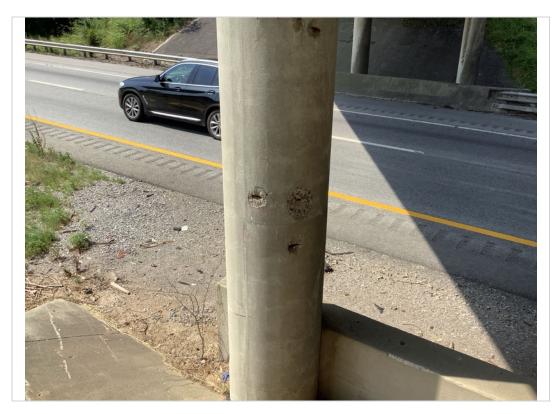
Typical spall with exposed rebar

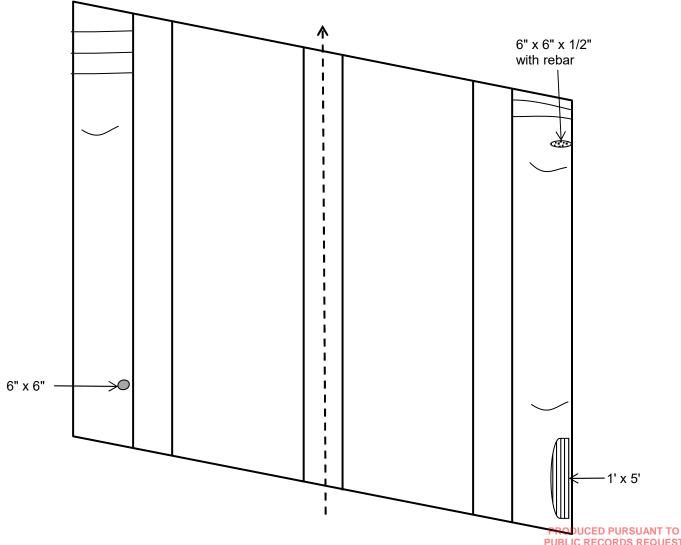
The superstructure is rated fair. The beams have widespread minor cracking.

#### -Cracks are hairline with efflorescence

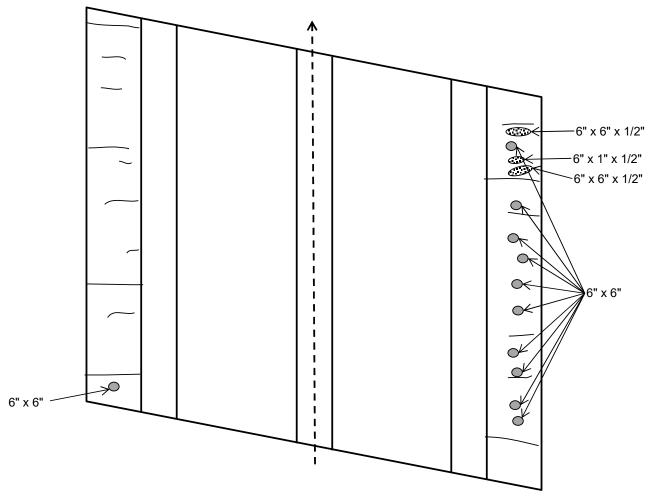
-Cracks are hairline with efflorescence

-All spalls have rebar

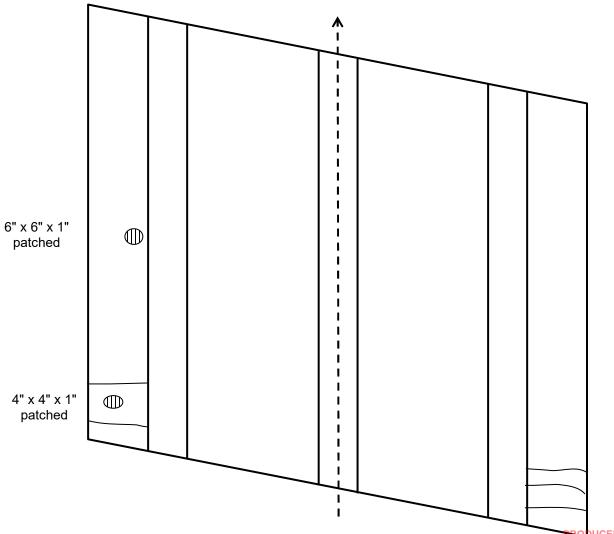
#### Top of Deck Span No. 3

cracks are hairline with efflorescence
