# QLA DATA SHEET

| TEST HOLE DATA REPORT | | |
|---|---|---|
| PROJECT NO: 132524.00 | | CITY, COUNTY: NASHVILLE / DAVIDSON |
| CLIENT PROJECT: ASI / SR-6 | | LOCATION/INTERSECTION: SR-6 (GALLATIN PIKE) |

VACUUM TEST HOLE REPORT NO.:

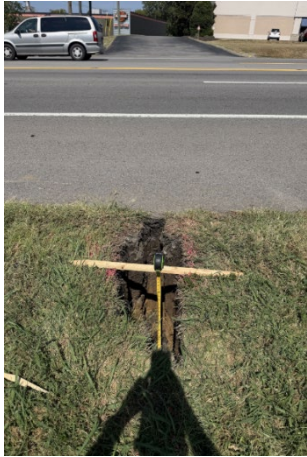
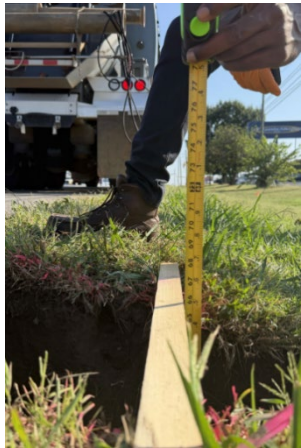
| TEST HOLE DATA REPORT | | |
|---|---|---|
| MAP | | SITE PHOTO |

| TEST HOLE DATA REPORT | | |
|---|---|---|
| UTILITY TYPE | UGF | NORTHING 718461.1470 |
| UTILITY MATERIAL | PLASTIC CONDUIT | EASTING 1765776.7210 |
| APPARENT UTILITY OWNER | ZAYO | STATION 107+40.74 |

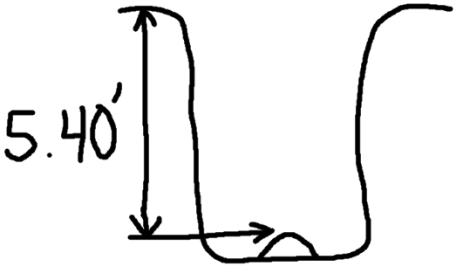
| TEST HOLE DATA REPORT | | |
|---|---|---|
| CROSS SECTION - NOT TO SCALE | | TEST HOLE - UTILITY |

| TEST HOLE DATA REPORT | | |
|---|---|---|
| UTILITY DIRECTION | W/E | ELEVATION 536.71' |
| UTILITY WIDTH (RECORD) | 2', 1", (2 CONDUITS) | MARKED BY - |
| TOP OF UTILITY | 5.40' | OFFSET FROM: SR6 GALLATIN PK |
| TOP OF UTILITY | 531.31' | |

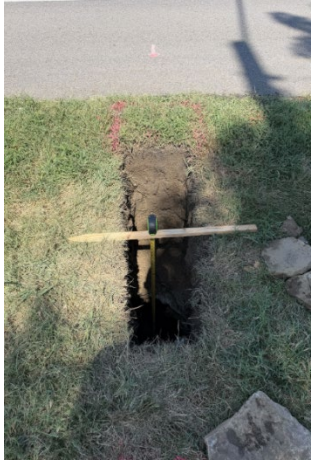
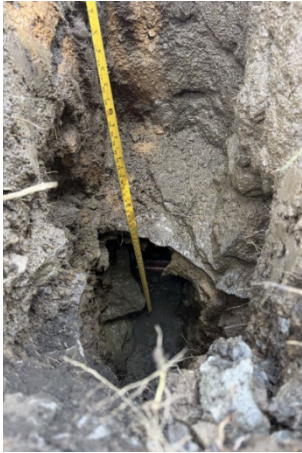
| TEST HOLE DATA REPORT | | |
|---|---|---|
| MAP | | SITE PHOTO |

| TEST HOLE DATA REPORT | | |
|---|---|---|
| UTILITY TYPE | UGF | NORTHING 718606.3790 |
| UTILITY MATERIAL | PLASTIC CONDUIT | EASTING 1765953.2870 |
| APPARENT UTILITY OWNER | ZAYO | STATION 109+69.36 |

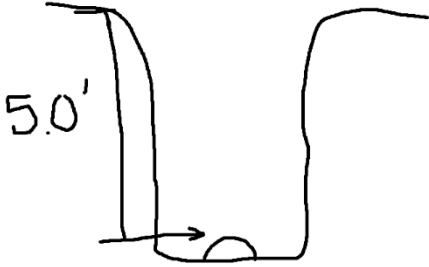
| TEST HOLE DATA REPORT | | |
|---|---|---|
| CROSS SECTION - NOT TO SCALE | | TEST HOLE - UTILITY |

| TEST HOLE DATA REPORT | | |
|---|---|---|
| UTILITY DIRECTION | W/E | ELEVATION 540.61' |
| UTILITY WIDTH (RECORD) | 2" | MARKED BY - |
| TOP OF UTILITY | 5.00' | OFFSET FROM: SR6 GALLATIN PK |
| TOP OF UTILITY | 535.61' | |

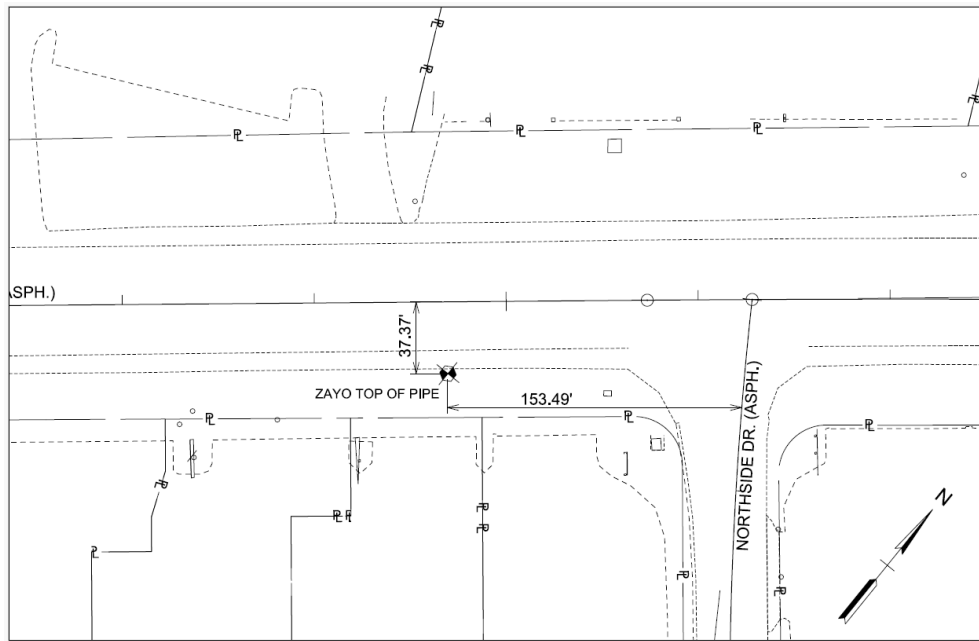
NOT TO SCALE

| UTILITY REQUESTED: | 2" PVC | SHEET#: | OF PROPOSED: ROADWAY WORK |
| UTILITY FOUND: | 2" PVC | FORM BY: | ASSISTED BY: # OF HOLES: 1 |
| MATERIAL AS FOUND: | PVC | PAVING CONDITION: | DATE DUG: |
| SIZE AS FOUND: | 2" | SOIL CONDITIONS: | |
| 540.61' | _____ | INSTALLED: AT: OF UTILITY. MARKING TAPE: | |
| 5.00' | | SURVEY INFO.: ALL MEASUREMENTS ON THIS FORM ARE IN US SURVEY FEET.<br><br>HORIZONTAL DATUM = NAD83(2011)<br>VERTICAL DATUM = NAVD 1988<br>ADJUSTED BY SCALE FACTOR OF 1.00006 AND TIED TO TGRN<br>GEOID 18 MODEL | |
| 535.61' | | | |
| | WIDTH<br>2" | FACING<br>W/E | |

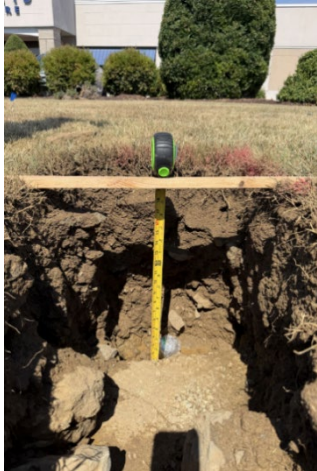
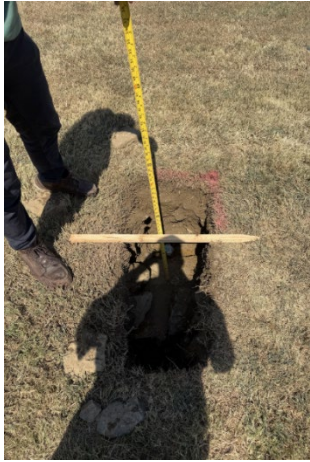
| TEST HOLE DATA REPORT | | |
|---|---|---|
| MAP | | SITE PHOTO |

| TEST HOLE DATA REPORT | | |
|---|---|---|
| UTILITY TYPE | UGF | NORTHING 718637.1670 |
| UTILITY MATERIAL | PLASTIC CONDUIT | EASTING 1765826.7380 |
| APPARENT UTILITY OWNER | MCI | STATION 108+91.39 |

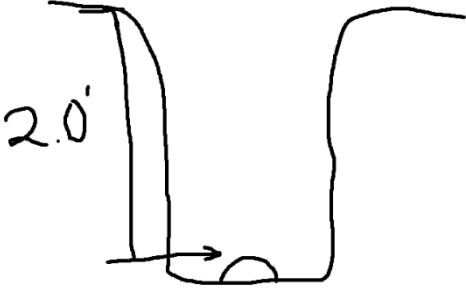
| TEST HOLE DATA REPORT | | |
|---|---|---|
| CROSS SECTION - NOT TO SCALE | | TEST HOLE - UTILITY |

| TEST HOLE DATA REPORT | | |
|---|---|---|
| UTILITY DIRECTION | W/E | ELEVATION 541.82 |
| UTILITY WIDTH (FIELD) | 1", 2", 1" (3 CONDUITS) | LOCATION CENTER OF UTILITY |
| TOP OF UTILITY | 2.00' | OFFSET FROM: SR6 GALLATIN PK |
| TOP OF UTILITY | 539.82' | |

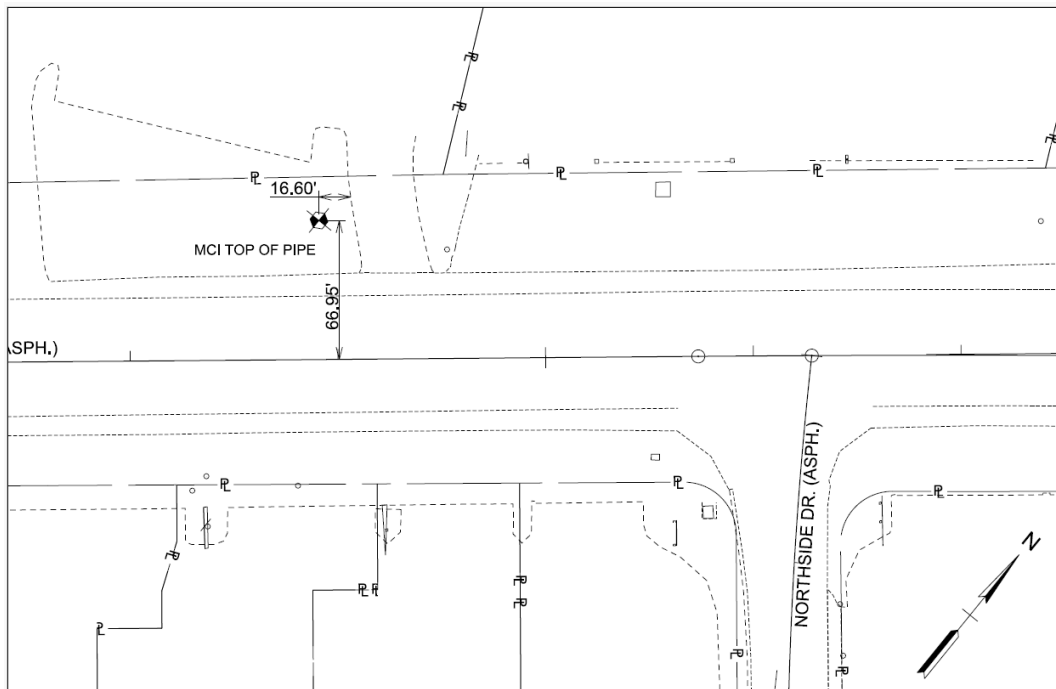
NOT TO SCALE

| UTILITY REQUESTED: | 2-1" AND 1-2" PVC | SHEET#: | OF PROPOSED: ROADWAY WORK |
| UTILITY FOUND: | 2-1" AND 1-2" PVC | FORM BY: | ASSISTED BY: # OF HOLES: 1 |
| MATERIAL AS FOUND: | PLASTIC CONDUIT | PAVING CONDITION: | DATE DUG: |
| SIZE AS FOUND: | 2" | SOIL CONDITIONS: | |
| 541.82' | _____ | INSTALLED: AT: OF UTILITY. MARKING TAPE: | |
| 2.00' | | SURVEY INFO.: ALL MEASUREMENTS ON THIS FORM ARE IN US SURVEY FEET. | |
| 539.82' | | HORIZONTAL DATUM = NAD83(2011) | |
| | WIDTH 2" | FACING W/E | |

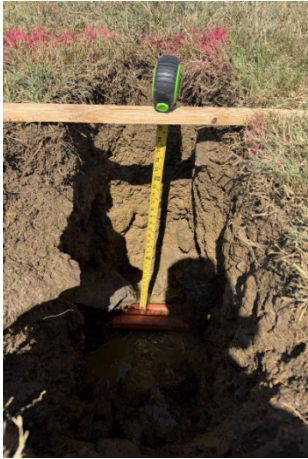
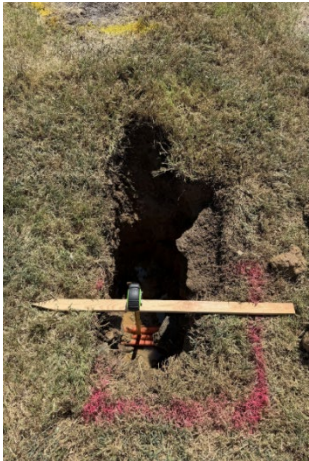
| TEST HOLE DATA REPORT | | |
|---|---|---|
| MAP | | SITE PHOTO |

| TEST HOLE DATA REPORT | | |
|---|---|---|
| UTILITY TYPE | UGF | NORTHING 718599.1930 |
| UTILITY MATERIAL | PLASTIC CONDUIT | EASTING 1765774.778 |
| APPARENT UTILITY OWNER | MCI | STATION 108+27.15 |

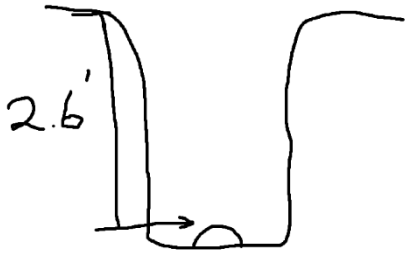
| TEST HOLE DATA REPORT | | |
|---|---|---|
| CROSS SECTION - NOT TO SCALE | | TEST HOLE - UTILITY |

| TEST HOLE DATA REPORT | | |
|---|---|---|
| UTILITY DIRECTION | W/E | ELEVATION 538.52' |
| UTILITY WIDTH (FIELD) | 1", 2", 1" (3 CONDUITS) | LOCATION CENTER OF UTILITY |
| TOP OF UTILITY | 2.60' | OFFSET FROM: SR6 GALLATIN PK |
| TOP OF UTILITY | 538.52' | |

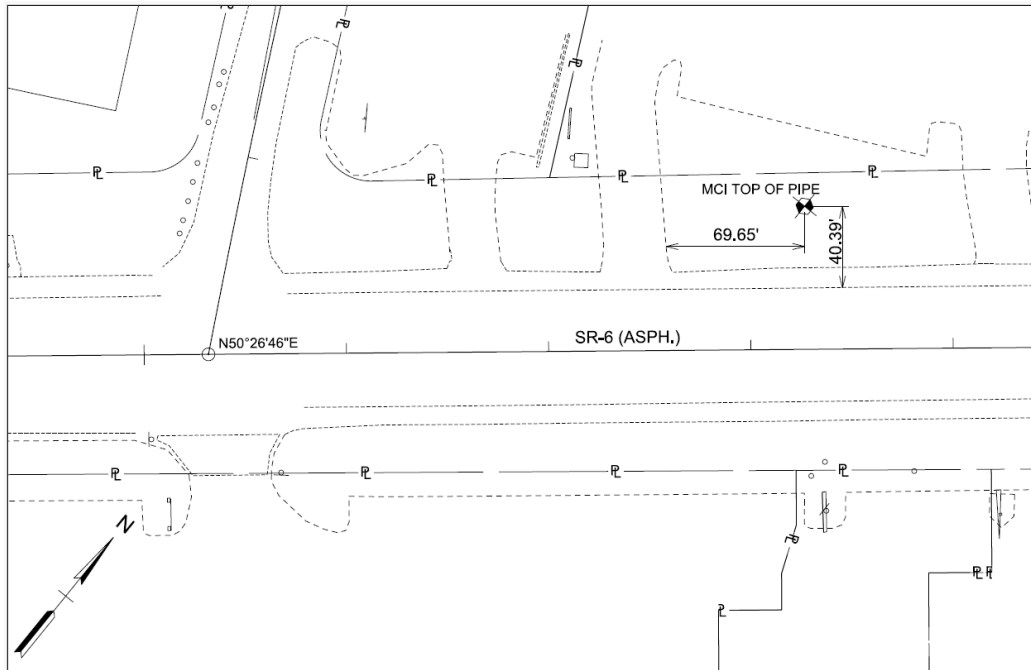
NOT TO SCALE

| UTILITY REQUESTED: | 2-1" AND 1-2" PVC | SHEET#: | OF PROPOSED: ROADWAY WORK |
| UTILITY FOUND: | 2-1" AND 1-2" PVC | FORM BY: | ASSISTED BY: # OF HOLES: 1 |
| MATERIAL AS FOUND: | PLASTIC CONDUIT | PAVING CONDITION: | DATE DUG: |
| SIZE AS FOUND: | 2" | SOIL CONDITIONS: | |
| 541.12' | _____<br>INSTALLED: | AT: OF UTILITY. MARKING TAPE: | |
| 2.60' | | SURVEY INFO.: ALL MEASUREMENTS ON THIS FORM ARE IN US SURVEY FEET. | |
| 538.52' | | HORIZONTAL DATUM = NAD83(2011) | |
