# Report of Preliminary Geotechnical Exploration

## Epps Mill Road Interchange Project Bridge Report

TDOT Project No. 75I024-S1-010  
GES File No. 7513321 / PIN No. 124683.06  
Murfreesboro, Rutherford County, Tennessee

Project No. 00024082902.00  
September 23, 2025

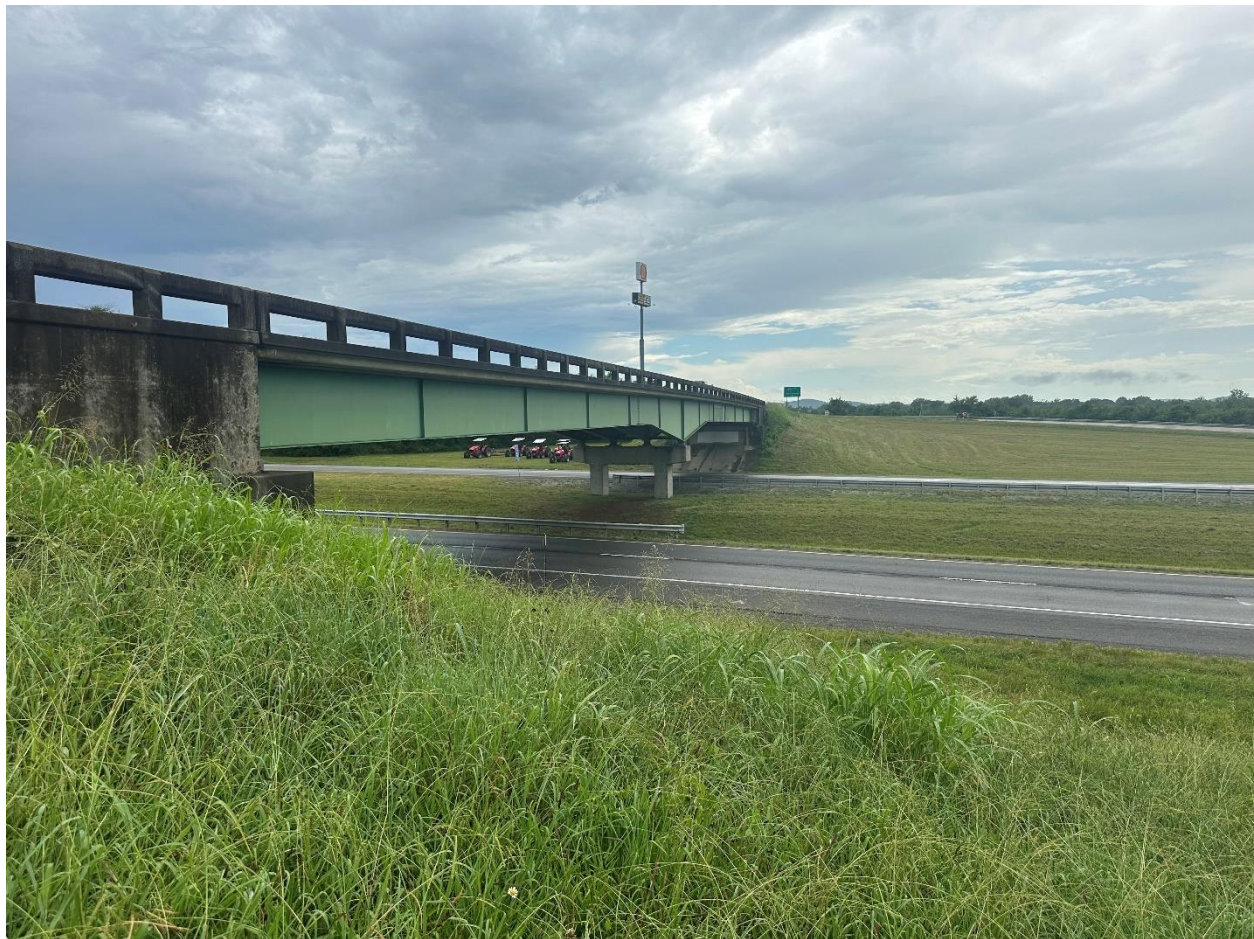
View looking south at existing Epps Mill Road Bridge

| Item | Description |
|---|---|
| Current Ground Cover | The ground surface below the bridge is mostly grass covered. Asphalt pavements are present on the east and west bound travel lanes and shoulders of I-24. The slopes below the abutments are concrete covered. |

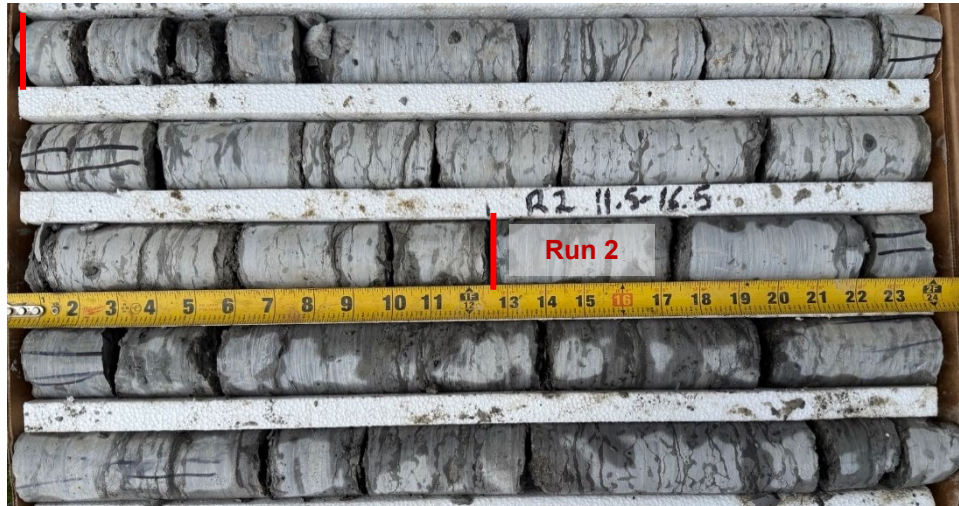
Boring B-04  
6-½ feet to 16-½ feet

| Run No. | Depth (feet) | Recovery (percent) | RQD (percent) | Rock Quality |
|---|---|---|---|---|
| 1 | 6-½ to 11-½ | 100 | 56 | Fair |

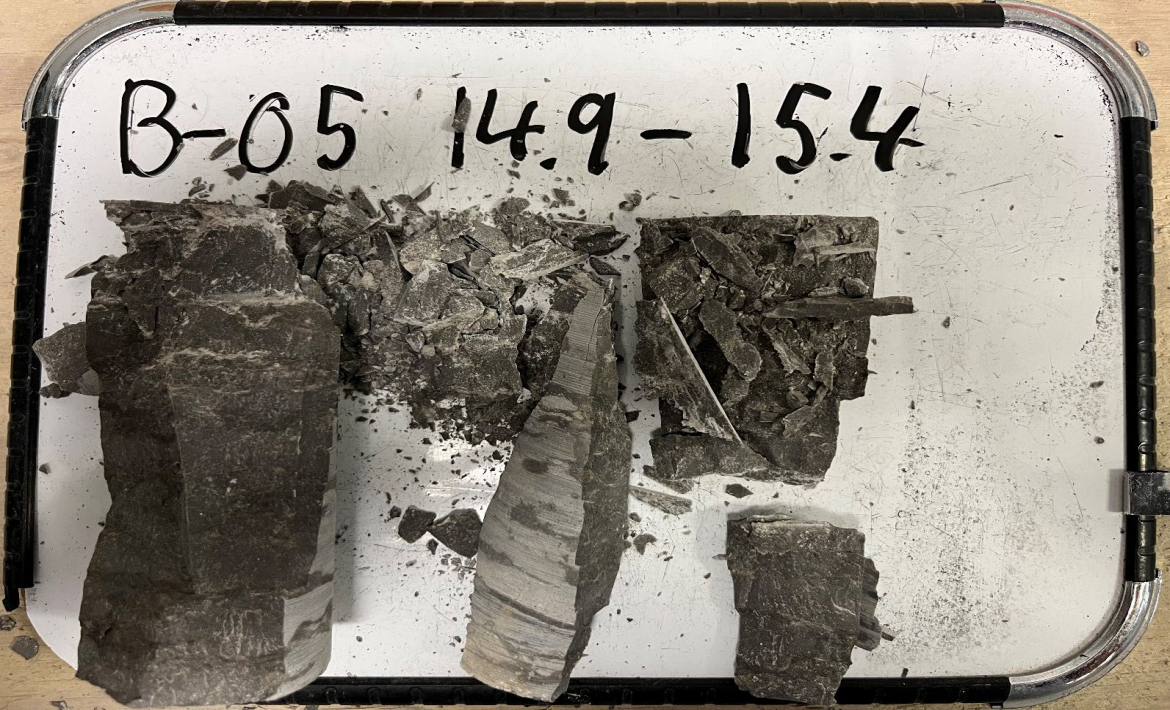
| Boring No. | Specimen Depth (ft) | Avg. Diameter (in) | Length (in) | Load (lbs) | Area (in <sup>2</sup> ) | l/d Ratio | Correction Factor | Density (lb/ft <sup>3</sup> ) | Time to Failure (min:sec) | Compressive Strength (psi) |
|---|---|---|---|---|---|---|---|---|---|---|
| B-05 | 14.9-15.4 | 1.979 | 4.748 | 18,294 | 3.076 | 2.4 | 1 | 168.0 | 2:36 | 5,950 |

Stress Rate: 80 psi/s
