# Report of Preliminary Geotechnical Exploration

## Epps Mill Road Interchange Project Mainline Report

TDOT Project No. 75I024-S1-010  
GES File No. 7513321 / PIN No. 124683.06  
Murfreesboro, Rutherford County, Tennessee

*Prepared by:*  
TTL, Inc.  
Nashville, Tennessee

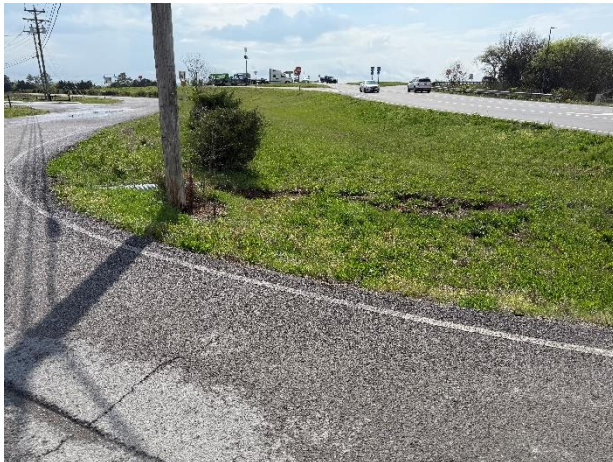
View of Epps Mill Road near its intersection with  
Miller Lane

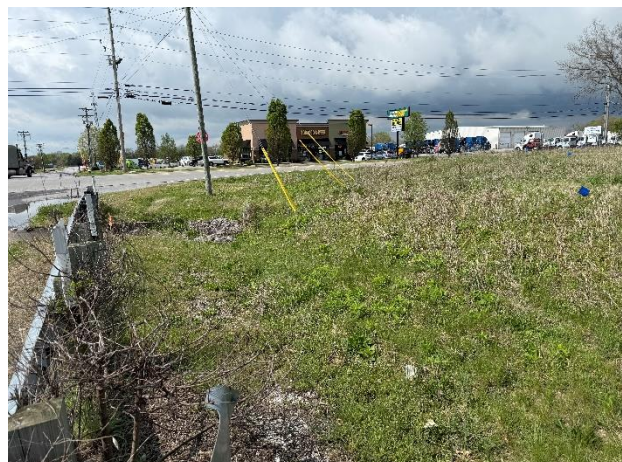
View of Epps Mill Road near its intersection with  
Forbus Drive

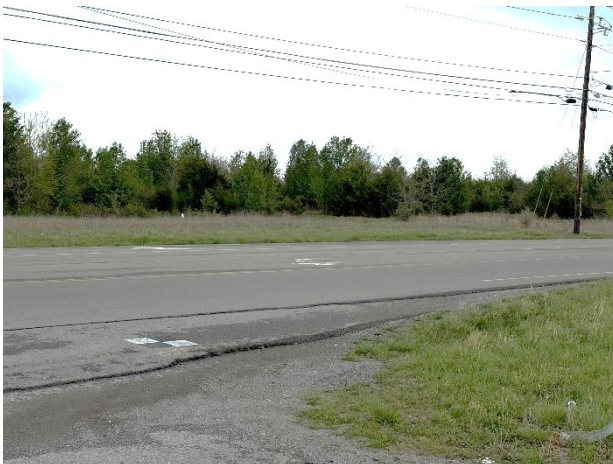
View of Epps Mill Road near its intersection with  
Capital Way

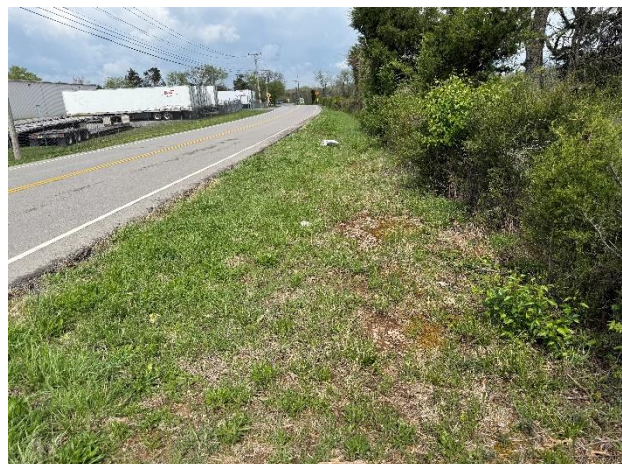
View of Epps Mill Road looking north towards its  
intersection with SR2

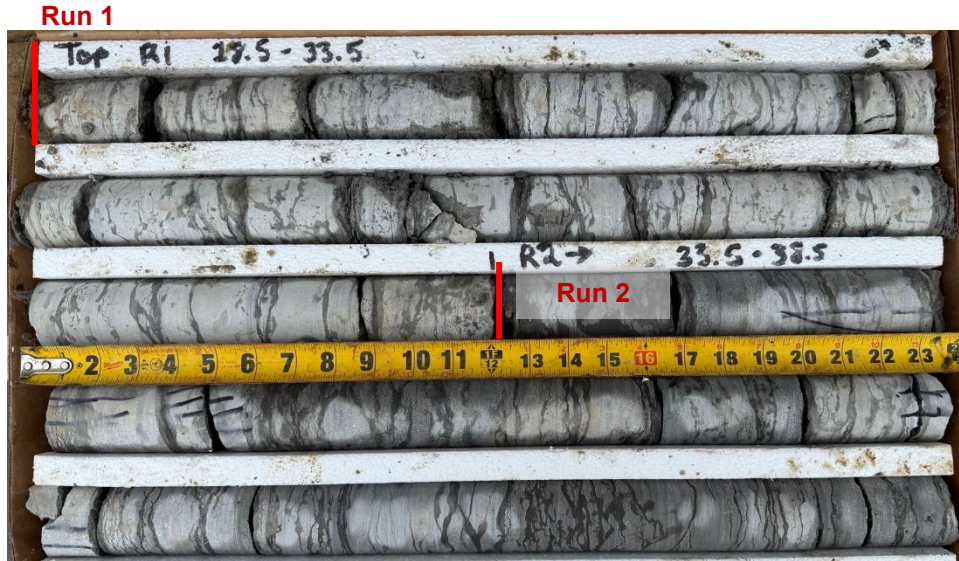
Boring B-02  
28-½ feet to 38-½ feet

| Run No. | Depth (feet) | Recovery (percent) | RQD (percent) | Rock Quality |
| 1 | 28-½ to 33-½ | 100 | 76 | Good |
