**RE: Bridge ACM Assessment Report**  
**Bridge Number: 24014580003**  
**SR-193 Bridge over Branch, LM 7.72**  
**Const: 24029-4205-04 PIN: 118540.00**  
**Fayette County, Tennessee**

## TENNESSEE DEPARTMENT OF TRANSPORTATION ACM ASSESSMENT REPORT

Bridge Number: 24014580003  
SR-193 Bridge over Branch, LM 7.72  
Const: 24029-4205-04  
PIN: 118540.00  
Fayette County, Tennessee

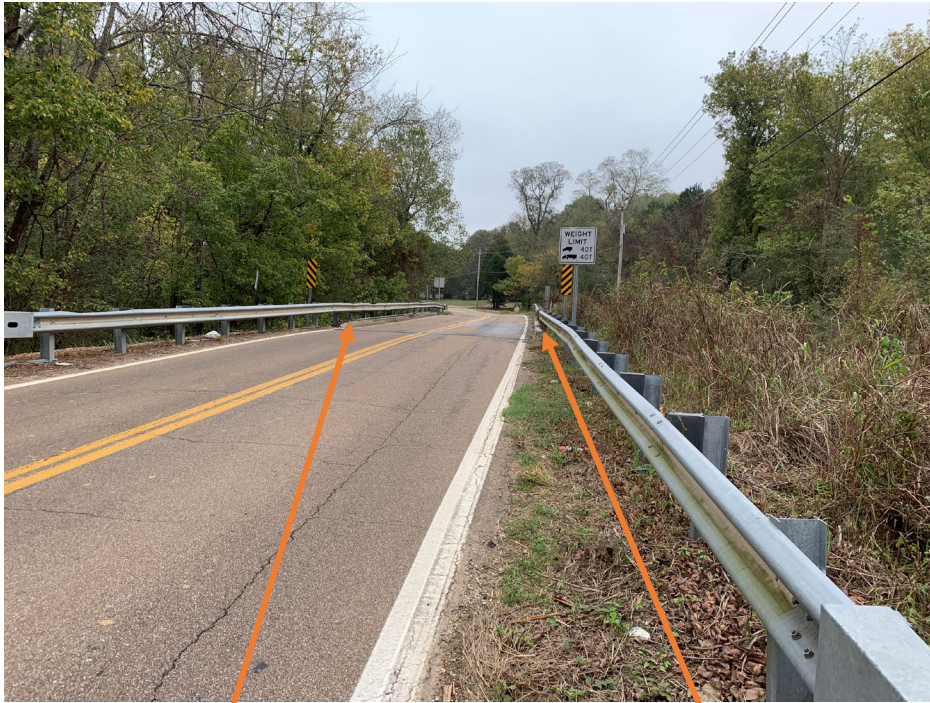
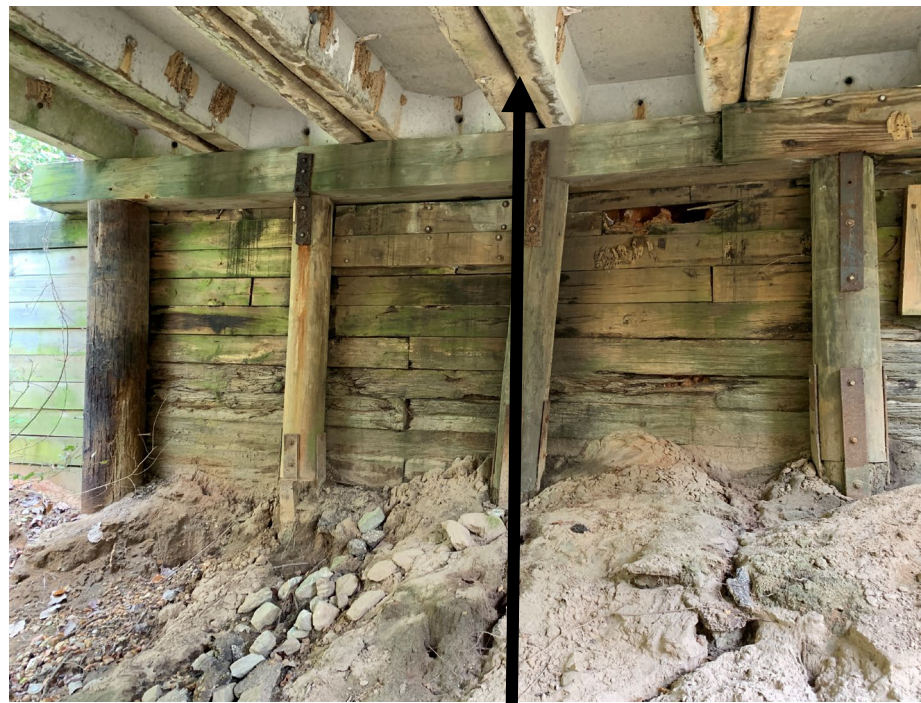
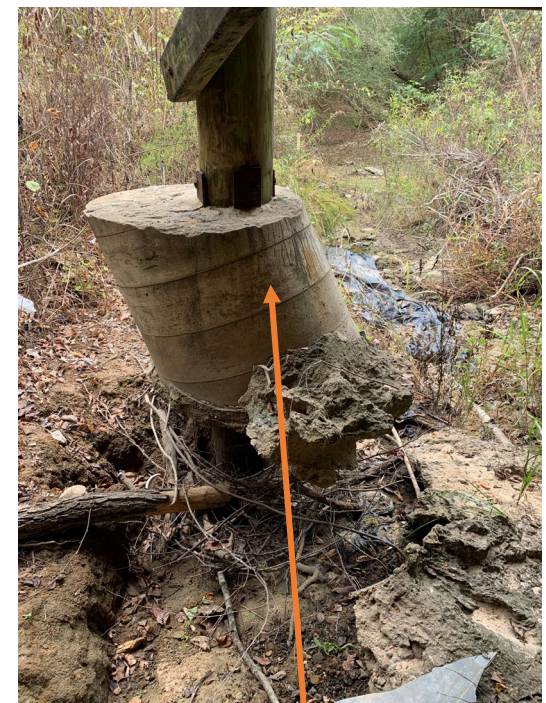
Figure 2: Sample  
Locations

A total of 12 samples were obtained from the bridge. A depiction of the sample locations is shown on Figure 2. Multiple samples of each homogeneous area were collected in accordance with State of Tennessee, Department of Transportation Environmental Division, Social and Cultural Resources Office, Hazardous Materials Section requirements and delivered to the laboratory for visual observation and microscopic analysis. The samples were selected based on homogeneous areas of suspect materials, as described in Section 2.3.

**HA-2**  
Old Curb  
3-2-4  
3-2-5  
3-2-6

**HA-1**  
New Curb  
3-1-1  
3-1-2  
3-1-3

**HA-4**  
Bottom of  
Deck  
3-4-10  
3-4-11  
3-4-12

**HA-3**  
Pier Base  
3-3-7  
3-3-8  
3-3-9

HA #1 and #2 location are switched. (Old Curb is HA-2 and New curb is HA-1)

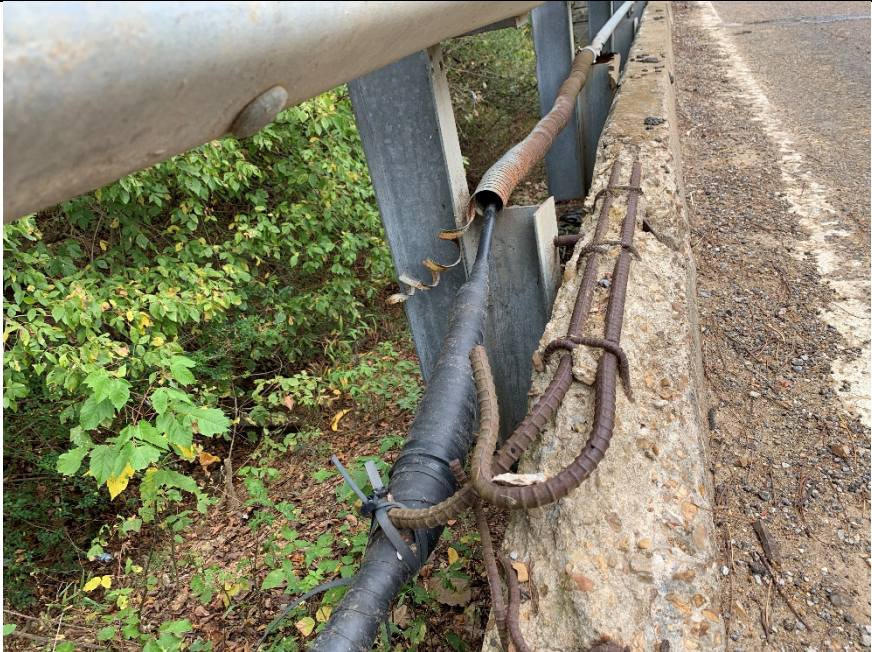
| <b>Description:</b><br>Photograph 2:<br><br><b>Exposed rebar along old curb.</b><br><br><b>Utility line wrapped in tape (not sampled)</b> | |

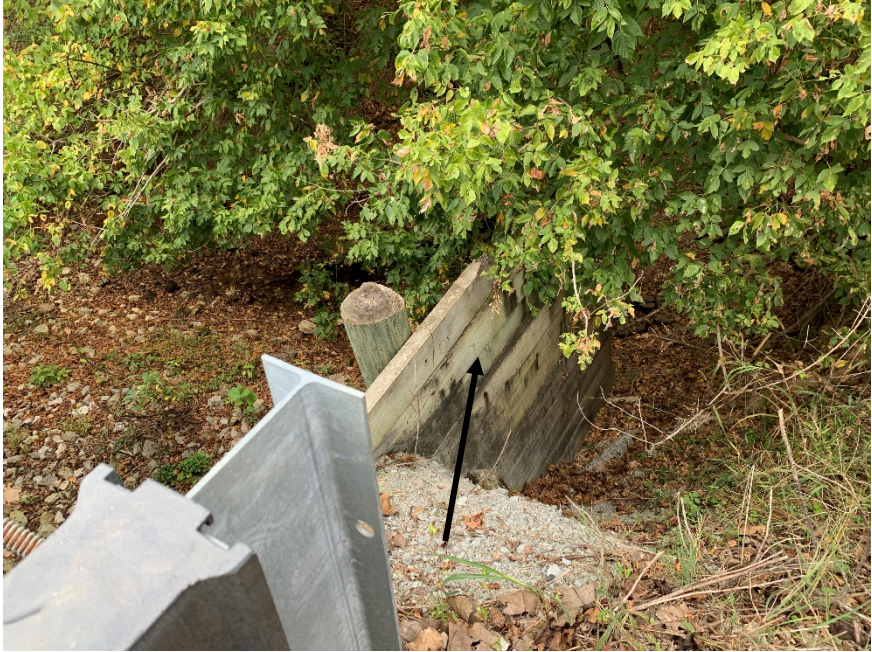
Bridge Number 24014580003 is located over Branch LM 7.72 (24-SR193-07.71), is a two-lane, 77-foot, four-span bridge constructed of pre-stressed concrete channel beams with a concrete deck and asphalt wearing surface. The end walls and the wing walls were constructed of wood. The bridge was constructed in 1965. The bridge location is shown on Figure 1.

| <b>Description:</b><br>Photograph 3:<br><br><b>Wooden wing wall</b> | |

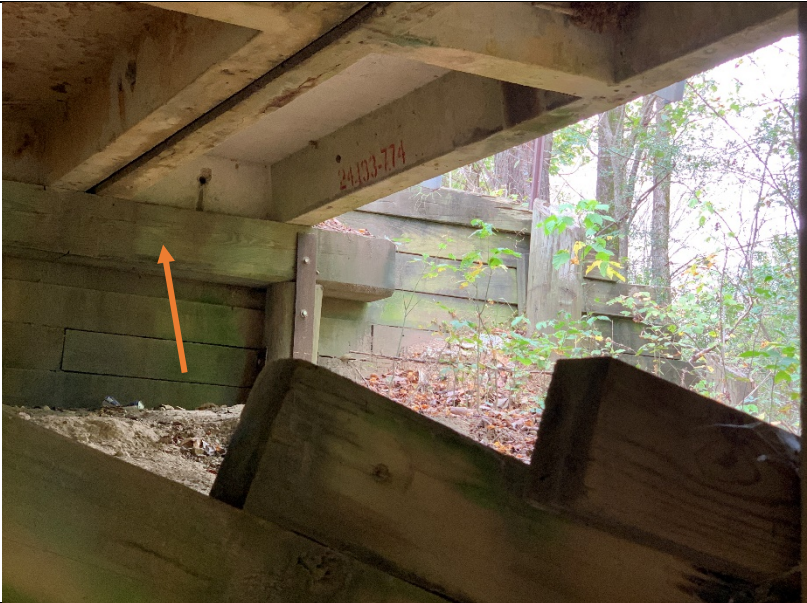
| <b>Description:</b><br>Photograph 4:<br><br><b>Wooden<br/>Endwall/abutment</b> | |

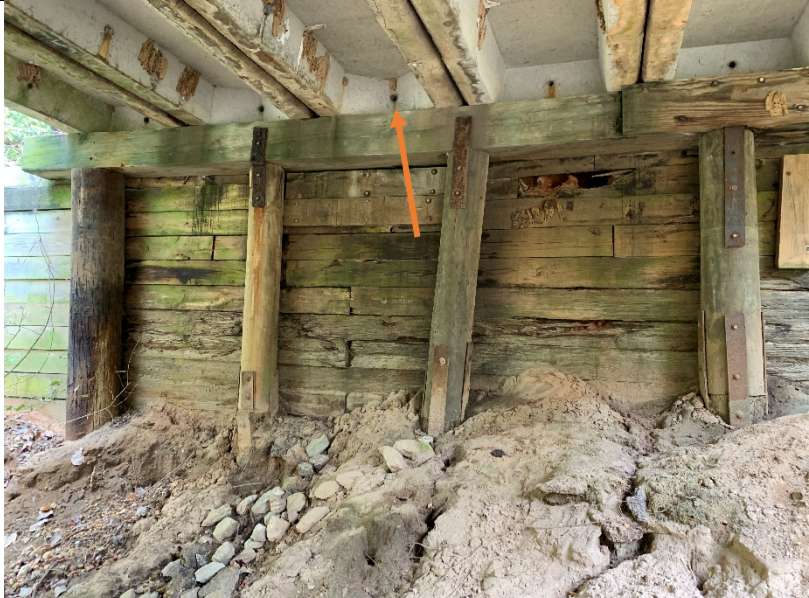
Cast in place drains are located on both ends of the bridge. Samples were not collected.

| <b>Description:</b><br>Photograph 5:<br><br><b>Cast in place drains<br/>(not sampled)</b> | |

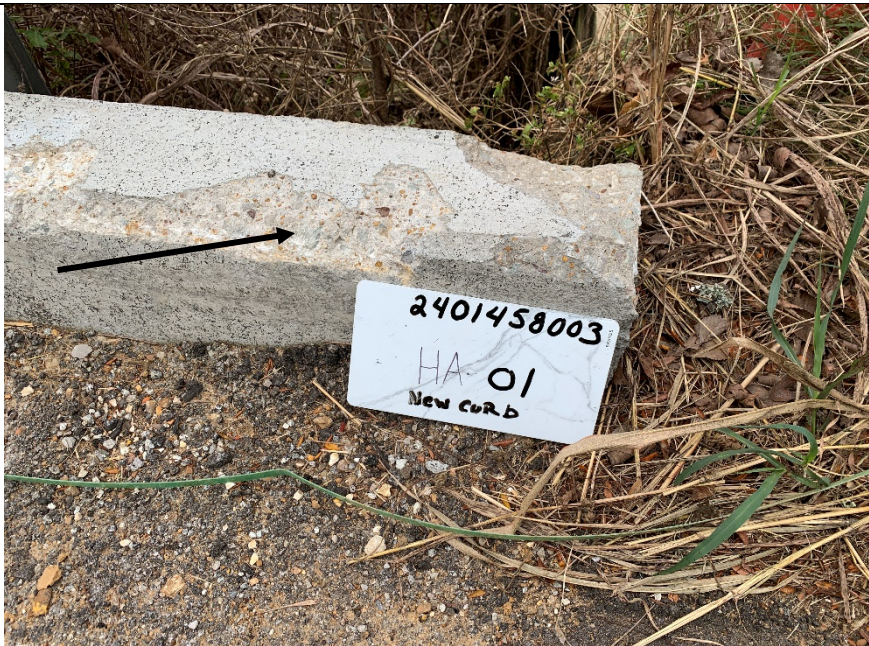
Three samples labeled 3-1-1, 3-1-2, 3-1-3 were collected from the new curb. Three samples labeled 3-2-4, 3-2-5, 3-2-6 were collected from the old curb. Samples obtained using a hammer.

Asbestos minerals were not detected in the collected samples.

| <b>Description:</b><br>Photograph 6:<br><br><b>HA-1<br/>New Curb<br/>3-1-1<br/>3-1-2<br/>3-1-3</b> | |

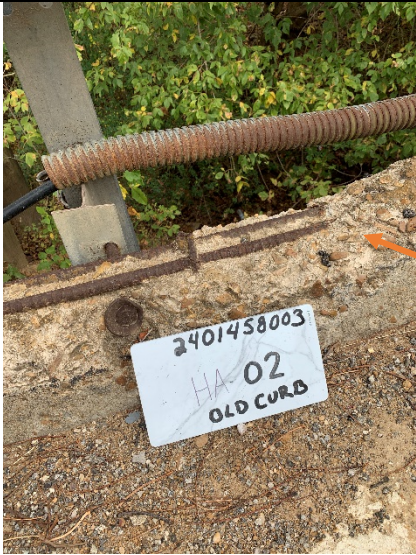
| <b>Description:</b><br>Photograph 7:<br><br><b>HA-2<br/>Old Curb</b><br>3-2-4<br>3-2-5<br>3-2-6 | |

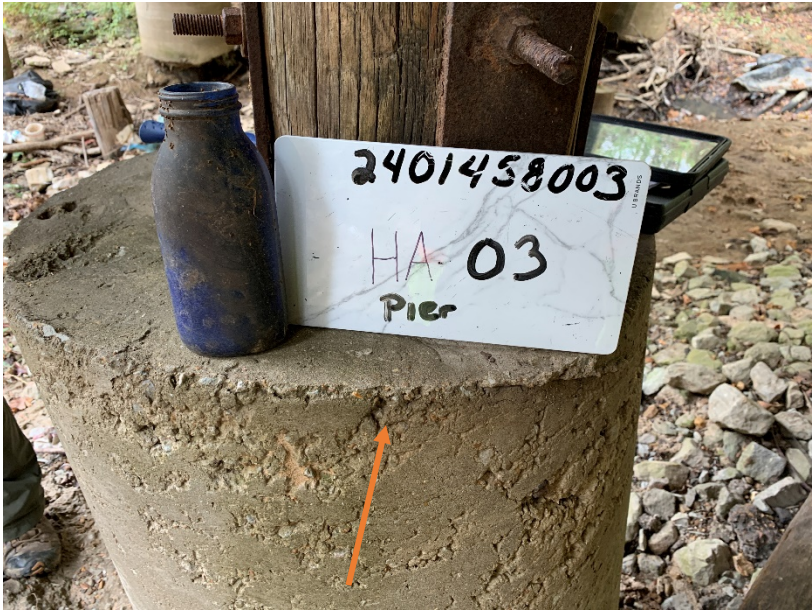
Three samples labeled 3-4-10, 3-4-11, 3-4-12 were collected from the pier bases. The piers were constructed of wood. Samples of the pier bases were obtained using a hammer.

| <b>Description:</b><br>Photograph 8:<br><br><b>HA-3<br/>Pier Base</b><br>3-3-7<br>3-3-8<br>3-3-9 | |
