## ASBESTOS INSPECTION REPORT

Bridge Number 24F00240001  
SR-196 over Branch of Russell Creek LM 1.35  
PIN: 134849.00; PE-D: 24S196-S1-005  
Fayette County, Tennessee

Re: Asbestos Inspection Report  
Bridge No.: 24F00240001  
Termini: SR-196 Bridge over Branch of Russell Creek, LM 1.35 (TMA)  
PIN: 134849.00; PE-D: 24S196-S1-005  
County: Fayette  
TTL Project Number 240800285.00

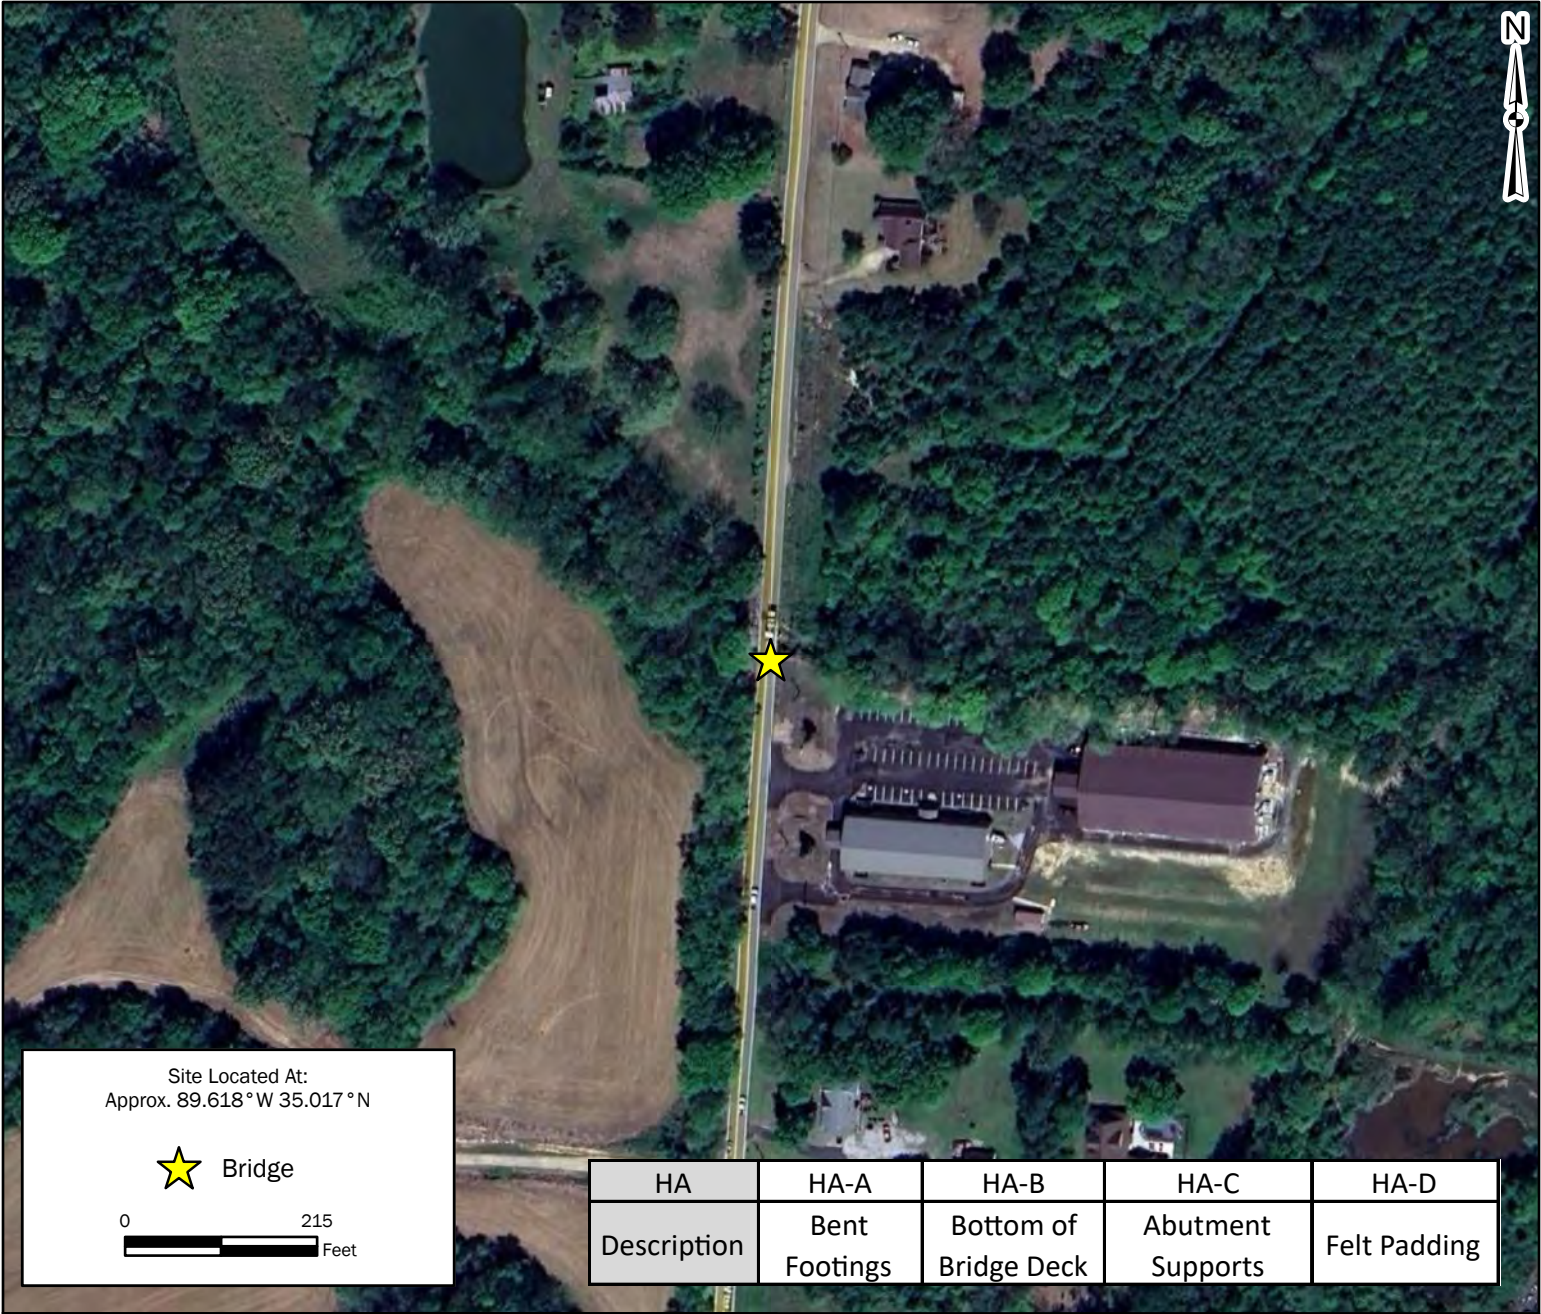
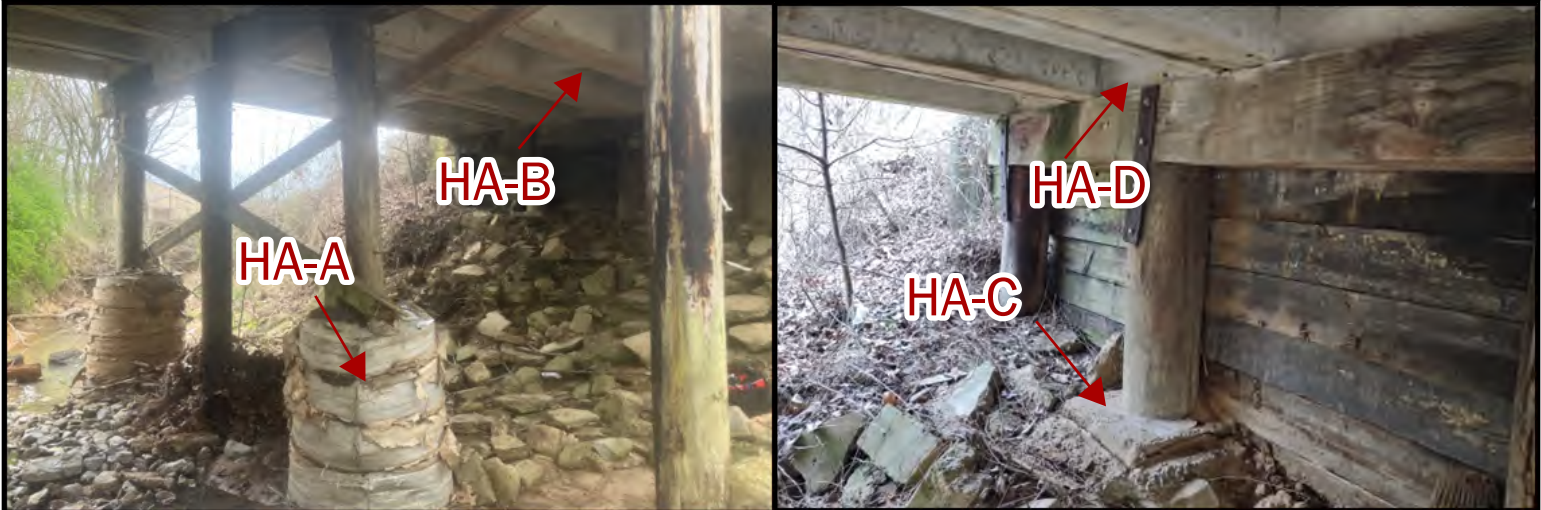
## FIGURE 2: SAMPLE LOCATION MAP

Individual bridge components sampled during our survey are as described in the following subsections. Materials such as metal, wood, fiberglass, and foam (if present) were not considered suspect ACM and not sampled. Materials associated with the upper bridge wearing surfaces (i.e., reflector mastic, asphalt, pavement marker mastic, etc.) were not sampled per TDOT's request. TTL collected bulk samples of each identified HA in a representative manner, as determined by the inspector. The sample locations are depicted on **Figure 2**.

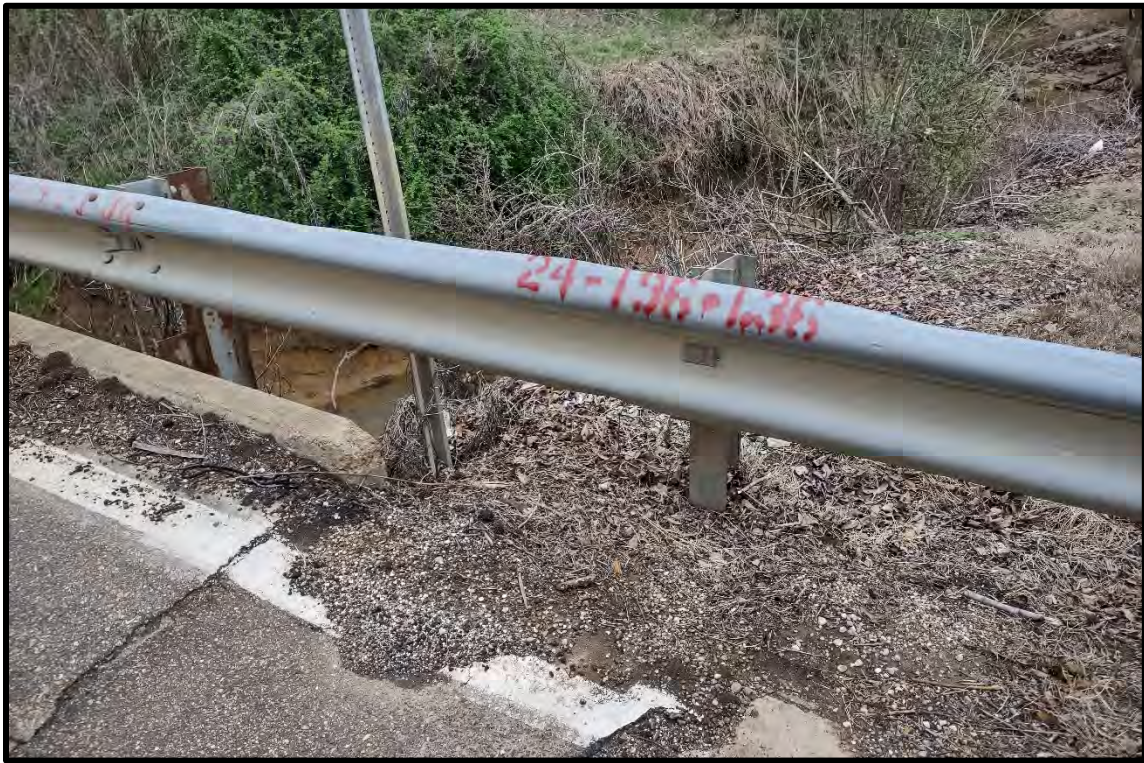
**Photo 1:** View of the bridge number.

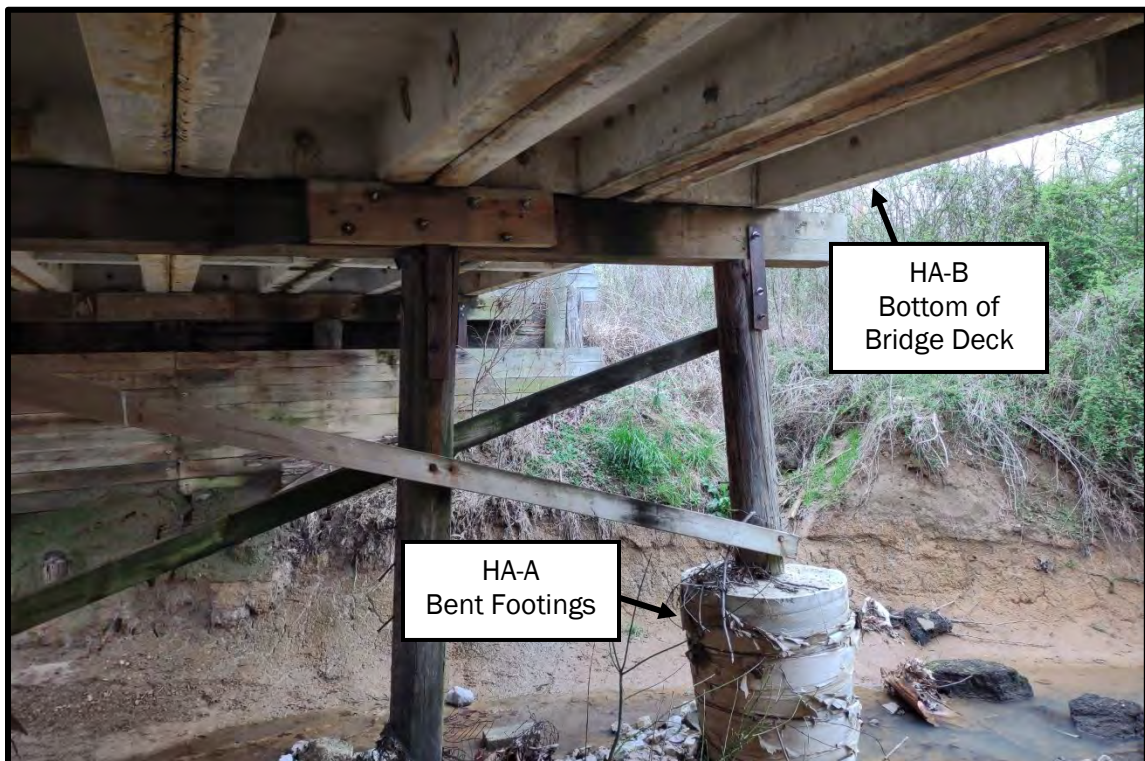
Three bulk samples of concrete were collected from the bent footings.

Three bulk samples of concrete were collected from the bottom of the bridge deck.

**Photo 2:** View of HA-A and HA-B on the southern end of the bridge, facing north.

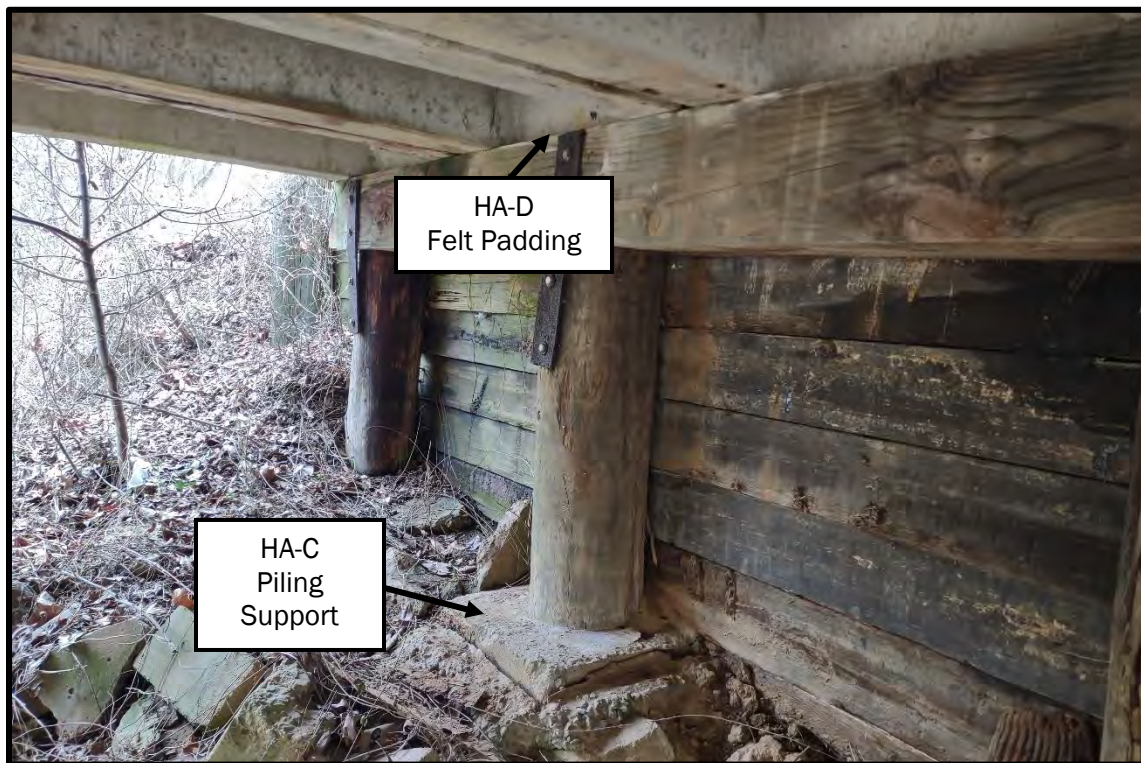
Three bulk samples of concrete were collected from the piling support.

Three bulk samples of felt padding were collected between the bearings.

**Photo 3:** View of HA-C and HA-D on the southern end of the bridge, facing southeast.

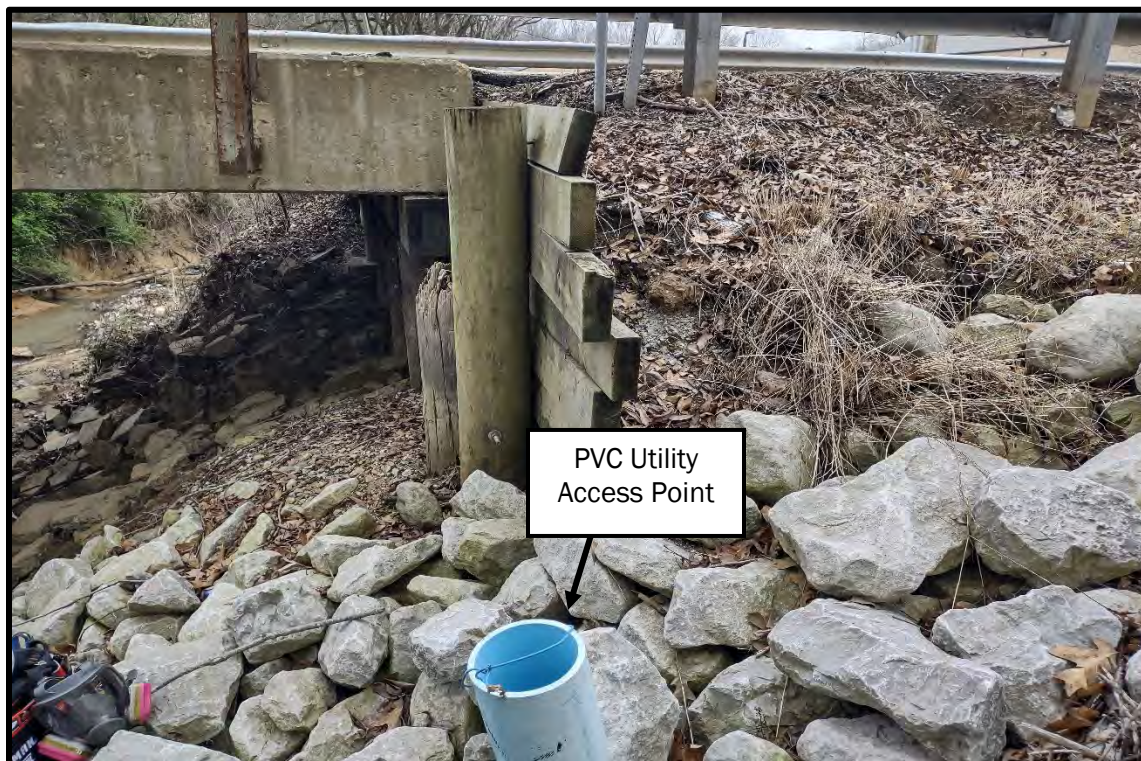
An access point for a utility conduit comprised of PVC was observed along the southwest corner of the bridge. No suspect materials related to the utility conduit were observed during the site visit.

**Photo 3:** View of access point for a utility conduit comprised of PVC along the southwest corner of the bridge, facing east.
