**RE: Asbestos Assessment Report**  
**11 Bridges on Various State Routes over Various Crossings**  
**TDOT Const: 38945-4270-04, PIN: 125341.00**  
**Bridge Number: 38S80520001**  
**Haywood County, Tennessee**

## **TENNESSEE DEPARTMENT OF TRANSPORTATION ASBESTOS ASSESSMENT REPORT**

Bridge Number: 38S80520001

Haywood County, Tennessee

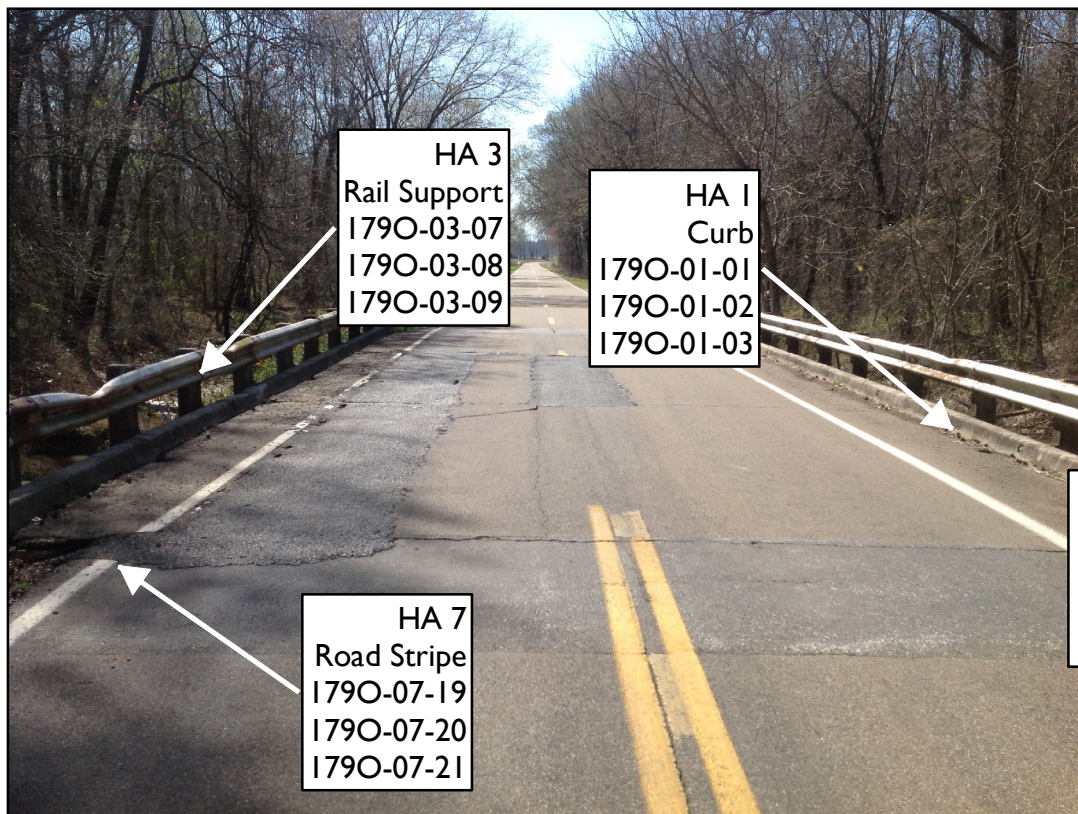
**HA 1**  
 Curb  
 179O-01-01  
 179O-01-02  
 179O-01-03

**HA 5**  
 Slope Wall  
 179O-05-13  
 179O-05-14  
 179O-05-15

**HA 4**  
 Underside of Deck  
 179O-04-10  
 179O-04-11  
 179O-04-12

Not Pictured:  
 HA-2 Rail Pad  
 179O-02-04  
 179O-02-05  
 179O-02-06

**HA 6**  
 Bent Foundation  
 179O-06-16  
 179O-06-17  
 179O-06-18

**Notes:**  
 Locations are typical of the homogeneous area, some sample locations were not visible from the angle of the photo therefore a representative location was labeled.  
 HA = Homogeneous Area

A total of 21 samples were obtained from the bridge. A depiction of the sample locations is shown on Figure 2. Multiple samples of each homogeneous area were collected in accordance with State of Tennessee, Department of Transportation Environmental Division, Social and Cultural Resources Office, Hazardous Materials Section requirements and delivered to the laboratory for visual observation and microscopic analysis. The samples were selected based on homogeneous areas of suspect materials, as described in Section 2.2.

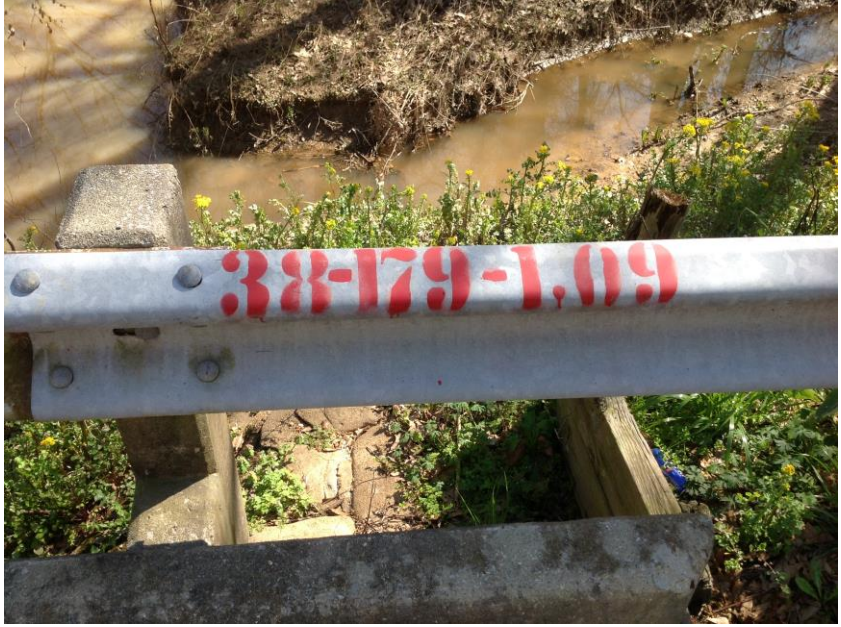
| <b>Description:</b><br>Photograph 1 –<br><br>Bridge number | |

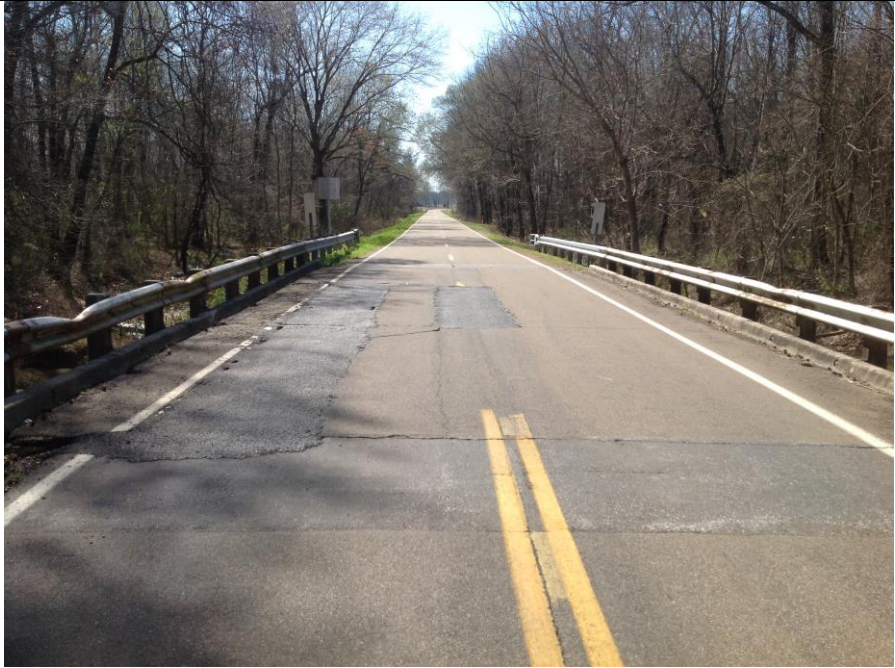
| <b>Description:</b><br>Photograph 2 –<br><br>View across deck | |

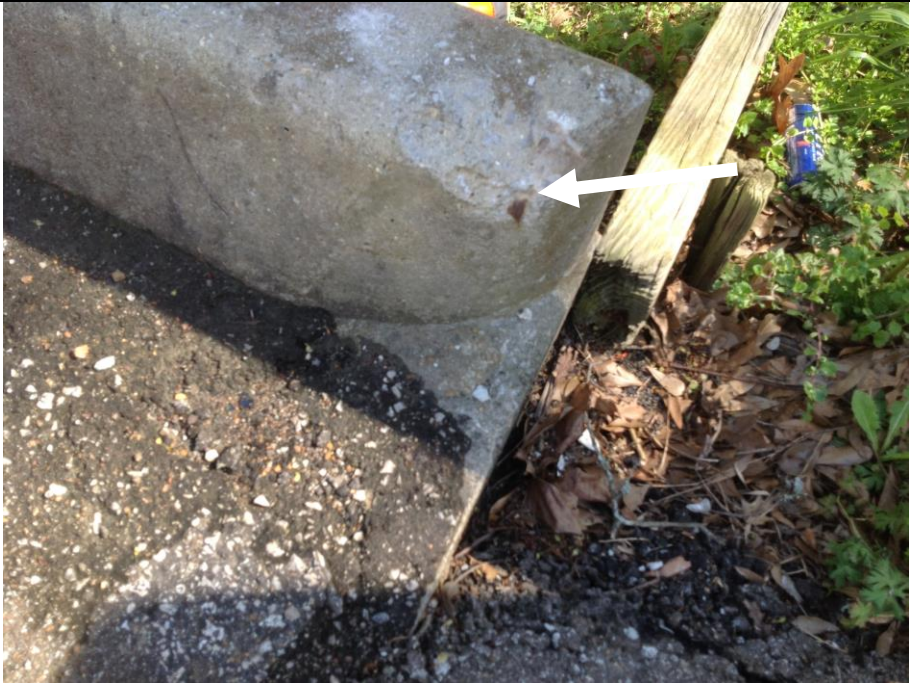
The bridge had an asphalt wearing surface and concrete curb. Three samples labeled 1790-01-01, 1790-01-02, and 1790-01-03 were collected from the curb. Three samples labeled 1790-07-19, 1790-07-20, and 1790-07-21 were collected from the road stripes. Samples were obtained using hammers and chisels.

| <b>Description:</b><br>Photograph 3 –<br><br>Homogeneous Area 1<br>Curb<br><br>Sample Locations<br>179O-01-01<br>179O-01-02<br>179O-01-03 | |

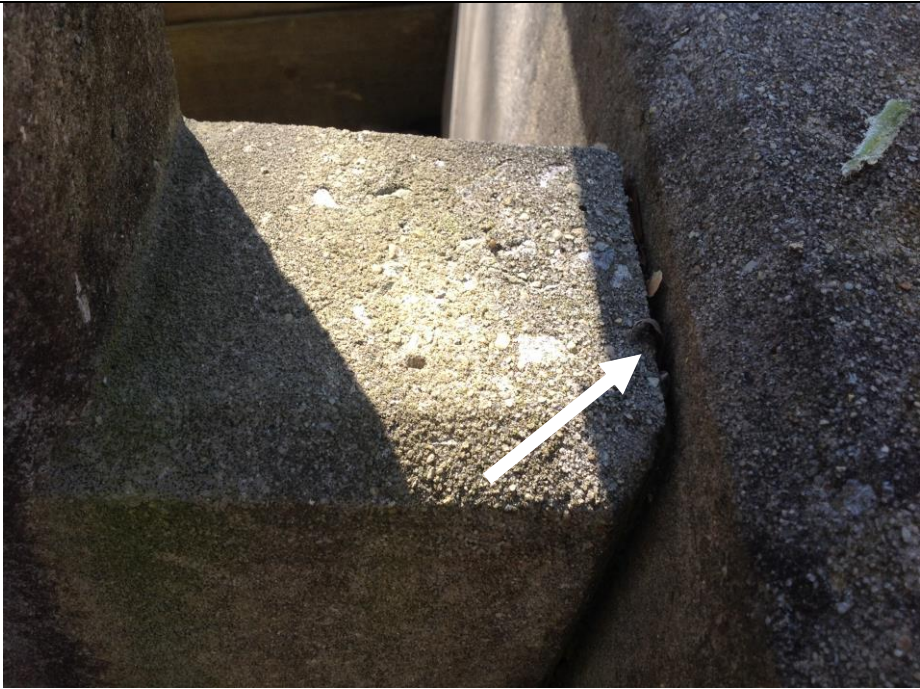
The rails were made of metal, with concrete supports. Three samples labeled 1790-02-04, 1790-02-05, and 1790-02-06 were collected from the rail pad located between the concrete rail supports and the curb. Samples were collected using a razor knife. Three samples labeled 1790-03-07, 1790-03-08, and 1790-03-09 were collected from the concrete rail supports. Samples were collected using hammers and chisels.

| Sample No. | Material Type | Location | Quantity (Estimated) | NESHAP Cat. | Condition | % Asbestos and Type |
|---|---|---|---|---|---|---|
| 1790-02-04<br>1790-02-05<br>1790-02-06 | White Fibrous Material | HA 2 – Rail Pad (located between the curb and concrete rail supports) | 30 square feet | RACM | Fair | 60-Chrysotile |

| <b>Description:</b><br>Photograph 4 –<br><br>Homogeneous Area 2<br>Rail pad - <b>ACM</b><br><br>Sample Locations<br>179O-02-04<br>179O-02-05<br>179O-02-06 | |

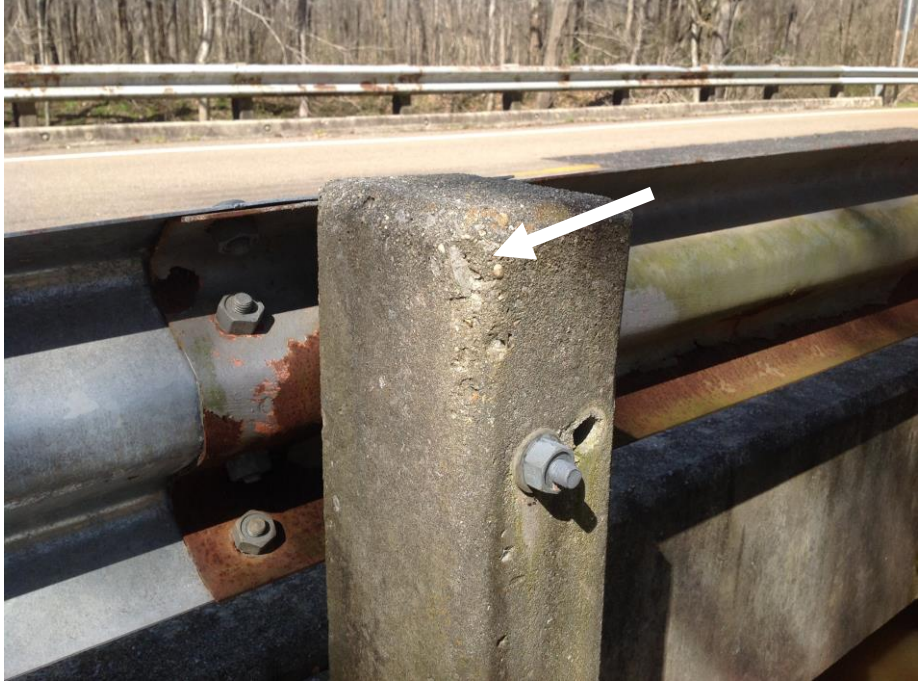
| <b>Description:</b><br>Photograph 5 –<br><br>Homogeneous Area 3<br>Rail support<br><br>Sample Locations<br>179O-03-07<br>179O-03-08<br>179O-03-09 | |

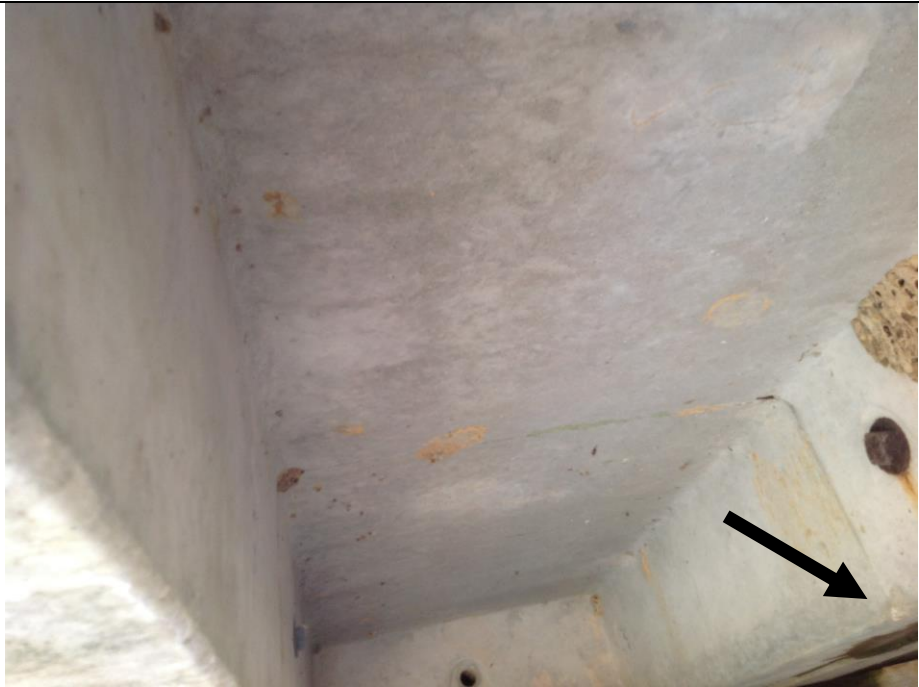
The underside of the bridge and beams were one homogenous area constructed of concrete. Three samples labeled 1790-04-10, 1790-04-11, and 1790-04-12 were collected from the underside of deck. Three samples labeled 1790-05-13, 1790-05-14, and 1790-05-15 were collected from the slope wall. Samples were obtained using hammers and chisels.

| <b>Description:</b><br>Photograph 6 –<br><br>Homogeneous Area 4<br>Underside of deck<br><br>Sample Locations<br>179O-04-10<br>179O-04-11<br>179O-04-12 | |

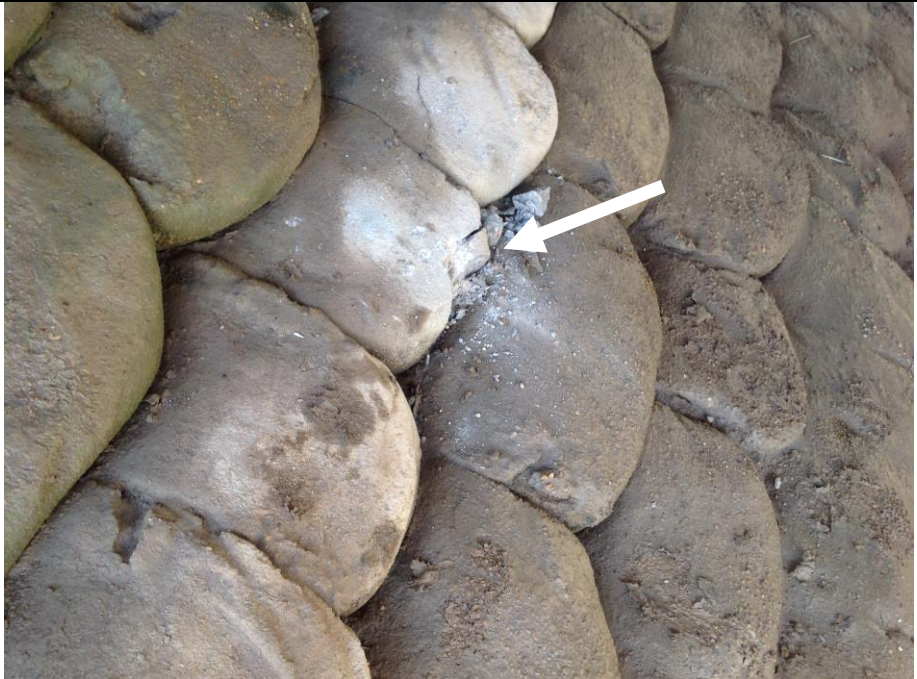
| <b>Description:</b><br>Photograph 7 –<br><br>Homogeneous Area 5<br>Slope wall<br><br>Sample Locations<br>179O-05-13<br>179O-05-14<br>179O-05-15 | |

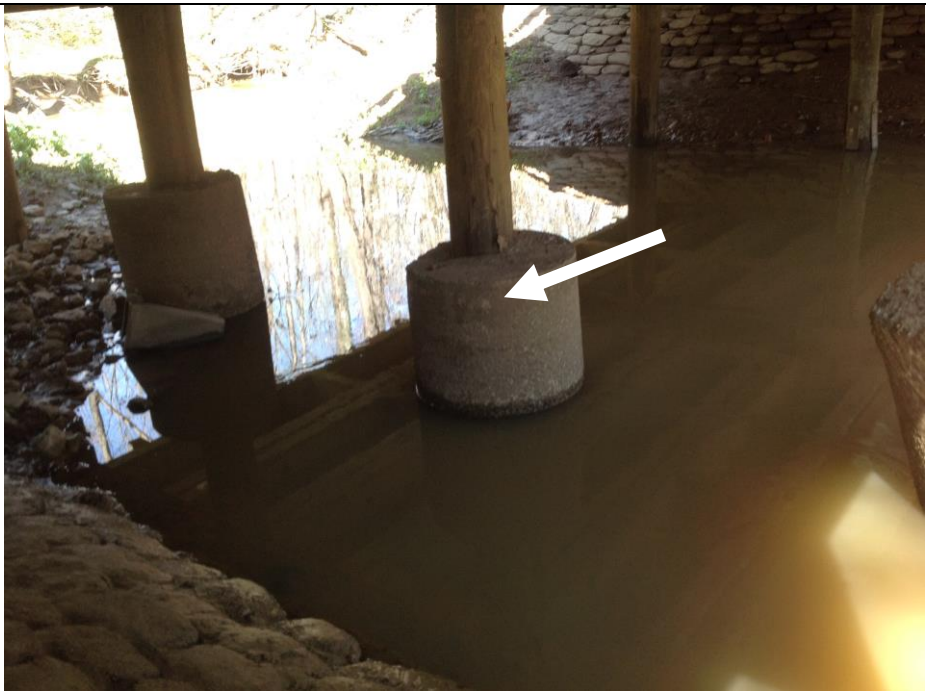
The bents were made of wood, with concrete foundations. Three samples labeled 1790-06-16, 1790-06-17, 1790-06-18 were collected from the concrete bent foundations. Samples were collected using hammers and chisels.

| <b>Description:</b><br>Photograph 8 –<br><br>Homogeneous Area 6<br>Bent foundation<br><br>Sample Locations<br>179O-06-16<br>179O-06-17<br>179O-06-18 | |

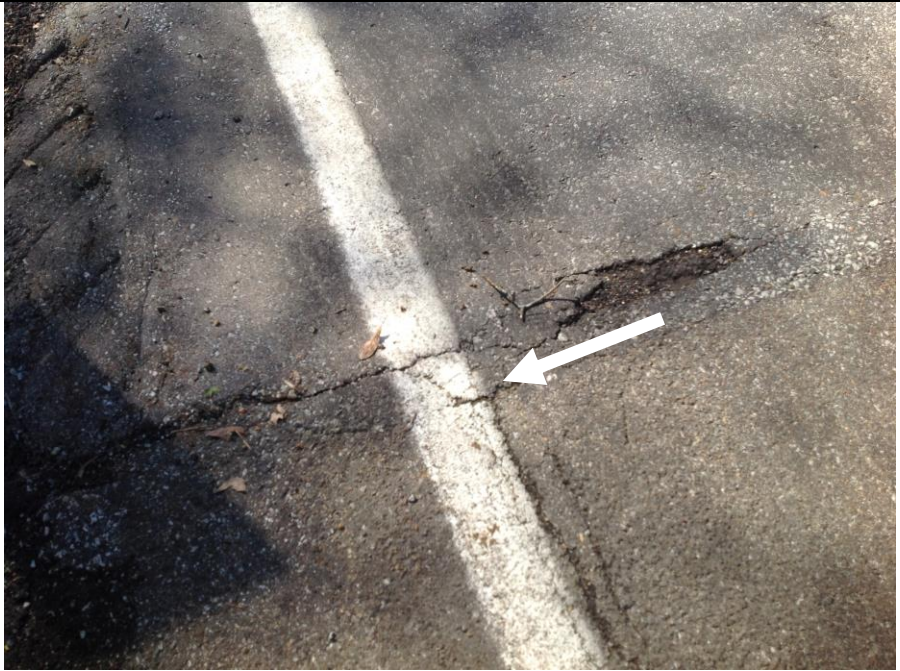
| <b>Description:</b><br>Photograph 9 –<br><br>Homogeneous Area 7<br>Road stripe<br><br>Sample Locations<br>179O-07-19<br>179O-07-20<br>179O-07-21 | |
