## TENNESSEE DEPARTMENT OF TRANSPORTATION ASBESTOS SURVEY REPORT

Federal Bridge Number: 57SR1380007  
SR-138 Bridge over Overflow LM 4.69  
PIN: 134864.00, Project Number: 99109-0138-04  
Madison County, Tennessee

10 May 2024

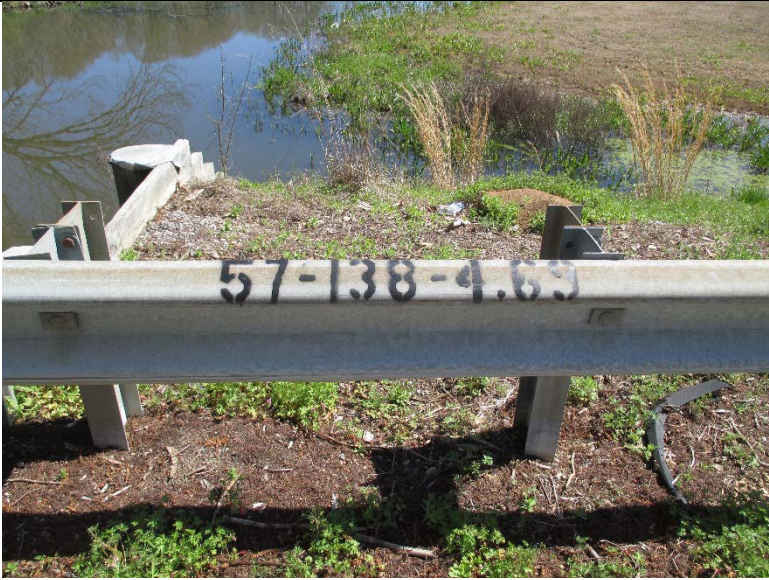
| <b>Description:</b><br>Photograph 1 —<br><br>Bridge Identification<br>Number | |

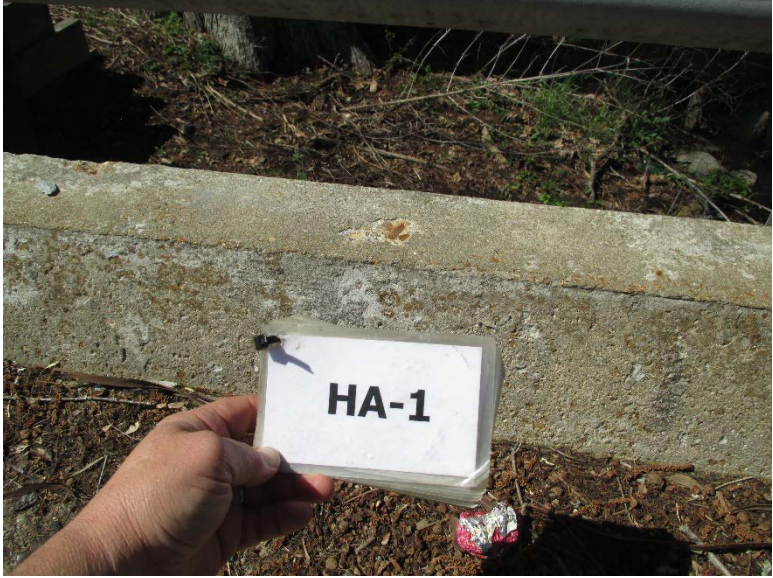
| <b>Description:</b><br>Photograph 3 —<br><br>Homogeneous Area 01 —<br>Concrete Curb<br><br>Sample Locations<br>HA01-01<br>HA01-02<br>HA01-03 | |

The bridge had a concrete deck covered with asphalt. The concrete top of the bridge deck was the same pour/homogeneous area as the underside of the bridge deck discussed below in Section 2.3.2. There was a concrete curb associated with the top deck. Samples HA01-01, HA01-02, and HA01-03 were taken using hammers and chisels.

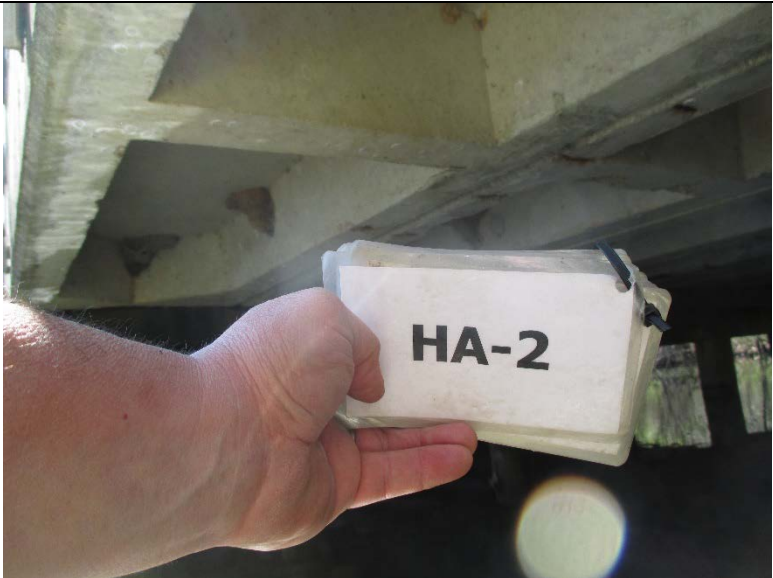
| <b>Description:</b><br>Photograph 4 —<br><br>Homogeneous Area 02 —<br>Concrete channel beams<br><br>Sample Locations<br>HA02-01<br>HA02-02<br>HA02-03 | |

The bridge had concrete channeled beams. These beams were sampled and labeled HA02-01, HA02-02, and HA02-03. Samples were obtained using hammers and chisels.
