## ASBESTOS INSPECTION REPORT

Bridge Number 57I00400011  
Lower Brownsville Rd over I-40 LM 4.54  
PIN: 136174.00; PE-N: 57I040-F0-008  
Madison County, Tennessee

624 Grassmere Park, Suite 14  
Nashville, Tennessee 37211  
TTL Project No. 250800975.00  
June 11, 2025

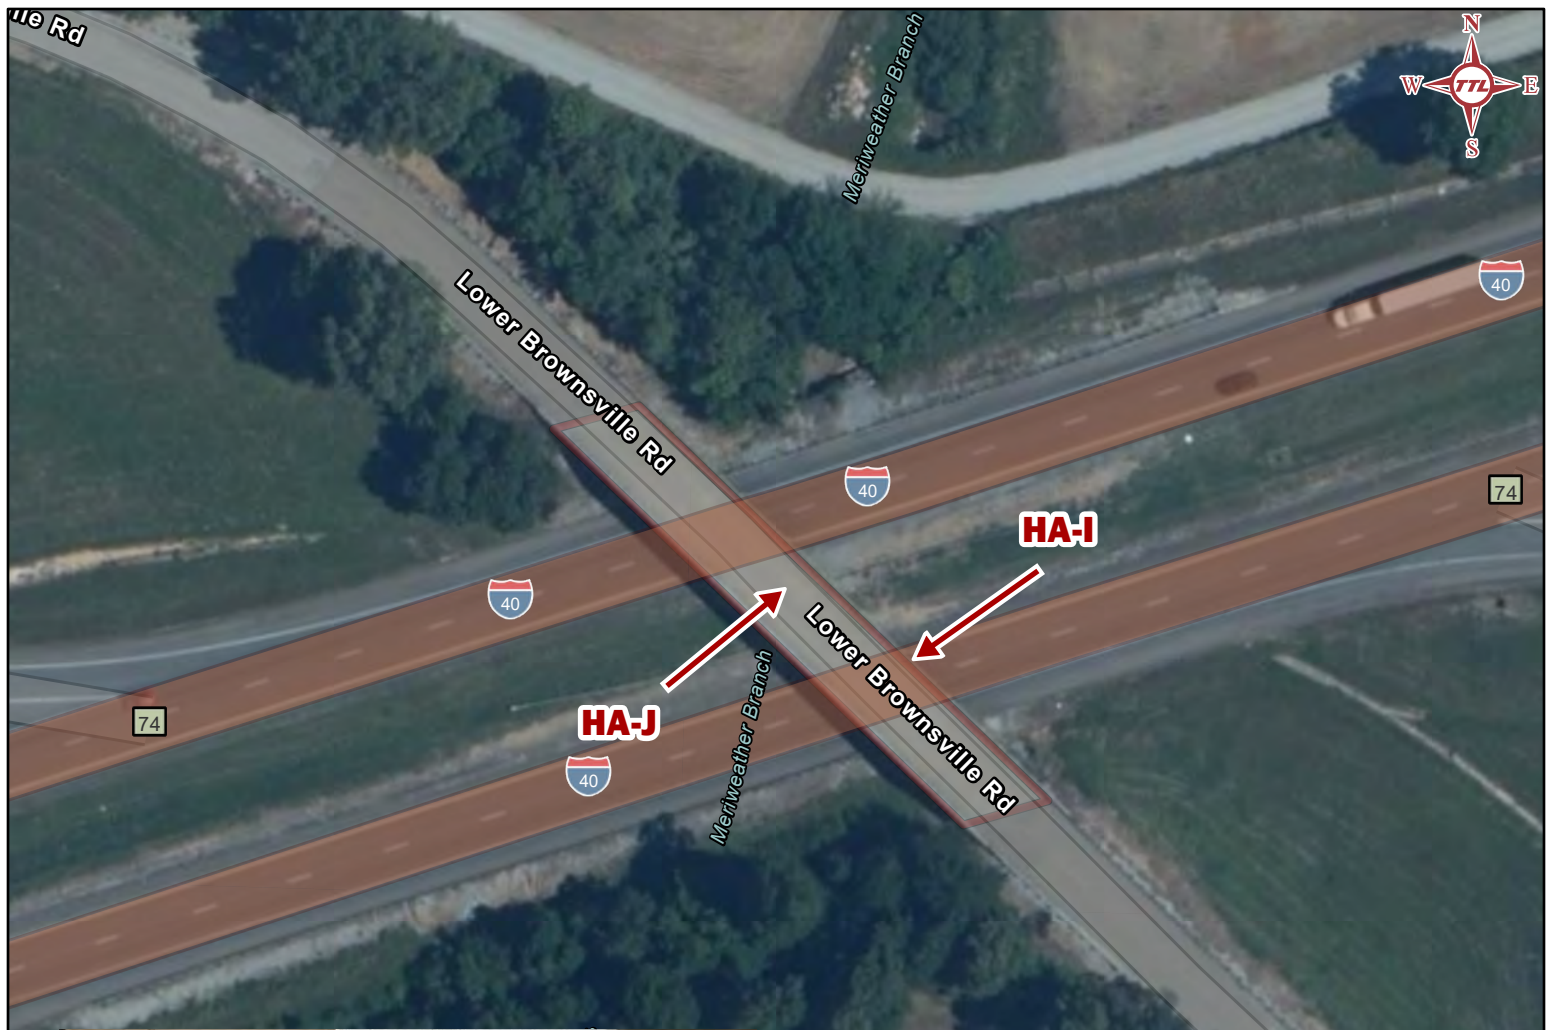
## FIGURE 2: SAMPLE LOCATION (AERIAL PHOTOGRAPH)

Individual bridge components sampled during our survey are as described in the following subsections. Materials such as metal, wood, fiberglass, and foam (if present) were not considered suspect ACM and not sampled. Materials associated with the upper bridge wearing surfaces (i.e., reflector mastic, asphalt, pavement marker mastic, etc.) were not sampled per TDOT's request. TTL collected bulk samples of each identified HA in a representative manner, as determined by the inspector. The sample locations are depicted on **Figure 2**.

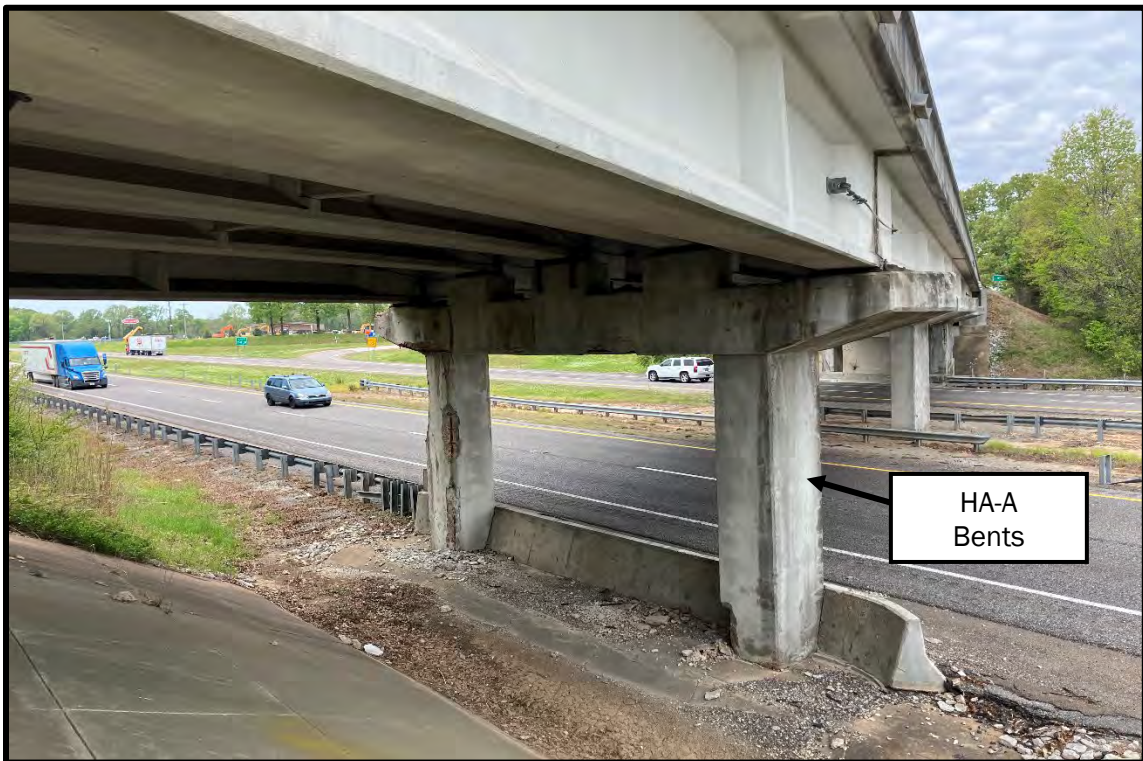
Three bulk samples of concrete were collected from the bents.

Photo 2: View of HA-A from the southeast portion of the bridge.

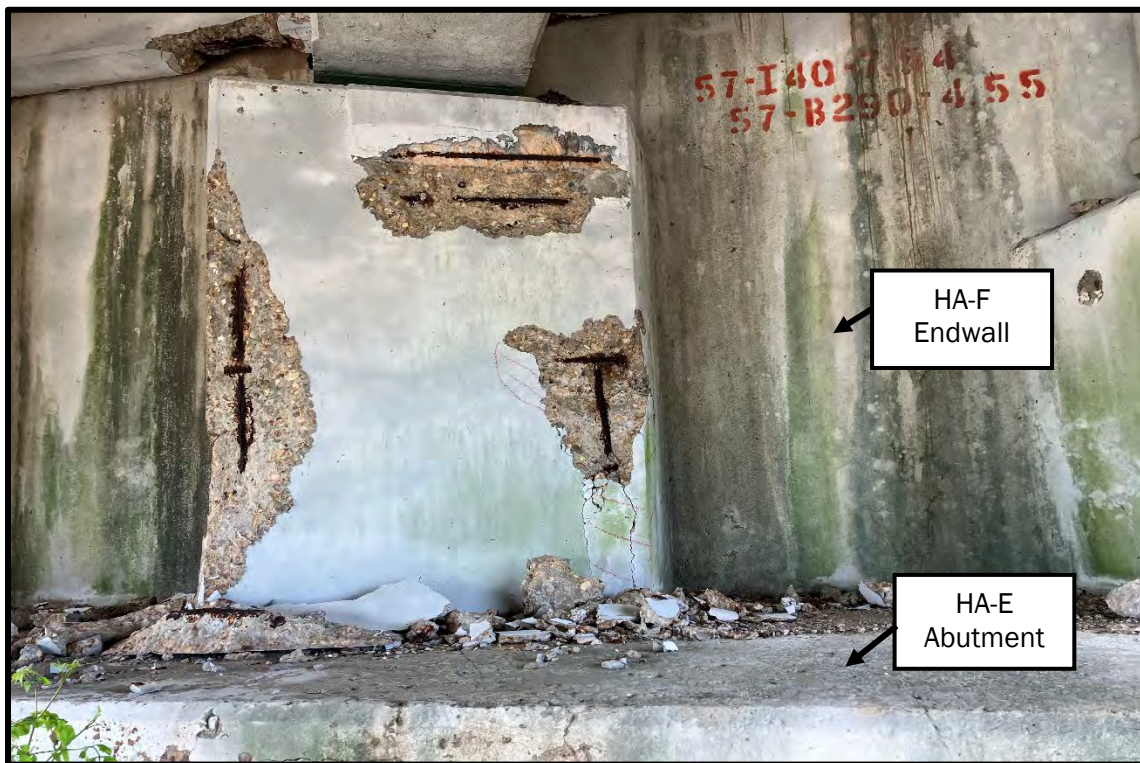
Three bulk samples of concrete were collected from the abutments.

Three bulk samples of concrete were collected from the endwall.

**Photo 5:** View of HA-E and HA-F from the southeast end of the bridge.

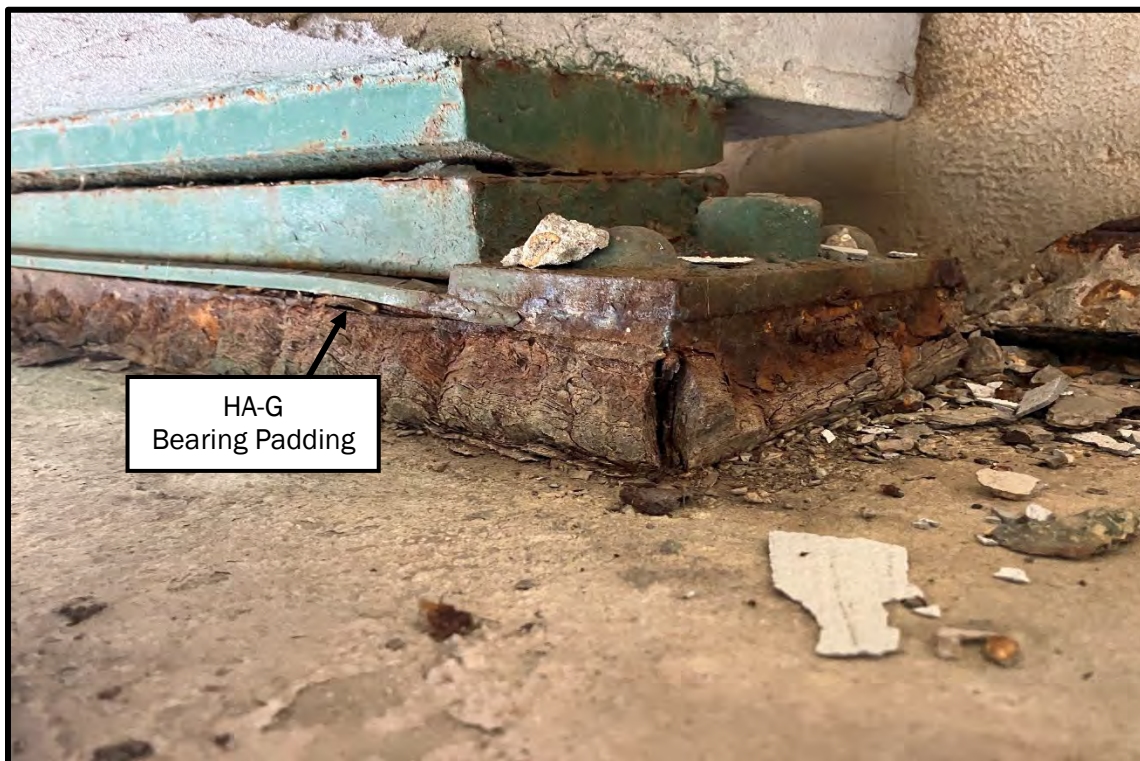
Three bulk samples of bearing padding were collected from under the bearings.

**Photo 6:** View of HA-G present at the northwest portion of the bridge.
