REPORT OF GEOTECHNICAL EXPLORATION

I-75 Interchange at I-24 Redevelopment of I-75/I-24 Interchange PIN 114174.00 Chattanooga, Tennessee

KSWA Project Number 300-18-0001

May 18, 2018

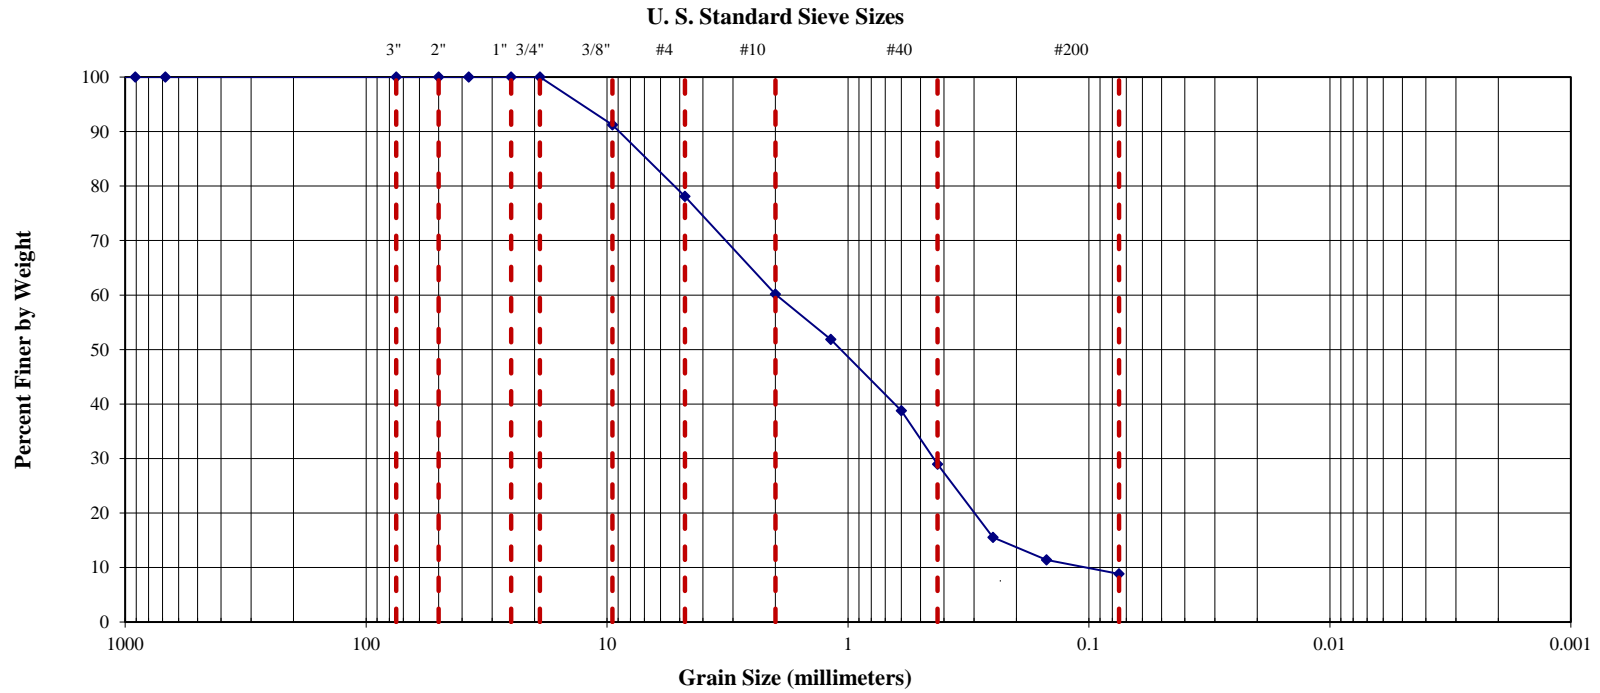
REPORT OF MATERIAL IN SOILS FINER THAN NO. 200 SIEVE, ASTM D422 AND SIEVE ANALYS ASTM C136

Project Name: I-75 @ I-24
 Project Number: 300-18-0001
 Sample Description: Brown
 Date Received: 4/26/2018

Sample ID: RW-3 13.5-15
 Test Date: 5/4/2018

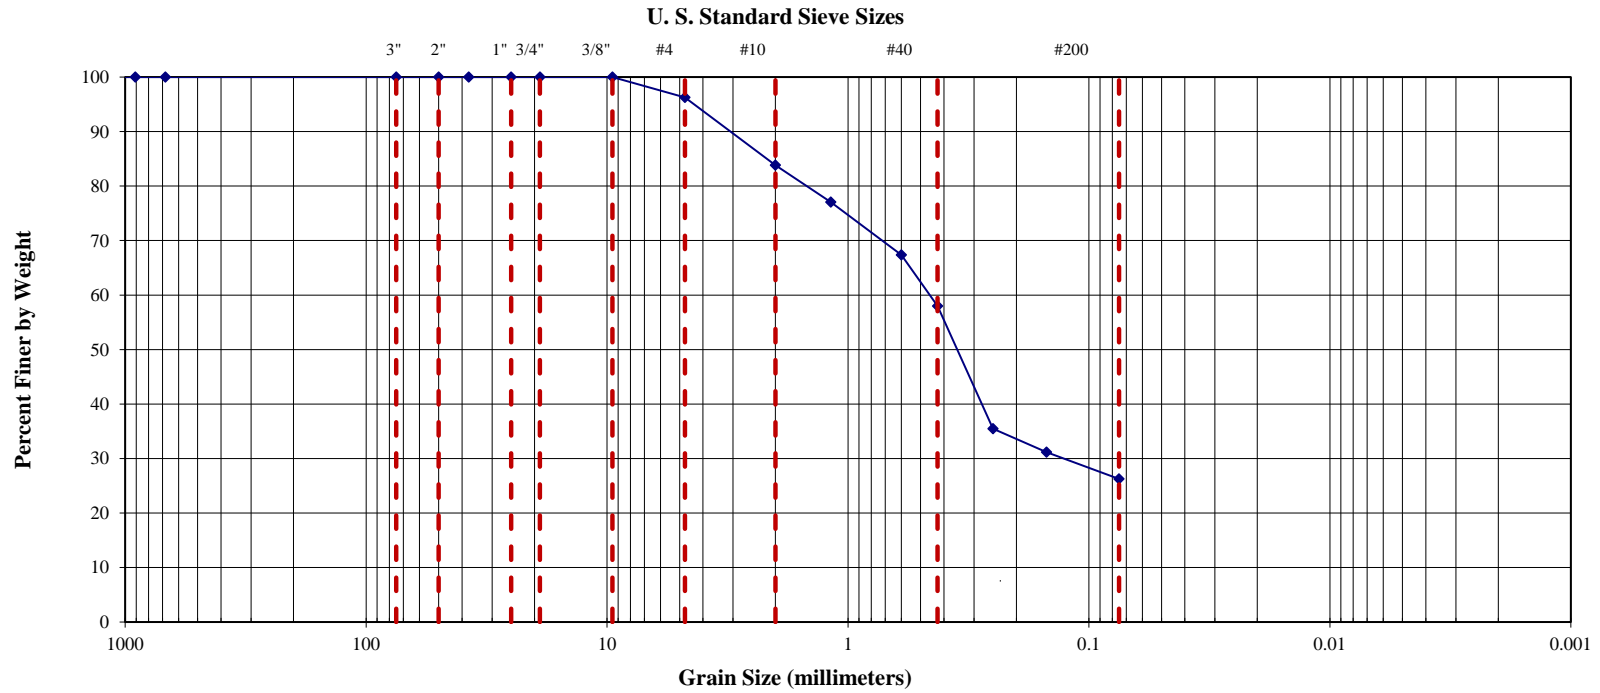
REPORT OF MATERIAL IN SOILS FINER THAN NO. 200 SIEVE, ASTM D422 AND SIEVE ANALYS ASTM C136

Project Name:	<u>I-75 @ I-24</u>	Sample ID:	<u>RW-6 33.5-35</u>
Project Number:	<u>300-18-0001</u>	Test Date:	<u>5/4/2018</u>
Sample Description:	<u>Light Brown</u>		
Date Received:	<u>4/26/2018</u>

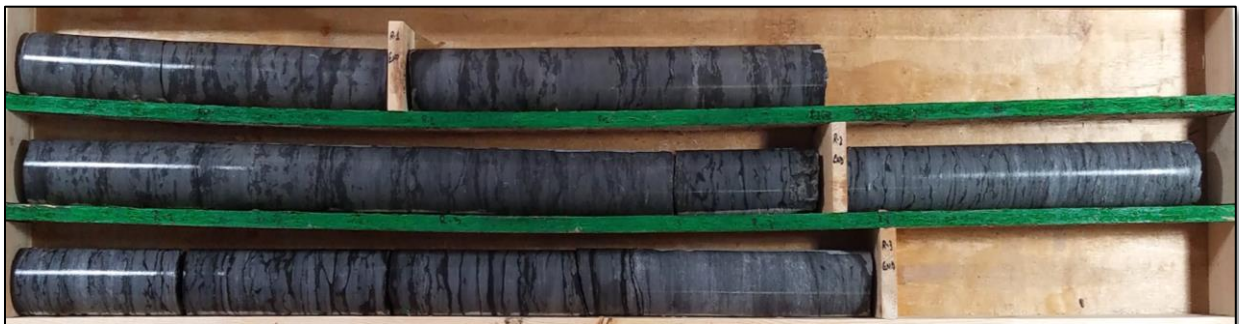
Boring	Run	Depth (feet)	Recovery (%)	RQD (%)
BN-22 Box 1 of 1	1	14 – 15.5	100	100
	2	15.5 – 20.5	100	100
	3	20.5 – 25.5	100	100

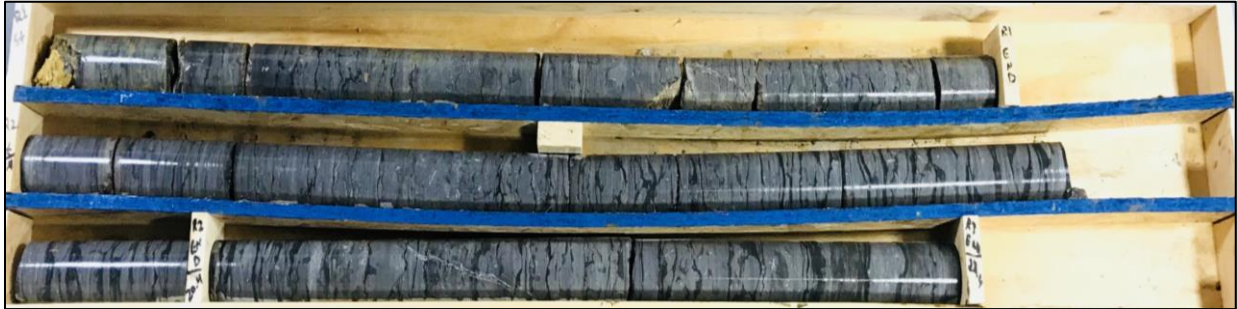
Boring	Run	Depth (feet)	Recovery (%)	RQD (%)
BN-23 Box 1 of 1	1	11.4 – 15.4	100	78
	2	15.4 – 20.4	100	100
	3	20.4 – 23.4	100	100

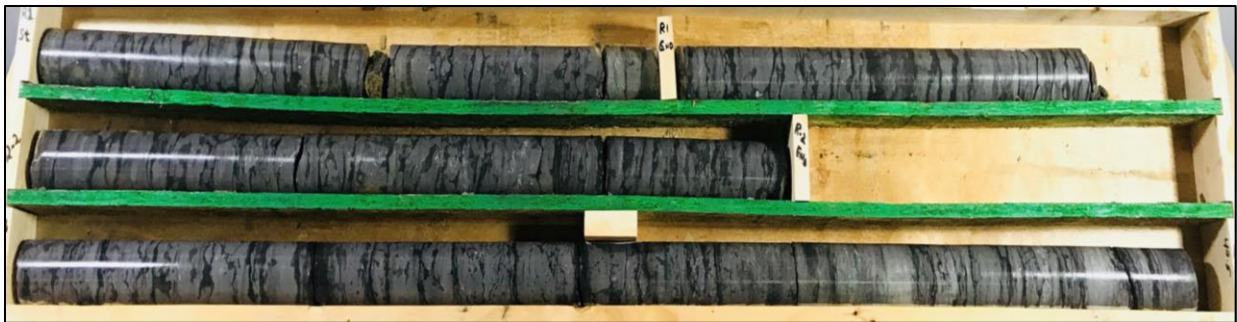
Boring	Run	Depth (feet)	Recovery (%)	RQD (%)
BN-24(A) Box 1 of 1	1	28 – 30.6	100	85
	2	30.6 – 35.5	100	94
	3	35.5 – 40.5	98	94

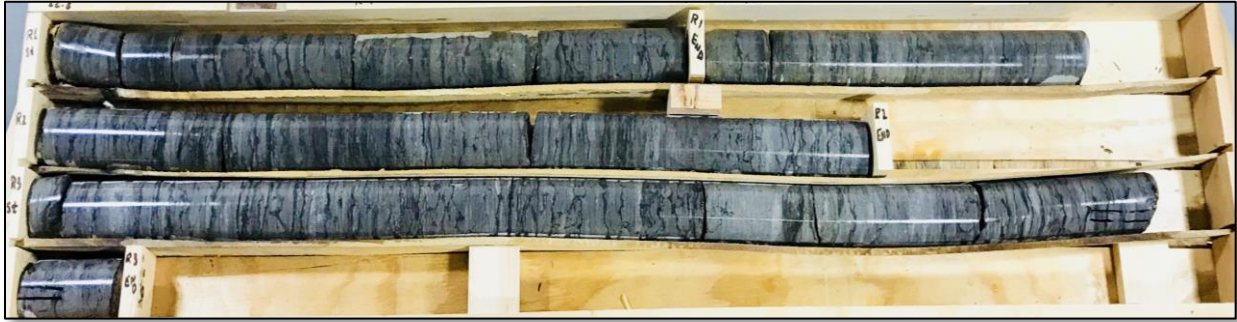
Boring	Run	Depth (feet)	Recovery (%)	RQD (%)
BN-31 Box 1 of 1	1	22.8 – 25.6	100	79
	2	25.6 – 30.6	100	98
	3	30.6 – 35.6	100	96

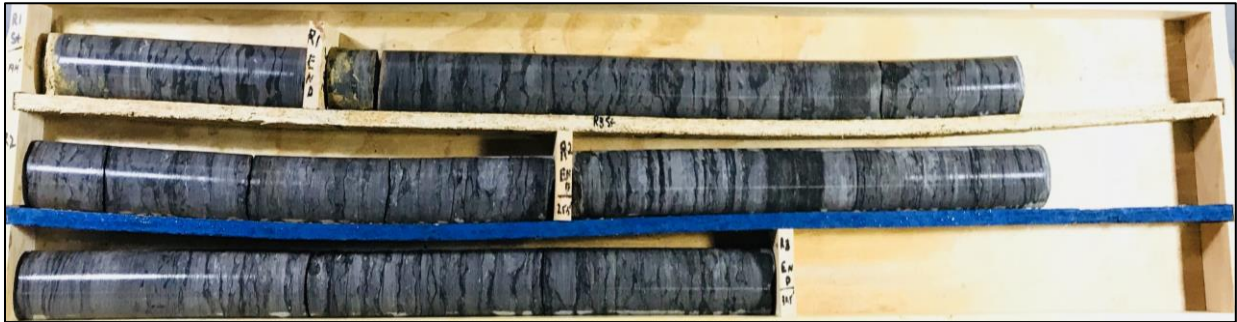
Boring	Run	Depth (feet)	Recovery (%)	RQD (%)
BN-32 Box 1 of 1	1	19.4 – 20.6	100	100
	2	20.6 – 25.5	100	96
	3	25.5 – 30.5	100	100

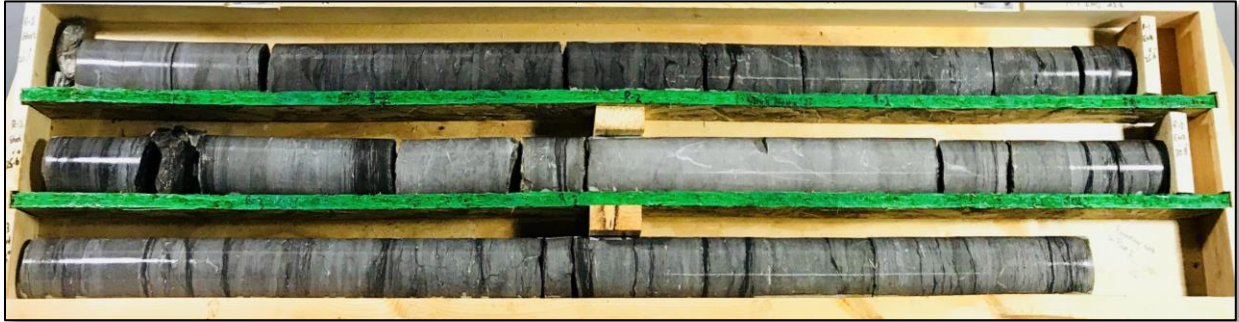
Boring	Run	Depth (feet)	Recovery (%)	RQD (%)
BN-34 Box 1 of 2	1	21.1 – 25.7	100	83
	2	25.7 – 30.7	94	72
	3	30.7 – 35.7	100	98

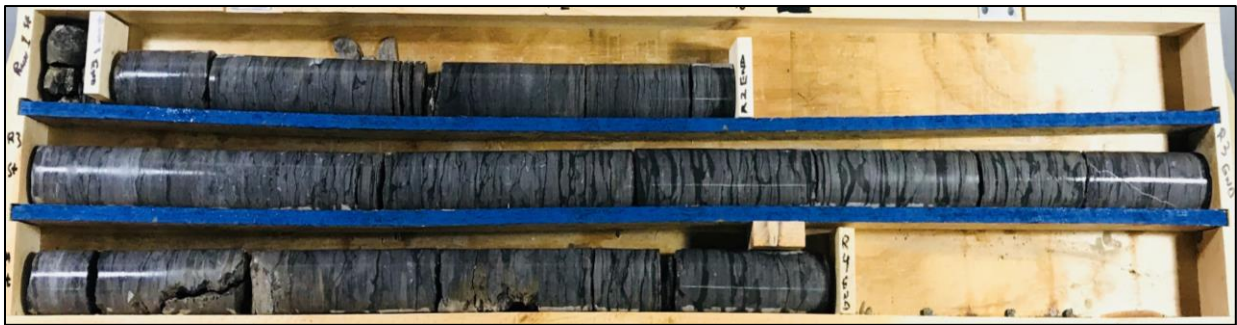
Boring	Run	Depth (feet)	Recovery (%)	RQD (%)
BS-24 Box 1 of 2	1	13 – 13.4	31	0
	2	13.4 – 16	100	84
	3	16 – 21	100	98
	4	21 – 24.3	100	42

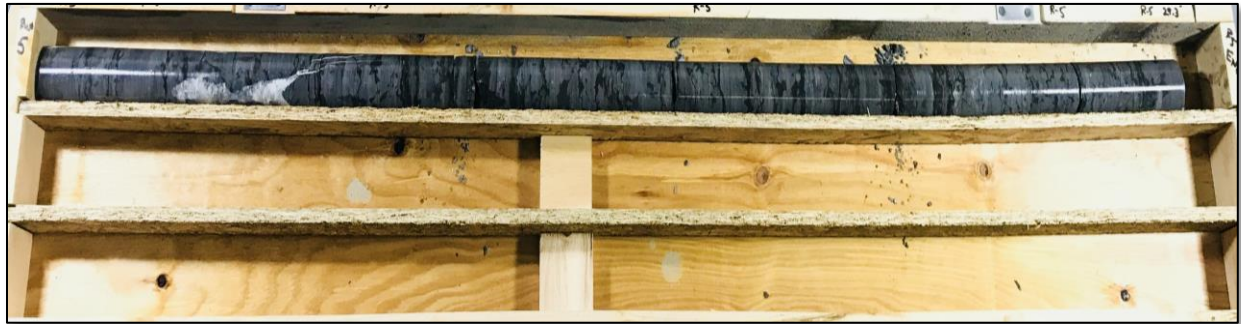
Boring	Run	Depth (feet)	Recovery (%)	RQD (%)
BS-24 Box 2 of 2	5	24.3 – 29.3	98	96

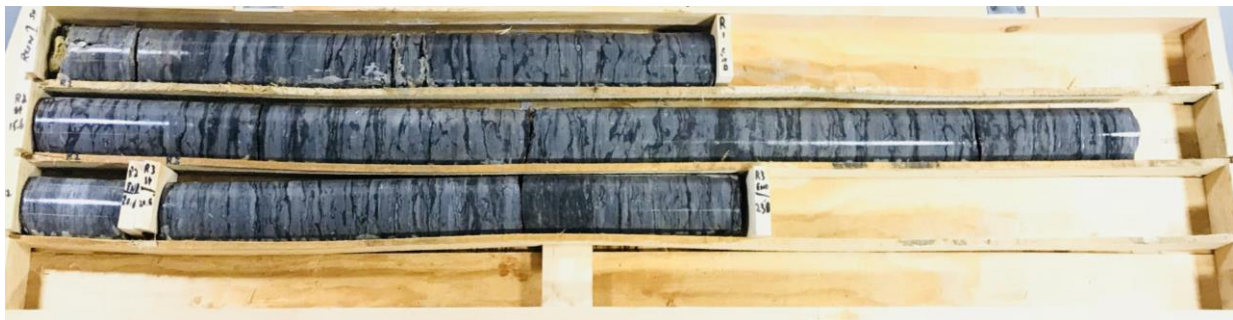
Boring	Run	Depth (feet)	Recovery (%)	RQD (%)
BS-32 Box 1 of 1	1	12.9 – 15.7	100	82
	2	15.7 – 20.7	100	100
	3	20.7 – 23.1	100	100

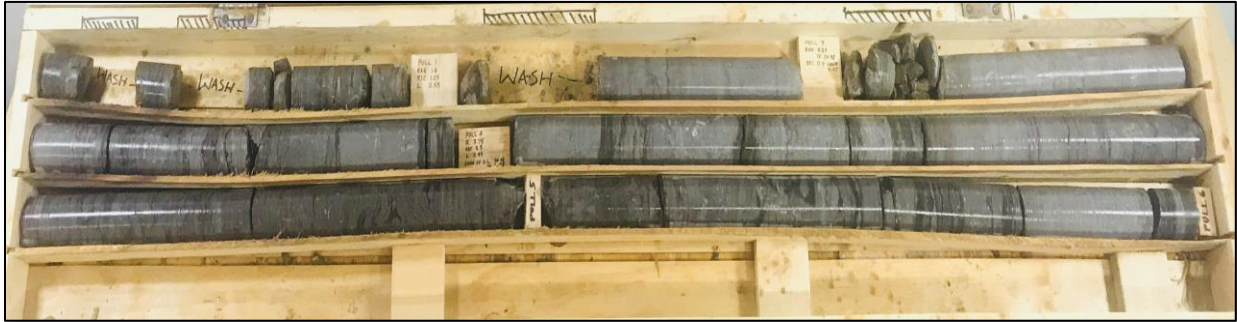
Boring	Run	Depth (feet)	Recovery (%)	RQD (%)
BS-33 Box 1 of 1	1	27.9 – 29.5	69	0
	2	29.5 – 30.2	14	0
	3	30.2 – 31	100	100
	4	31 – 34.5	100	63
	5	34.5 – 39.5	100	92
	6	39.5 – 42.2	100	93

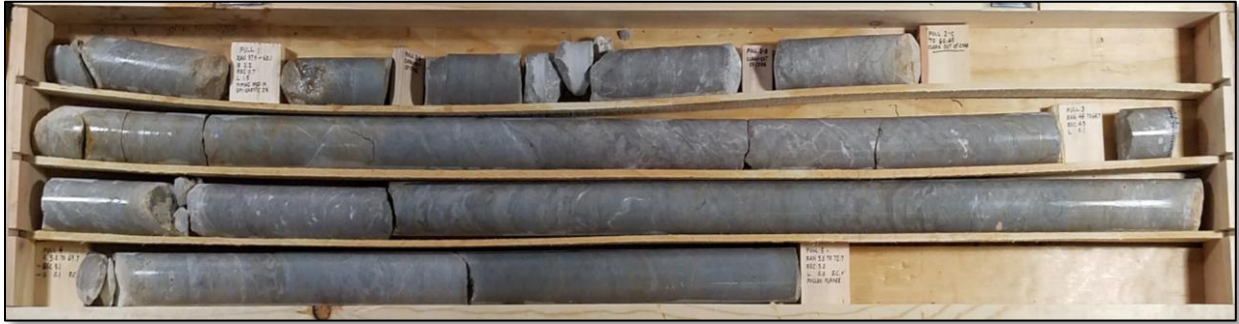
Boring	Run	Depth (feet)	Recovery (%)	RQD (%)
CSX-3 Box 1 of 1	1 and 2	57.9 – 60.3	50	0
	3	60.3 – 64.7	100	100
	4	64.7 – 69.7	100	100
	5	69.7 – 72.7	100	100

Bedrock encountered by the borings CSX-1 through CSX-3 was composed of hard, gray, siliceous dolomite. Calcite healed fractures were common in the recovered core. Drilling operations reported slow penetration rates and above normal wear on drilling tools. At CSX-1 and the offset boring drilled after CSX-1 was abandoned, floating brecciated rock above the steeply sloping surface was noted. Both attempts as CSX-1 were unsuccessful in recovering measurable rock core. As noted previously, we believe this location is within or near a thrust fault zone.

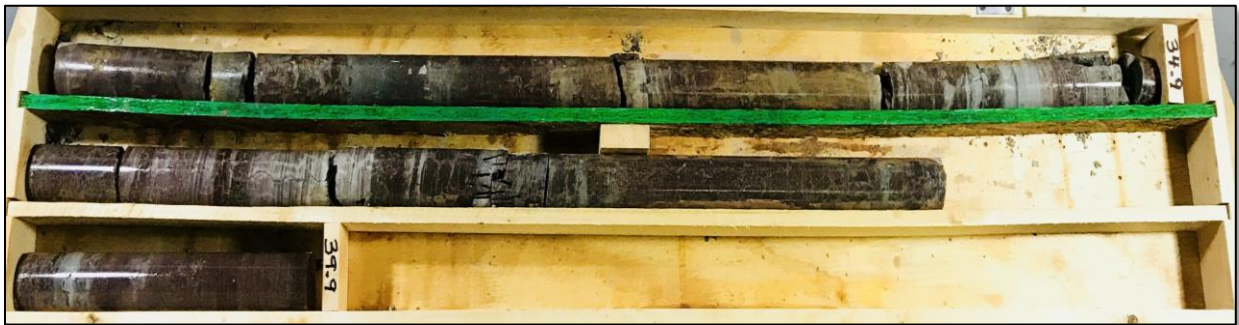
Boring	Run	Depth (feet)	Recovery (%)	RQD (%)
M-1 Box 1 of 1	1	30.1 – 34.9	100	88
	2	34.9 – 39.9	100	92

The bedrock encountered at the two bridges in this section, Moore Road and McBrien Road overpasses, was different. At M-1 and M-2 (Moore Road), pink to dark red limestone and gray, brown and green calcareous shale was recovered. The rock quality varied from fair to good, but the recovery percentages were good to excellent. Fractured zones within the rock were common. Most of the fractures appeared to be closed but some weathering was encountered on open fractures. The higher degree of fracturing is believed to be related to a thrust fault zone located west of the project area. Bedrock encountered at McB-1 and McB-2 (McBrien Road) returned to the hard, gray, argillaceous limestone. The upper 5 feet of coring at McB-1 encountered significant weathering and mud seams. The remainder of the rock quality was good to excellent.

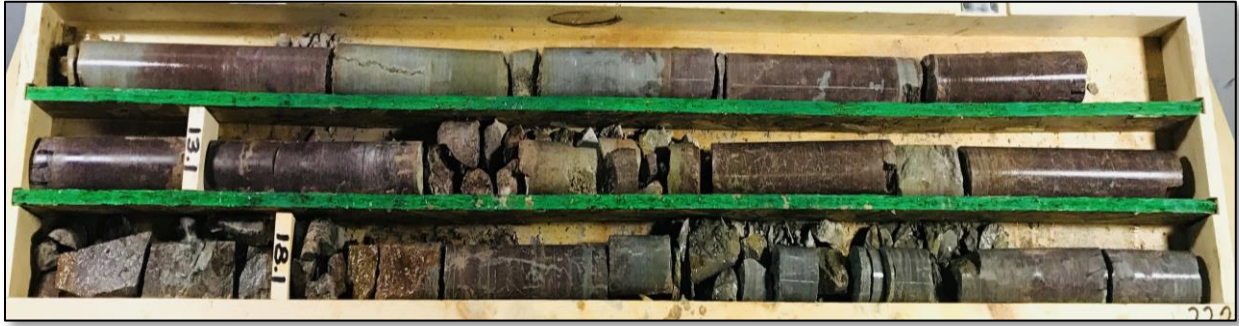
Boring	Run	Depth (feet)	Recovery (%)	RQD (%)
M-2 Box 1 of 2	1	8.1 – 13.1	100	96
	2	13.1 – 18.1	100	52
	3	18.1 – 23.1	100	56

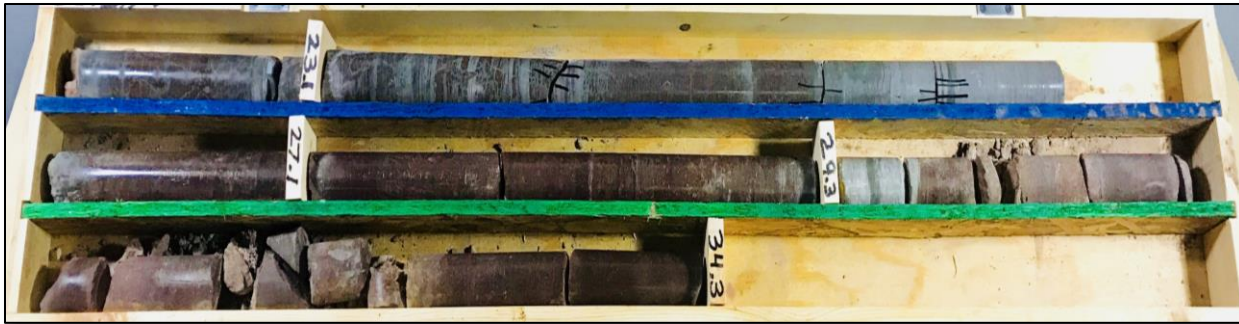
Boring	Run	Depth (feet)	Recovery (%)	RQD (%)
M-2 Box 2 of 2	3	18.1 – 23.1	100	56
	4	23.1 – 27.1	100	100
	5	27.1 – 29.3	100	100
	6	29.3 – 34.3	48	48

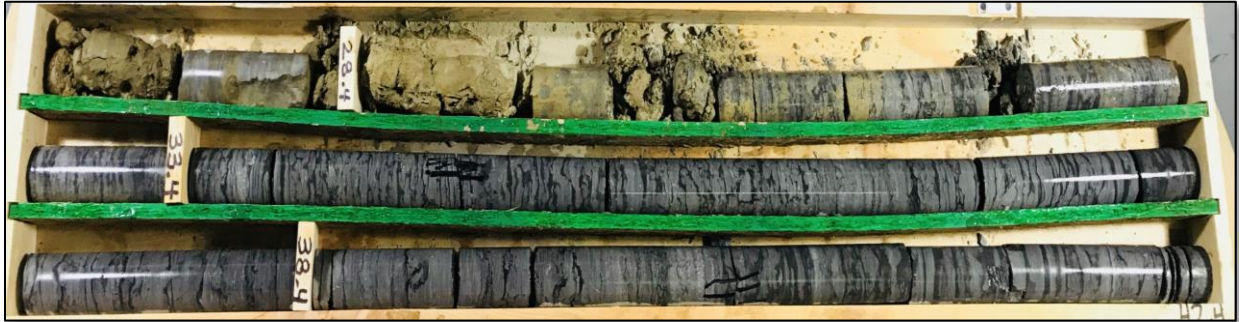
Boring	Run	Depth (feet)	Recovery (%)	RQD (%)
MCB-1 Box 1 of 1	1	27.2 – 28.6	100	43
	2	28.6 – 33.4	88	50
	3	33.4 – 38.4	100	100
	4	38.4 – 42.4	100	100

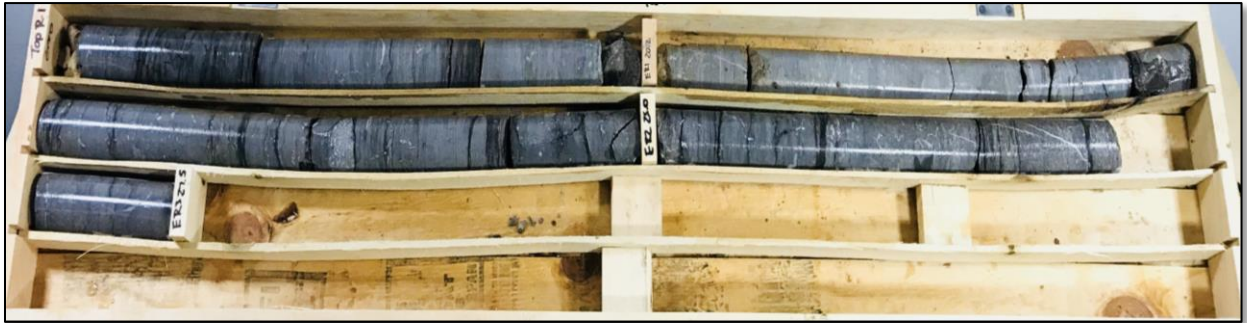
Boring	Run	Depth (feet)	Recovery (%)	RQD (%)
SCC-1 Box 1 of 1	1	17.5 – 20	96	84
	2	20 – 25	98	94
	3	25 – 27.5	100	100

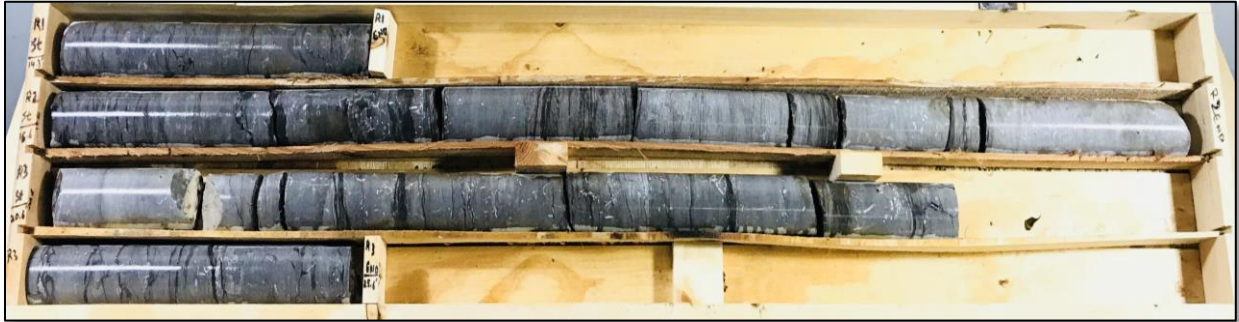
Boring	Run	Depth (feet)	Recovery (%)	RQD (%)
SCC-3 Box 1 of 1	1	14.3 – 15.6	100	100
	2	15.6 – 20.5	100	92
	3	20.5 – 25.6	100	88

At SCC-2, shallow auger refusal was encountered. After coring through about a foot and a half of limestone, an interval of soil about 12 feet thick was encountered. Sloping rock surface conditions were encountered at SCC-4. Because the drilling tools were turning to follow the shape of the rock surface, the boring had to be abandoned after reaching a depth of 30 feet in favor of an offset boring, which encountered rock at about 17 feet. SCC series borings encountered bedrock (except as noted above) between 14 and 18 feet below the ground surface. Rock quality in these borings was generally good to excellent.

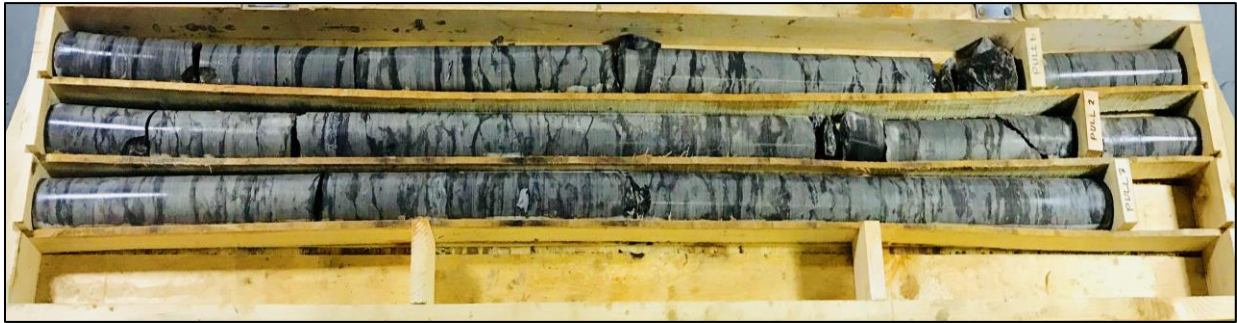
Boring	Run	Depth (feet)	Recovery (%)	RQD (%)
SCK-1 Box 1 of 1	1	29.8 – 34.3	93	91
	2	34.3 – 39.3	100	92
	3	39.3 – 44.3	100	92

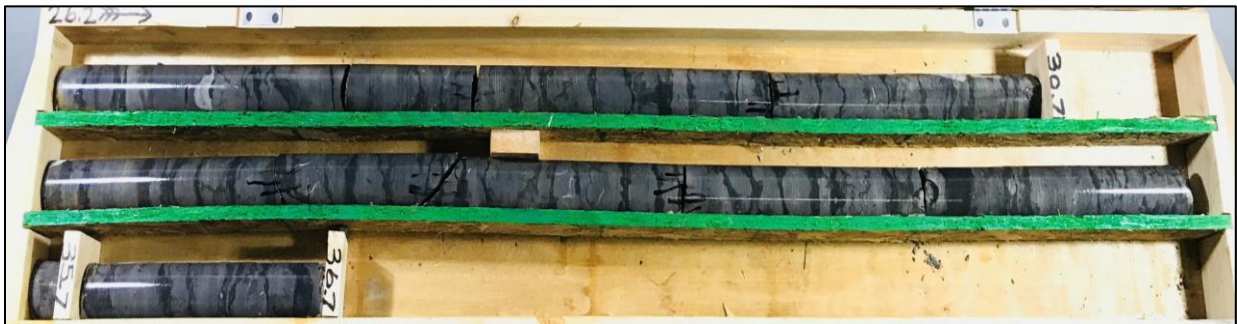
Boring	Run	Depth (feet)	Recovery (%)	RQD (%)
SCK-2 Box 1 of 1	1	26.2 – 30.7	96	96
	2	30.7 – 35.7	100	100
	3	35.7 – 36.7	100	100

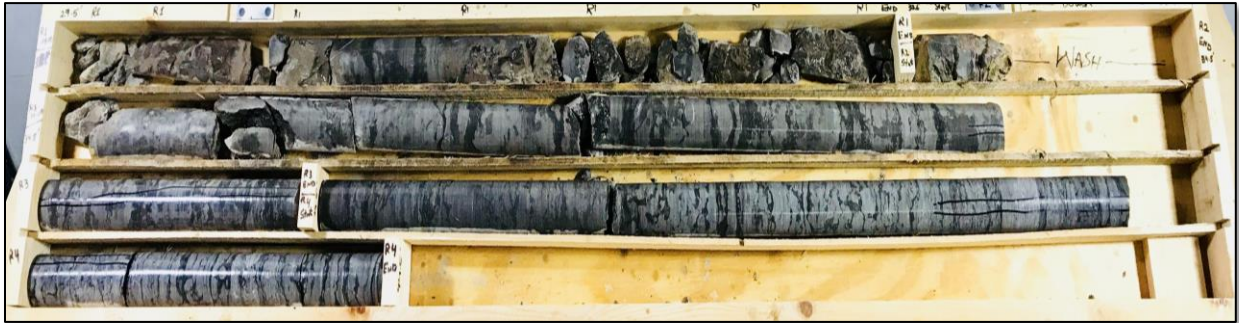
Boring	Run	Depth (feet)	Recovery (%)	RQD (%)
SCK-3 Box 1 of 1	1	29.5 – 33.6	90	15
	2	33.6 – 34.5	78	0
	3	34.5 – 39.5	100	84
	4	39.5 – 44.5	100	100

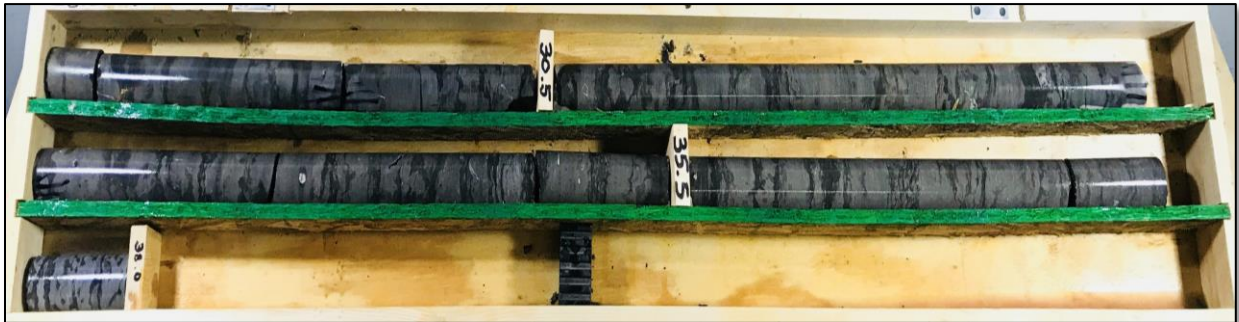
Boring	Run	Depth (feet)	Recovery (%)	RQD (%)
SCK-4 Box 1 of 1	1	28 – 30.5	80	90
	2	30.5 – 35.5	100	100
	3	35.5 – 38	100	100

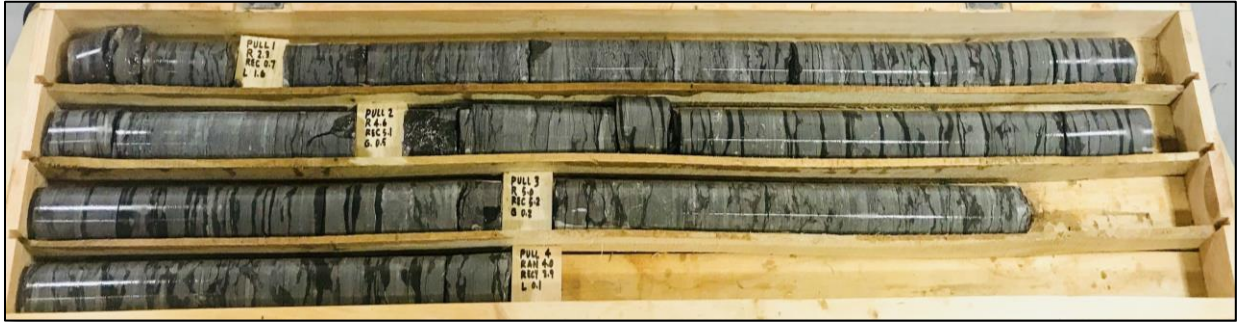
Boring	Run	Depth (feet)	Recovery (%)	RQD (%)
SCK-5 Box 1 of 1	1	32.8 – 34.7	37	12
	2	34.7 – 39.2	100	100
	3	39.2 – 44.7	100	100
		44.7 – 48.7	100	100

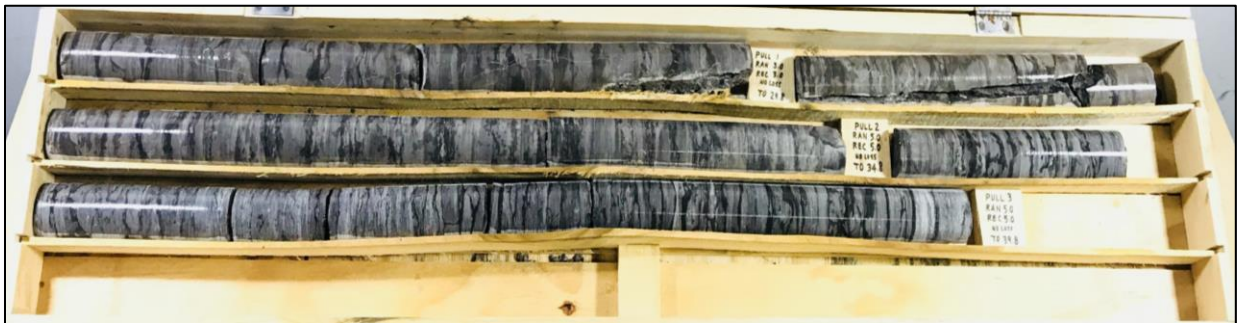
Boring	Run	Depth (feet)	Recovery (%)	RQD (%)
SCK-6 Box 1 of 1	1	26.8 – 29.8	100	87
	2	29.8 – 34.8	100	76
	3	34.8 – 39.8	100	100

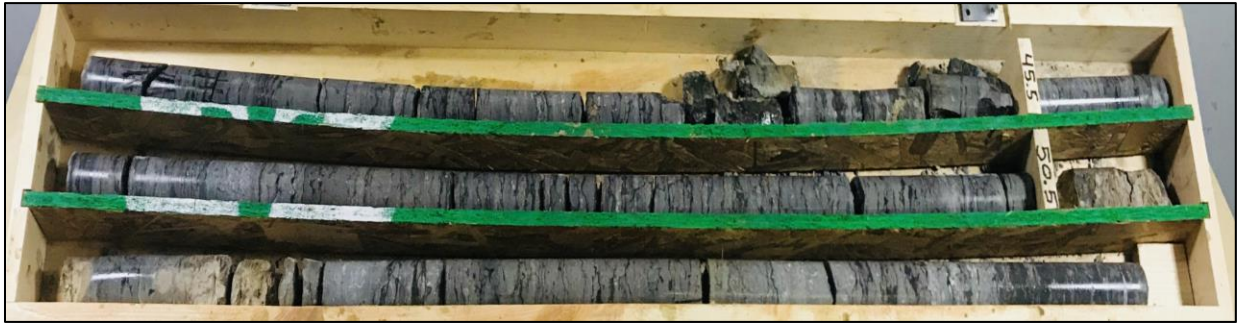
Boring	Run	Depth (feet)	Recovery (%)	RQD (%)
SCR-1 Box 1 of 1	1	40.7 – 45.5	94	60
	2	45.5 – 50.5	98	84
	3	50.5 – 55.5	96	82

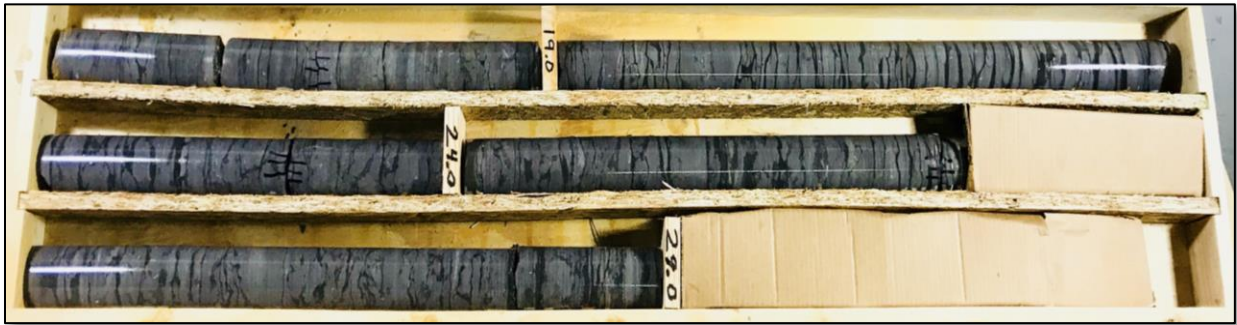
Boring	Run	Depth (feet)	Recovery (%)	RQD (%)
SCR-2 Box 1 of 1	1	17 – 19	100	100
	2	19 – 24	90	90
	3	24 – 29	96	96
