**TENNESSEE DEPARTMENT OF TRANSPORTATION
ASBESTOS INSPECTION REPORT
SR-2 Bridge over CFW Railroad, LM 14.28
Bridge 16SR0020015 (16-SR002-14.28)
Manchester, Coffee County, Tennessee
TDOT Project No. 16003-4244-04, PIN 123696.00**

December 15, 2016
Amec Foster Wheeler Project No. 193416001

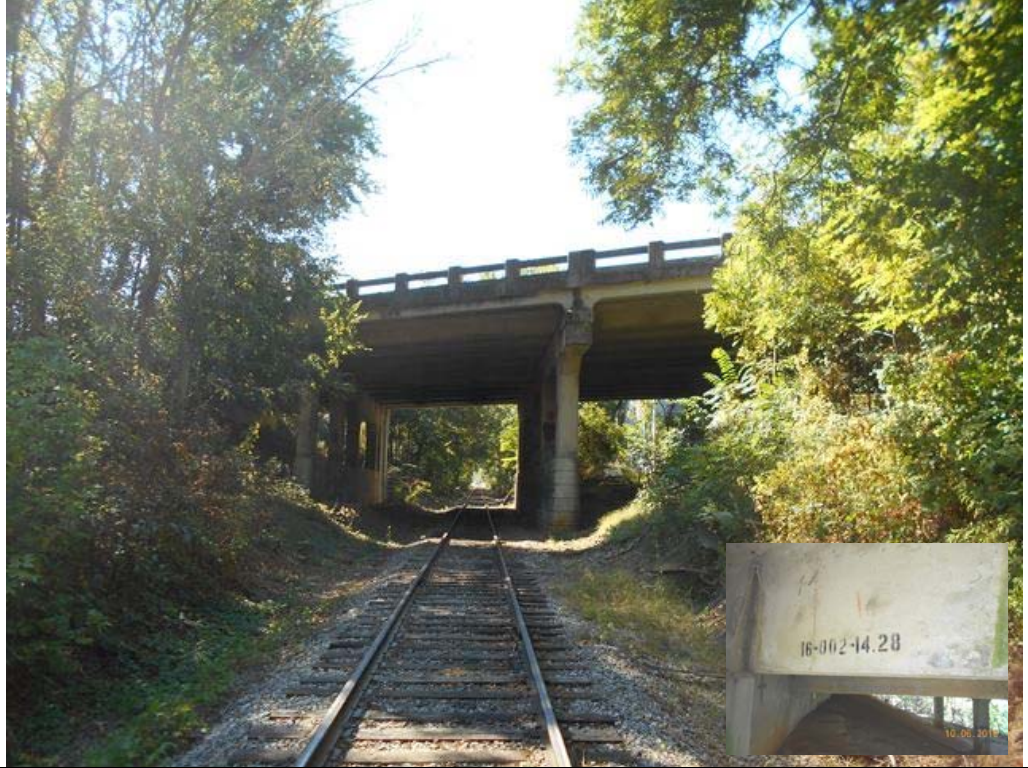
Comments:
P-1 –Profile of Bridge.
Bridge has 4 spans
supported by 3 pier
bents and abutments.

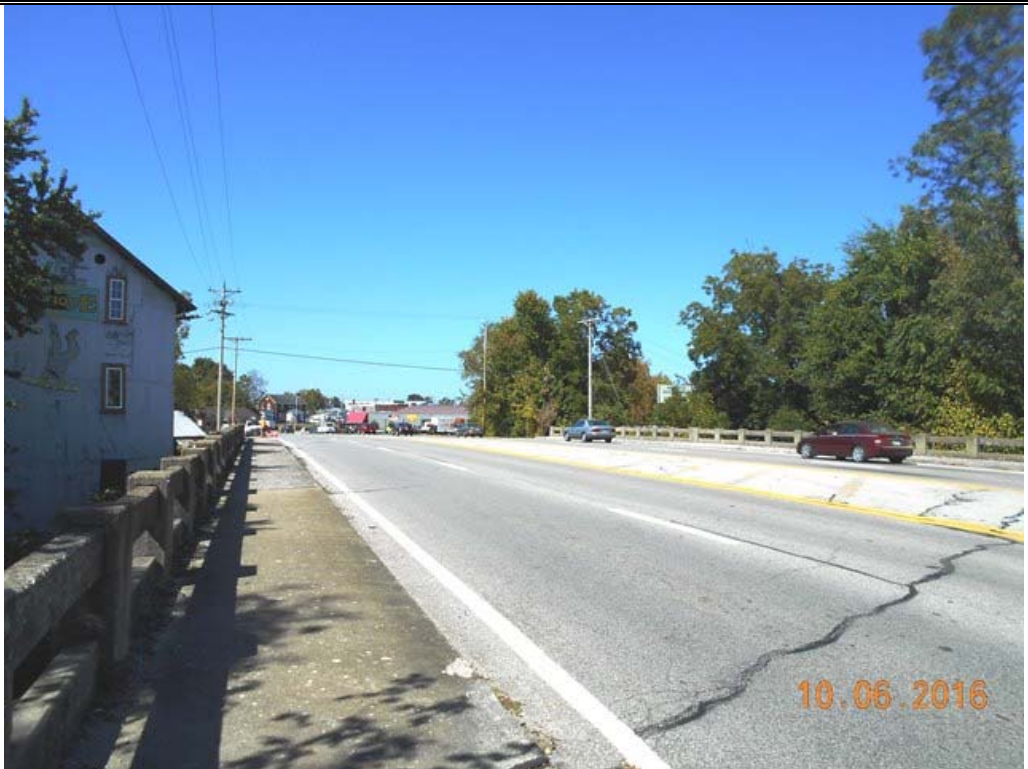
Comments:
P-2 – View of the top of
the bridge and railings.
Post & rail barriers and
sidewalk on both sides
of bridge. Traffic lanes
topped with asphaltic
concrete.

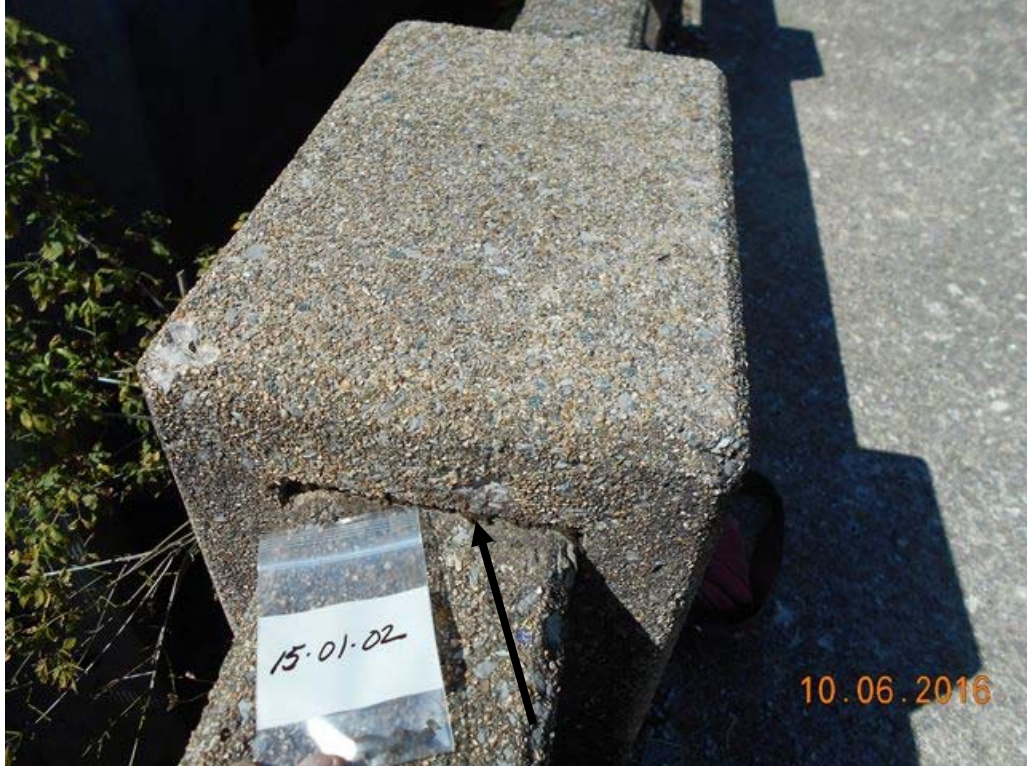
Comments:
P-3 – Post and Rail
barrier concrete was
sampled as HA-02.
Builders felt from post
socket was sampled as
HA-01. Neither HA
contained asbestos
material.

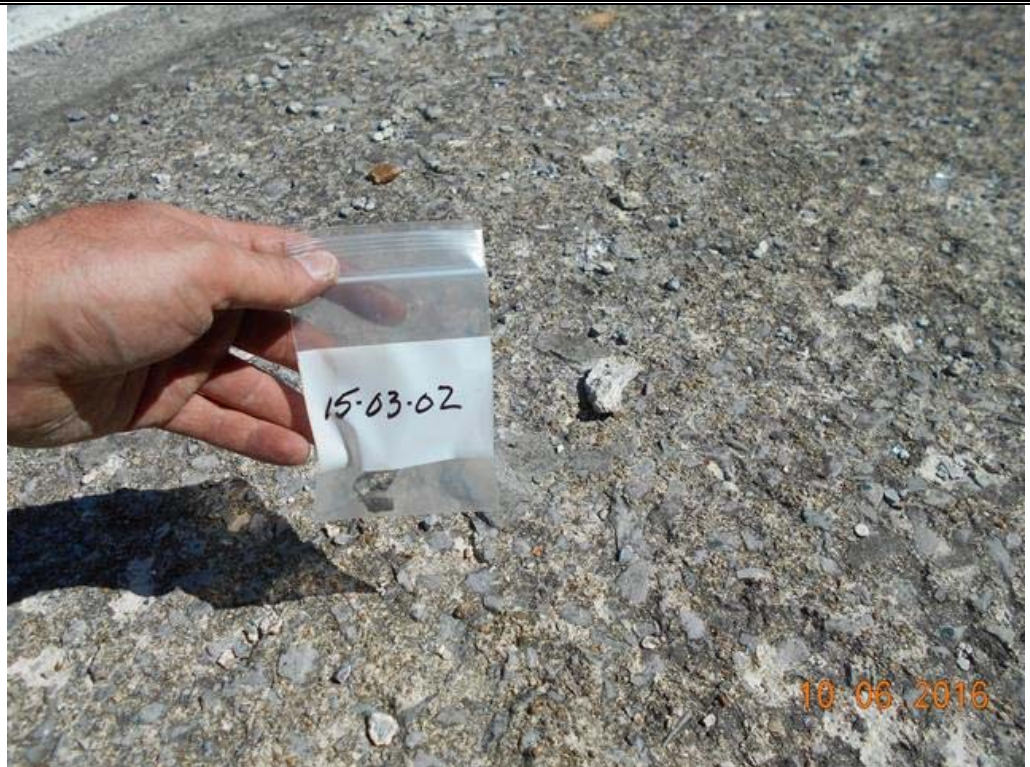
Comments:
P-4- Concrete from
sidewalk was sampled
as HA-03. Sidewalk
appeared to be same
as deck. No asbestos
was observed in the
concrete samples by
the analyst.

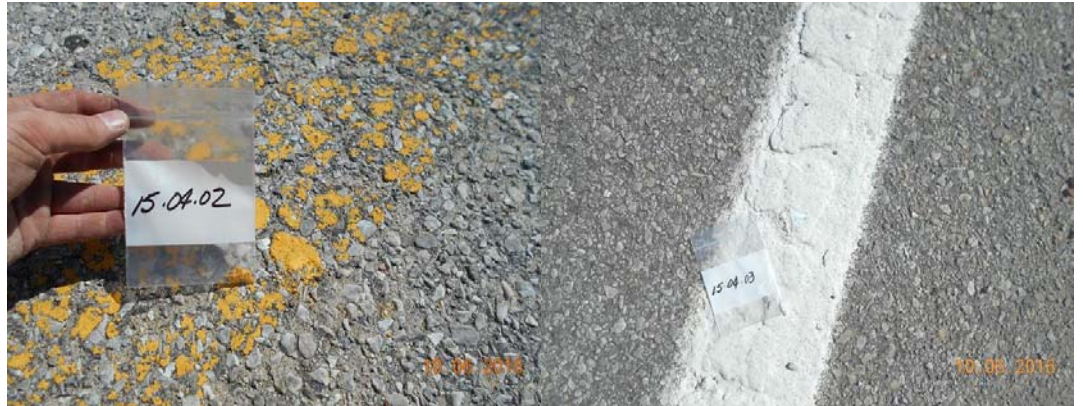
Comments:
P-5 – Roadway striping was sampled as HA-04. Striping samples were not asbestos.

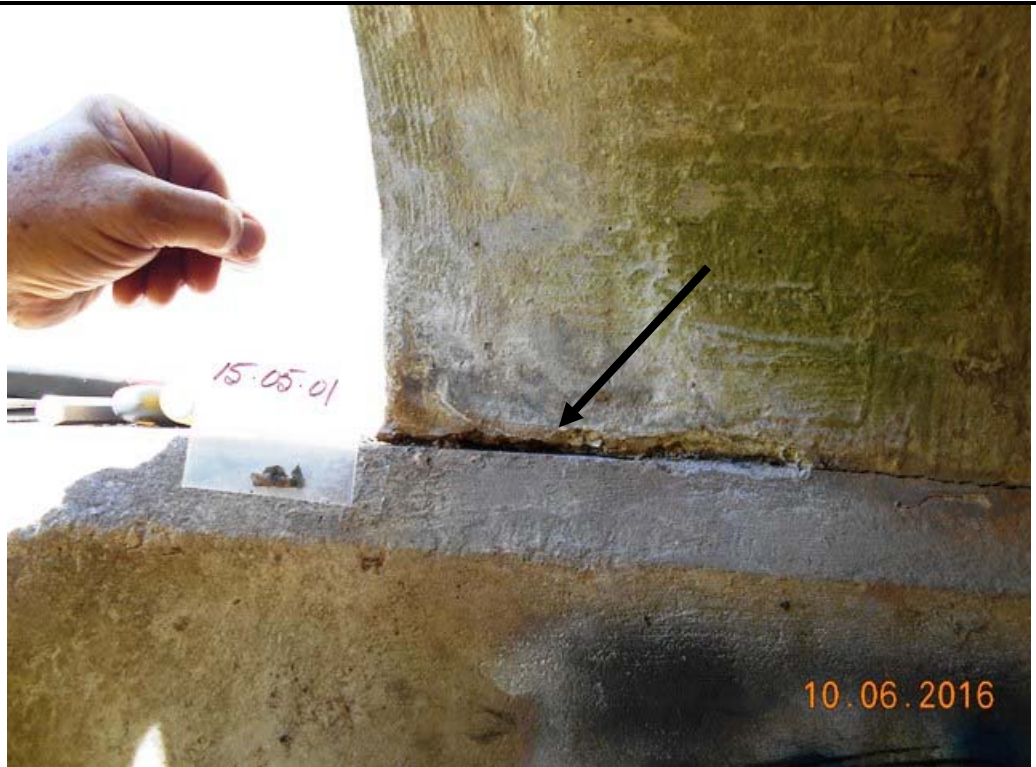
Bridge beams and diaphragms appear to have been cast with the concrete deck. Beams were included in HAs 09 & 11. Black expansion material under diaphragms and around abutments was sampled as HA-06. In the SW corner of the bridge under the outside beams a thin Transite pad was observed. The thin bearing pads from under the beam was sampled as HA-05. The joint is present in the other corners, but the Transite was not present on the surface.

Comments:
P-6 – A thin piece of Transite (HA-05) was found in the joint of the SW corner expansion beam seat. Material from slot was 30% asbestos. Material was not visible at other corners.

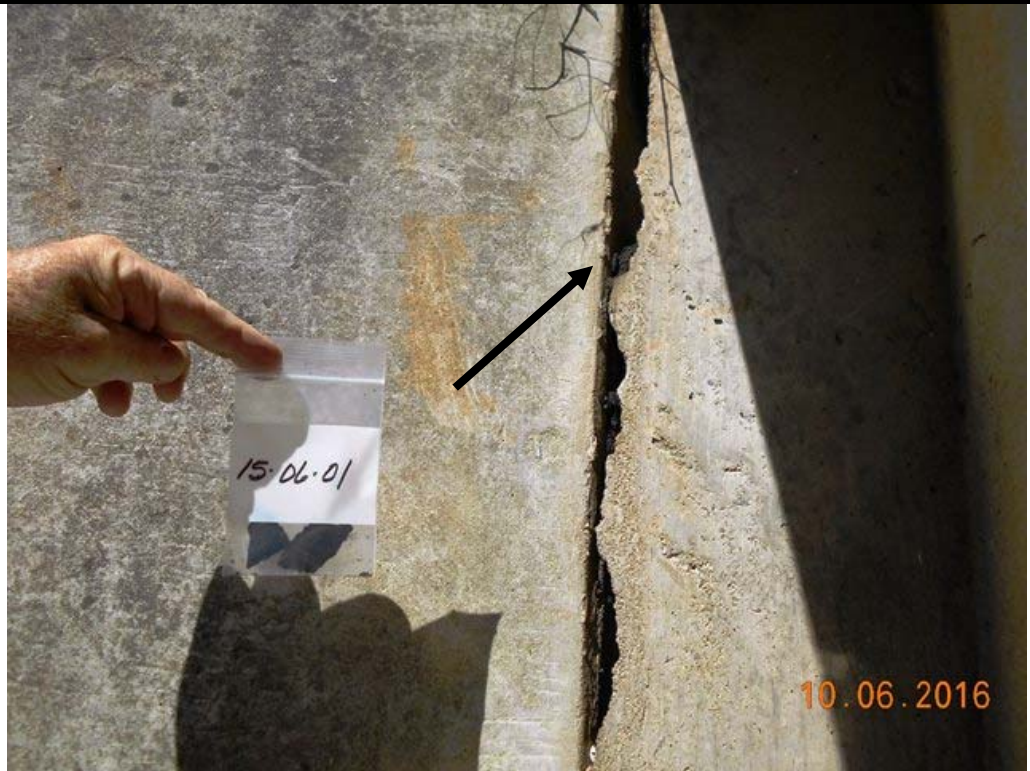
Comments:
P-7 – Samples of black expansion material (HA-06) were collected from wing walls at abutments & under diaphragms. No asbestos fibers were observed in the samples.

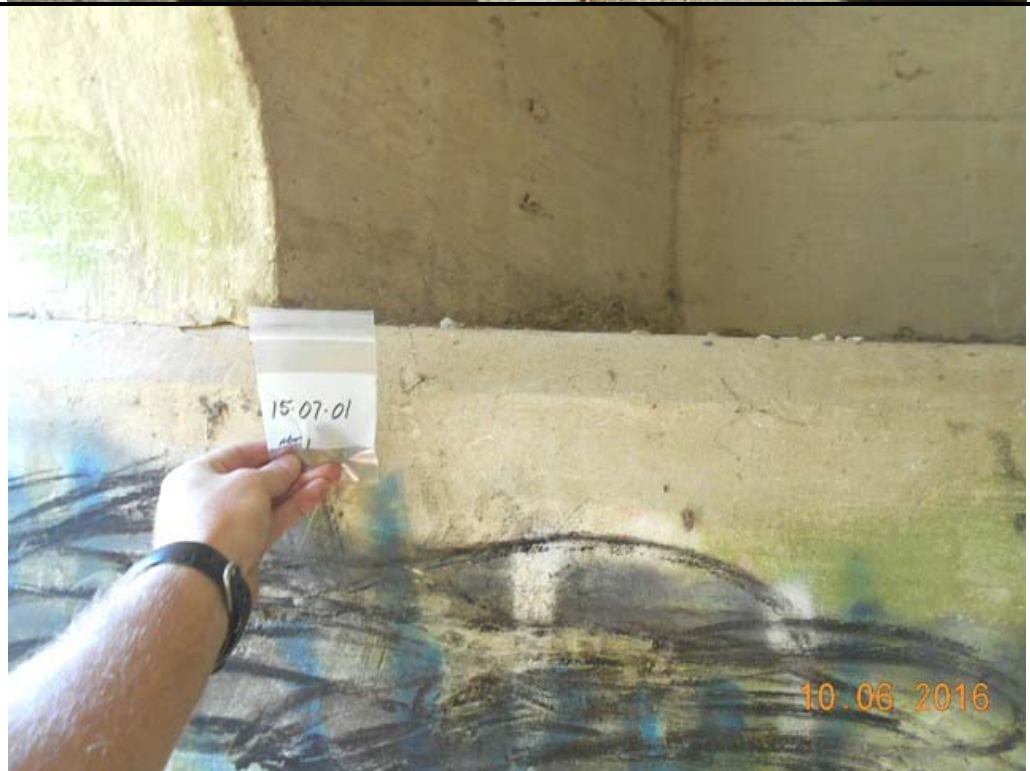
Comments:
P-8 – Substructure concrete was sampled as HA-07. No asbestos was found in concrete from the original structure or the expansion.

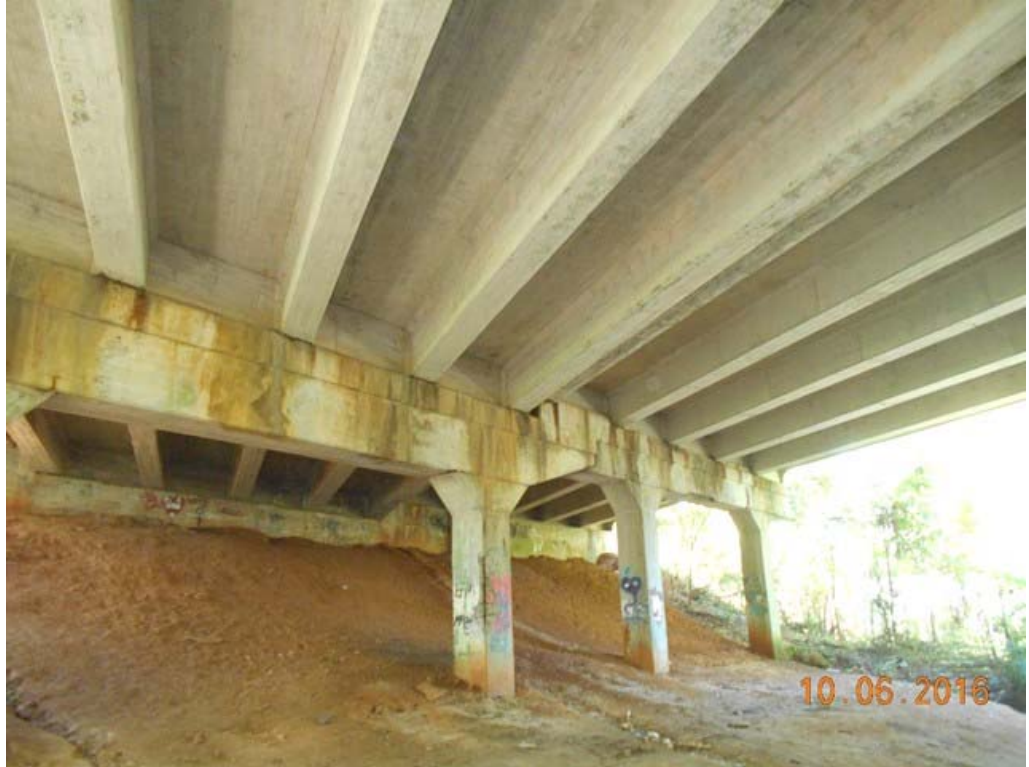
Comments:
P-9 – Substructure concrete was collected from abutments and bent caps as HA-07. HA-07 included concrete of both ages. No asbestos was identified in the concrete samples.

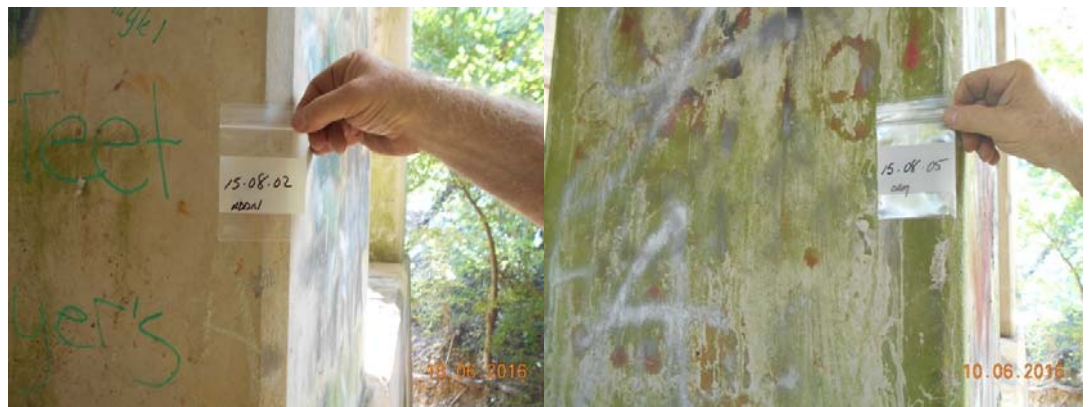
Comments:
P-10 – Concrete samples were collected from piers of both ages. No asbestos was identified in concrete pier samples from HA-08.

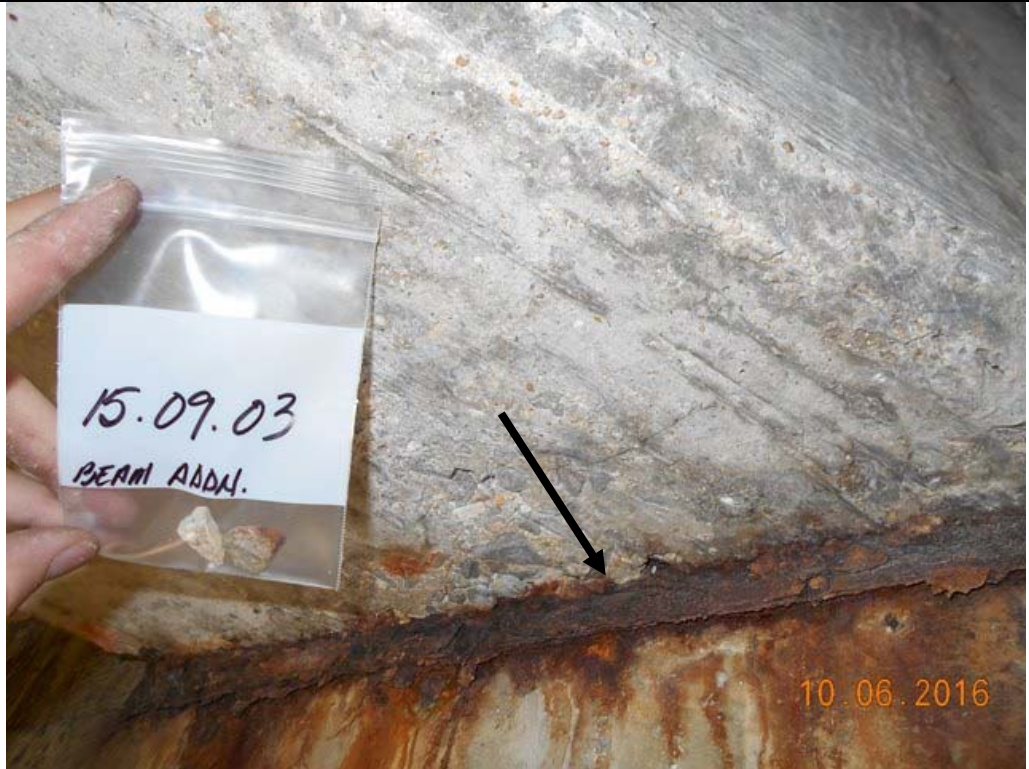
Comments:
P-11 – Samples from expanded concrete beams & underside of deck were collected as HA-09. No asbestos was identified in the concrete. Rusty steel bearing plates under beams were observed.

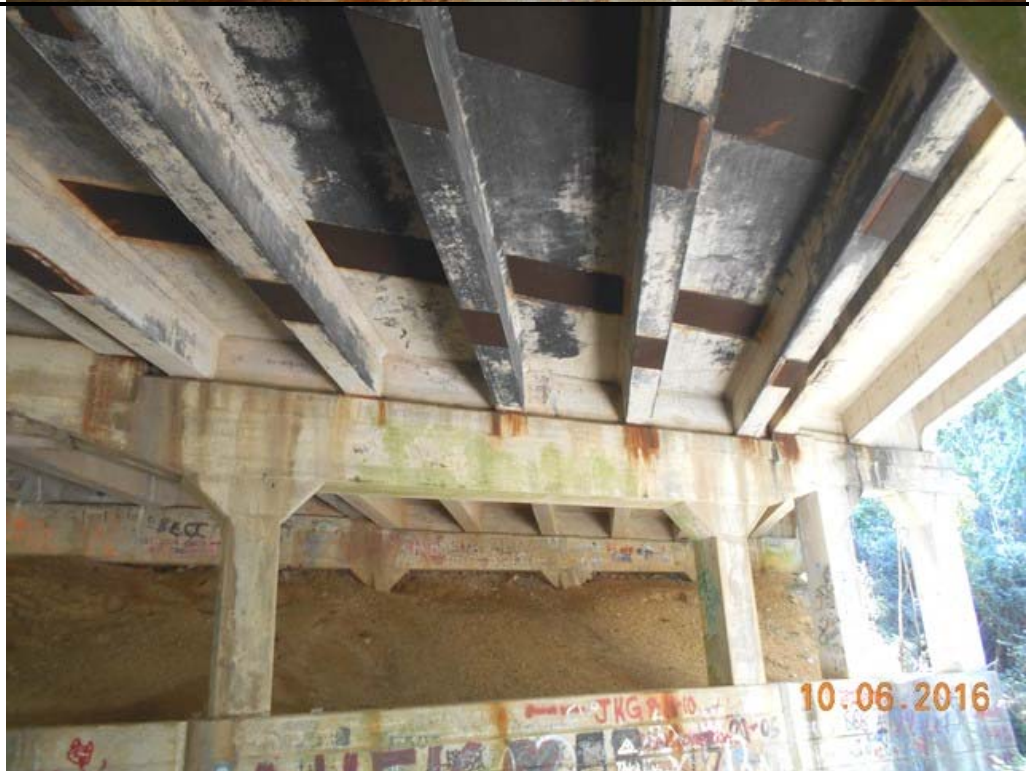
Comments:
P-12 – Concrete of original beams and deck over railroad bed were stained with soot and had metal plates. Bridge expansion beams were still clean.

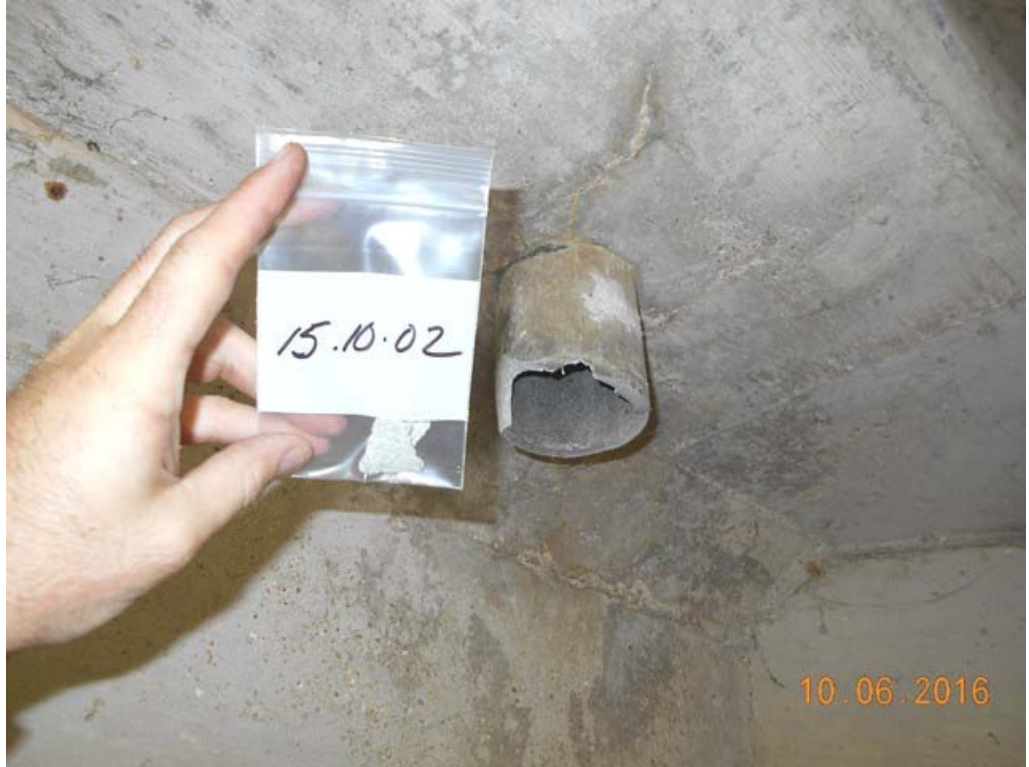
Comments:
P-13 –Samples from
Transite scuppers
visible only from
underside of deck were
collected. The ACM
contained 12%
asbestos.
