BRIDGE REPAIR DETAILS

SR14 OVER OVERFLOW
BRIDGE NO. 79-SR14-27.25

SHELBY COUNTY
2015

BR-118-190

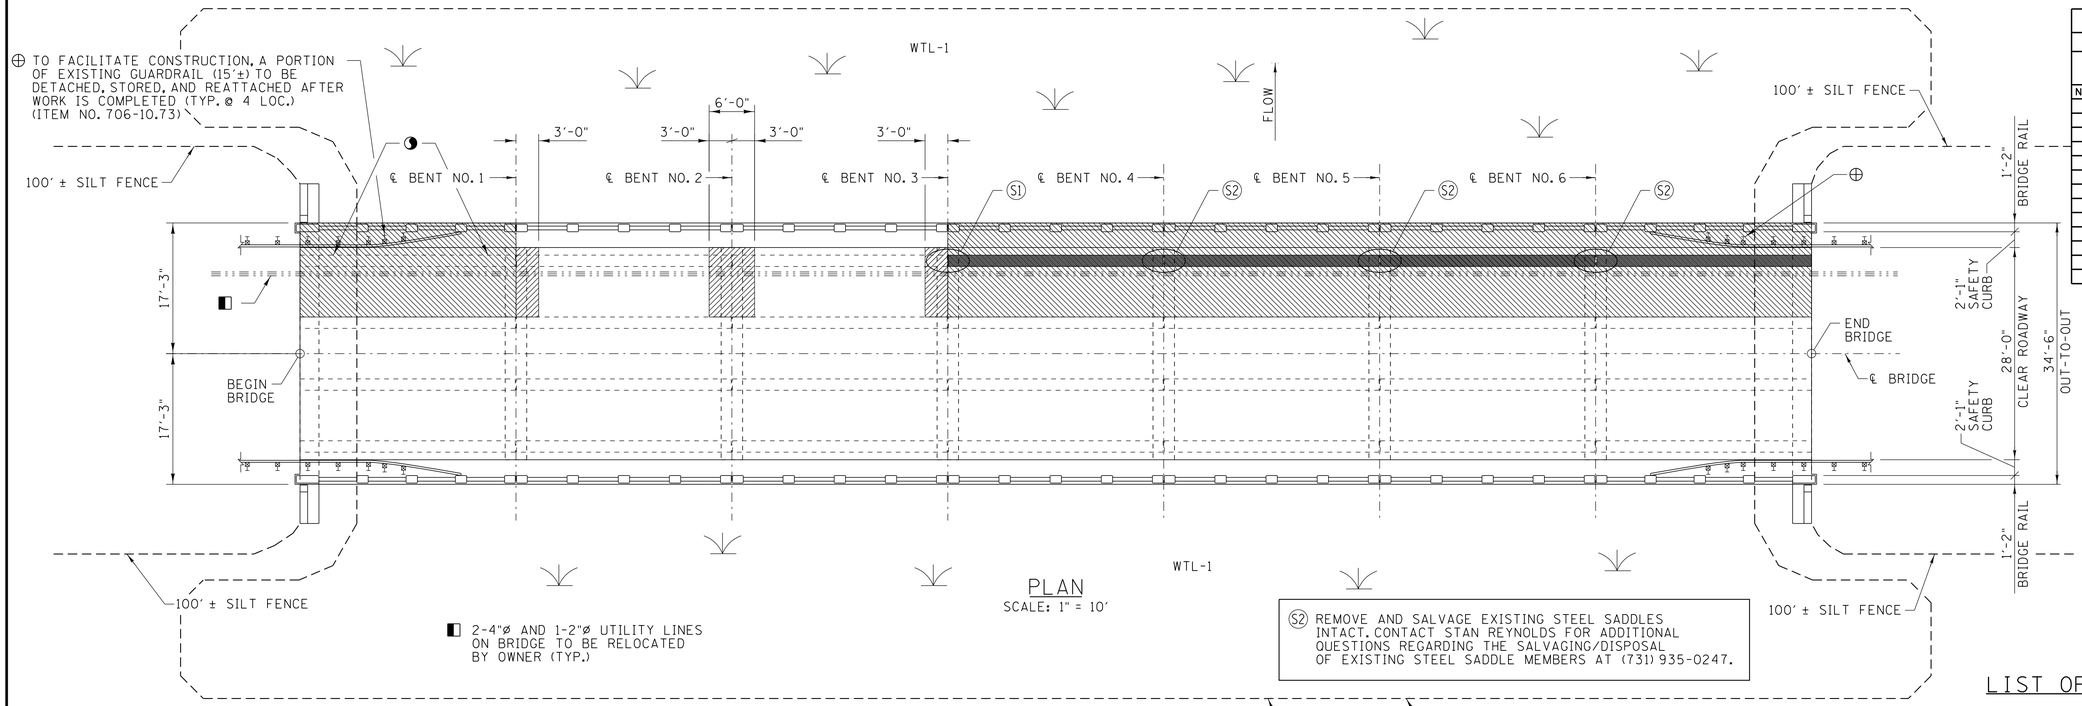
PLAN

2-4"ø AND 1-2"ø UTILITY LINES ON BRIDGE TO BE RELOCATED BY OWNER (TYP.)

(S2) REMOVE AND SALVAGE EXISTING STEEL SADDLES INTACT. CONTACT STAN REYNOLDS FOR ADDITIONAL QUESTIONS REGARDING THE SALVAGING/DISPOSAL OF EXISTING STEEL SADDLE MEMBERS AT (731) 935-0247.
