951004000011
95-I40-7.43R
OVER
WILSON
CREEK

BRIDGE MAINTENANCE RECOMMENDATIONS

Field Report No. 19 Date 2/26/2010
Previous Report No. 18 Date 2/21/2008
Plans: YES

SUMMARY
95-I40-7.43 RT
2/26/2010

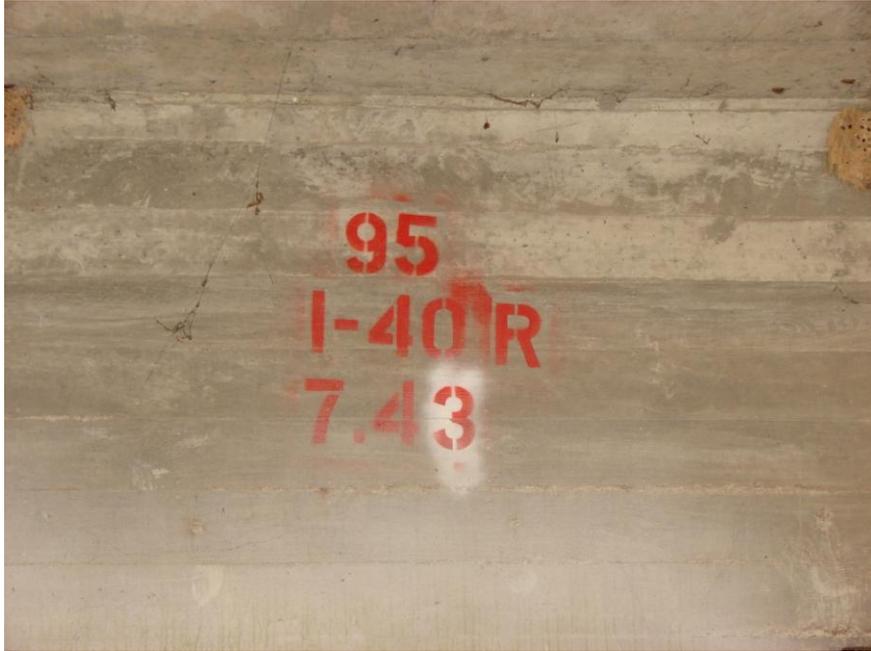
BRIDGE NO.

SPALLS W/EXP REBAR BACKSIDE OF CAP BENT-1

Caps	FAIR	2" DEEP SPALLS WITH HEAVILY RUSTED REBAR
Columns	GOOD	
Plumb	GOOD	
Footings	GOOD	
Piles	NA	
Bearing Surface	GOOD

No.	RECOMMENDATIONS	REPAIR DATE	REPAIRED BY
1.	REPAIR BENT CAPS
