HAMILTON COUNTY

33-03611-01.01
33I00240057 (I-24 LM 12.59)
Belvoir Avenue OVER I-24 EB & WB
4-SPAN

BRIDGE MAINTENANCE RECOMMENDATIONS

BRIDGE INSPECTION REPORT

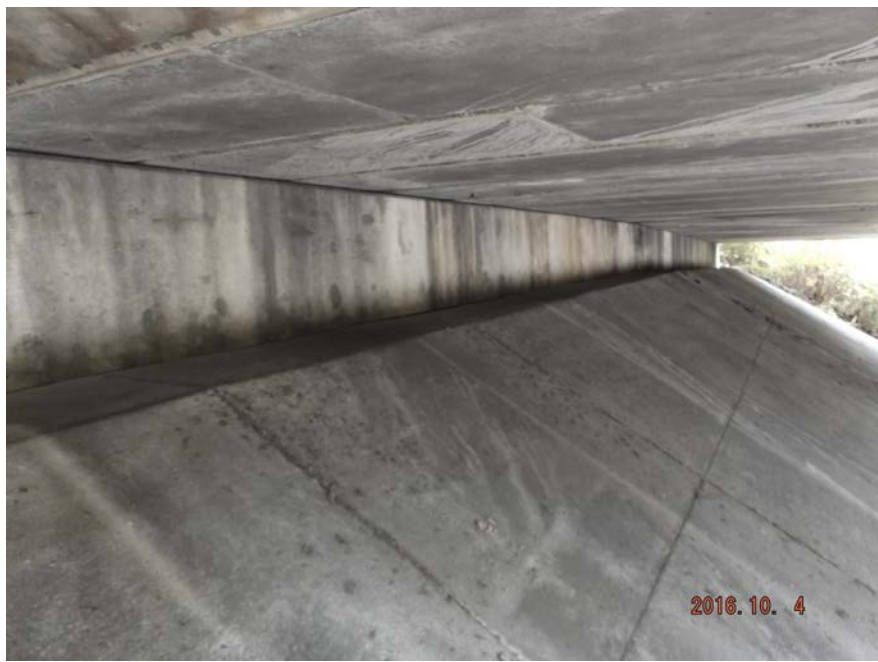
SUPER/SUB STRUCTURE - ABUTMENT 2 - TYPICAL

<u>ABUTMENTS</u>	Rating	Comments
Caps	GOOD	
Stem:	G-F	<i>HL CRACKS.</i>
Wings	GOOD	
Backwall	NV	
Plumb	GOOD	
Footing	NA	
Piles	NV	
Embankment	GOOD	
Bridge Seat:	NV	
Rip Rap	NA

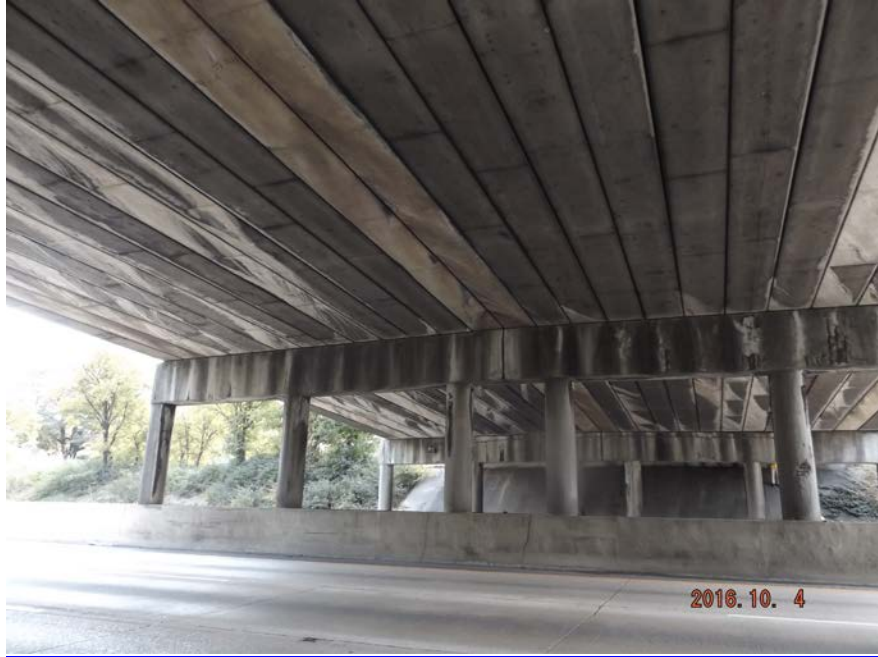
SUPER/SUB STRUCTURE - SPAN 3 - BENT 2 - TYP.

Bridge Seat:	NV	<i>NO VISIBLE SIGNS OF STRUCTURAL ISSUES</i>
Caps	FAIR	<i>HL-SMALL CRACKS, DELAMS, SPALLS, PATCHES.</i>
Columns / Shaft	G-F	<i>DELAM S, SPALLS, PATCHES. BENT 2 - COLUMN B - SIGNIFICANT REBAR SPALL</i>
Pier / Crash Walls:		
Plumb	GOOD	
Footings	NV	
Piles	NV

SUGGESTED ROUTINE MAINTENANCE AND COMMENTS
Cut vegetation blocking sidewalk
PAINT PROTECT EXPOSED REBAR BENT 2
LEVEL THE WEARING SURFACE OVER THE COVERED JOINTS.
SEAL VOIDS IN DECK WEARING SURFACE AT CENTERLINE.

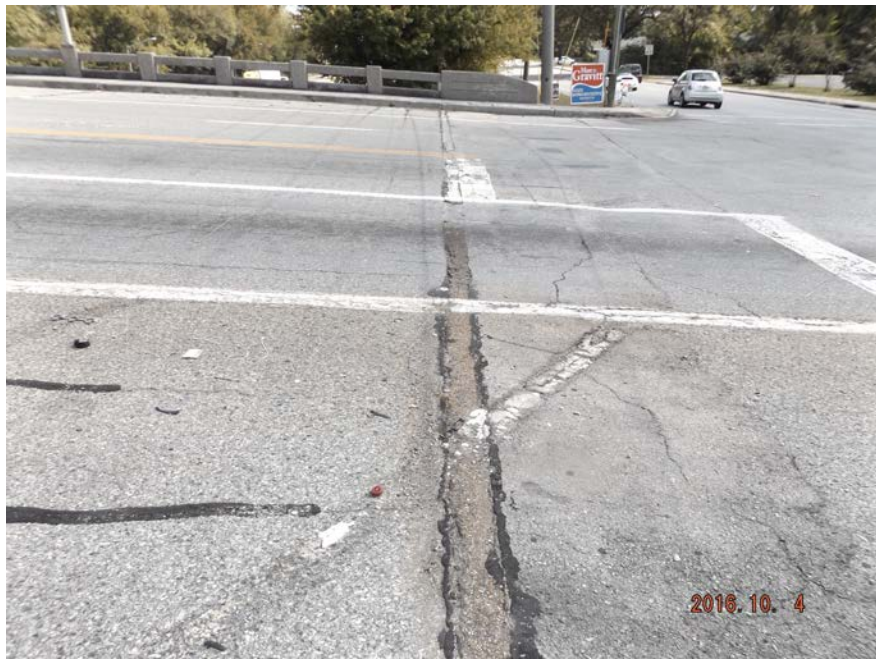
APPROACH 1

App Pvmnt: F Uneven, cracks, rutting

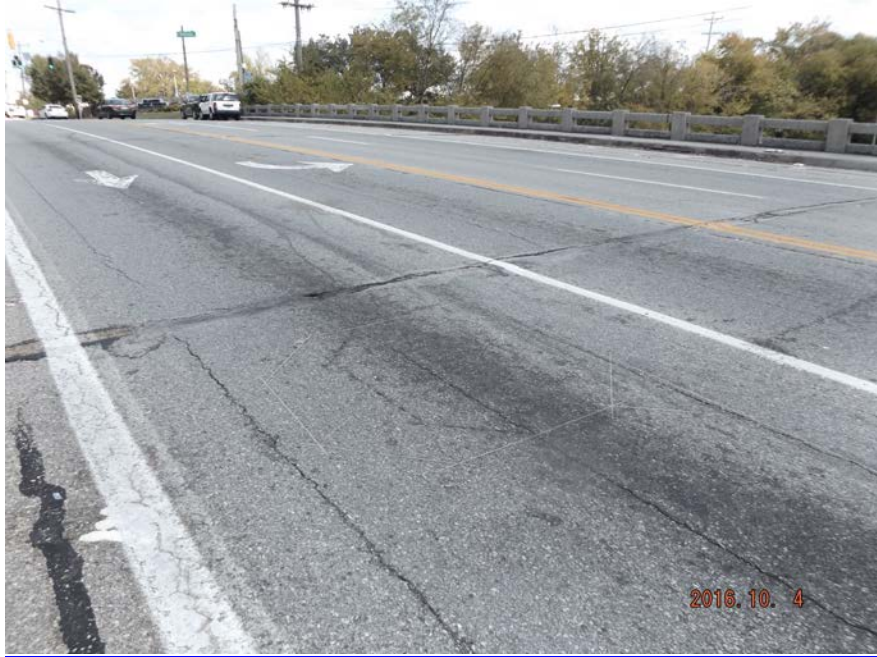
WEARING SURFACE

Rating	Comments
Wearing Surface	FAIR	<i>UNEVEN, RUTTING</i>
Deck - TRIMS Item 58	7	
Deck - Structural Condition	NV	<i>NO VISIBLE SIGNS OF STRUCTURAL ISSUES</i>
Curbs	GOOD	
Median	NONE	
Sidewalks	GOOD	<i>Partly blocked by vegetation at approach 2</i>
Paint	NA	
Drains	NONE	
Lighting Standards	GOOD	
Utilities	NONE	
Joint Leakage	POOR	<i>HEAVY</i>
Expansion Joints	NV	<i>OVERLAYED</i>

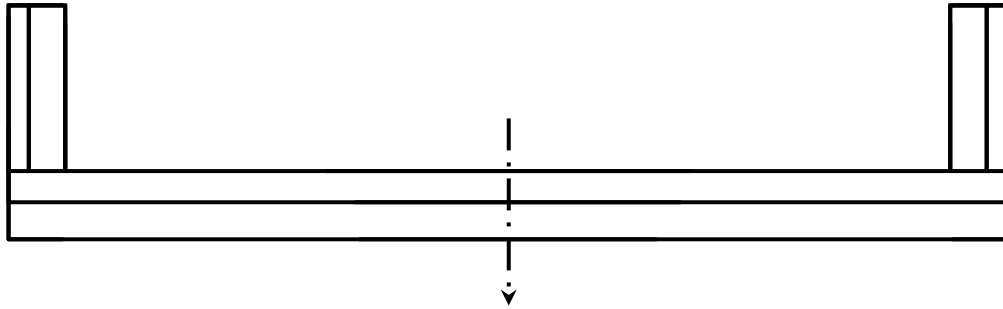
Bent No. 1

cracks are hairline unless noted otherwise
shaded areas are delaminated

rebar popout 7" X 1' X 1" deep Delam/Spalled with rebar exposed 20' x 2' x 1" rebar popout 7" X 8" X 1" deep
Back Side
