140 RL / 8TH AVE (SR 6)

IDENTIFICATION	
(1) State Names	47 - Tennessee
(8) Structure Number	19I00400079
(5) Inventory Route	1
(2) Highway Agency District	Region 3
(3) County Code	19 - Davidson

INSPECTIONS *			
(90) Inspection Date	12/04/2023		
(91) Frequency	24		
(92) Critical Feature Inspection	Done	Freq. (Mon)	Date
A: Fracture Critical Detail	No		
B: Underwater Inspection	No		
C: Other Special Inspection	No		
<p>* The inspection date and frequency information in this box contains the current NBI date and frequency information. Please refer to the report header for the date this inspection was conducted.</p>

3 span Bridge / W.P.G.
I-40 EB / 8TH AVE (SR 6)

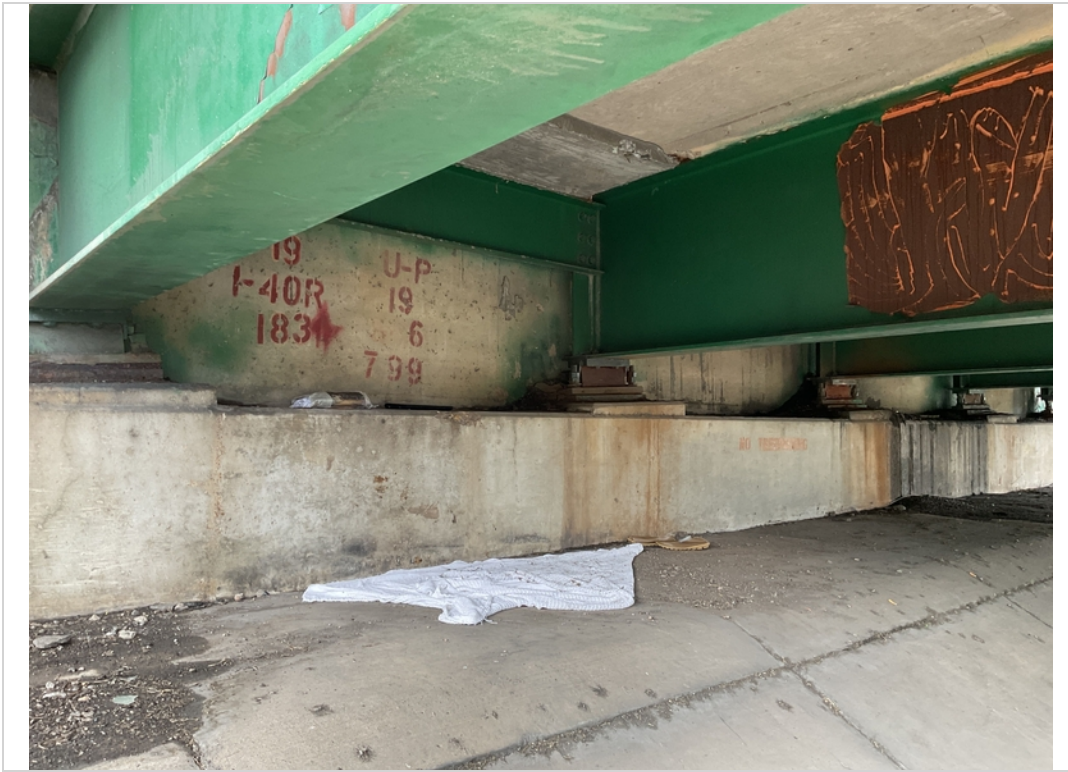
Abutment 1

Abutment cap and backwall at abutment 1 are fair with scale and map cracks with efflorescence. Wing at abutment #2 left side is poor with heavy spall resulting from impact damage.

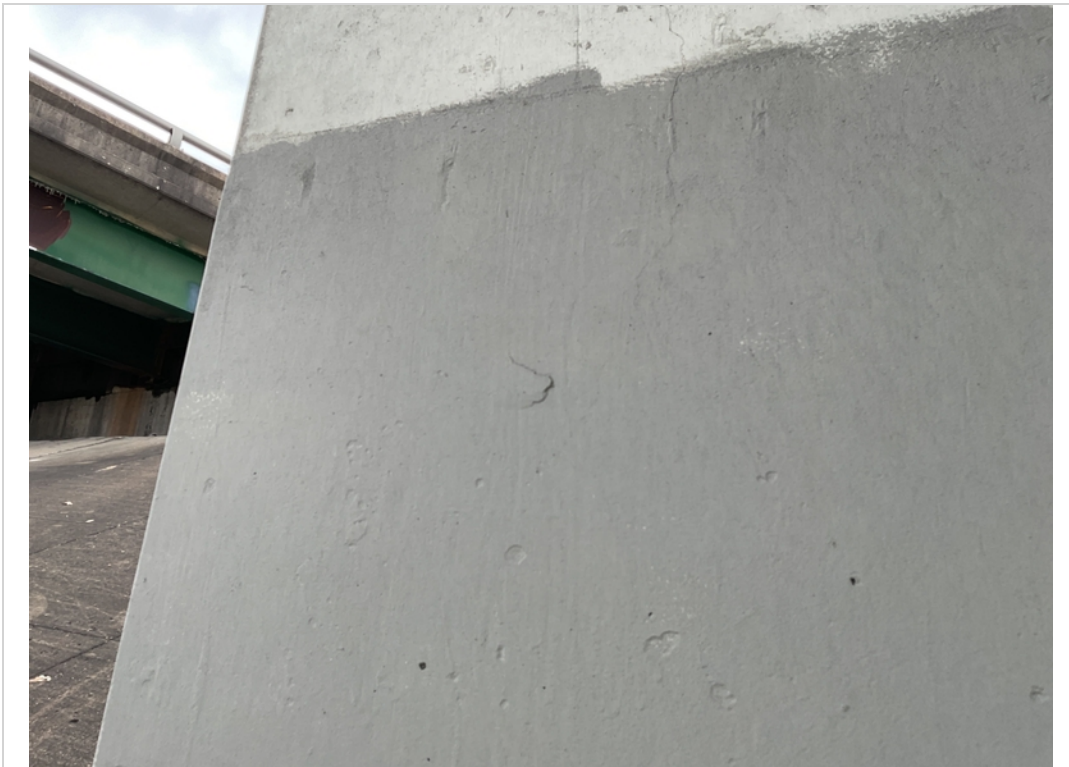
Bent 1 column C HSP

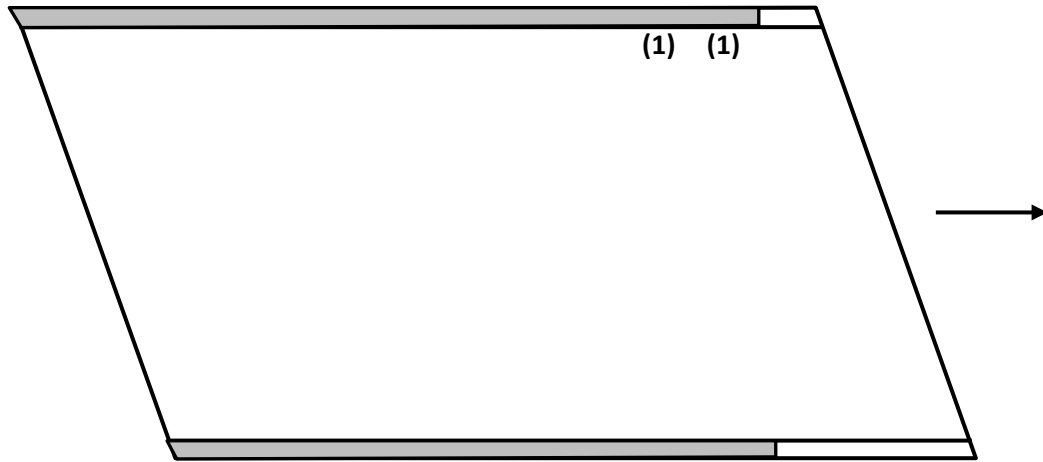
Approach 'B'

G.RAILS	GOOD	(1) IMPACT DAMAGE W/ MISSING BLOCKOUT
PAVEMENT	GOOD	
EMBANKS	GOOD	
PARAPETS	GOOD

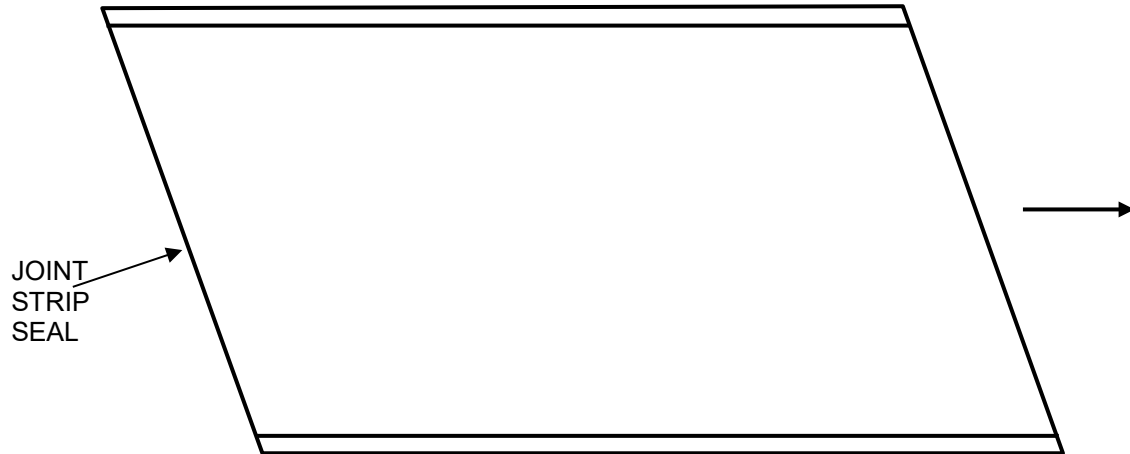
Top of Deck Span No. 2

DECK	NV	ASPHALT- GOOD
PARAPETS	FAIR	MOD SCALE & RANDOM CRACKS LEFT SIDE, RT SIDE LARGE
		PATCHED AREAS
JOINT	POOR	HVY. DEBRIS ACCUMULATION

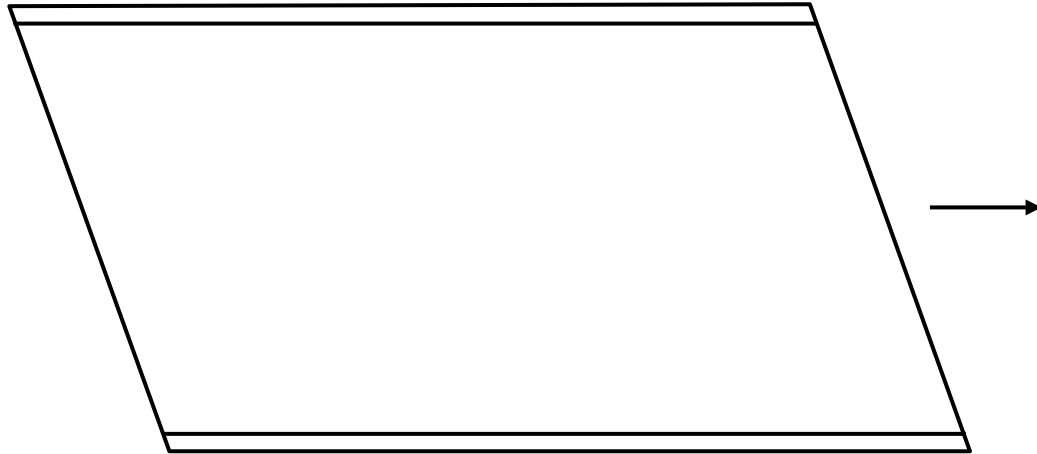
Top of Deck Span No. 3

DECK	NV	ASPHALT - GOOD
PARAPETS	FAIR	MOD SCALE & RANDOM CRACKS LEFT SIDE, RT SIDE LARGE
		PATCHED AREAS

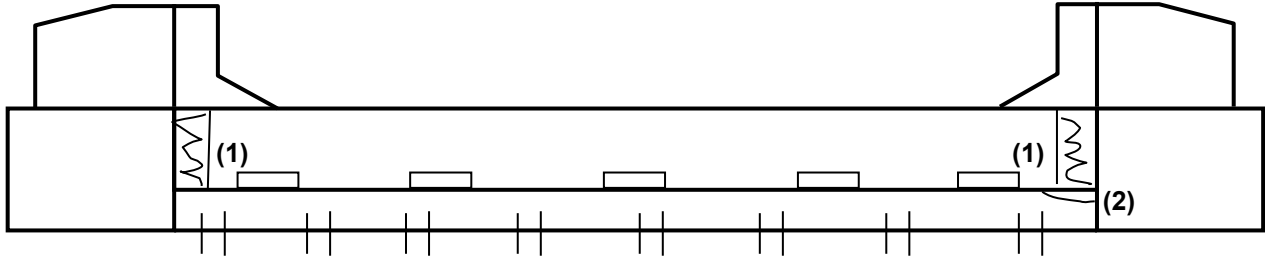
BACKWALL	FAIR	(1) SCALE / RANDOM MAP CRACKING W/ DELAM @ 3' X 3'
CAP	FAIR	(2) SCALE 2' L X 1' H- SPALL 1'L X 6" W X 1/2" DP
WINGS	GOOD	MAP CRACKING W/ EFF., RANDOM DIAG H.C.'S
BEARINGS	FAIR	LGH-MOD. CORR.; HVY DEBRIS BULD-UP ON BEARINGS; ROCKED
		BACKSTATION UPTO 15 DEGREES
"A"	POOR	A' MISSING ANCHOR BOLT
"C" & "D"	POOR	MISSING/BROKEN BEARING PINS
RISERS	GOOD	
"A"	FAIR	SCALE, SPALL 3'L X 1' W X 1" DP
SLOPE PVT	FAIR	EROSION LEFT SIDE FULL LENGTH X 3'W X 8"DP
		BROKEN SECTION 4'L X 4'W

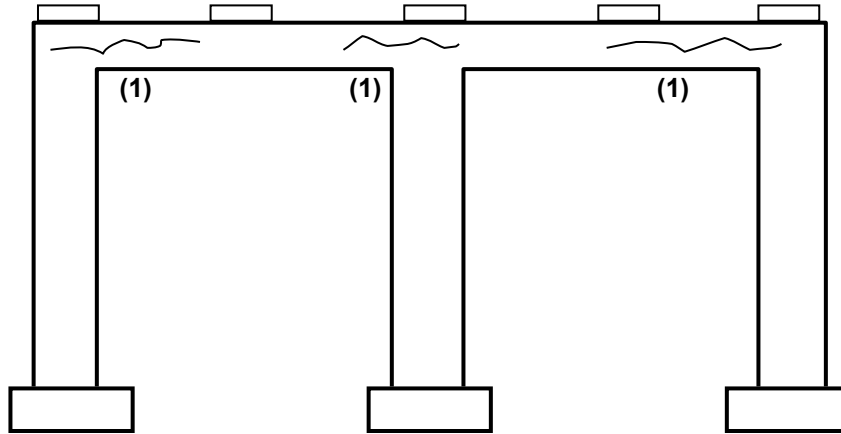
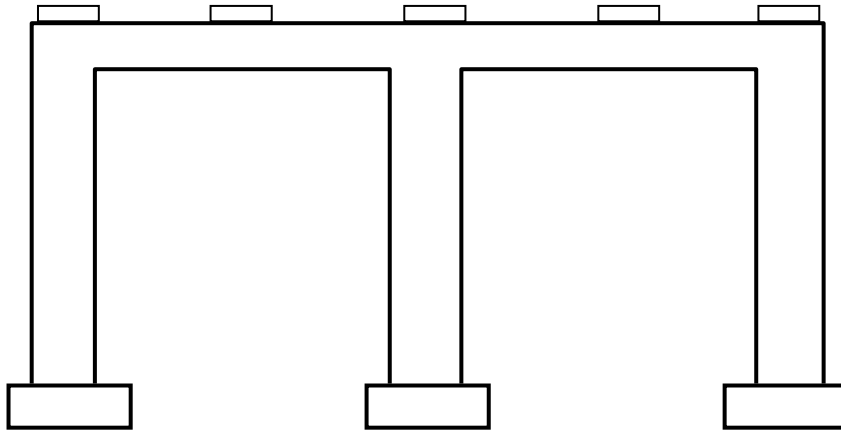
BENT # 1

CAP	GOOD	(1) HORIZONTAL HAIR CRACK
COLUMNS	GOOD	VERTICAL HAIR CRACK ALL COLUMNS / FULL LENGTH
		RANDOM I.P.B.O.'S UP TO 3" DIA- ALL BEAMS
'C'		RANDOM H.S.P.O.'S
FOOTING	NV	
BEARINGS	GOOD	
RISERS	GOOD

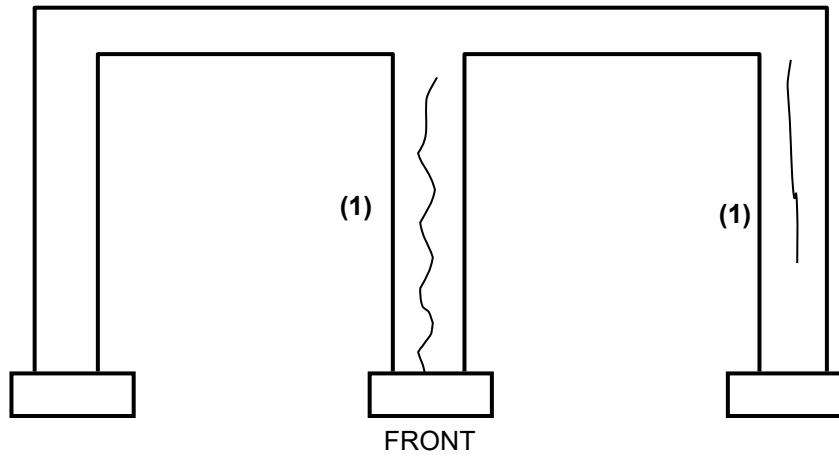
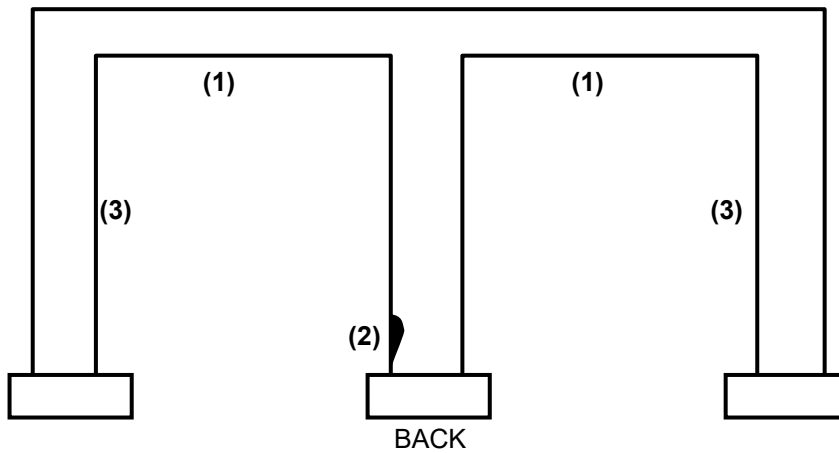
CAP	GOOD	(1) RANDOM HAIR CRACKS
COLUMNS	GOOD	(2) SPALL 18" L X 6" W X 1.5" DP; (3) H.C. FULL LENGTH
FOOTING	NV	
BEARINGS	GOOD	
RISERS	GOOD

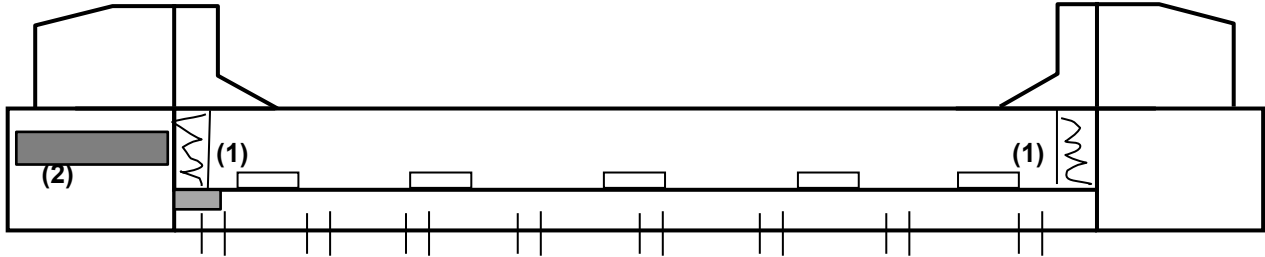
Abutment No. 2

BACKWALL	GOOD	(1) SCALE / LEACHING / DELAM W/ EFF. 3' X 3'; RANDOM VERT. CRACKS W/ EFF.
CAP	GOOD	MOD CRACKING W/EFF.
WINGS	FAIR	MAP CRACKING W/ EFF.; (2) SPALL W/ EXP. STL. 8' X 2.5' X 4" DP
BEARINGS	GOOD	LGH CORROSION-PAINTED OVER
"E"	FAIR	MOD. CORROSION
RISERS	GOOD	
SLOPE PVT	GOOD
