BRIDGE MAINTENANCE RECOMMENDATIONS

LOCATION: 79-I0240-15.43-

CROSSING: PARK AVE / I240

Inspection Team's Summary
Bridge Location No. 79 - I0240 - 15.43
Inspection Date 02-19-13
Bridge Rating FAIR

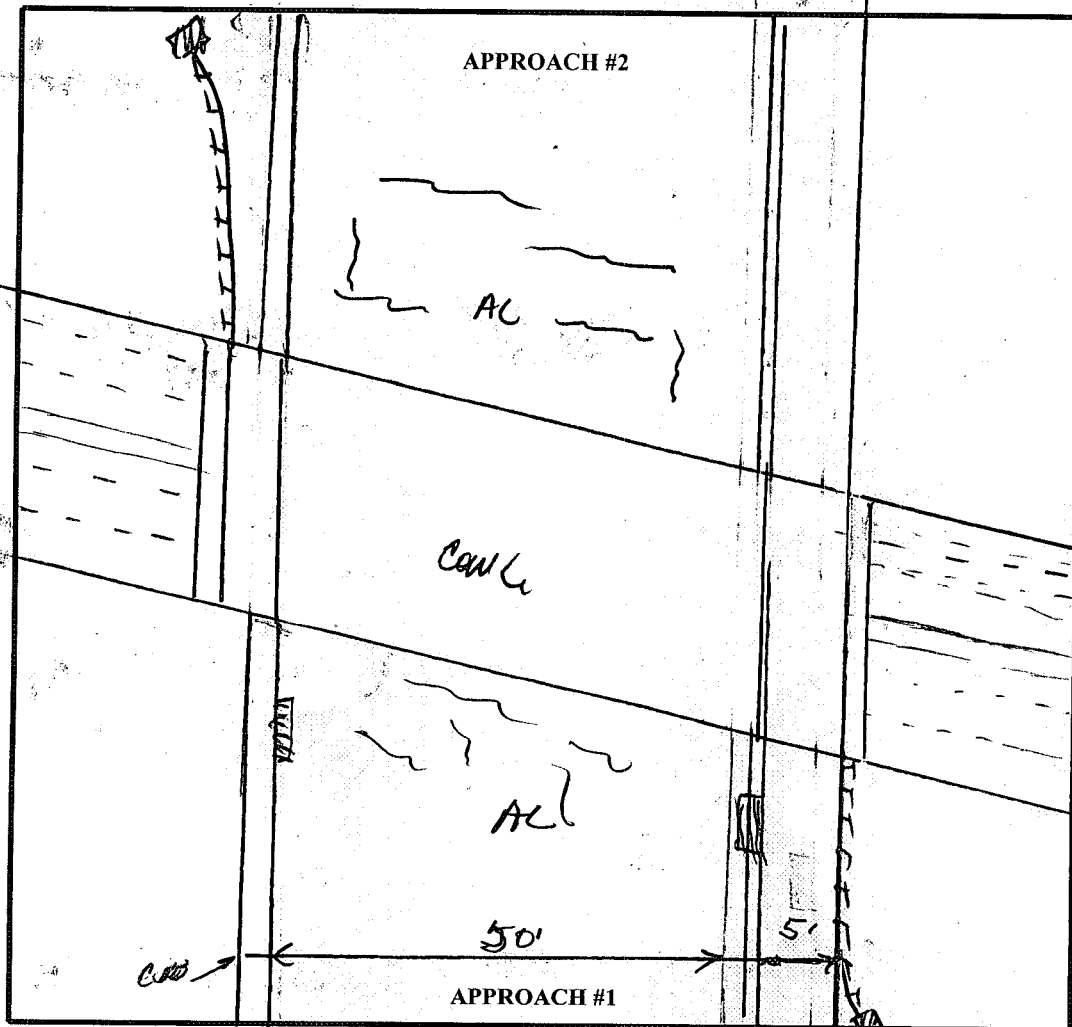
ELEMENT	RATING	COMMENTS
ALIGNMENT	Ⓒ F P C	
APPROACH PAVEMENT	G Ⓒ P C	Fin cracks
APPROACH SLAB	G F P C	N/A
APPROACH GUARDRAIL	Ⓒ F P C	
EMBANKMENT	Ⓒ F P C	
DRAINS	Ⓒ F P C	
APPROACH JOINT	G F P C	N/A
SIGNS	G F P C	NONE

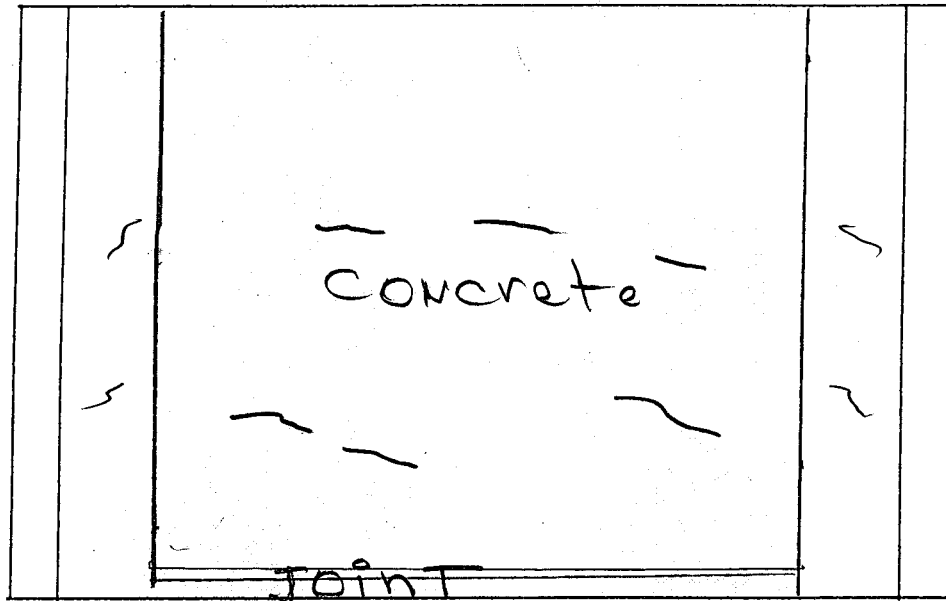
SPAN. NO. 1

ELEMENT	RATING	COMMENT
TOP DECK	G <u>F</u> P C	fine cracks
PARAPET	G <u>F</u> P C	fine cracks
Metal RAILS	G <u>F</u> P C	
DRAIN	G <u>F</u> P C	
JOINT	G <u>F</u> P C	material, torn w/ sections w/ material missing
Sidewalk	G <u>F</u> P C	hair line cracks

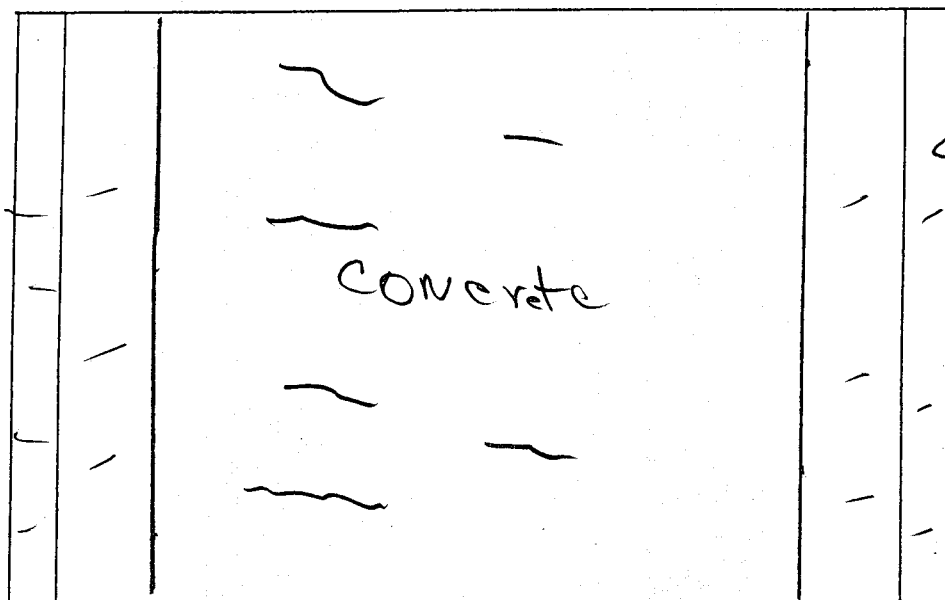
SPAN. NO. 2

ELEMENT	RATING	COMMENT
TOP DECK	G F P C	fine cracks
PARAPET	G F P C	hair line to fine cracks
metal RAILS	G F P C	
LIGHT DRAIN	G F P C	NONE
JOINT	G F P C	NONE
Sidewalk	G F P C	hairline cracks

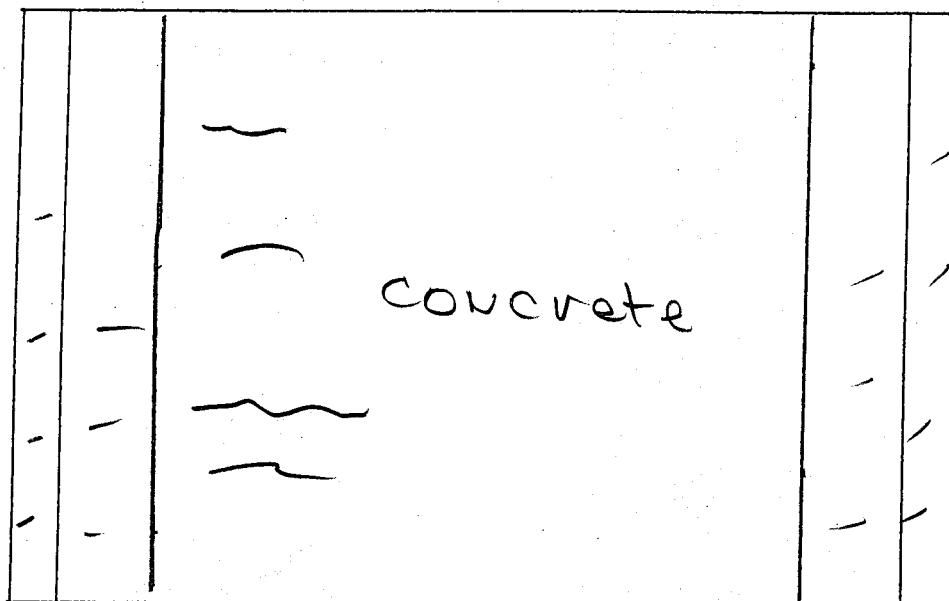
SPAN. NO. 3

ELEMENT	RATING	COMMENT
TOP DECK	G F P C	fine cracks
PARAPET	G F P C	hairline cracks
metal RAILS	G F P C	
DRAIN	G F P C	None
JOINT	G F P C	None
Sidewalk	G F P C	hairline cracks

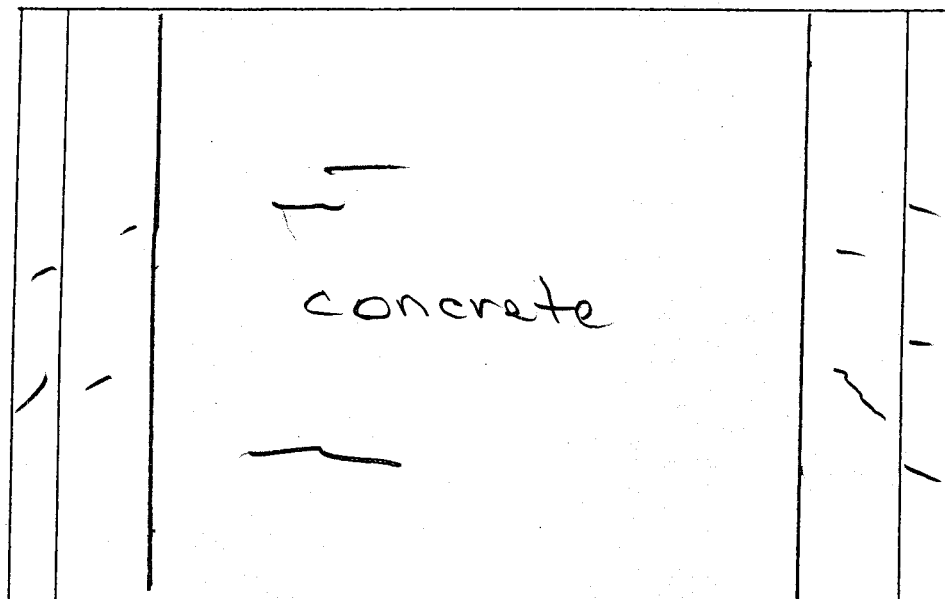
SPAN. NO. 4

ELEMENT	RATING	COMMENT
TOP DECK	G F P C	fine cracks
PARAPET	G F P C	hairline to fine cracks
metal RAILS	G F P C	
DRAIN	G F P C	NONE
JOINT	G F P C	None
Sidewalk	G F P C	hairline cracks

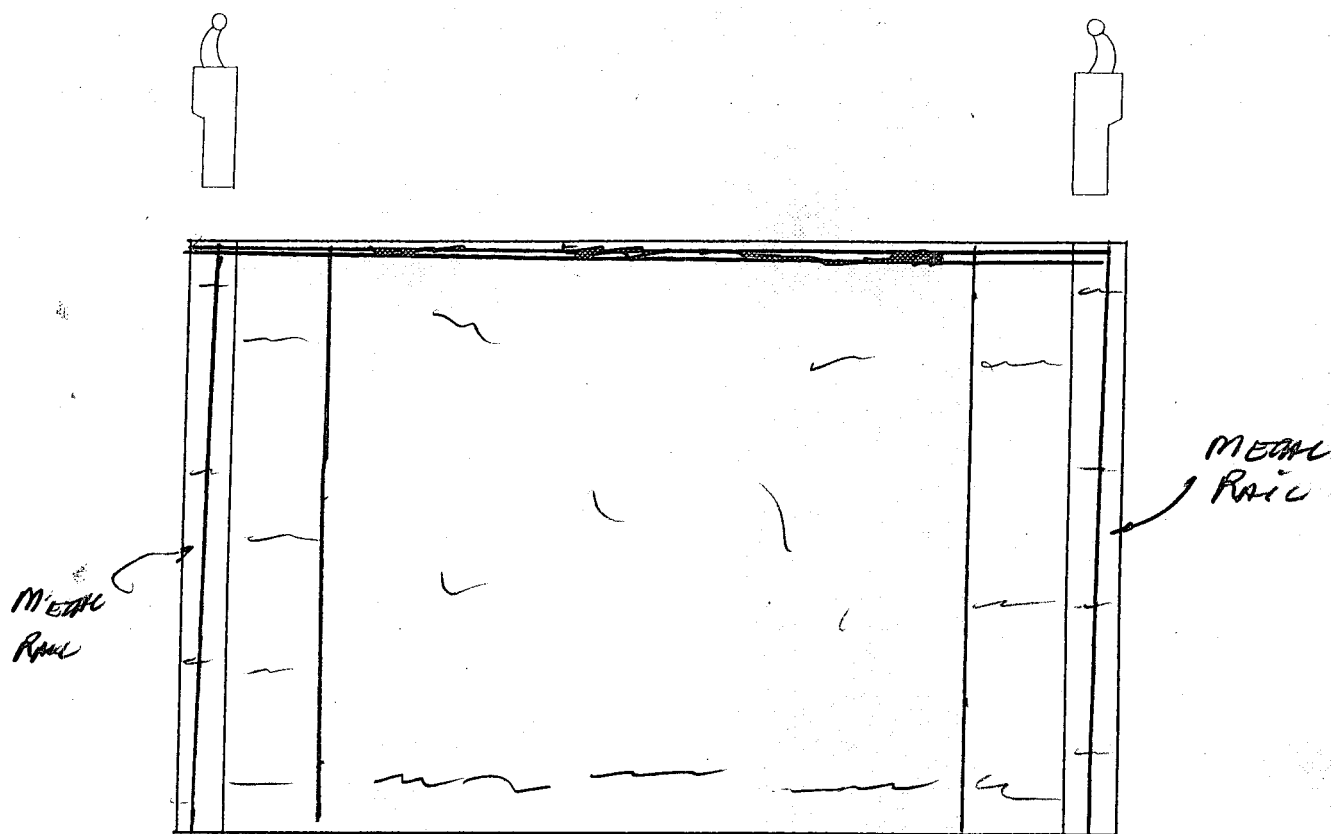
SPAN. NO. 5

ELEMENT	RATING	COMMENT
TOP DECK	G (P) P C	Hair Lot to Foe cracks
PARAPET	G (P) P C	Hair Lot cracks
METAL RAILS	(G) F P C	
DRAIN	(G) F P C	N/A
JOINT	G F (P) C	
Sidewalk	G (P) P C	Material peeling Fills with Debris and Holes begin to spruce Hair Lot cracks

CLEAN AND SEAL ROADWAY EXPANSION JOINTS.
