BRIDGE MAINTENANCE RECOMMENDATIONS

COUNTY: SHELBY LOCATION: 79-SR057-08.09-L CO. SEQ.: 1 SPEC. CASE: 0

CROSSING: 1240 & 1240 EXIT RAMP
 REPAIR LIST NO.:
 2

BRIDGE INSPECTION REPORT

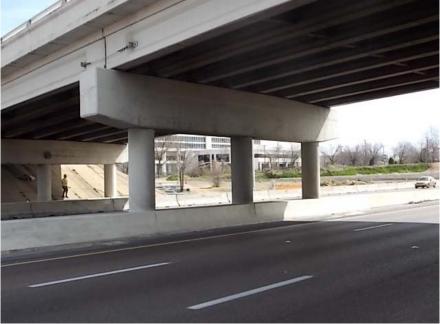
BENT 3 FRONT

THIS 5 SPAN CONCRETE I BEAM BRIDGE IS IN POOR CONDITION. THE APPROACH PAVEMENT AND CONCRETE WEARING SURFACE HAVE FINE CRACKS. SPAN 1,3&5 COVER PLATES ARE MISSING FROM LIGHTS. SPAN 3 BOTTOM DECK HAS DELAMINATION AND SPALLING. SPAN 5 CONCRETE I BEAM(C&D) SPALLED TO STEEL AND BROKEN. THE CONCRETE SUBSTRUCTURE HAS FINE CRACKS AND BEGINNING TO SPALL. THE MAIN LANE VERTICAL CLEARANCE IS UNDER CONSTRUCTION. THE MINIMUM VERTICAL ON RAMP IS 16'5". NOTE: APPROACH 1&2 LEFT AND RIGHT SIDEWALK SETTLED. SPAN 5 JOINT MATERIAL TORN AND MISSING. THERE IS POTENTIAL FOR CONCRETE TO FALL IN ROADWAY SPAN 2 BOTTOM HAS DELAMINATION AND BENT 3 HAS BEGINNING TO SPAL THAT COULD FALL IN ROADWAY.

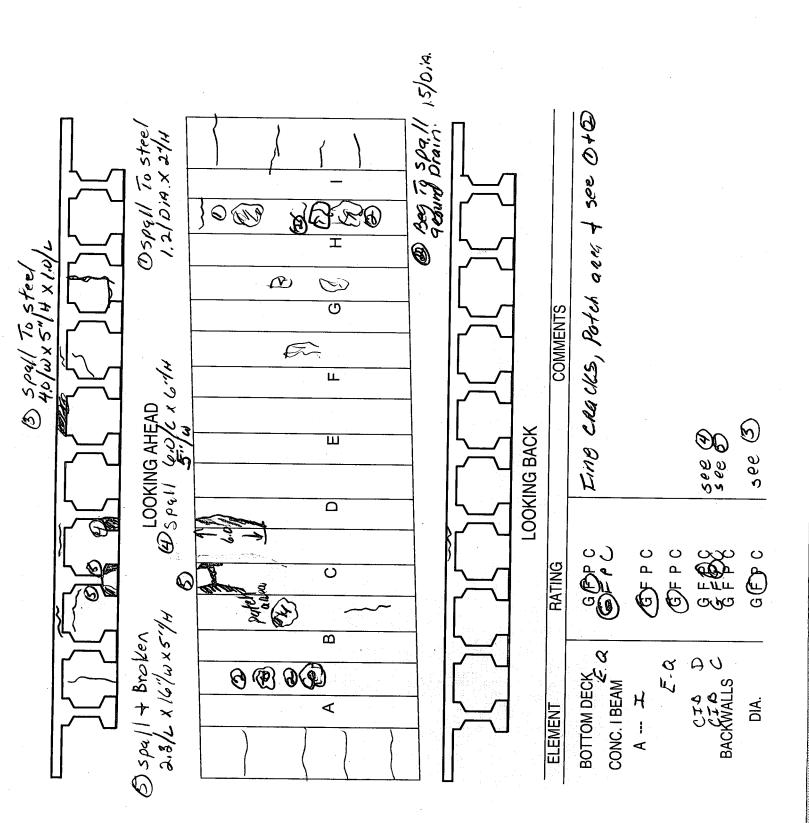
79-57-8,09 SKEW R\L_____ Span No. 5 Bridge No.

MAR 042013 79 57 8,09 Bridge No. Co. Log Mile R/L Skew SPAN. NO. 5 Route \overline{n} 70'WH Dspalling in hint Conc on hin header Shxz"Lkz" ELEMENT RATING COMMENT FINECracks GFPC TOP DECK finecracus GFP C PARAPET partially filled with debris GFP C DRAINS material torn & missing, see () G FPC JOINTS GFPC hails GBPC Enclarks Sidewalk Light cover plate missing

SUGGESTED ROUTINE MAINTENANCE AND COMMENTS
REPAIR CONCRETE BEAM "C & D" SPAN NO.5
PATCH BOTTOM OF DECK IN SPAN NO.3
CLEAN AND SEAL ROADWAY EXPANSION JOINTS.
REPAIR SIDEWALK AT APPROACH NO.1 RT & LT & 2 RT & LT
UNDERPASS SUBSTRUCTURE PROTECTION GUARDRAILS ARE SUBSTANDARD
