19100650113
19-I0440-4.85 RT
L4-SN 167 RL/L3-SN 164 & 165

BRIDGE MAINTENANCE RECOMMENDATIONS

Tennessee Department
of Transportation

BRIDGE INSPECTION REPORT

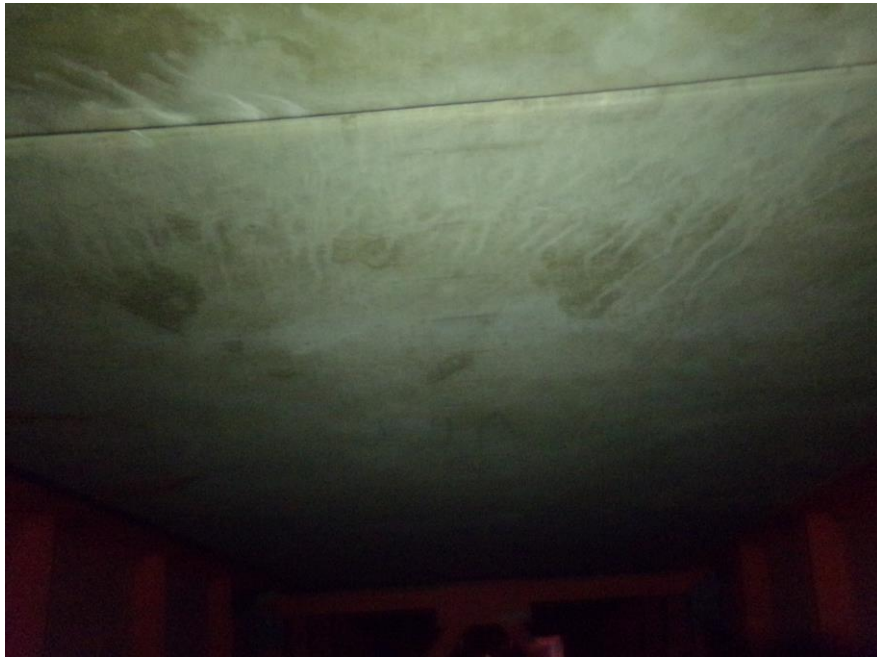
TUB "A" DECK PANELS - TYP.

Rating	Comments
Wearing Surface	GOOD	CONCRETE--THIN EPOXY OVERLAY
Deck - Structural Condition	FAIR	BTM--DECK PANELS W/H.C'S
Curbs	NA	
Median	NA	
Sidewalks	NA	
Parapet	GOOD	VERT. CRACKS W/ EFF
Railing	NA	
Paint	NA	
Drains	NA	
Lighting Standards	NA	
Utilities	NA	
Joint Leakage	POOR	
Expansion Joints	FAIR	LGH.. DEBRIS BLD-UP (ASSEMBLY TYPE)

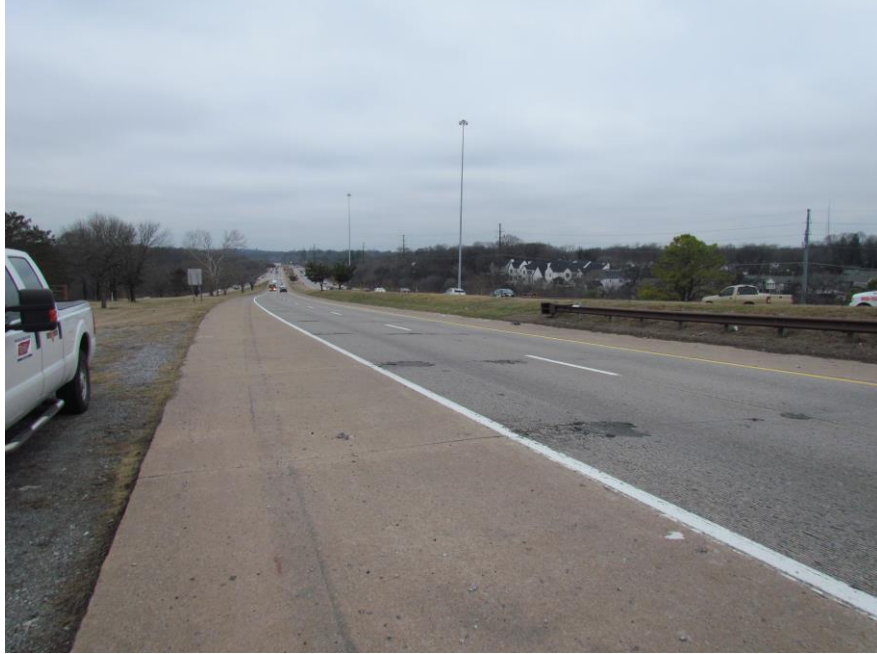
APPROACH "A" I440

Rating	Comments
Alignment	GOOD	NO SPEED REDUCTION REQUIRED
Slab	GOOD	
Joints	FAIR	CHIPPING @ EDGES & WORN FILLER
Pavement	POOR	'A' & 'B' ENDS- AC PATCHES, POTHOLES
Embankment	GOOD	
Drains	GOOD

No.	RECOMMENDATIONS	REPAIR DATE	REPAIRED BY
1.	REPAIR CRACKS IN TUB GIRDERS "A" & "B"		
2.	REPLACE MISSING BOLTS (NUMEROUS) IN DIAPHRAGM TUB "B"		
3.	SEAL/REPAIR APPROACH PAVEMENT

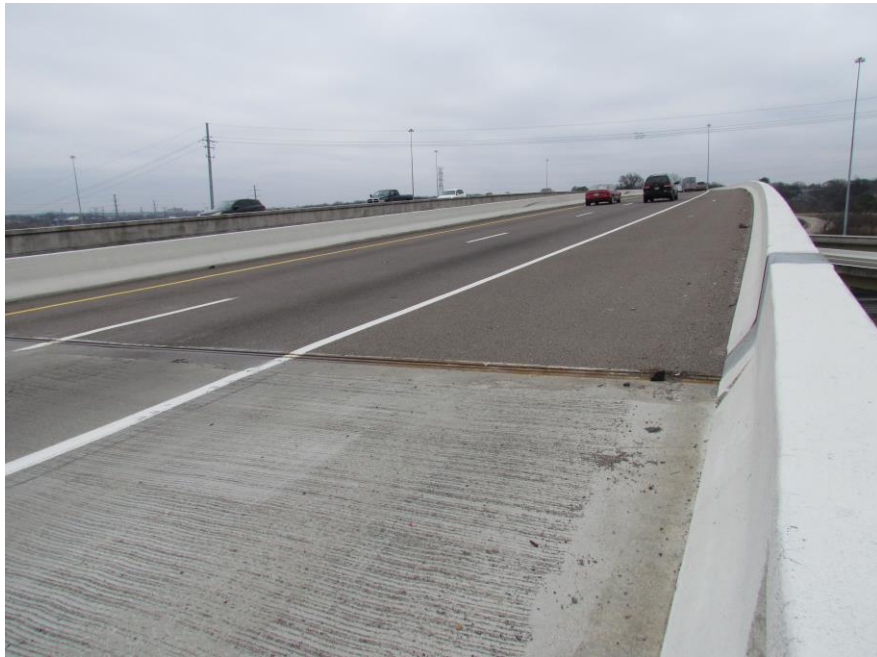
VIEW ACROSS TOP OF WEARING SURFACE I440

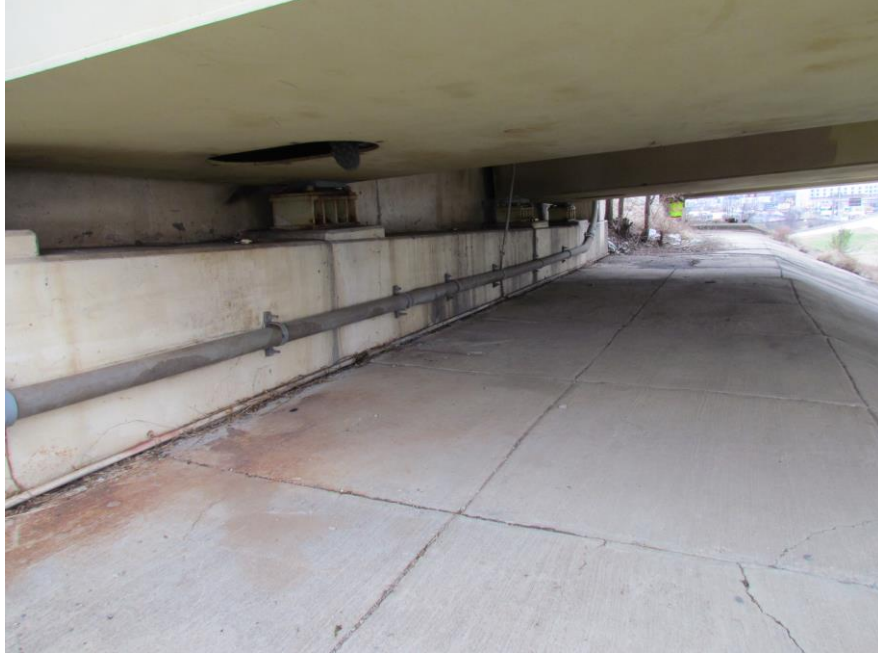
ABUTMENT #1

Rating	Comments
Caps	FAIR	MAP & VERT. CRACKS UP TO 1/16" OPEN
Breastwall	NA	
Wings	GOOD	H.L. MAP CRACKS, ABUT #2 RT-LGH SPALL
Backwall	FAIR	NUMEROUS PATTERN & MAP CRACKS @ #2
Plumb	GOOD	
Footing	NA	
Piles	NA	
Embankment	GOOD	ABUT #2 - 8" SETTLEMENT
Bearing Surface	GOOD	
Slope Paving	GOOD	
Rip Rap	NA

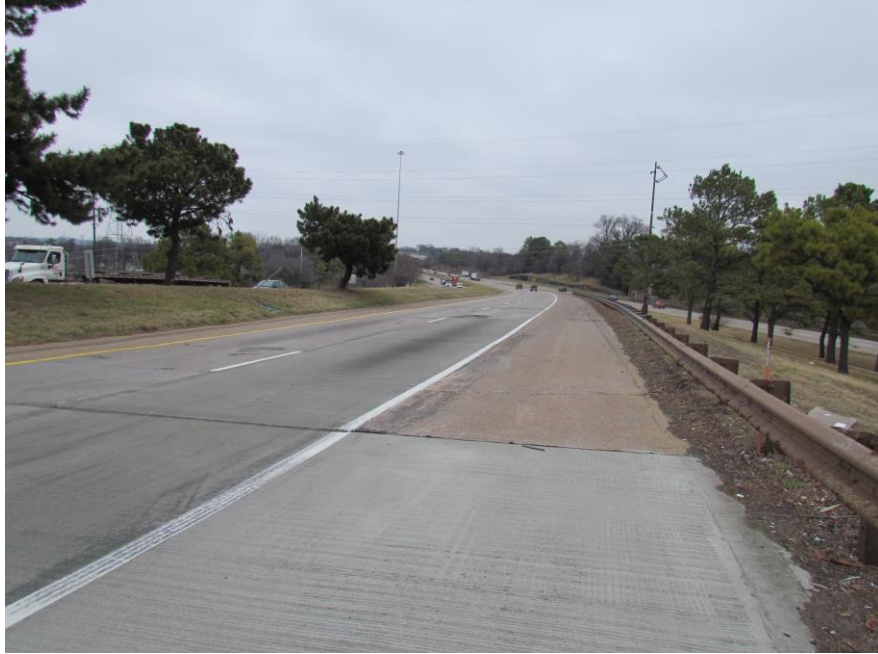
APPROACH "B" I440
