19I0440001
19-I0440-0.36 RT
1440 RL/CHARLOTTE AVE

BRIDGE MAINTENANCE RECOMMENDATIONS

Tennessee Department of Transportation

BRIDGE INSPECTION REPORT

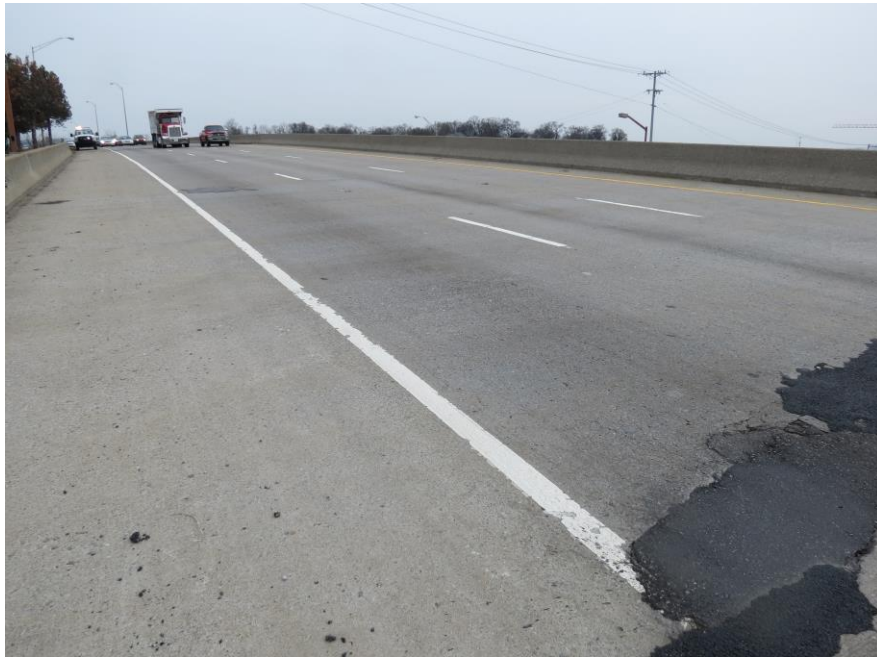
VIEW ACROSS TOP OF WEARING SURFACE

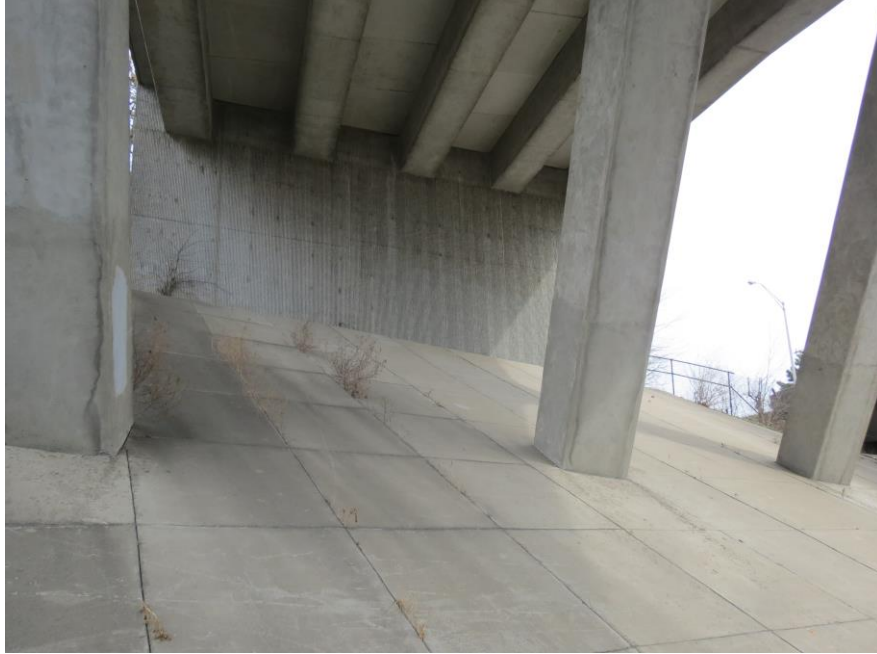
ABUTMENT #1

Rating	Comments
Caps	NA	
Breastwall	GOOD	<i>RANDOM VERT & DIAG CRACKS UP TO 1/16" OPEN</i>
Wings	FAIR	<i>RT. WING LT SIDE A ND 3" CREEP W/ 1/16" OPEN CRACK @ COLD JOINT</i>
Backwall	NV	
Plumb	GOOD	
Footing	NV	
Piles	NV	
Embankment	GOOD	
Bearing Surface	GOOD	
Slope Paving	GOOD	
Rip Rap	NA
