19I0440002
19-I0440-0.36 LT
1440 LL/CHARLOTTE AVE

BRIDGE MAINTENANCE RECOMMENDATIONS

BRIDGE INSPECTION REPORT

SUMMARY
19-I440-0.36 LT
2/22/2016

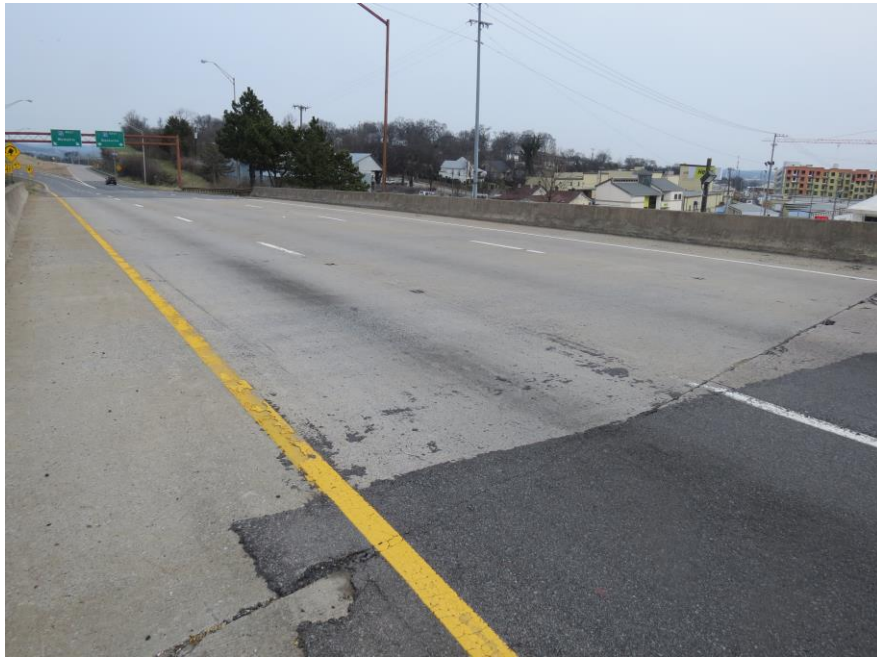
VIEW ACROSS TOP OF WEARING SURFACE

The concrete wearing surface is fair with 1/16-1/8" cracks, moderate surface scale, and aggregate popouts. Bottom deck panels are good. However; span #1 bay 'A' panel #3 has hairline transverse cracks. Open type joints with membrane are poor with filler loss.

SUGGESTED ROUTINE MAINTENANCE AND COMMENTS
SEAL CONCRETE WEARING SURFACE
APPROACH GUARDRAIL TERMINALS ARE SUBSTANDARD
REPAIR APPROACH A/C 'A' & 'B' ENDS

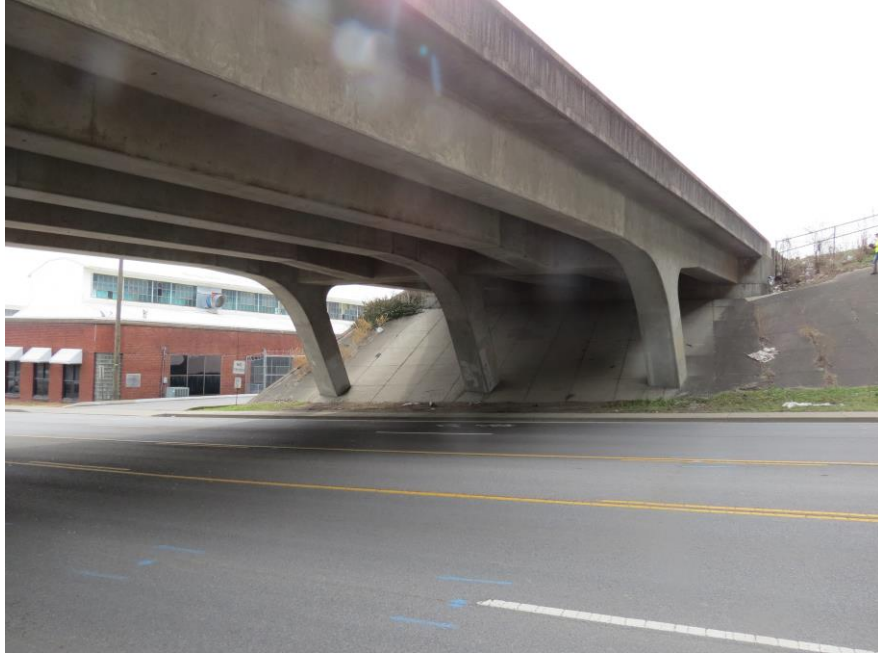
BENT #2 - FRONT VIEW

Caps	GOOD	CAP BEAM-LONGIT. H.L. CRACKS
Columns	GOOD	PATCHES W/ H.L. CRACKS, BENT #2-SPALL W/EXP. STL.
Plumb	GOOD	
Footings	NV	
Piles	NV	
Bearing Surface	GOOD

COLUMNS	GOOD	(1) PATCHED, H.L. HORIZ. CRACKS IN PATCHES
CAP BEAM	GOOD	LONGIT H.C.'S
