## Polk County

### Regular Inspection Report

Location: 70-SR040-03.12

14 Span Bridge

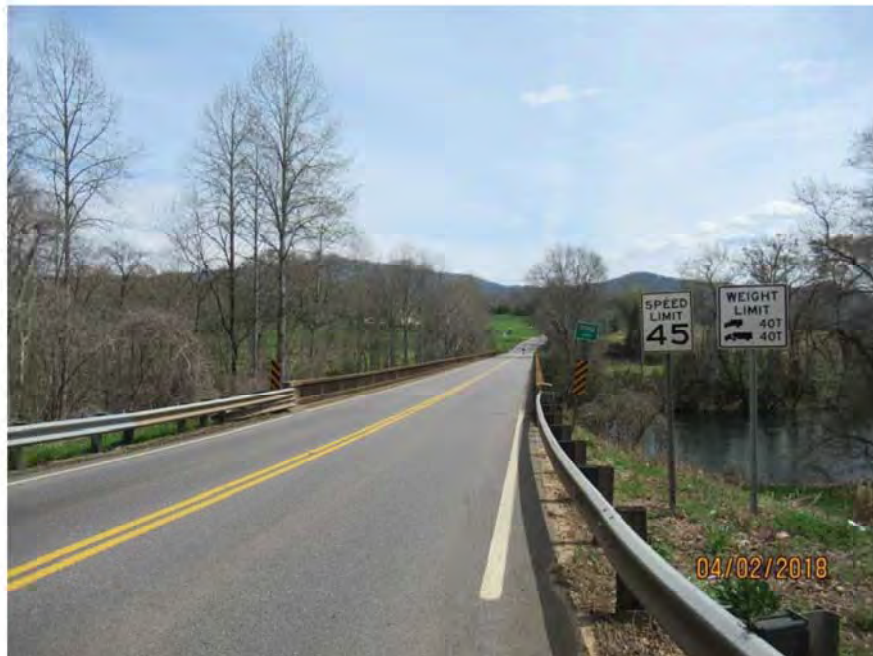
LOOKING AHEAD ON STRUCTURE - WEIGHT POSTING – TO NC

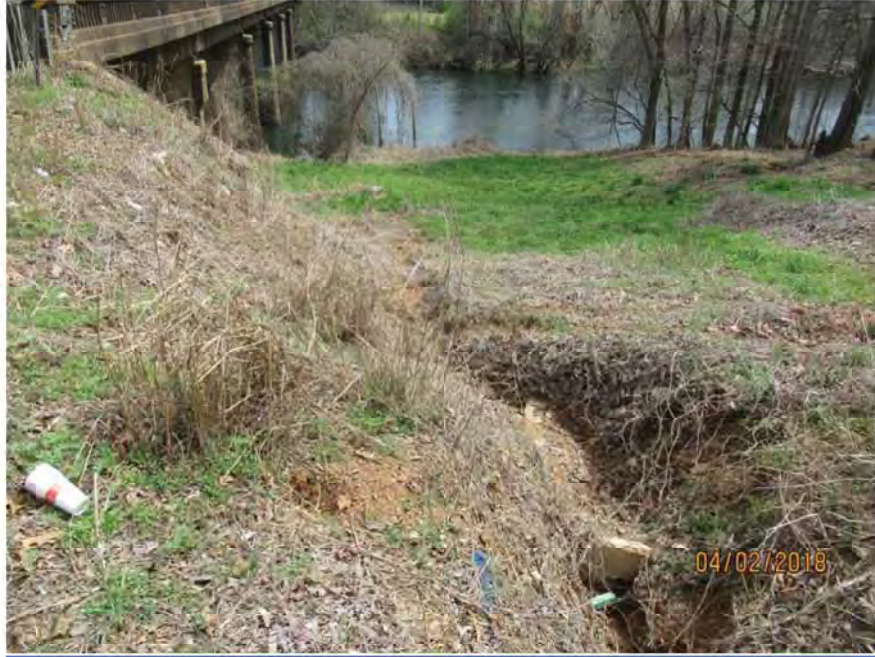
APPROACH 1 - RIGHT - EROSION

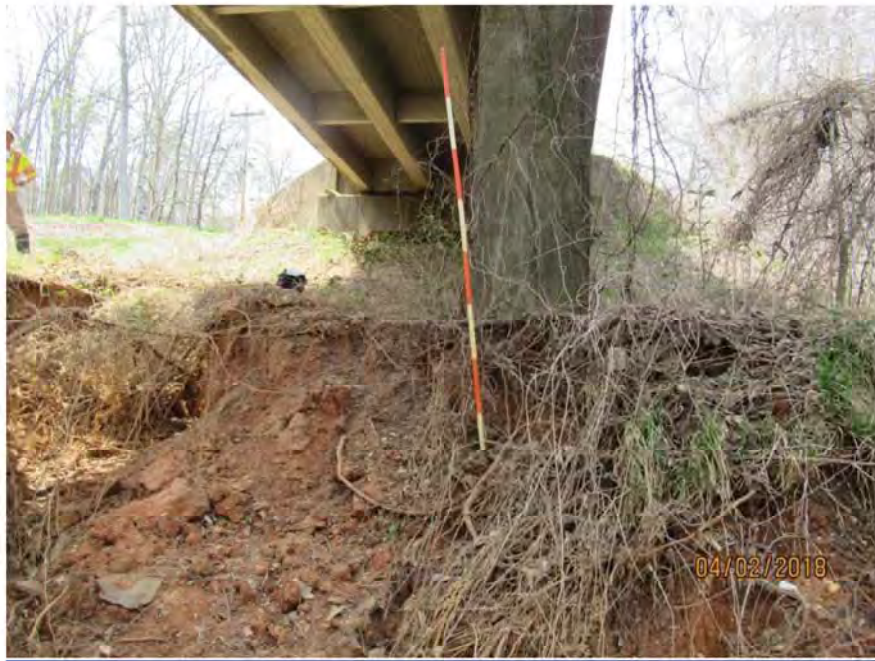
SPAN 2 - BENT 1 - COLUMN A - EROSION

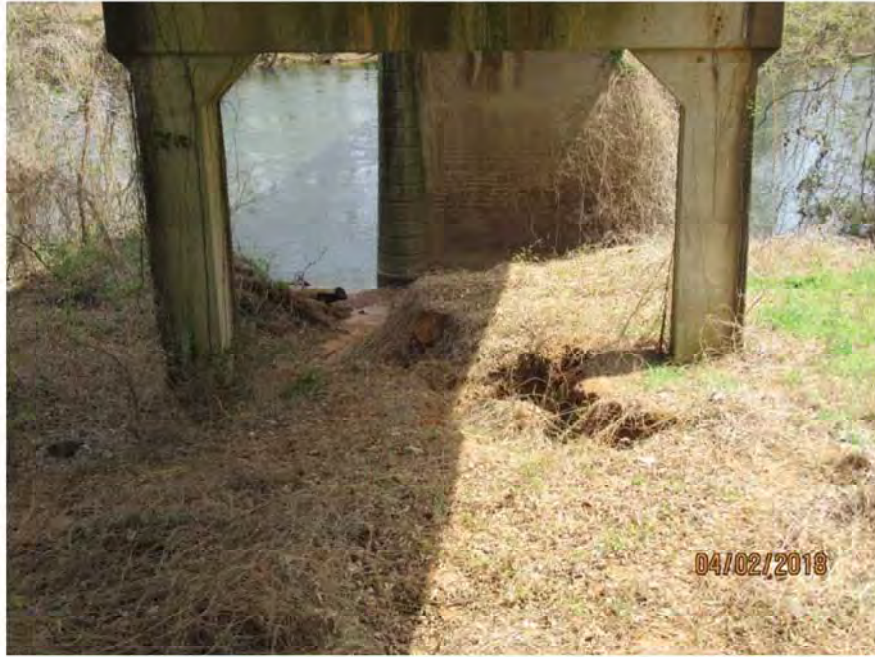
SPAN 1 AND 2 @ BENT 1 - EROSION

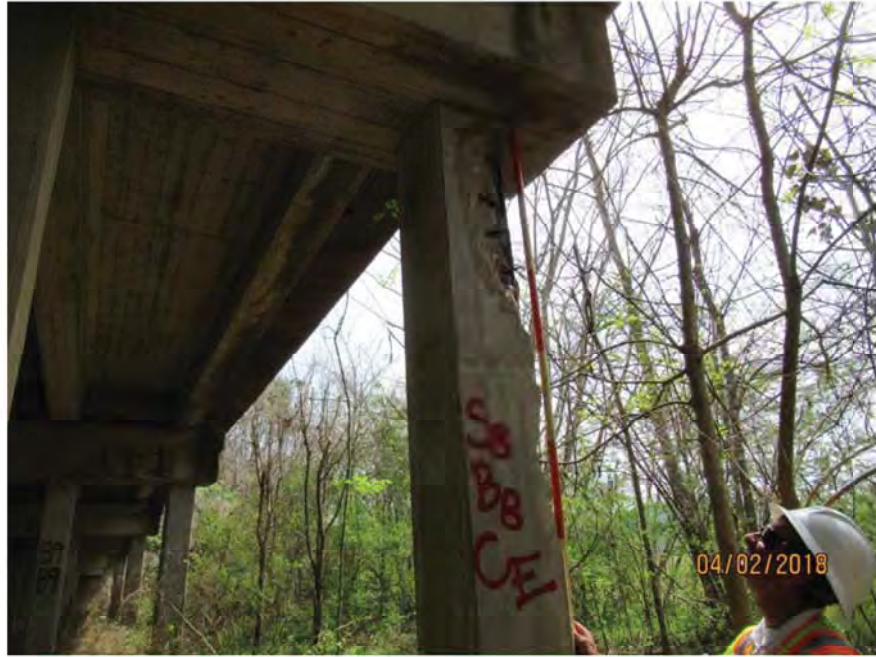
SPAN 8 - BENT 8 - COLUMN E

| Columns / Shaft | POOR | <i>Significant Rebar Spalls</i> |

REPAIR THE SEVERAL COLUMN REBAR SPALLS
