# HAYWOOD COUNTY

**38-SR001-0213**

Crossing: MUDDY CREEK

**BRIDGE INSPECTION REPORT**Form BIR 3.0  
(Rev. 9-22-98)  
DT-0069Field Report No.: \_\_\_\_\_ Date: 9/9/19  
Previous Report No.: 24 Date: 10/31/17  
Co. Seq 01 Plans: YES ( ) NO ( )Bridge No. 38SR0010001 Bridge Location No. 38 - SR001 - 0213  
Eleven Digit No. Co. Route Log Mile OVER/UNDER PASSHWY 79 MUDDY CREEK  
Road Name Feature Intersected CITYYear Constructed 1926 County Haywood Maint. Dist: 48 Maint.Resp: 02

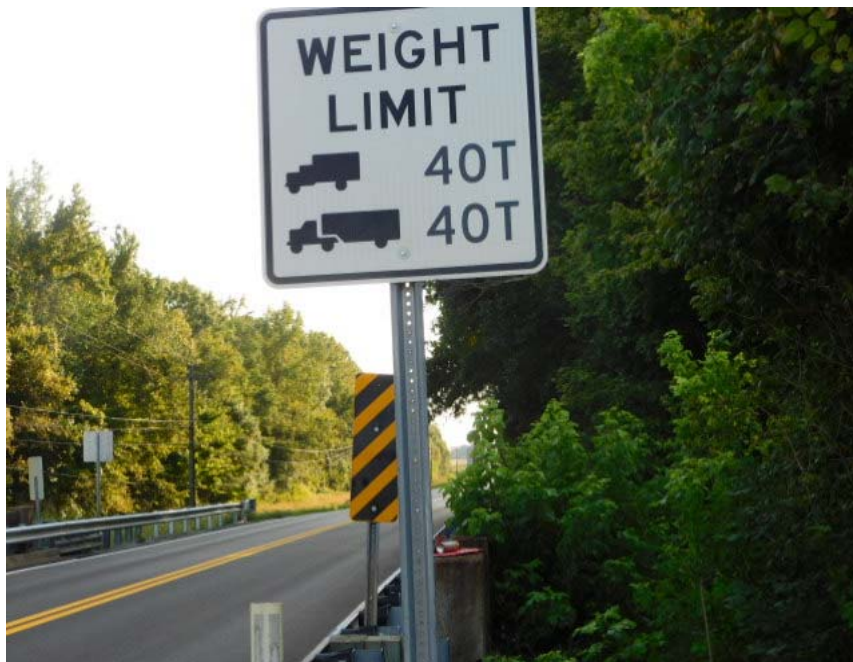
APPROACH # 1 WIEGHT LIMIT SIGN 40 T

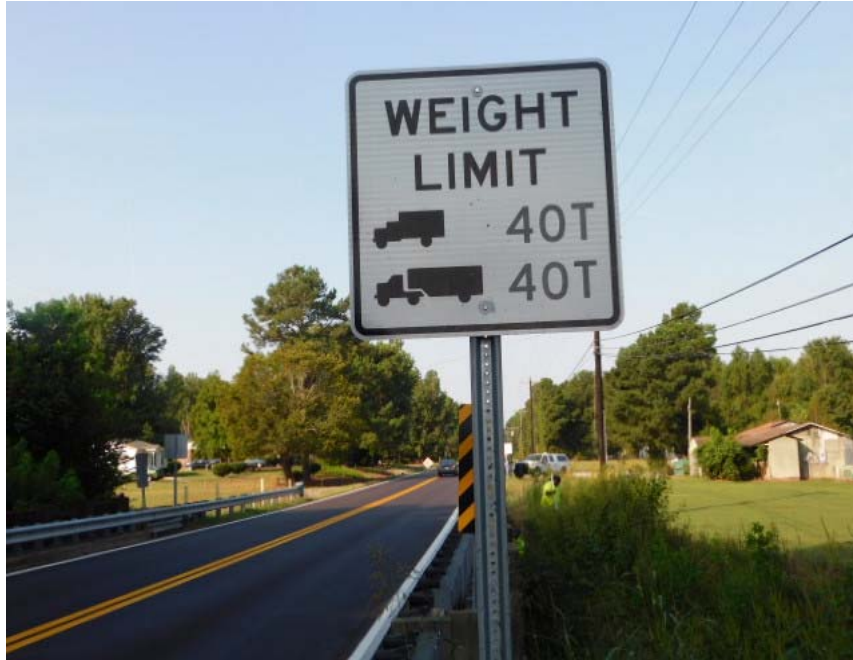
**APPROACH # 2 WEIGHT LIMIT SIGN 40T**

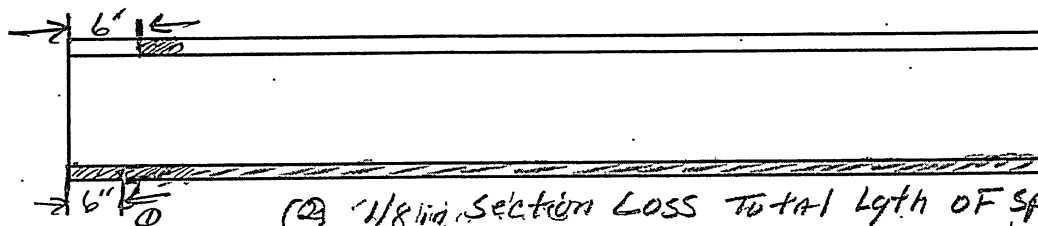
① Holes in Flg 3" W x 3" L x 6" From DIA.

② 1/8" dia. Section Loss Total Lgth of Span.

REPAIR STEEL BEAM "A, B, H &amp; I" IN SPAN NO.1

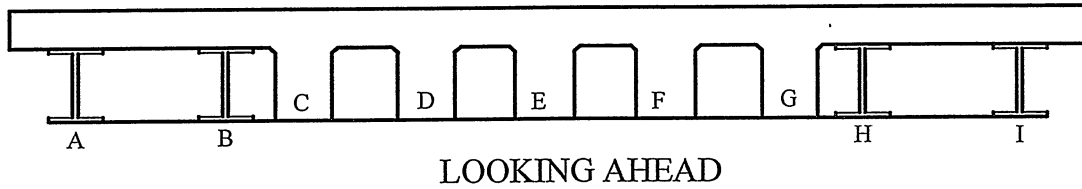
① spalls  
6" h x 1" b

② spalled  
to steel 8" h x 3" l x 1" b

③ spalled to steel  
1' D x 1.5" D

REPAIR CONCRETE GIRDER " C &amp; G " IN SPAN NO.2

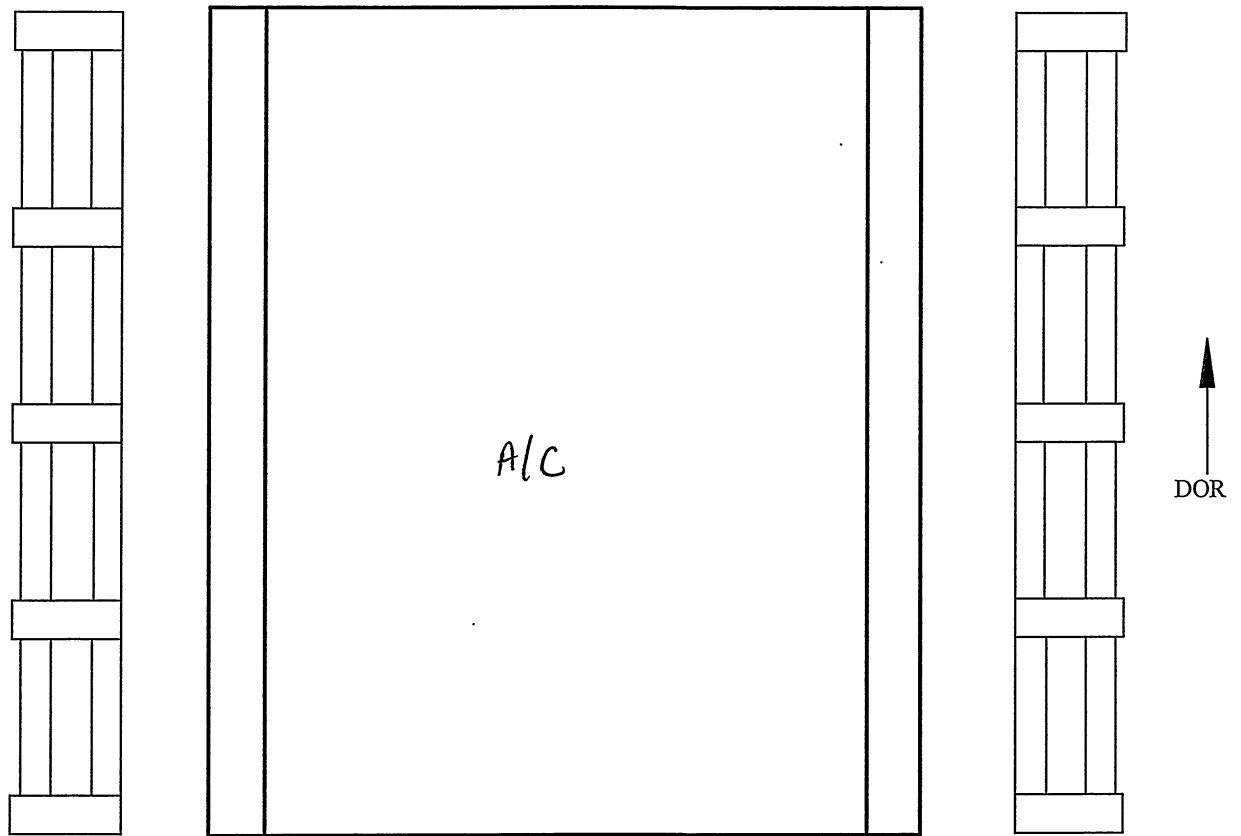
SPAN. NO. SEP 09 2016

ELEMENT		RATING	COMMENT
BOTTOM DECK		G (F) (P) C	up to fine cracks + see 3+4
S.I.B.	A	G F (P) C	see detail sheet
	B	G F (P) C	
GIRDER	C	G (F) P C	Fine cracks with eff + see 1+2
	D	G (F) P C	see ②
	E	G (F) P C	11 "
	F	(G) F P C	
	G	G (F) P C	see 1+2
S.I.B.	H	G F (P) C	see detail sheet
	I	G F (P) C	
PAINT		G F (P) C	up to 75% missing
BACKWALLS		(G) F P C	
DIA.		(G) F P C

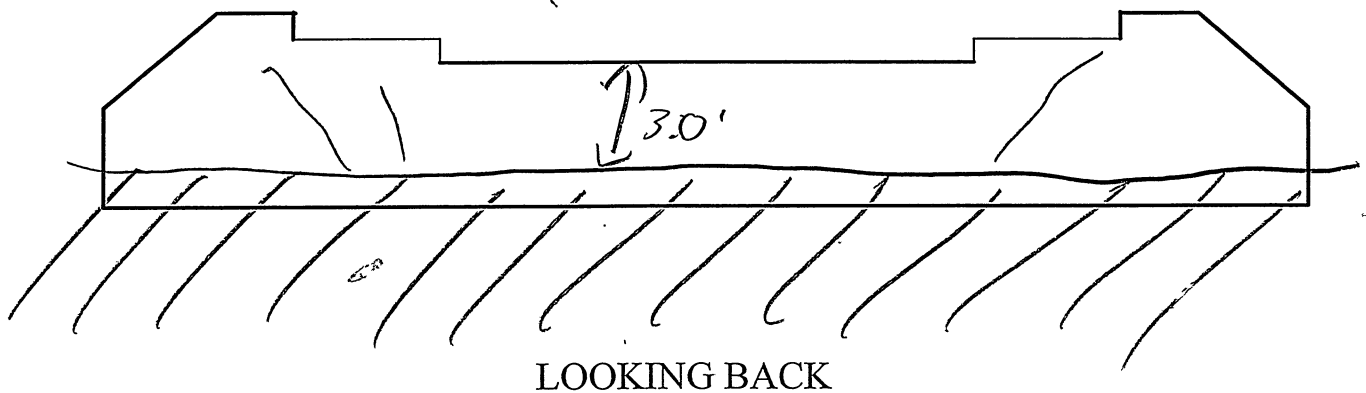
ABUT. NO. 1

ELEMENT	RATING	COMMENT
BEARING	G F P C	NV
PAINT	G F P C	
BREASTWALL	G (F) P C	Firecracks
WINGS	(G) F P C	
EMBANKMENT	(G) F P C	
RIP - RAP	G F P C	NV
VEGETATION	G F (P) C	Heavy growth

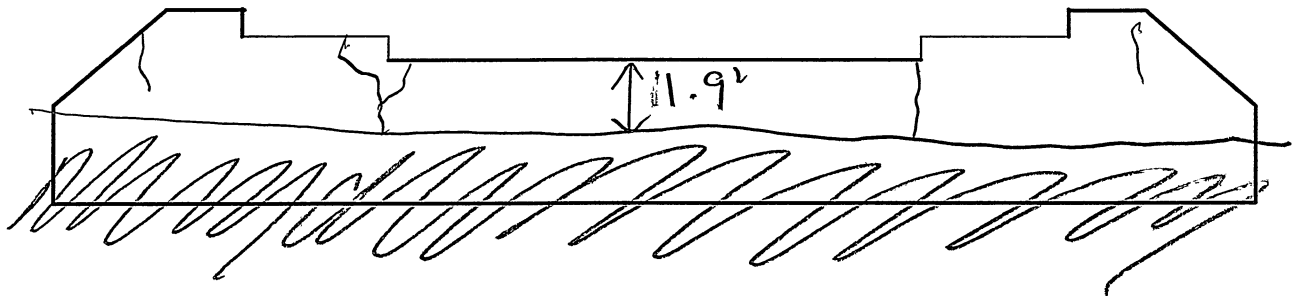
SEP 09 2019  
 ABUT. NO. 2

ELEMENT	RATING	COMMENT
<del>BEARING</del>	G F P C	
<del>BARREL</del>	G F P C	
<del>BREASTWALL</del>	G F P C	
WINGS	G (F) P C	- Hair line cracks
EMBANKMENT	(G) F P C	
RIP - RAP	G F P C	- NA
VEGETATION	G F (P) C	- Heavy growth
