38-SR001-0289

BRIDGE MAINTENANCE RECOMMENDATIONS

Tennessee Department
of Transportation

BRIDGE INSPECTION REPORT

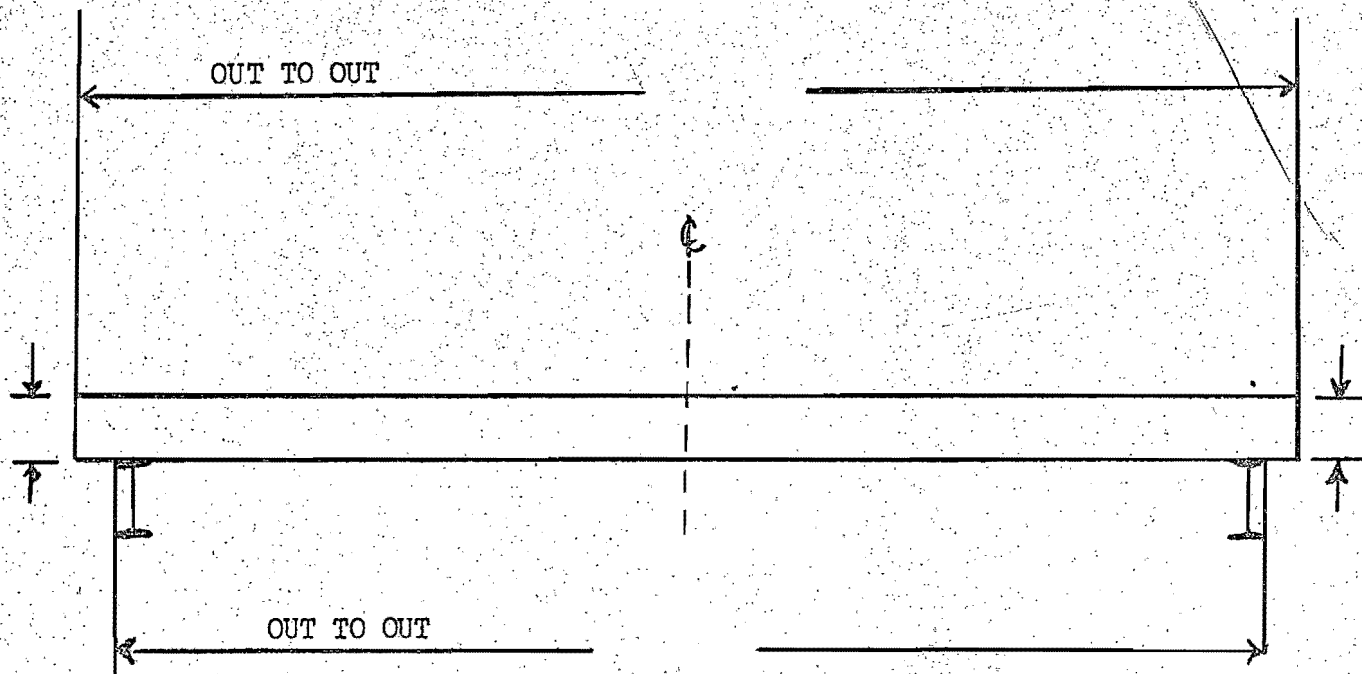
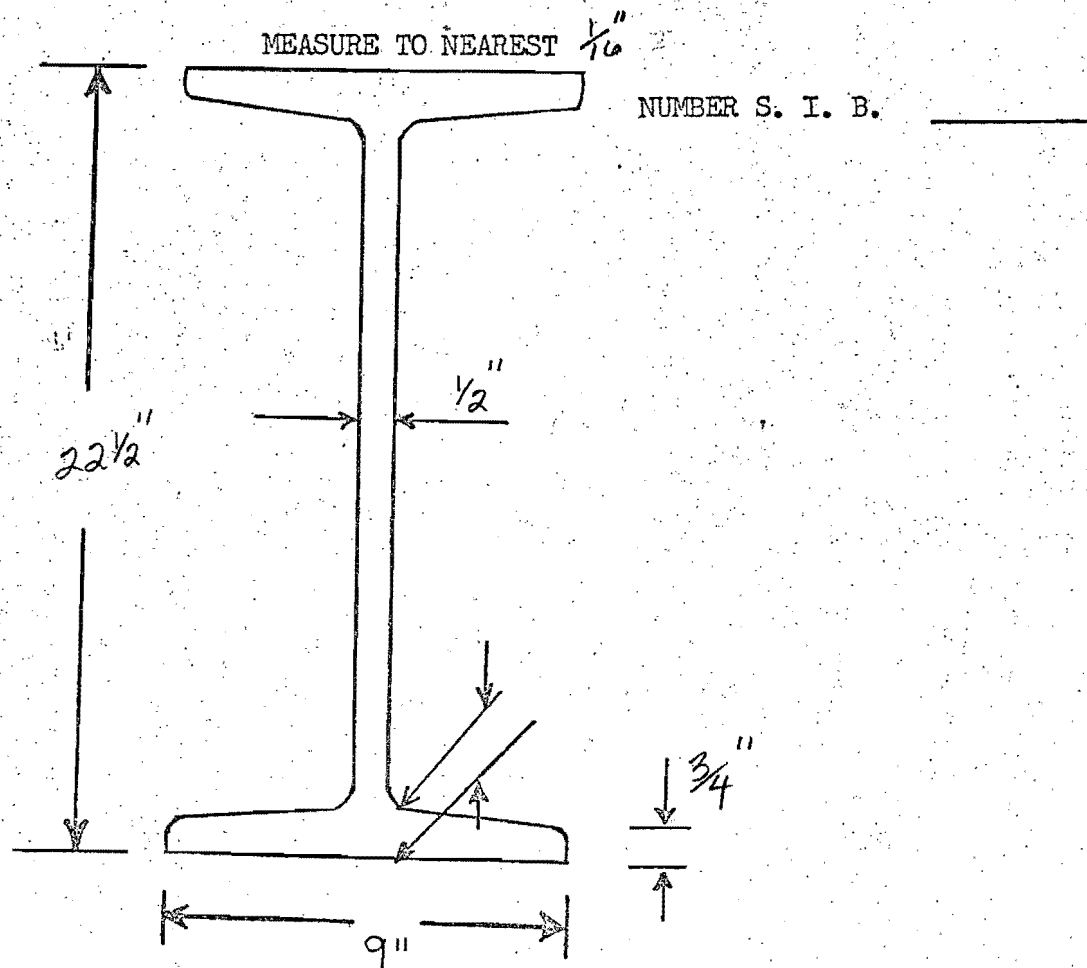
SPAN NO. 1

⑤ section of Fly missing
15.0/L x up to 4"W

⑥ section of Fly missing
18"L x up to 4"W

REPAIR STEEL BEAM "B & H" IN SPAN NO.1

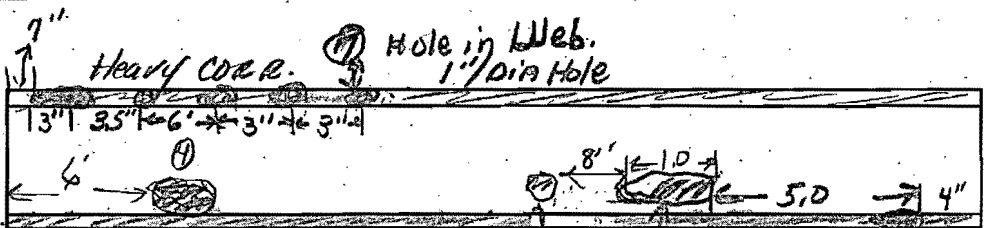
LEFT SIDE OF BEAM

① section of Fly missing
4"/L x 1"W
