HAYWOOD COUNTY

38-SR001-0289

BRIDGE MAINTENANCE RECOMMENDATIONS

BRIDGE INSPECTION REPORTForm BIR 3.0
(Rev. 9-22-98)
DT-0069

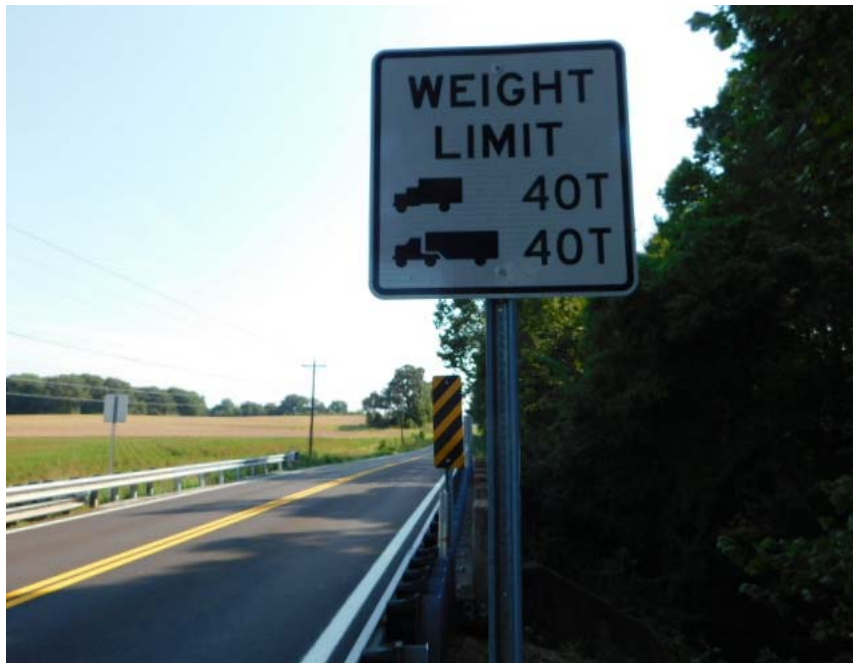
APPROACH # 1 WEIGHT LIMIT SIGN 40T

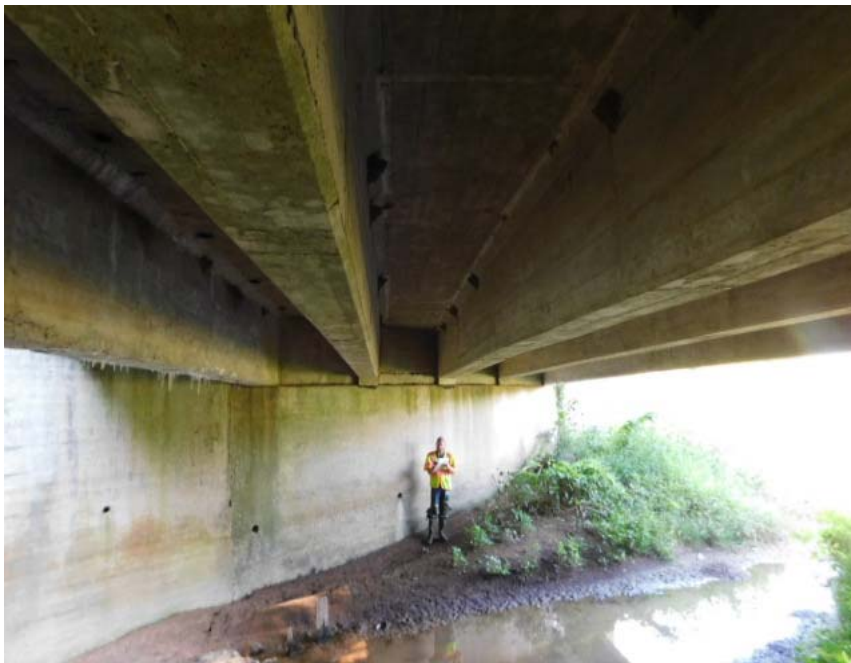
SPAN # 1 BOTTOM DECK

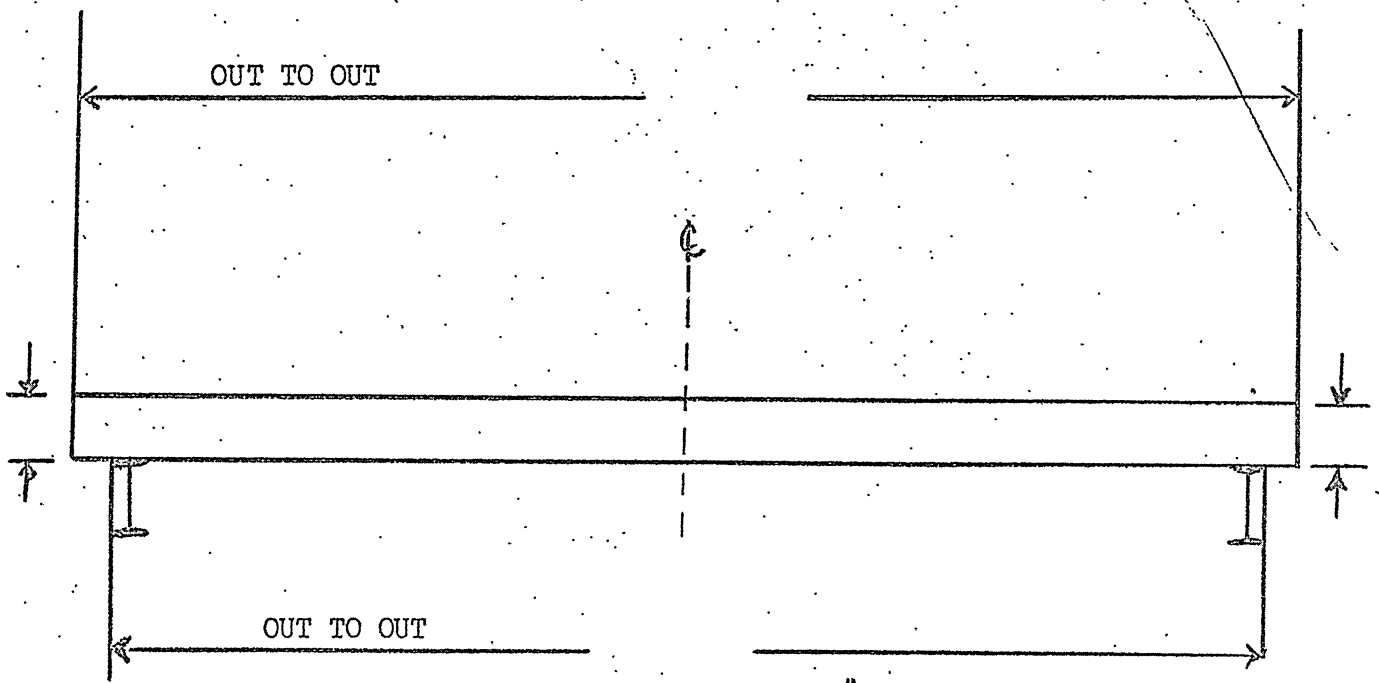
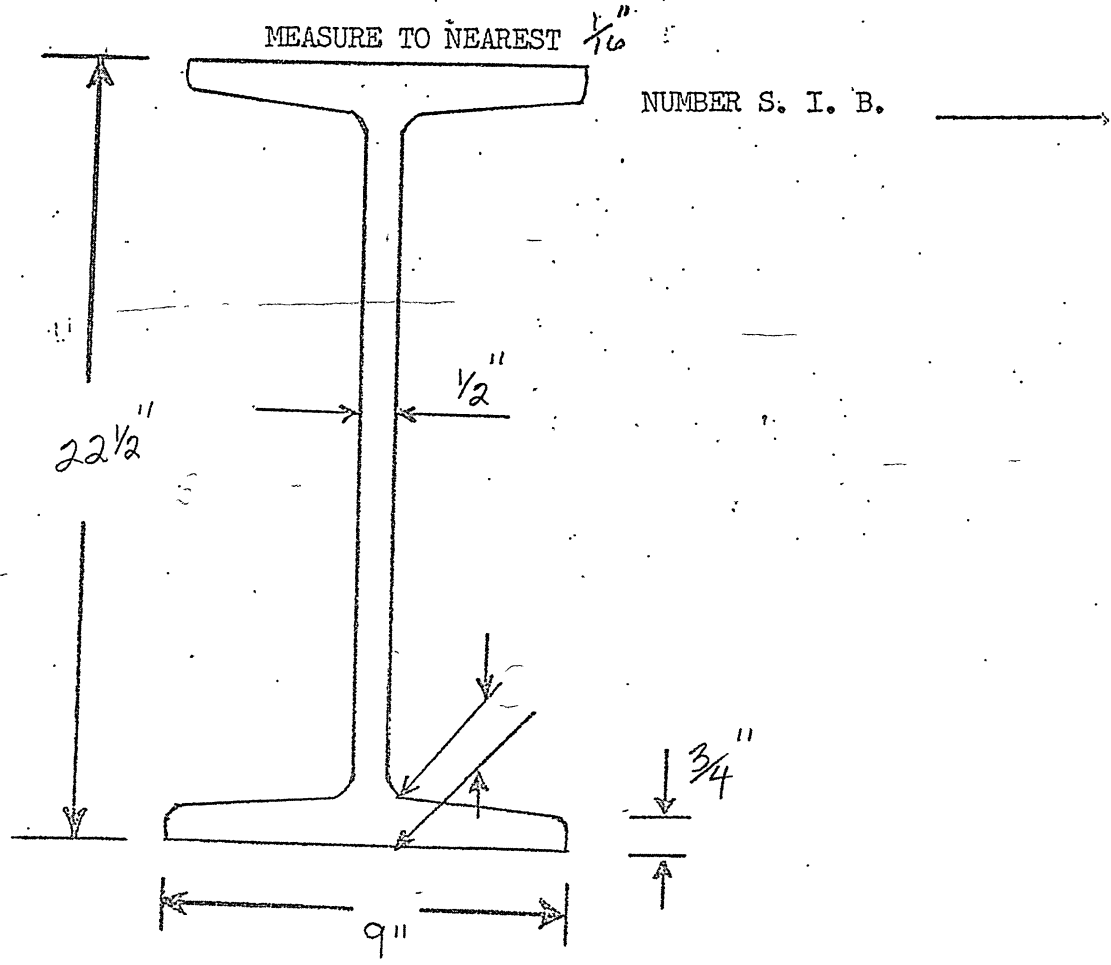
SPAN NO. 1

⑤ section of Fly missing
15.0/L x up to 4"/W

⑥ section of Fly missing
1.2"/L x up to 4"/W

① section of Fly missing
8 1/2 L x 3 1/4 W.

1 Flg. Missing up to 4' W x

Spalled to steel
6" W x 1" L x 1 1/2" D

Spalled to steel
Areas on Lt side
1 1/4" x 4 1/2" W x 1 1/2" D

No.	RECOMMENDATIONS	REPAIR DATE	REPAIRED BY
1.	REPAIR STEEL BEAM "B & H" IN SPAN NO.1

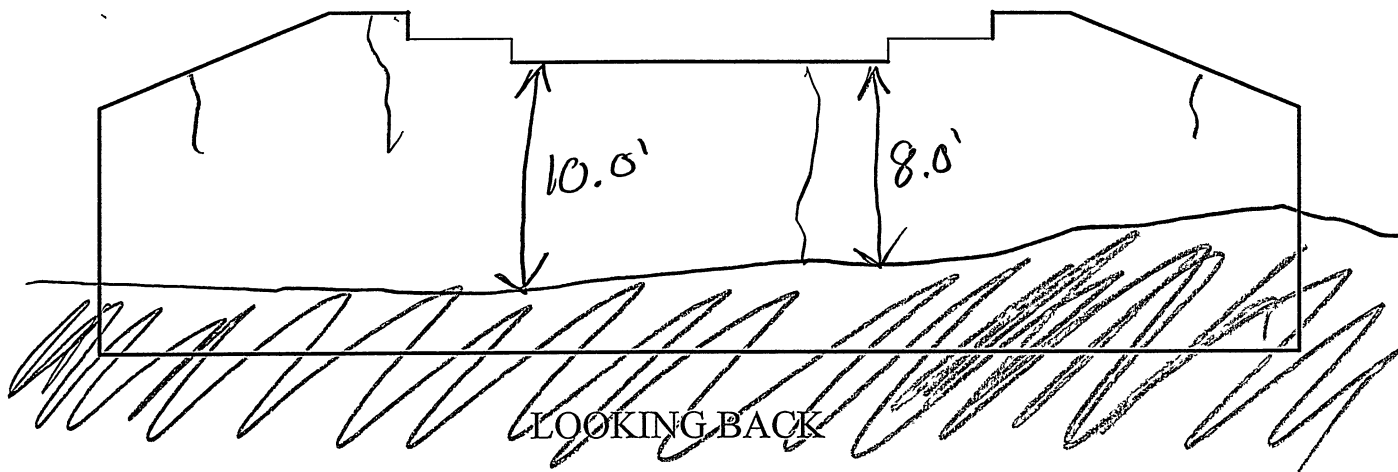
SEP 09 2010
 ABUT. NO. 1

ELEMENT	RATING	COMMENT
BEARING	G F P C	
PAINT	G F P C	
BREASTWALL	G F P C	
WINGS	G (F) P C	Hair line Cracks
EMBANKMENT	(G) F P C	
RIP RAP	G F P C	
VEGETATION	G F (P) C	- Heavy Growth

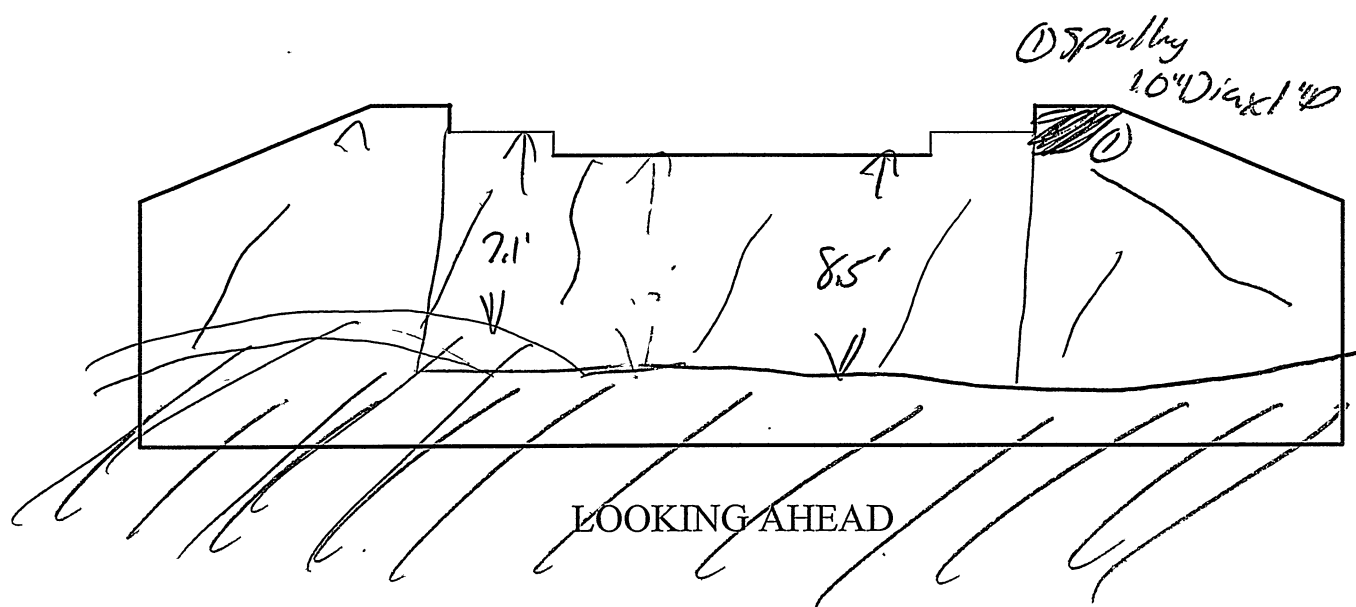
ABUT. NO. 2

ELEMENT	RATING	COMMENT
BEARING	G F P C	<i>MV</i>
PAINT	G F P C	
BREASTWALL	G (F) P C	<i>Cracks</i>
WINGS	G (F) P C	<i>Cracks + see ①</i>
EMBANKMENT	(G) F P C	
RIP - RAP	G F P C	<i>MV</i>
VEGETATION	G F (P) C	<i>Heavy growth</i>
