BRIDGE MAINTENANCE RECOMMENDATIONS

COUNTY: LAUDERDALE

LOCATION: 49-SR087-03.88-

FED. BRIDGE NO.: 49SR0870011

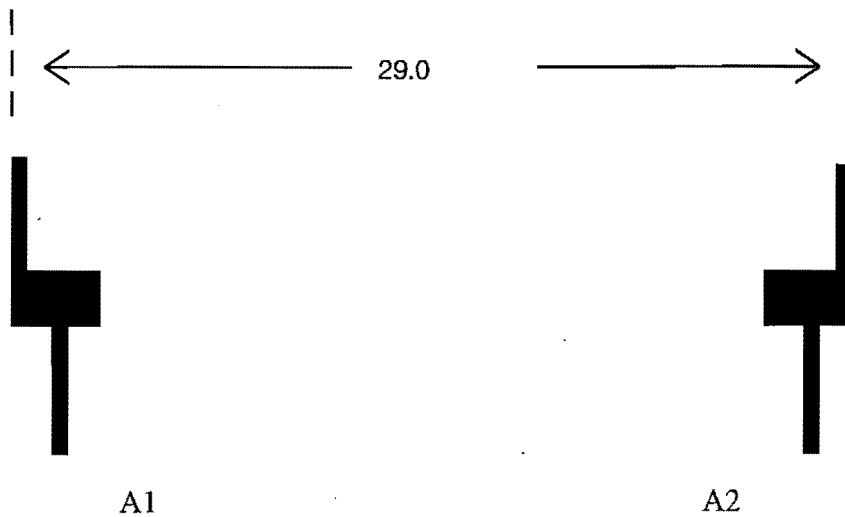
BR. NO. 49 87 3.98 SKEN 90° MAR 07 2018
 ① Light Corrosion W/ NO MEAS. SEC. LOSS @ Top Flange 3.90 ② Hole
 52" (Cross-Section)
 6" L x 1" H
 X 1/4" Through Beam

REPAIR STEEL BEAM " N " IN SPAN NO.1
