BAILEY BRIDGE RD. Crossing NOLICHUCKY RIVER

90 - LAST INSPECTION DATE 07/02/2024

IDENTIFICATION	
(1) State Names	47 - Tennessee
(8) Structure Number	90S23860001
(5) Inventory Route	1
(2) Highway Agency District	Region 1
(3) County Code	90 - Washington

Inspection Team's Summary

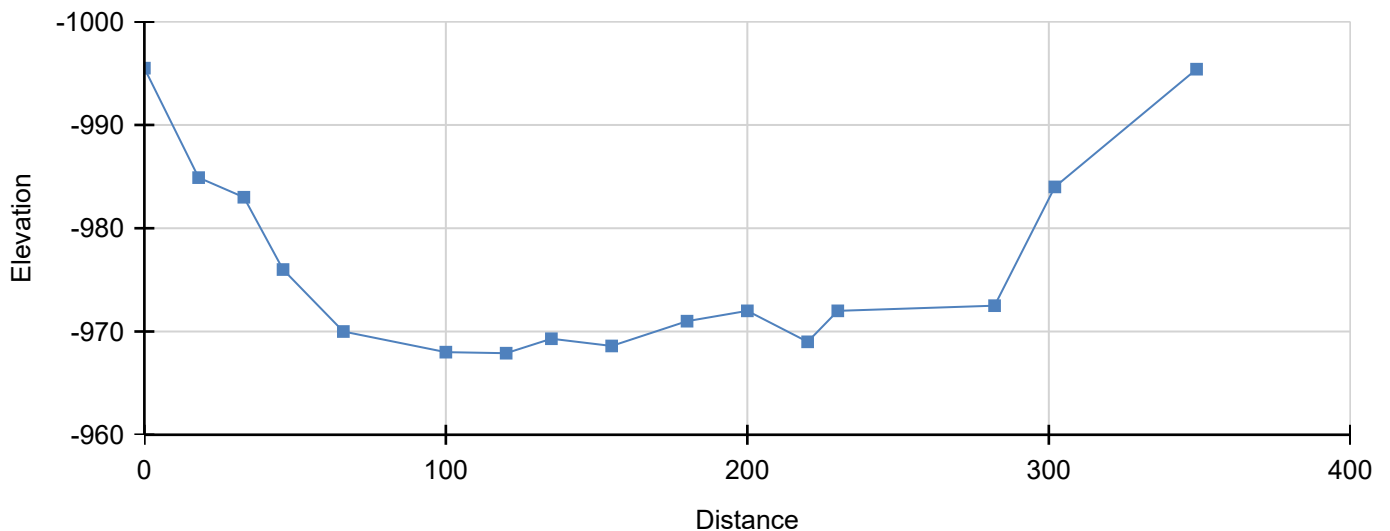
Channel Profile Downstream

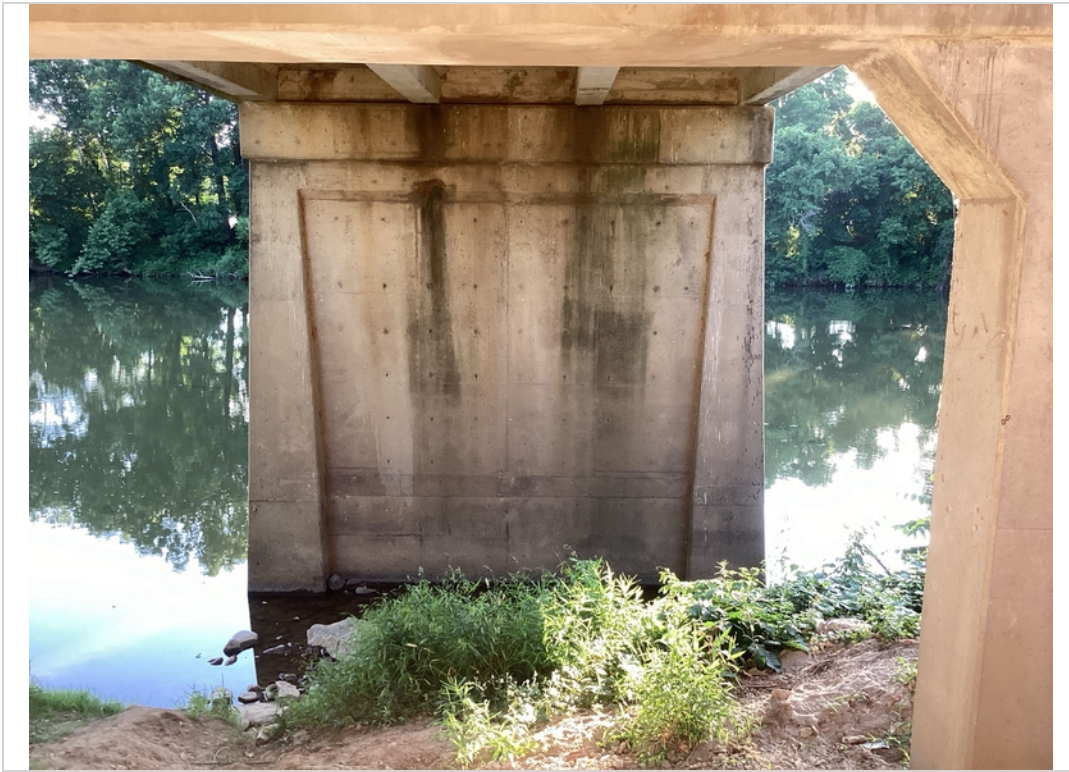
The abutments are good with previous deficiencies repaired. The piers are good with water abrasion and water stains. The bents are fair with minor scale, and water stains.

Pier typical

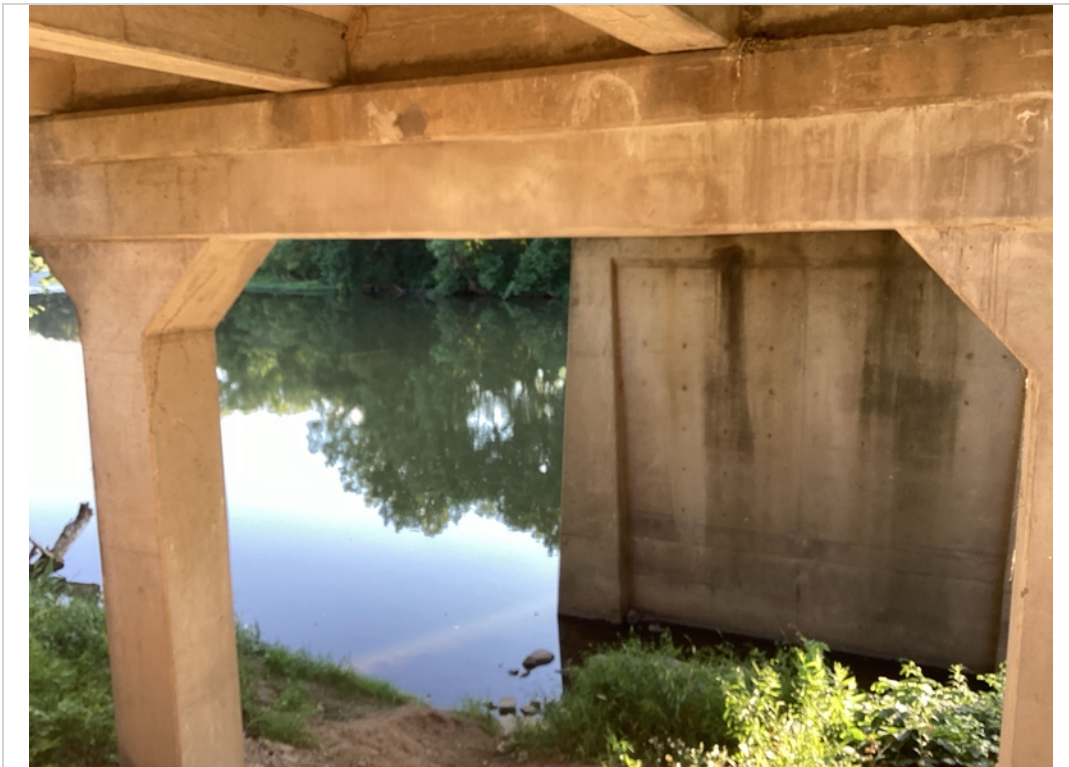
Bent typical

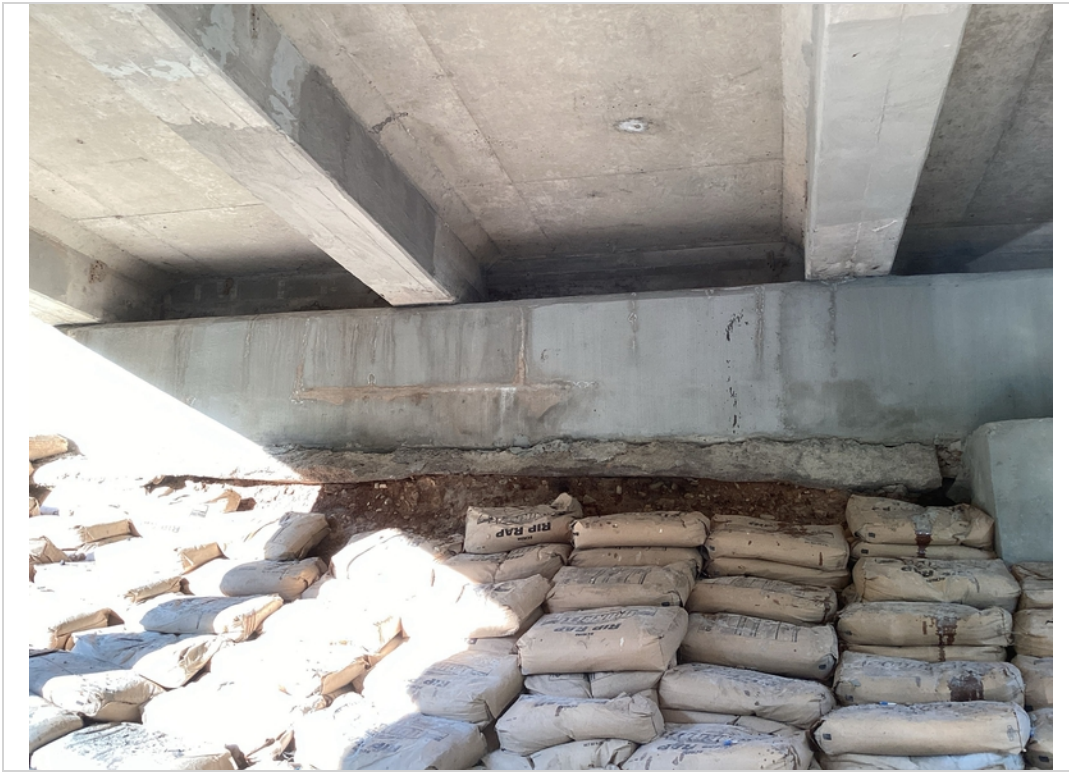
Abutment typical

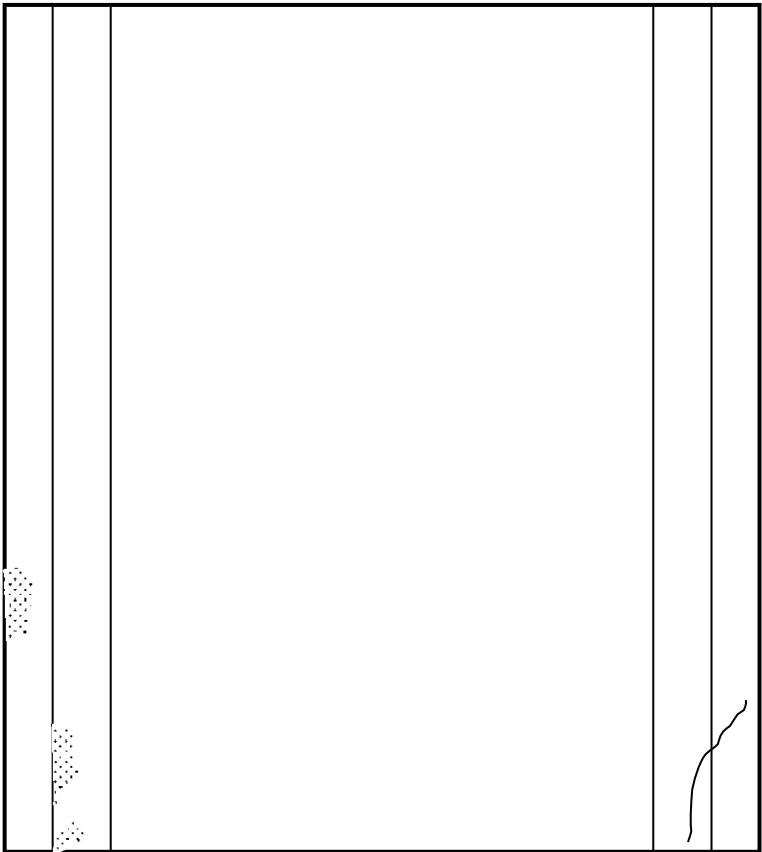
Element	Rating	Comments
Top Deck	G	
Bridge Rail	G	Concrete patches
Exp. Joint	G	Paved over
Drains	G	
Curbs	G	Minor spall @ outside edge

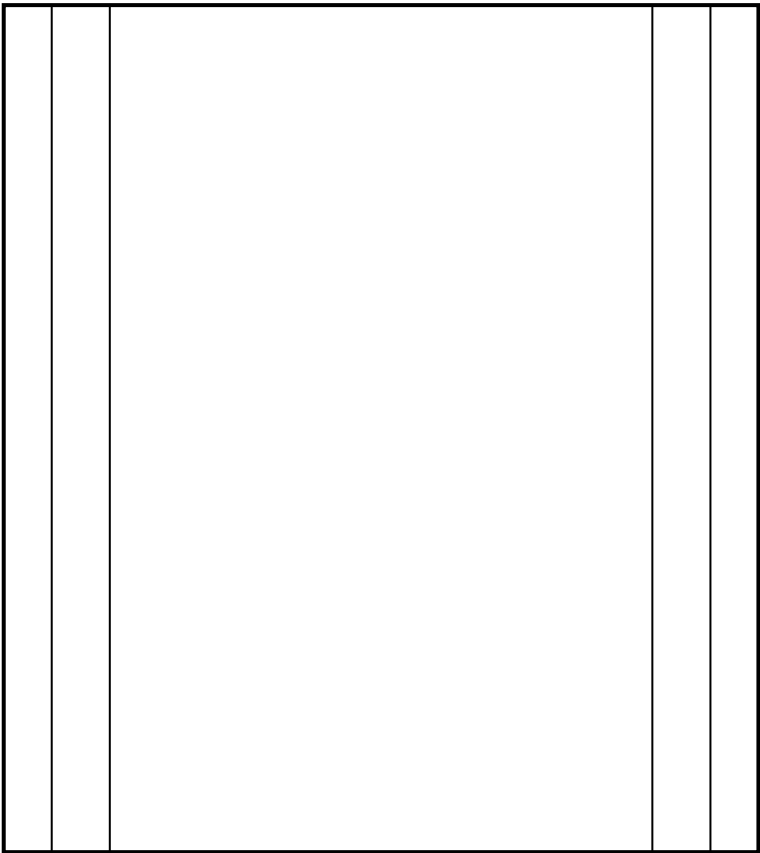
Element	Rating	Comments
Top Deck	G	
Bridge Rail	G	
Exp. Joint	G	Paved over
Drains	G	
Curbs	G	Minor scale

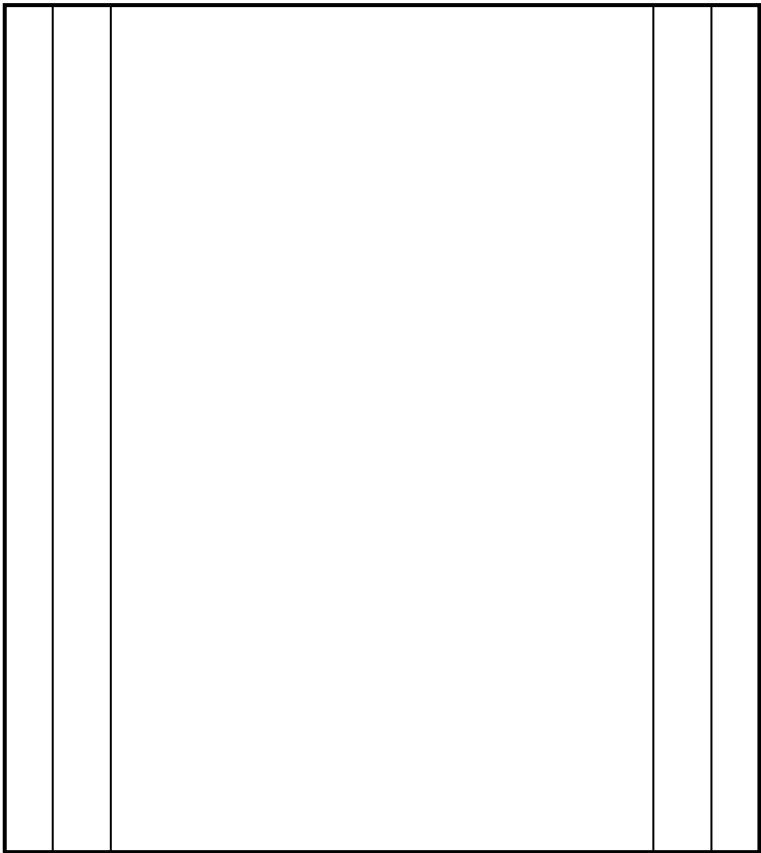
Element	Rating	Comments
Top Deck	G	
Bridge Rail	F	Minor scale, high steel pop-outs
Exp. Joint	G	Paved over
Drains	G	
Curbs	G	Minor scale

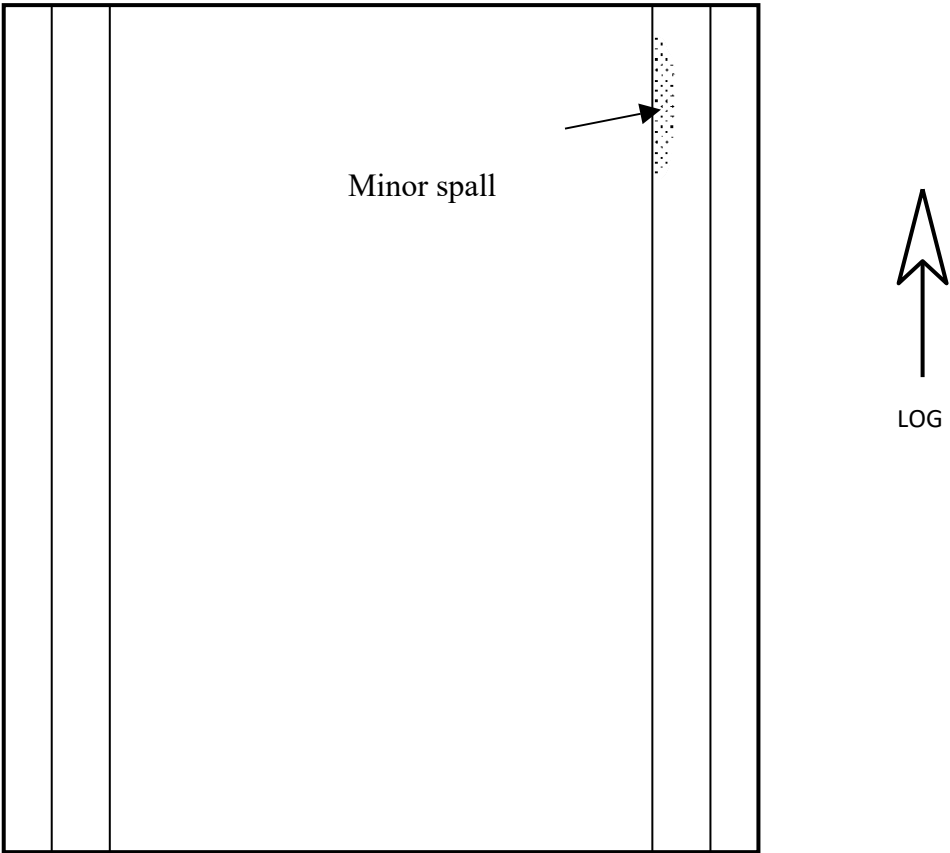
Element	Rating	Comments
Top Deck	G	
Bridge Rail	F	Minor scale, high steel pop-outs, minor spall
Exp. Joint	G	Paved over
Drains	G	
Curbs	G	Minor scale

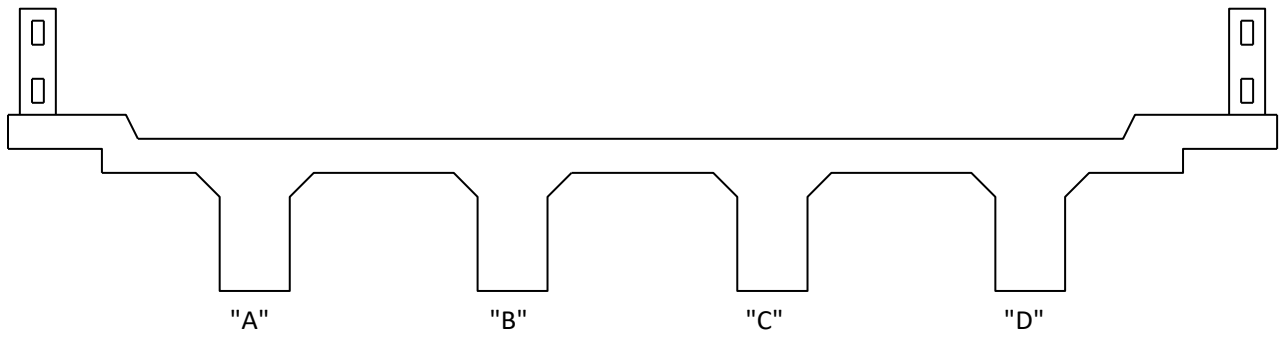
Bridge #:	90-SR353-00.45
Span #:	1 of 9
Date:	7/02/24

Element	Rating	Comments
Underside	F	
Diaphragms	G	
Beam "A"	F	
Beam "B"	F	
Beam "C"	F	
Beam "D"	F

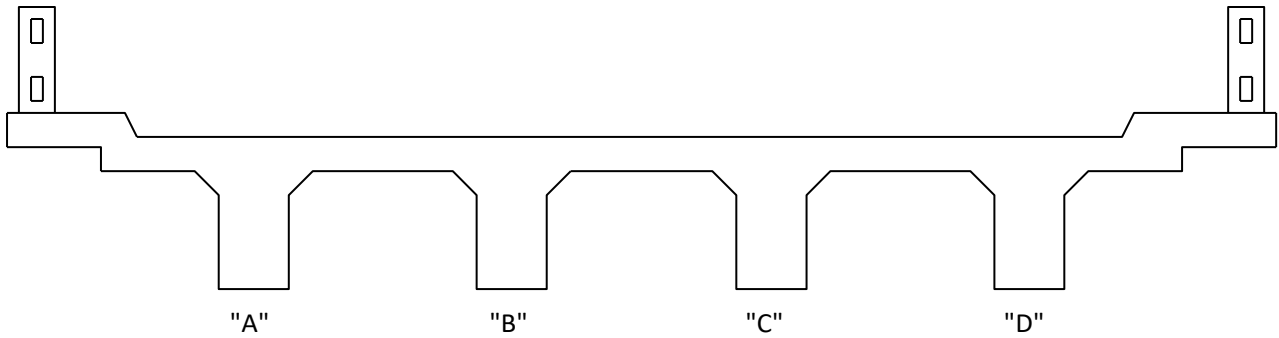
Bridge #:	90-SR353-00.45
Span #:	4 of 9
Date:	7/02/24

Element	Rating	Comments
Underside	F	
Diaphragms	G	
Bearing Device	F	
Beam "A"	F	
Beam "B"	F	
Beam "C"	F	
Beam "D"	F

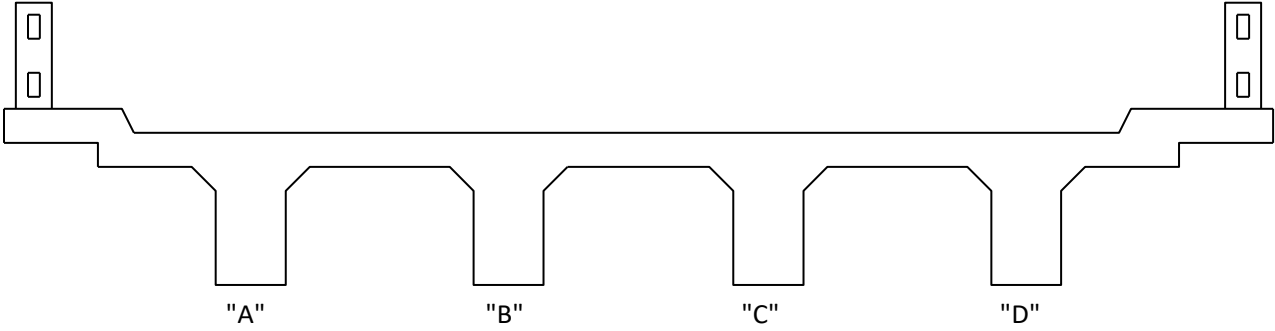
Bridge #:	90-SR353-00.45
Span #:	8 of 9
Date:	7/02/24

Element	Rating	Comments
Underside	F	
Diaphragms	G	
Beam "A"	F	
Beam "B"	F	
Beam "C"	F	
Beam "D"	F

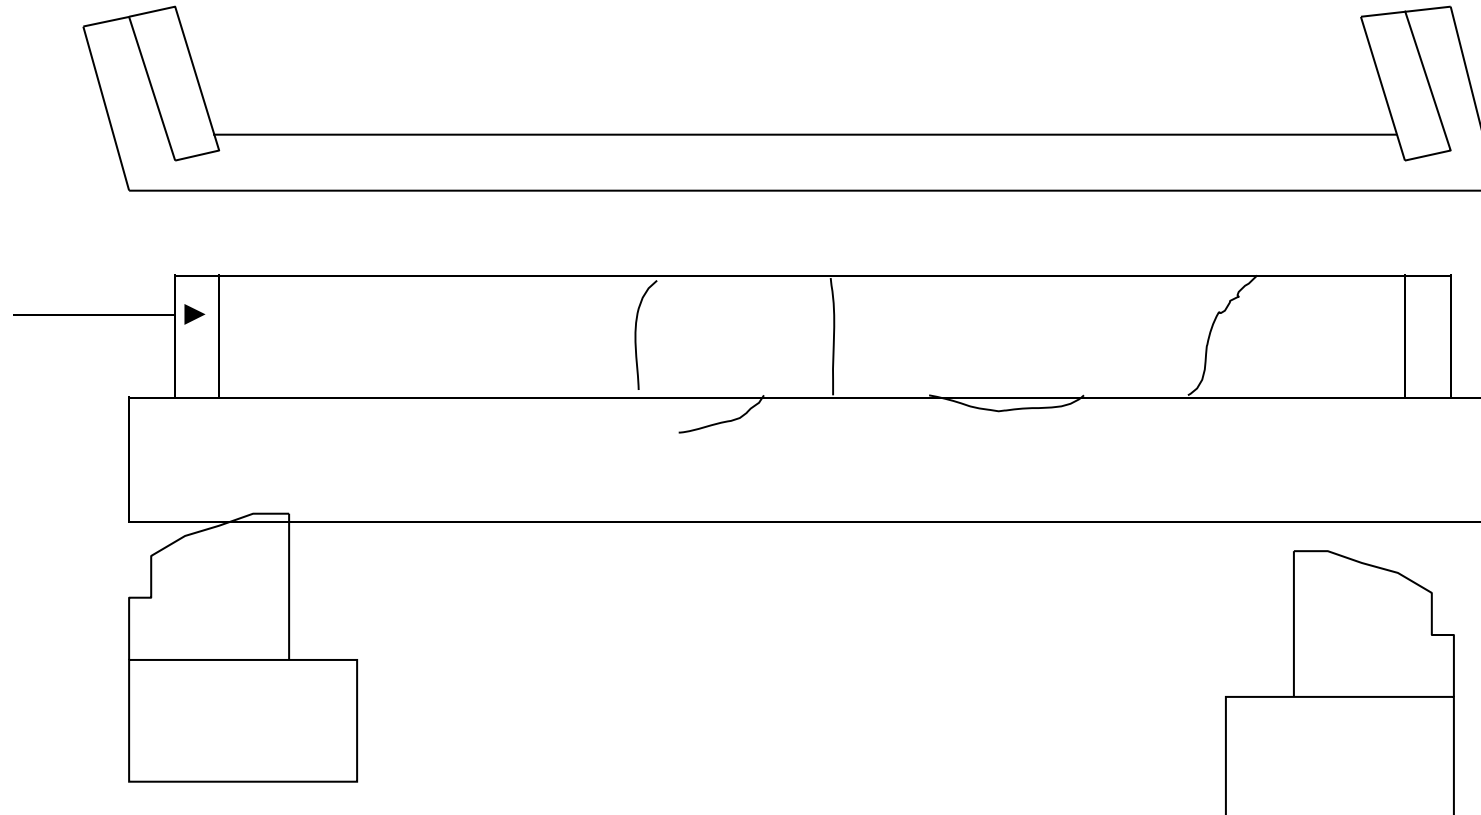
Bridge #:	90-SR353-00.45
Abutment #:	1
Date:	7/02/24

Element	Rating	Comments
Backwall	G	
Cap	G	
Wings	G	
Bearing Area	G	
Plumb	G	
Embankment	G	
Piles	N/V	
Rip Rap	G

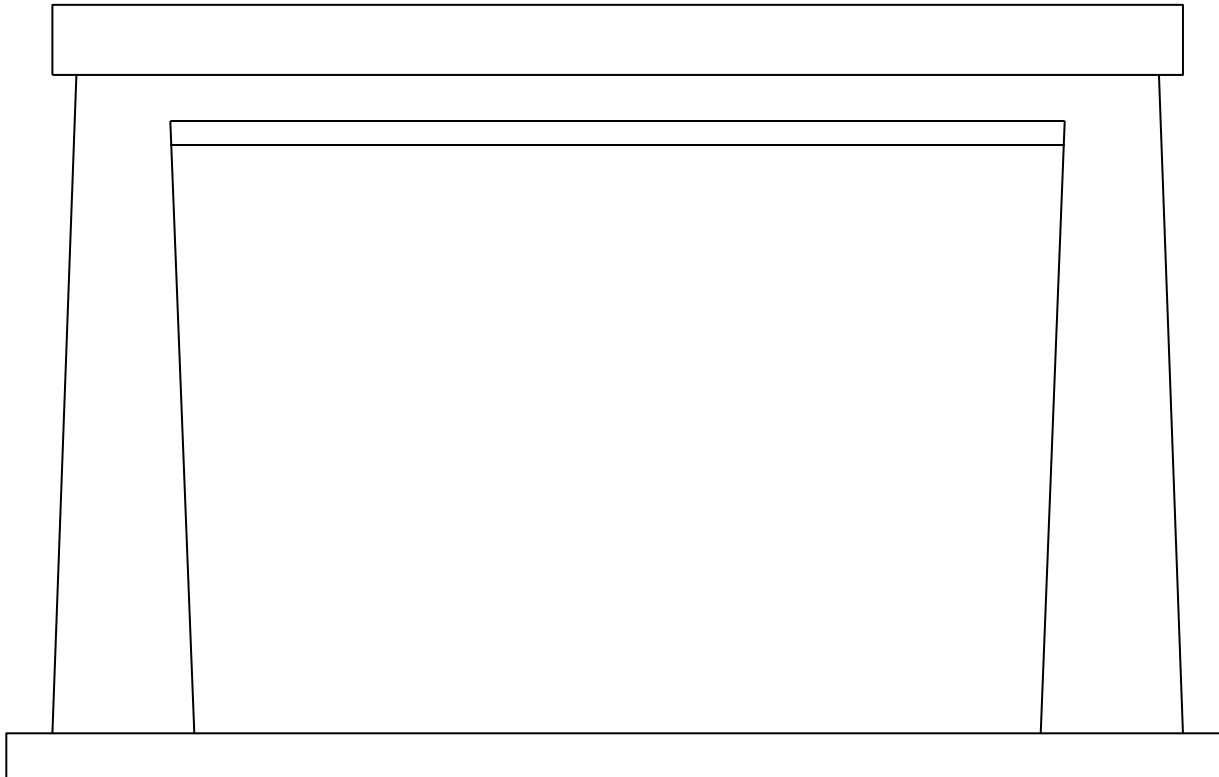
Element	Rating	Comments
Cap	G	Heavy water stains
Column	G	
Footing	N/V	
Bearing Area	G	
Plumb	G

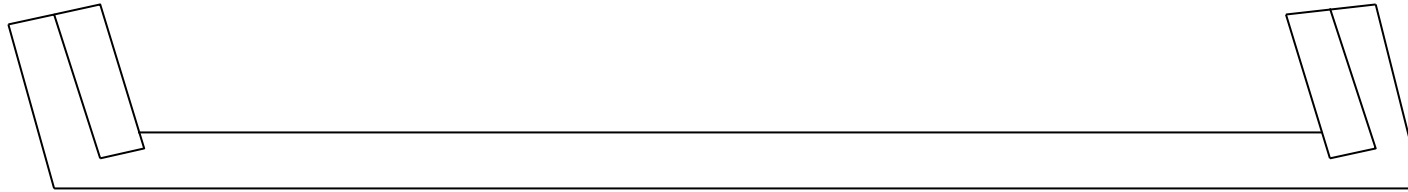
Bridge #:	90-SR353-00.45
Abutment #:	2
Date:	7/02/24

Element	Rating	Comments
Backwall	G	
Cap	G	
Wings	G	
Bearing Area	G	
Plumb	G	
Embankment	G	
Piles	G	
Rip Rap	G
