Region 04, 79 - Shelby County

I-40 Crossing I-40 W.B. / WOLF RIVER

90 - LAST INSPECTION DATE 10/02/2024

IDENTIFICATION	
(1) State Names	47 - Tennessee
(8) Structure Number	79I00400060
(5) Inventory Route	1
(2) Highway Agency District	Region 4
(3) County Code	79 - Shelby

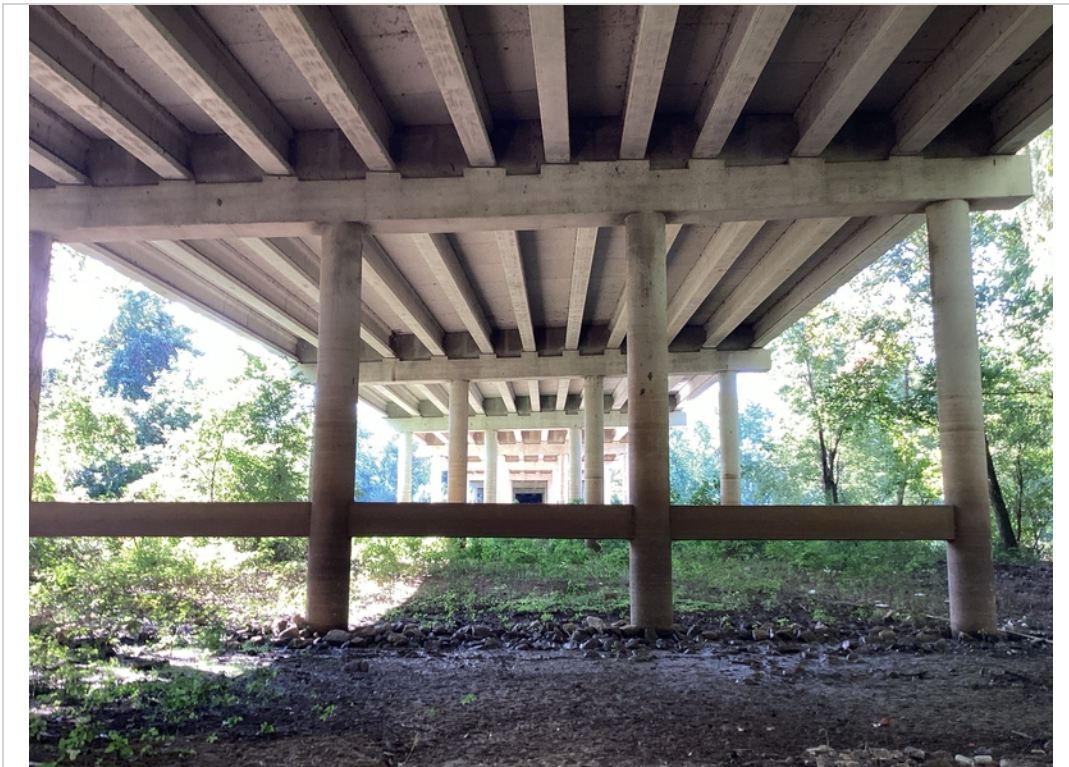
Bent 8 rear

Bent Caps	(Good)	
Bent Columns	(Good)	Spalling
Bent Plumb	(Good)	
Bent Footing	(Not Visible)	
Bent Bearing Surface	(Good)

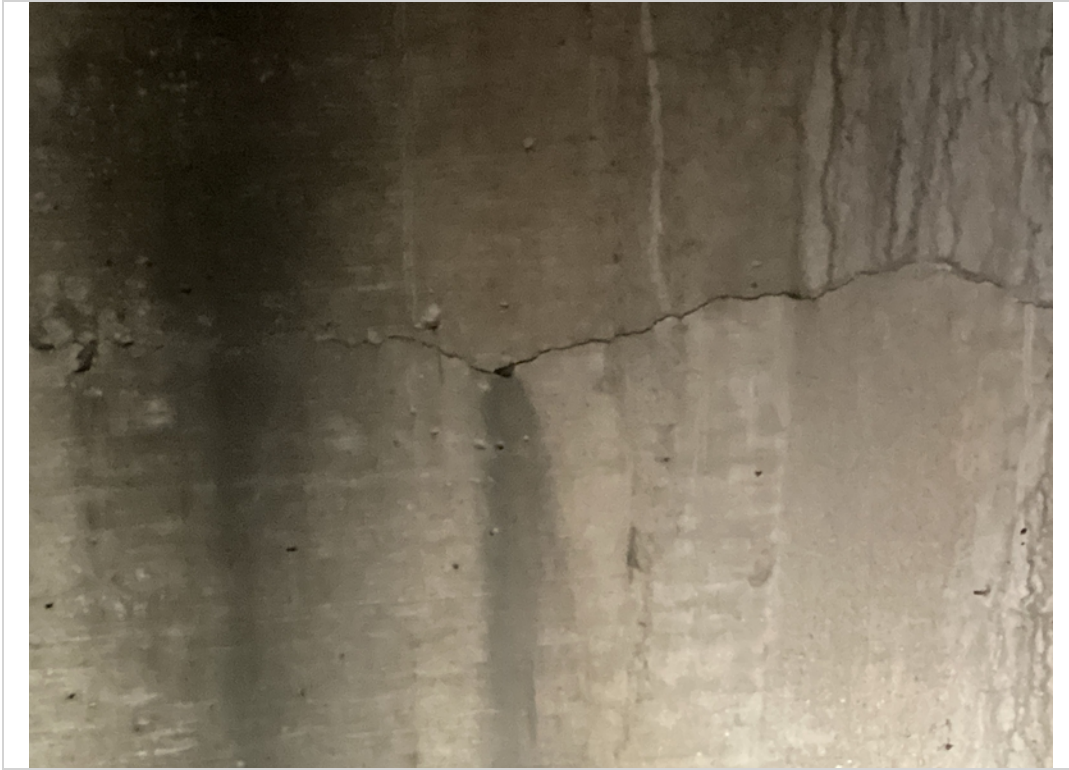
Abutment 2 backwall

Abutment Caps	(Fair)	Hairline cracks with efflorescence & spalling
Abutment Wings	(Fair)	Up to 1/32" cracks and efflorescence
Abutment Backwall	(Fair)	Up to 1/16" cracks with efflorescence , spalling , impending spall
Abutment Plumb	(Good)	
Abutment Piles	(Not Visible)	
Abutment Embankment	(Good)	
Abutment Bearing Surface	(Good)	
Abutment Rip Rap	(Fair)	Settled

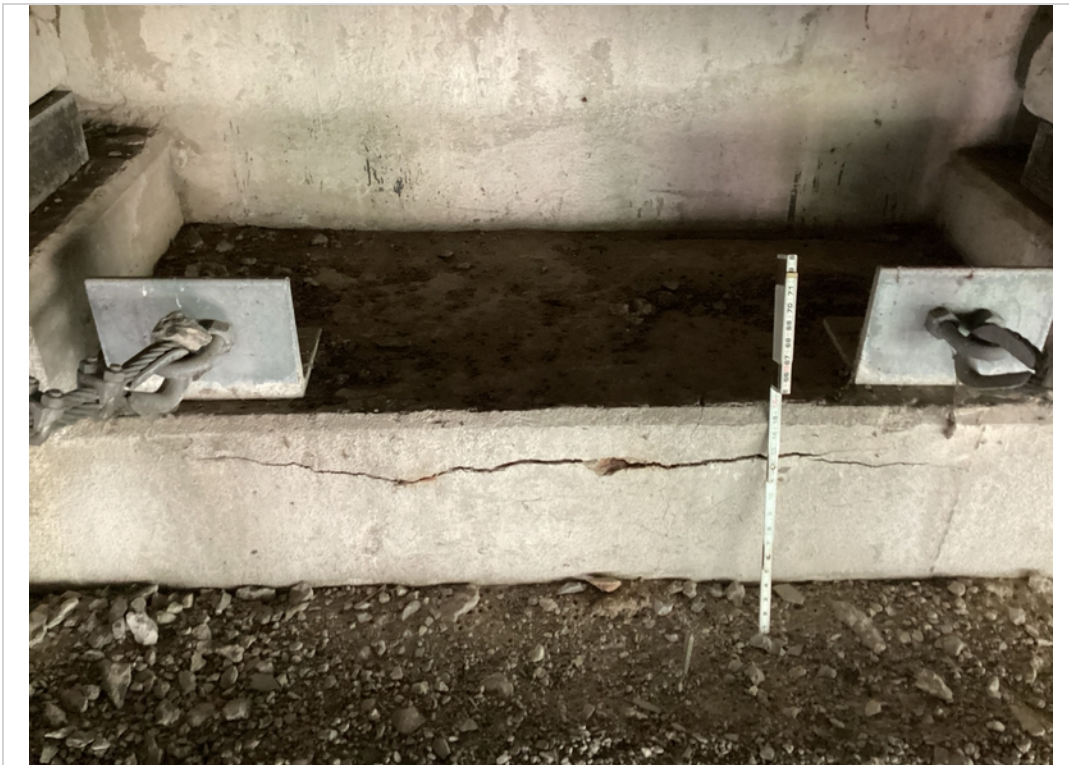
Abutment 1 impending spill

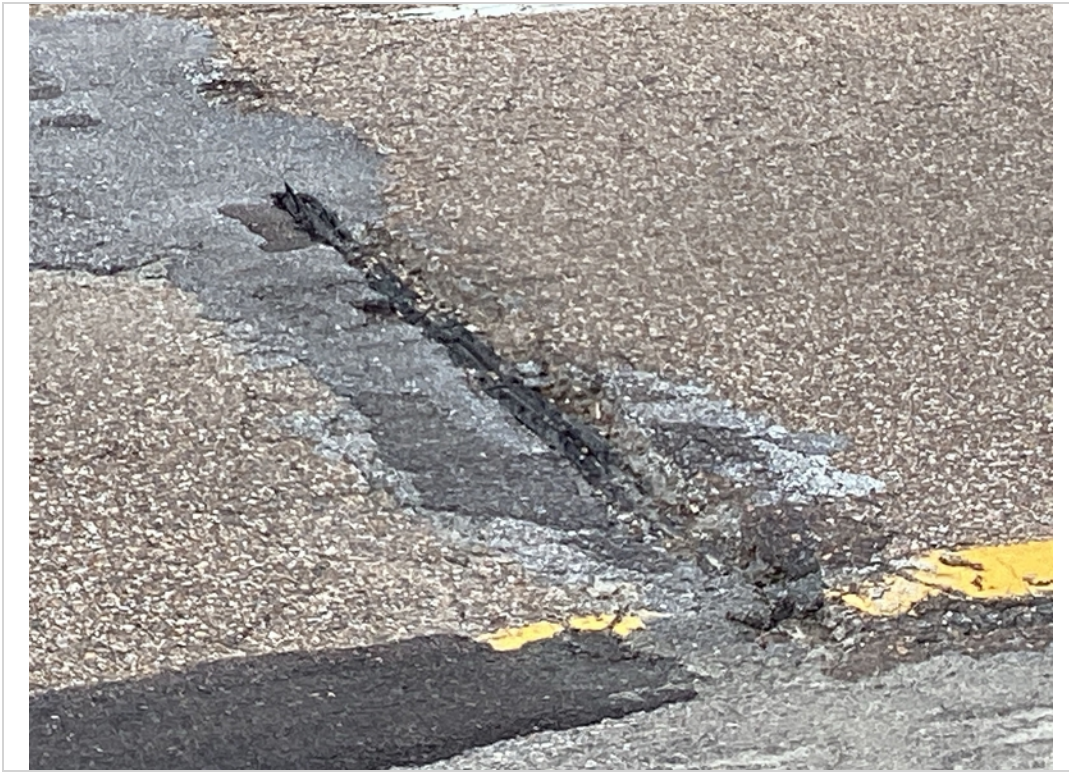
Approach 2 asphalt

Approach 1&2 have 1/2" cracks and potholes

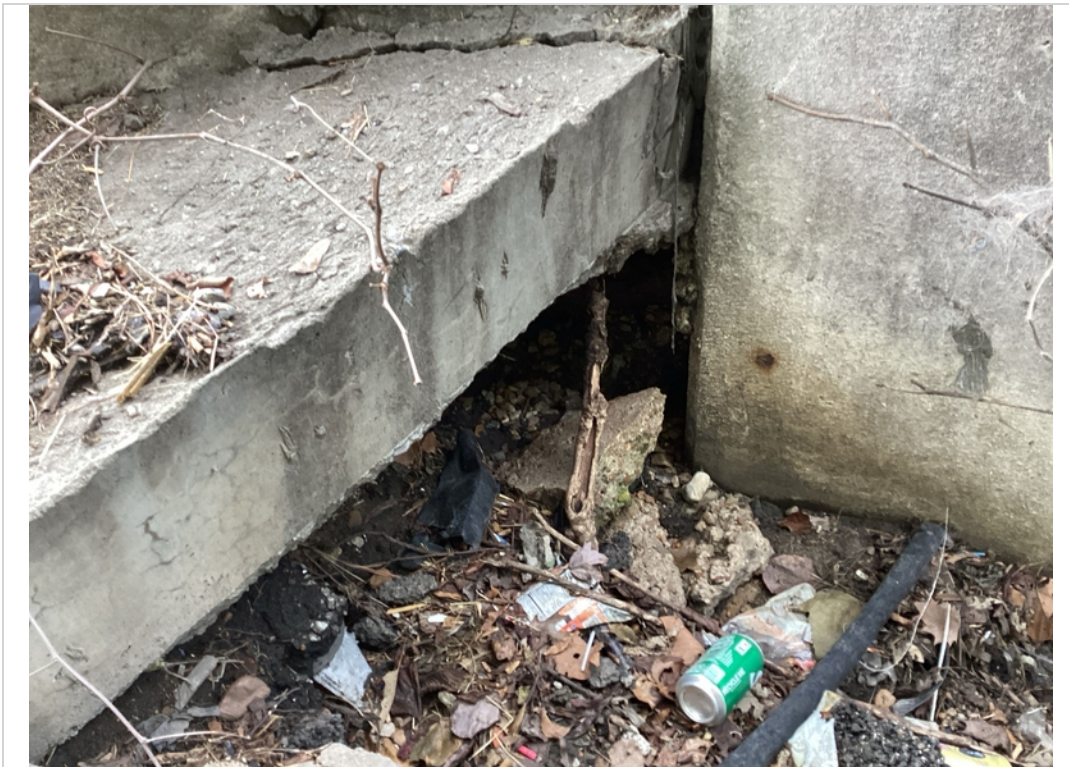
Approach 1 right embankment washing

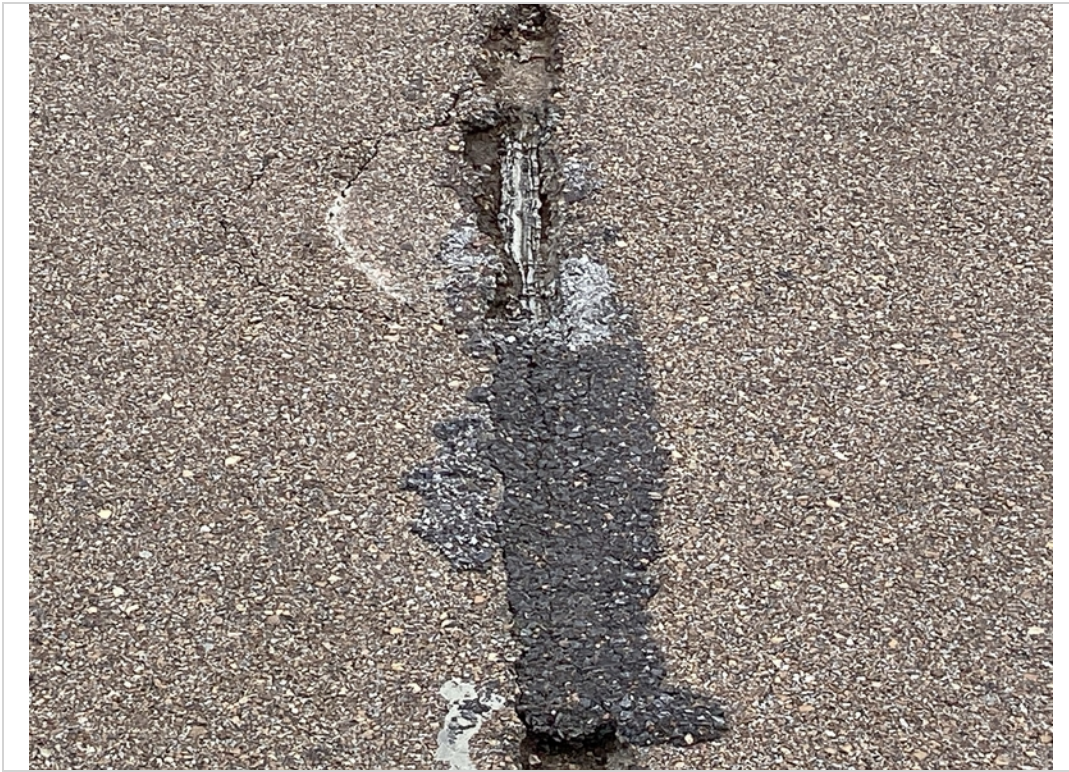
Approach 1 asphalt spill

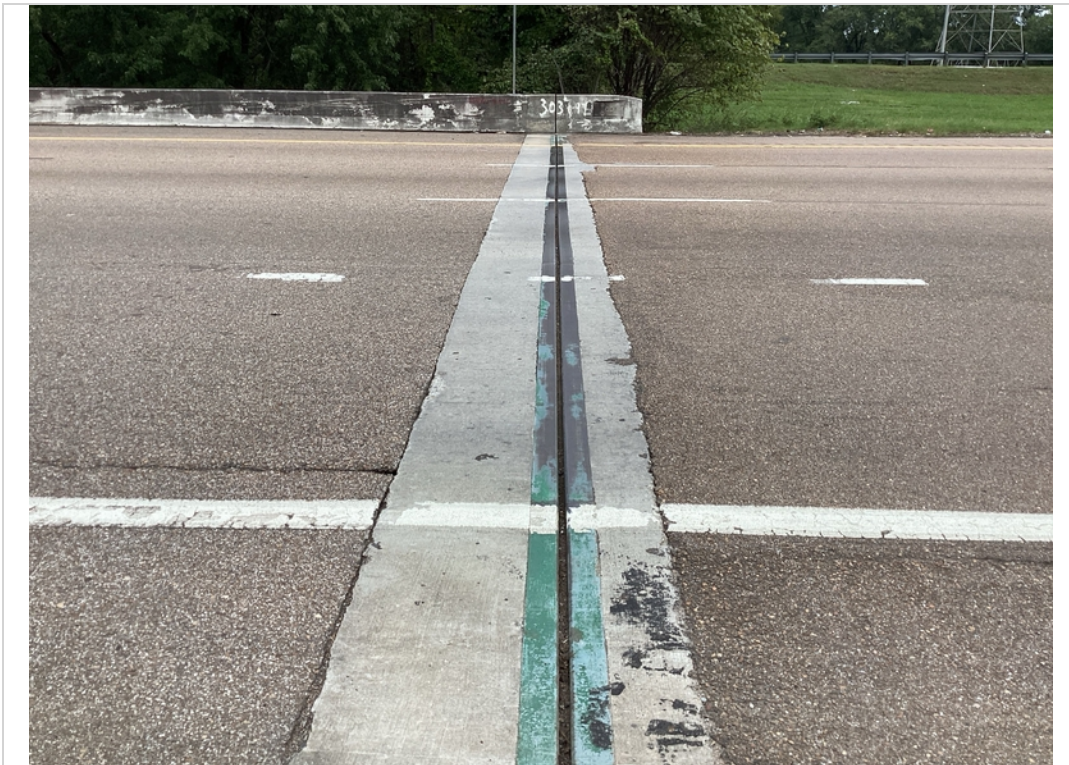
Span 1 joint

Wearing Surface Type		Asphalt	Wearing Surface Depth	4
Wearing Surface	(Poor)	Cracking up to 1/8" , patching, damage, & pot holes, Span 8 , large potholes		
Deck - Structural Condition	(Fair)	Spalling , impending spall , up to 1/32" , patched areas , hairline cracks with efflorescence in overhang		
Parapet	(Fair)	Pop outs spalling, 1/16" cracks, scaling, collision damage		
Deck Drains	(Poor)	100 % full of debris		
Expansion Joints	(Poor)	Full of debris

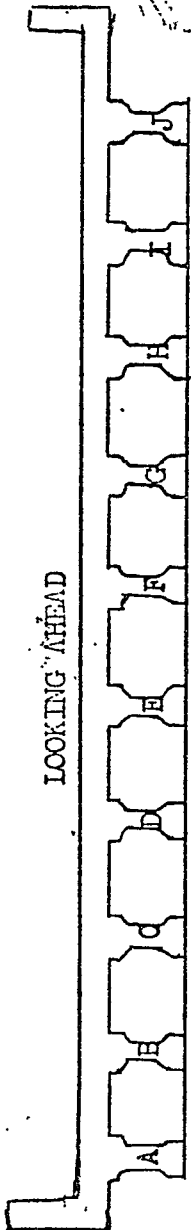
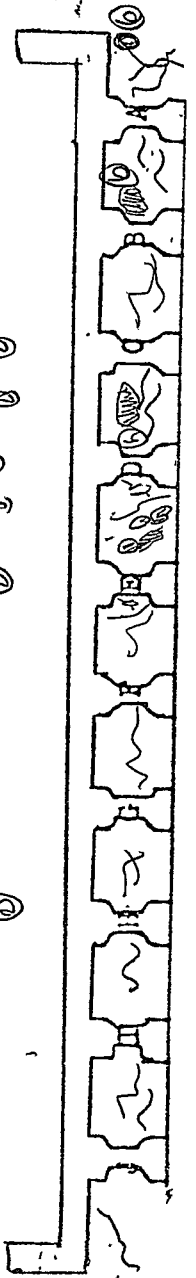
BR. NO. 79 I-40 5.01 SK. LT. SPAN NO.

ELEMENT	RATING	COMMENT
TOP DECK	G F P C	$\frac{1}{2}$ " crack
PARAPET	G F P C	
RAILS & POST	G F P C	
DRAINS	G F P C	
EXP. JOINTS	G F P C	
	G F P C

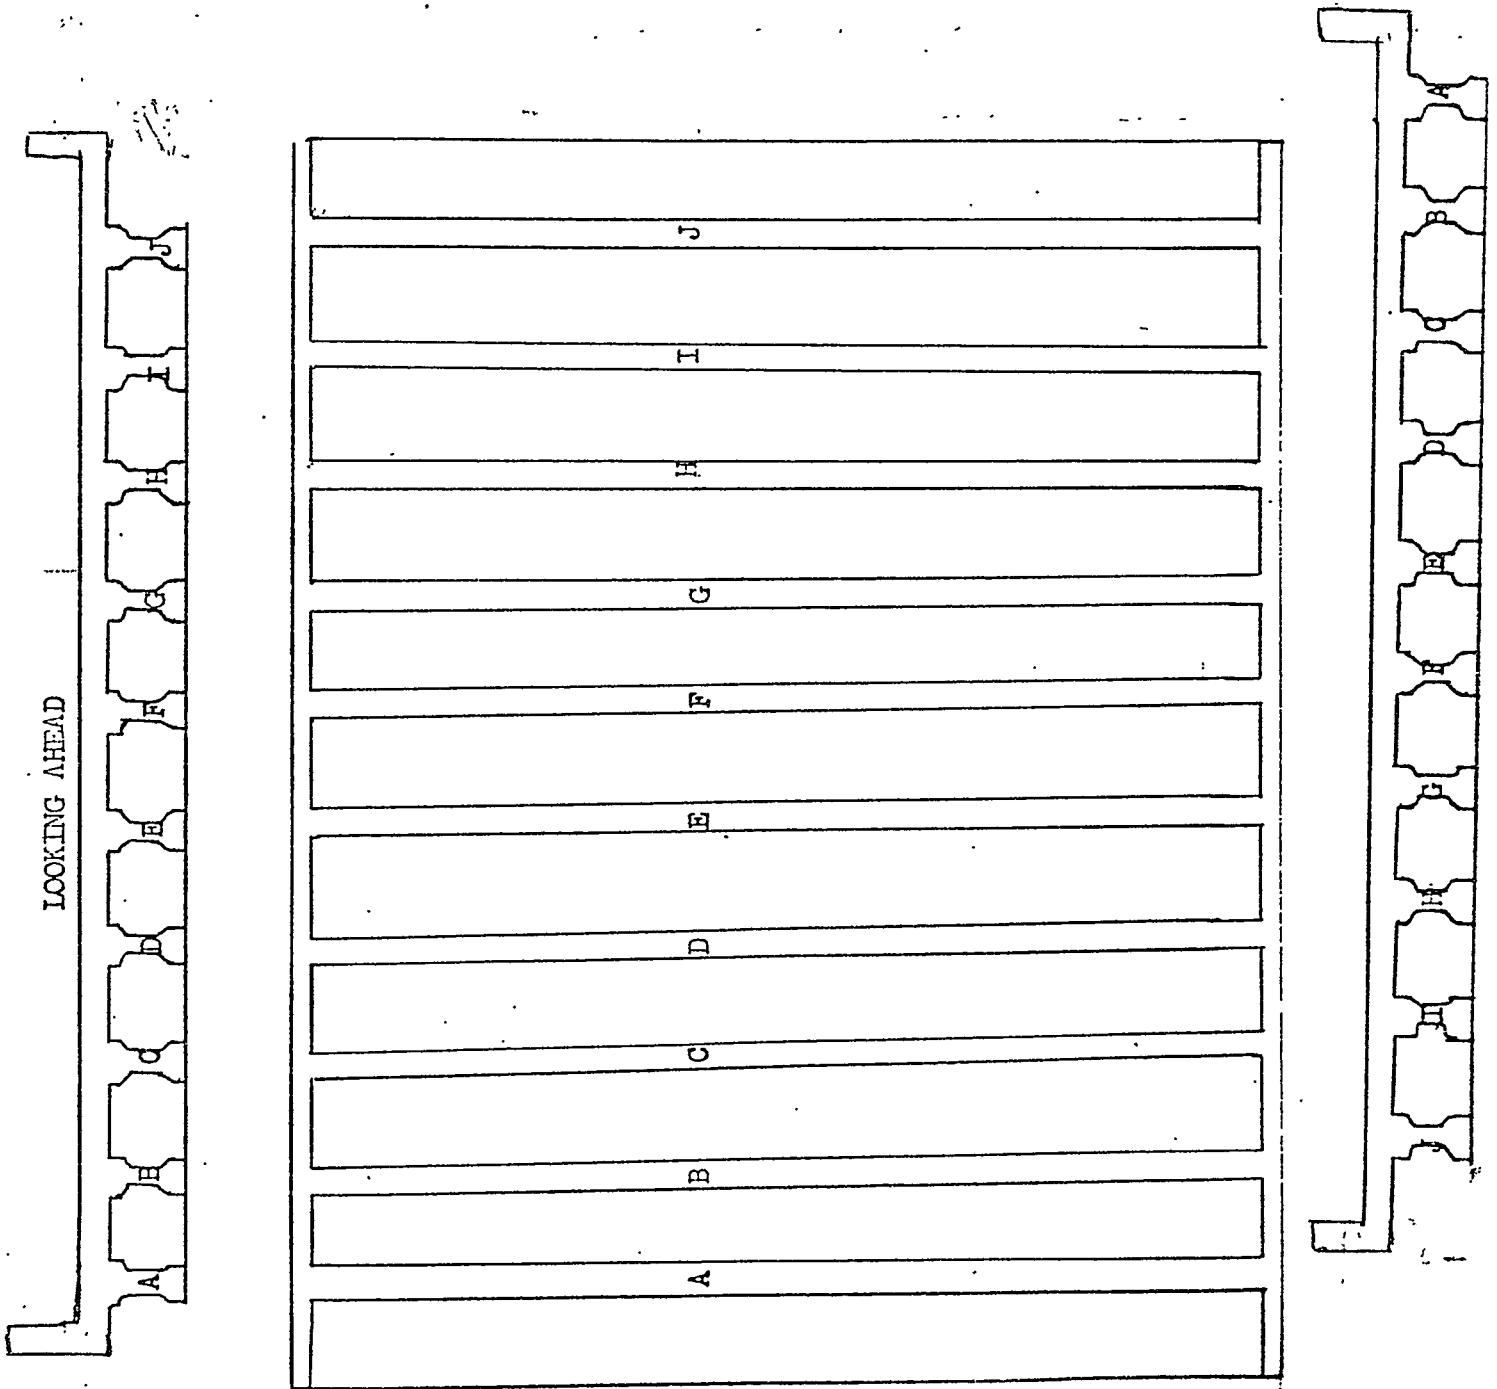
BR. NO. 79 TWO 501 SK. LT. SPAN NO. 4

ELEMENT	RATING	COMMENTS
BOTTOM DECK	G F P C	Horizontal cracks at all in crosshairs
CONC. I. BEAMS	G F P C	
A	G F P C	
B	G F P C	
C	G F P C	
D	G F P C	
E	G F P C	
F	G F P C	
G	G F P C	
H	G F P C	
I	G F P C	
J	G F P C	
DIA.	G F P C	
BACKWALLS	G F P C	N/A

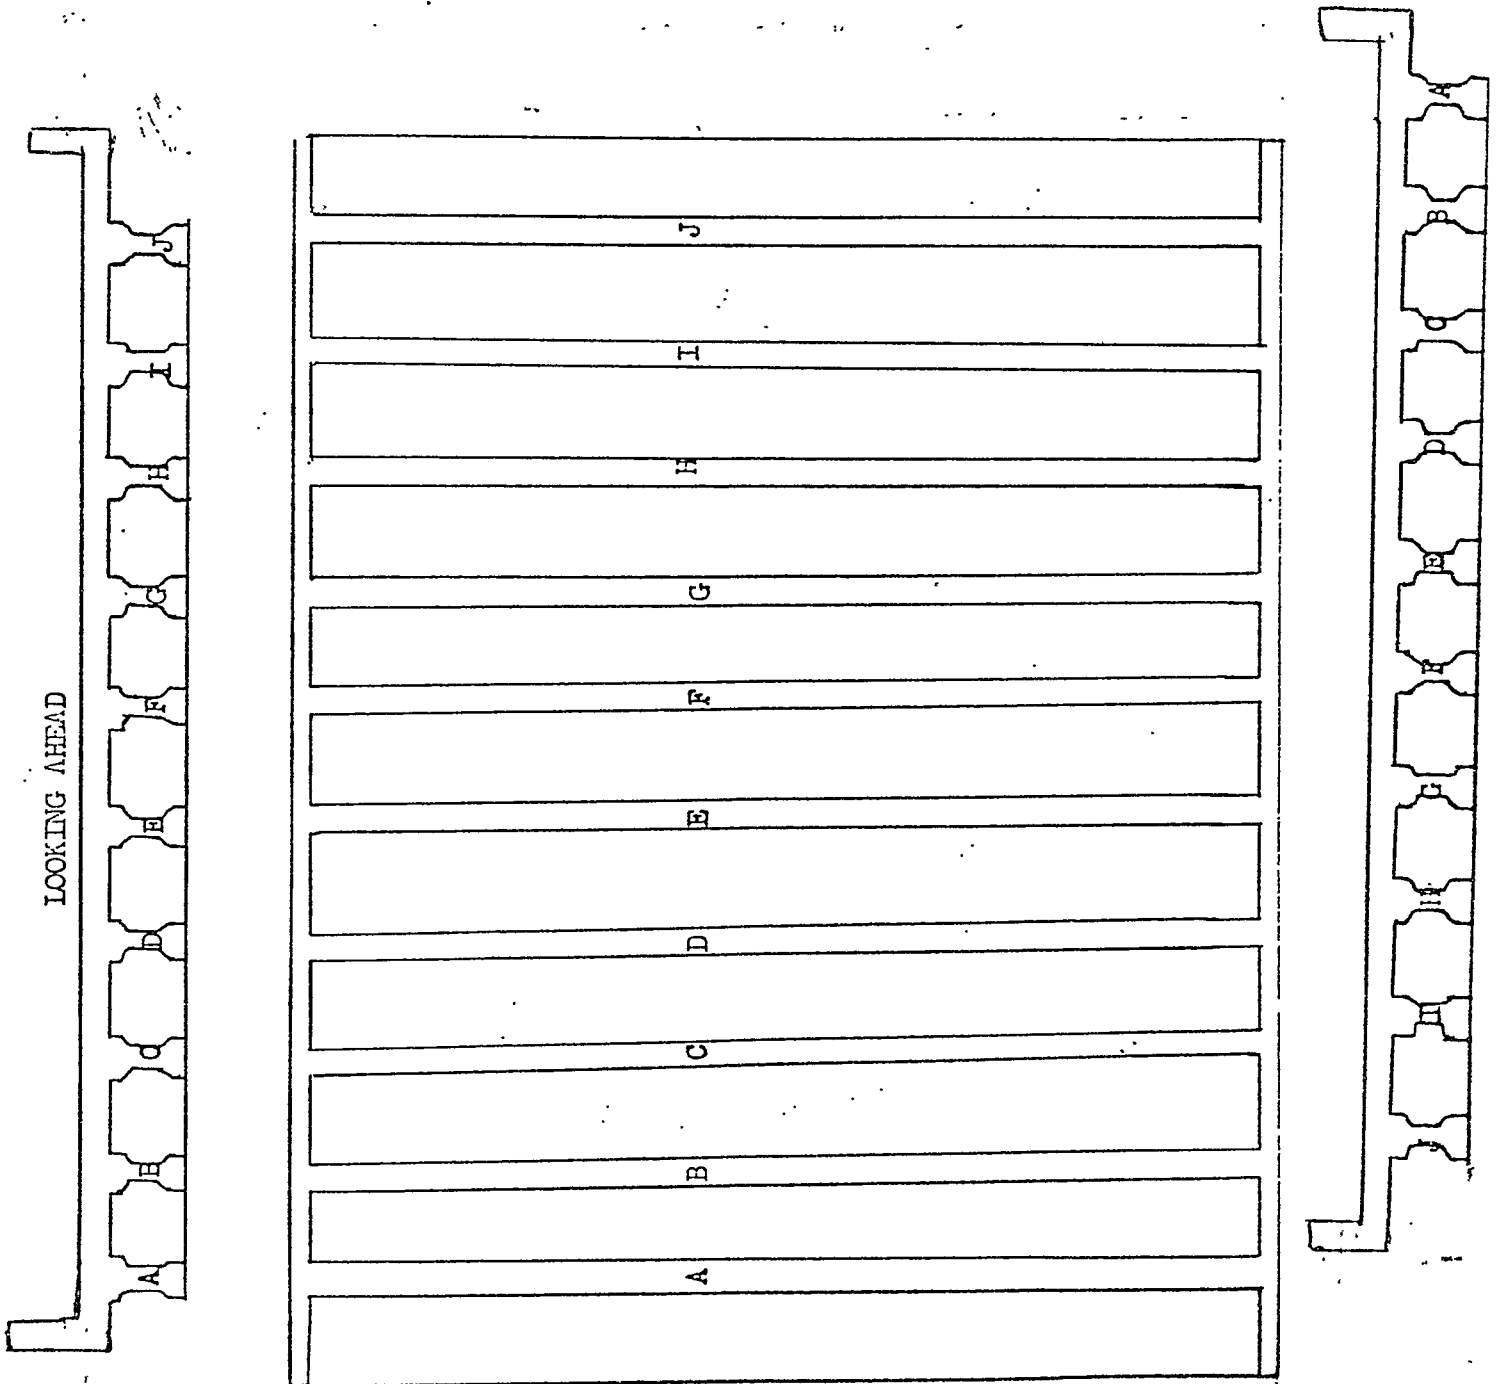
BR. NO. 79 I-40 5.01 SK. LT LT. SPAN NO. 5

ELEMENT	RATING	COMMENTS
BOTTOM DECK	(G) F P C	
CONC. I. BEAMS	(G) F P C	
A	(G) F P C	
B	(G) F P C	
C	(G) F P C	
D	(G) F P C	
E	(G) F P C	
F	(G) F P C	
G	(G) F P C	
H	(G) F P C	
I	(G) F P C	
J	(G) F P C	
DIA.	(G) F P C	
BACKFILLS	G F P C

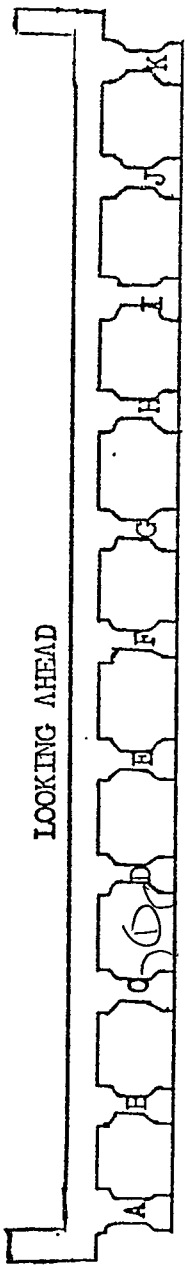
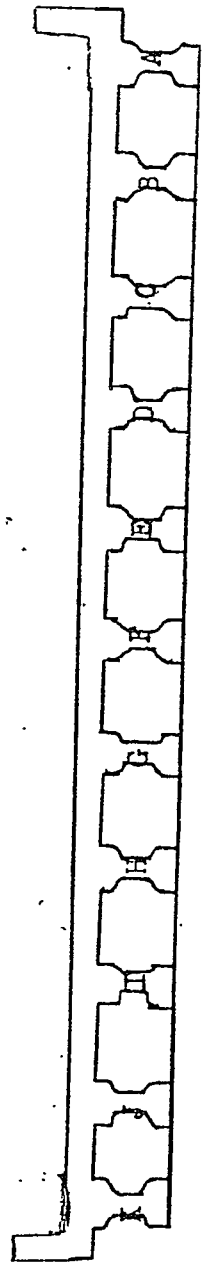
BR. NO. 79 I-40 5.01 SK. LT. SPAN NO. 7

① Spacing 8" dia 1/2" deep

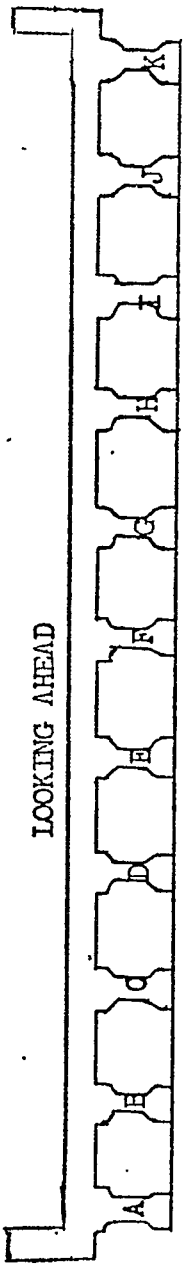
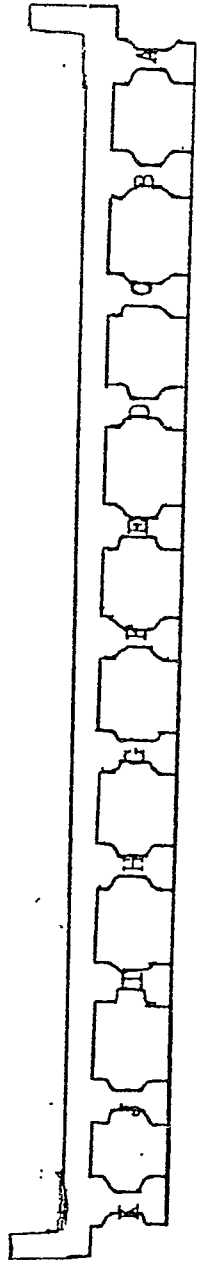
BR. NO. 79 I-40 5.01 SK. LT. SPAN NO. 8

ELEMENT	RATING	COMMENTS
BOTTOM DECK	(G) F P C	Hairline cracks eff
CONC. I. BEAMS	(G) F P C	
A	(G) F P C	
B	(G) F P C	
C	(G) F P C	
D	(G) F P C	
E	(G) F P C	
F	(G) F P C	
G	(G) F P C	
H	(G) F P C	
I	(G) F P C	
J	(G) F P C	
K	(G) F P C	
DIA.	G (F) P C	(1)
BACKFILLS	G F P C

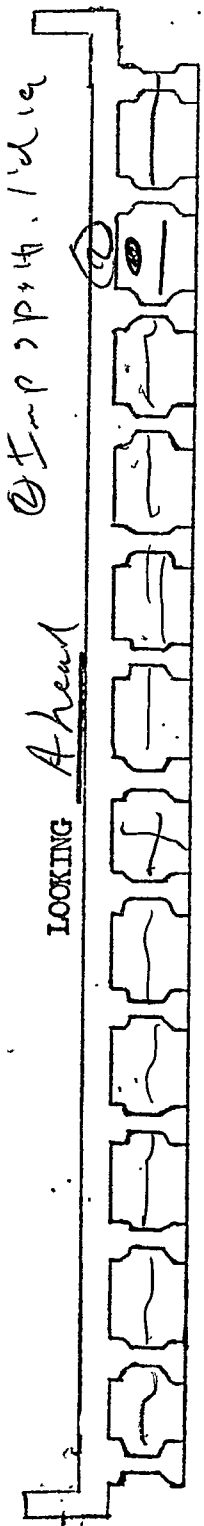
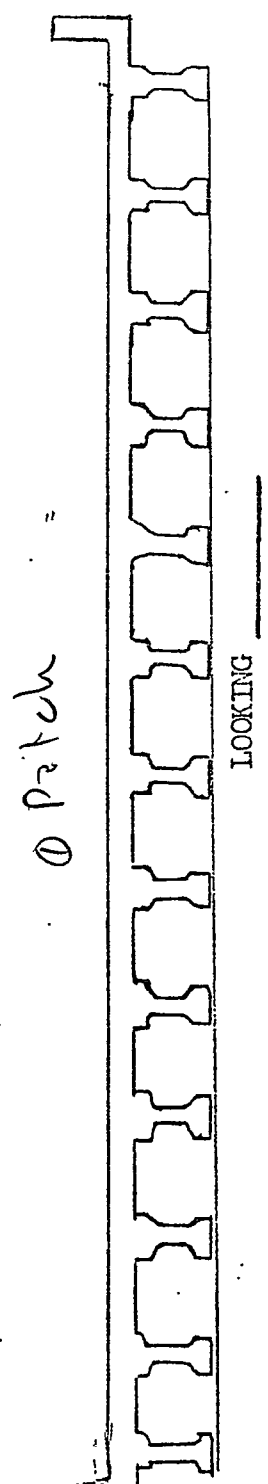
BENT NO. _____ SPAN NO. 10 ABT. NO. _____ PIER NO. _____

ELEMENT	RATING	COMMENTS
BOTTOM DECK	G(F) P C	Hairline cracks with egg ①
CONC. I. BEAMS	(G) F P C	
A	(G) F P C	
B	(G) F P C	
C	(G) F P C	
D	(G) F P C	
E	(G) F P C -	- - -
F	(G) F P C	
G	(G) F P C	
H	(G) F P C	
I	(G) F P C	
J	(G) F P C	
K	(G) F P C	
L	(G) F P C	
M	(G) F P C	
DIA.	(G) F P C	
BACKWALLS	G(F) P C	Up to 1/32" cracks ②

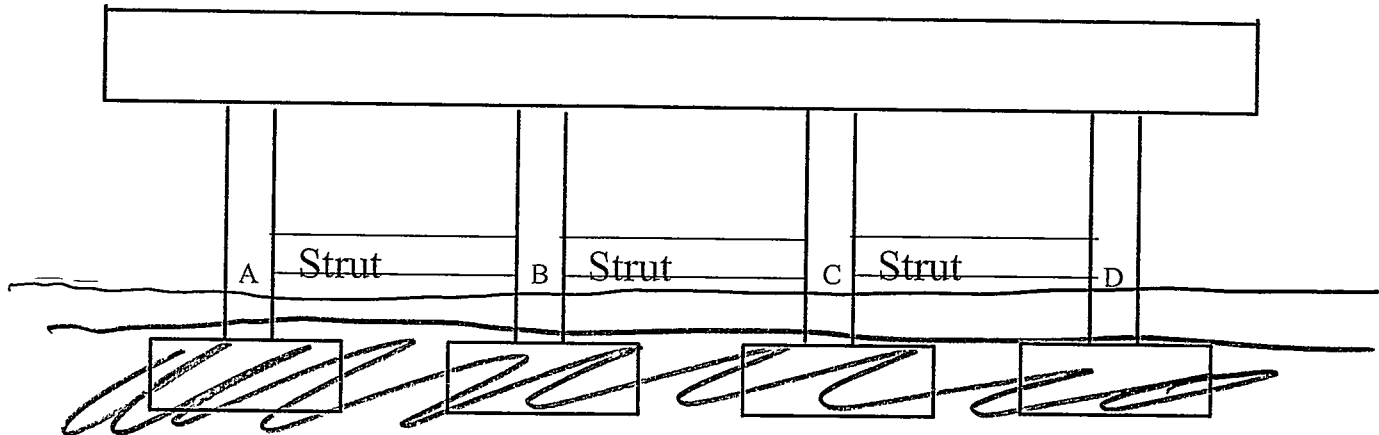
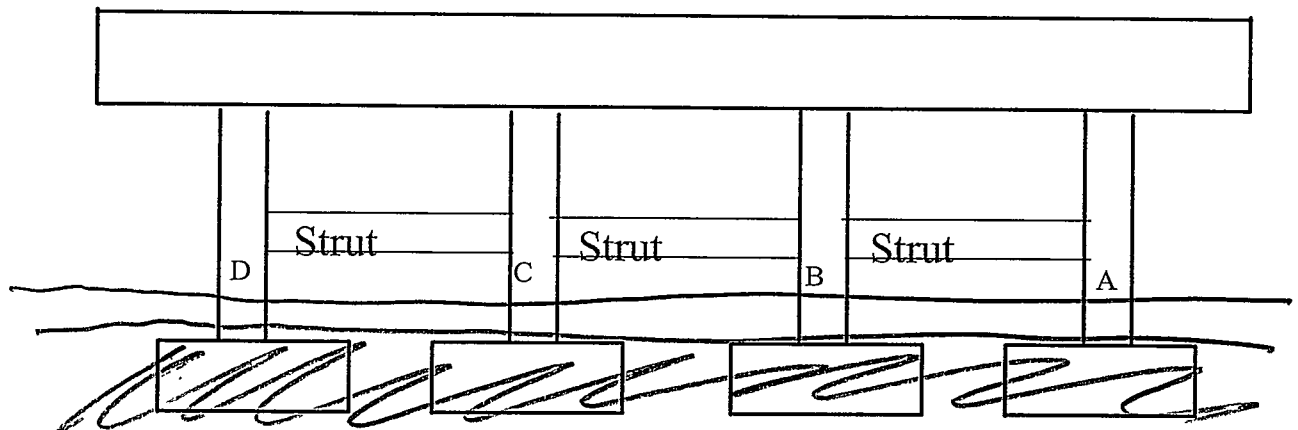
Bridge No. Co. Route Log Mile BENT. NO. 4

See scour sheet

ELEMENT	RATING	COMMENT
BEARING	G F P C	Light water abrasion up to 1/8" all columns
CAP	G F P C	
COLUMN A	G F P C	
B	G F P C	
C	G F P C	
D	G F P C	N/A
	G F P C	
FOOTING	G F P C

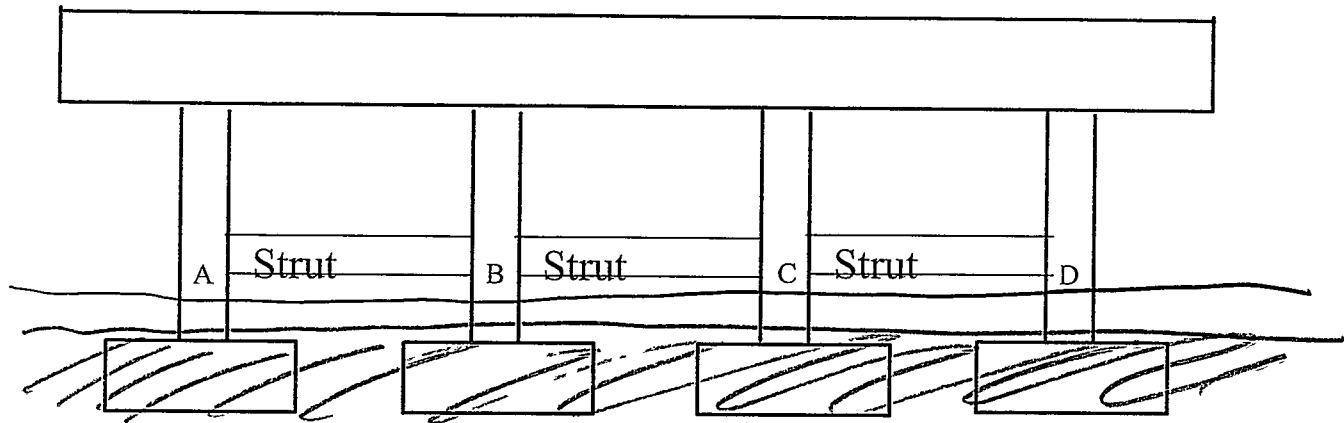
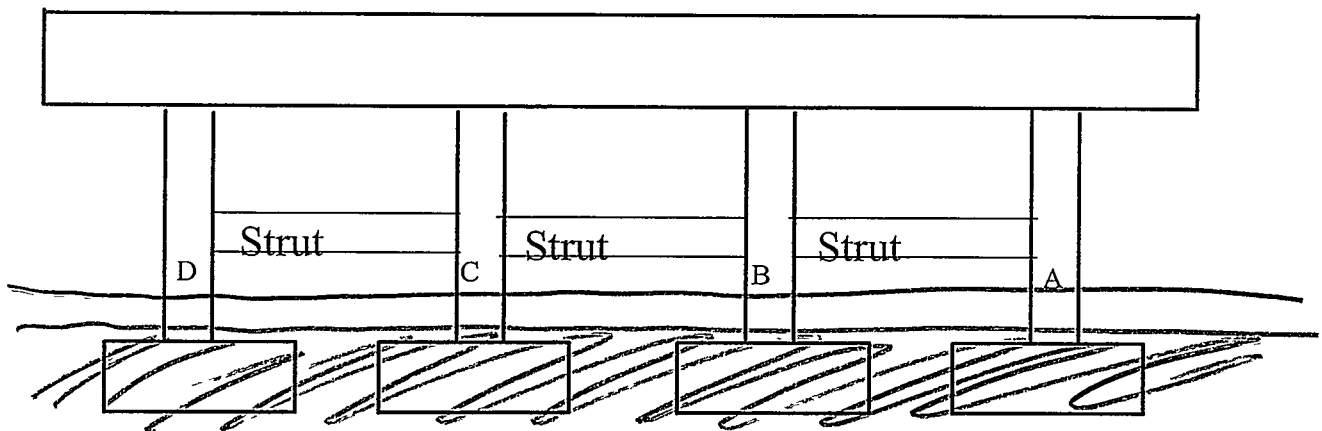
see scour sheet

ELEMENT	RATING	COMMENT
BEARING	G F P C	Light water abrasion all columns up to 1/9"
CAP	G F P C	
COLUMN A	G F P C	
B	G F P C	
C	G F P C	
D	G F P C	WIV
FOOTING	G F P C	
	G F P C

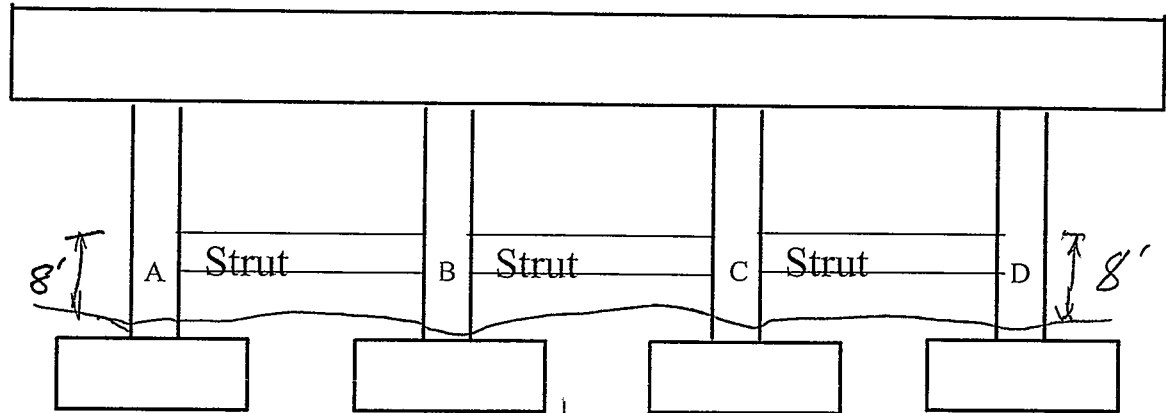
① Impending Spall
1' Dia X 3' / D

ELEMENT	RATING	COMMENT
BEARING	(G) F P C	
CAP	(G) F P C	
COLUMN A	(G) F P C	
B	(G) F P C	
C	(G) F P C	See ① + Set C,
D	(G) F P C	
	G F P C	
FOOTING	G F P C	N/A

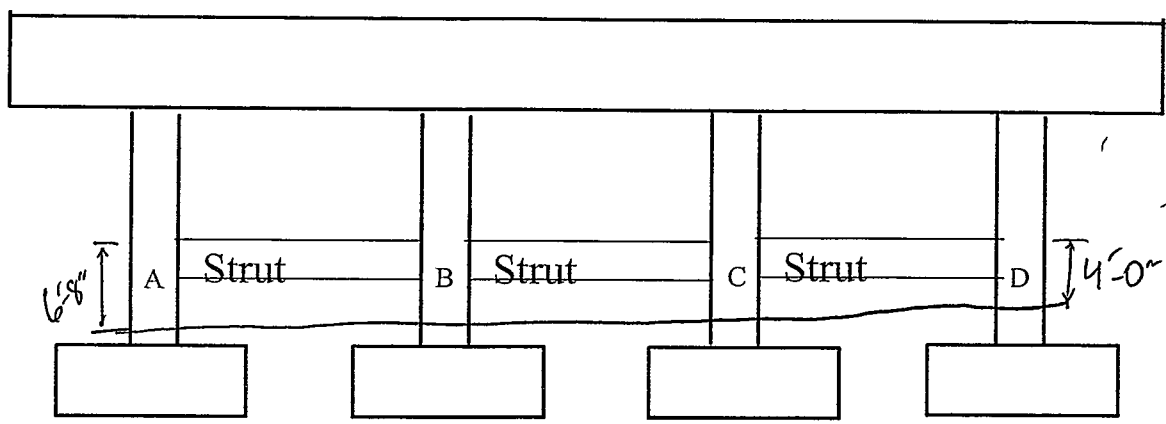
① Spall
up to 4" Dia x 0.5' / D.
