TENNESSEE DEPARTMENT OF TRANSPORTATION ASBESTOS SURVEY REPORT

Bridge 80I00400035 (80-I0040-17.13R)
I-40 East Bound Over Caney Fork River, LM 17.16
Smith County
TDOT Project No.: 80I040-S1-006, PIN: 131552.01

TriAD Project No. PROJ-042759 TDOT W021

08/16/24

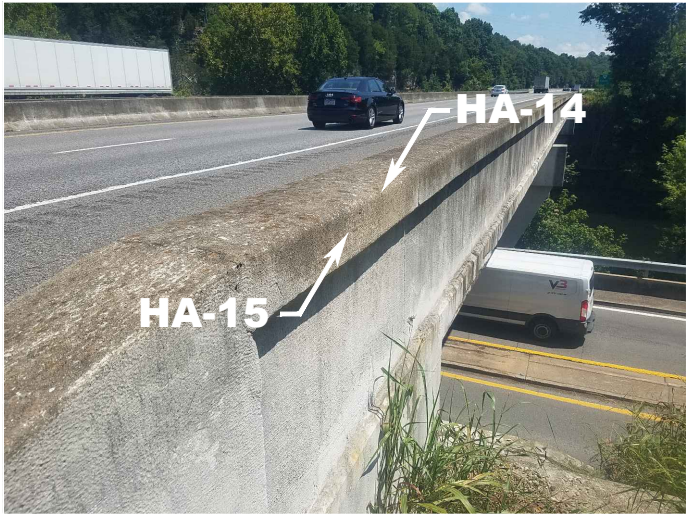
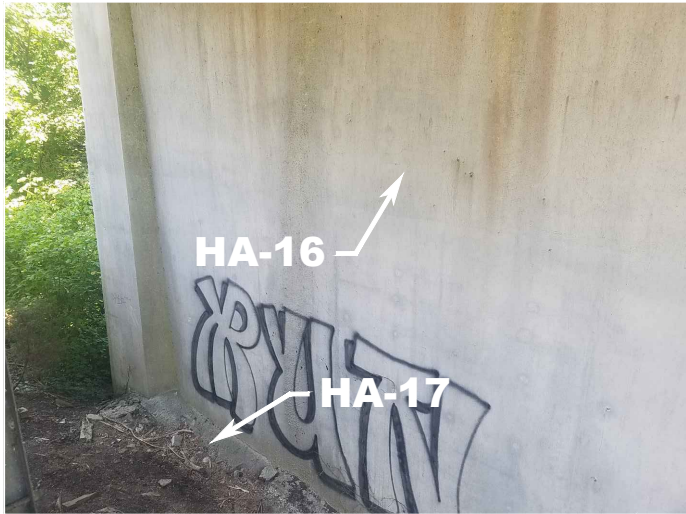
HOMOGENEOUS AREAS

Based on the analytical results, none of the sampled materials contained asbestos. The analytical results of all the samples collected, along with the chain-of-custody records, are included in Appendix A. Photographs of examples of the HAs are included in Appendix B. A Bridge Vicinity Map is provided as Figure 1. A profile of the bridge with homogenous area sample locations is depicted on Figure 2.
