I-24 Crossing I-24 WB / SHELLMOUND RD.

# Routine Bridge Inspection Report

| Marion County | |
|---|---|
| Description | Interstate 24 Westbound Lanes over Shellmound Road, I-24 Milepost 157.16 |
| Date | 7/16/2024 |

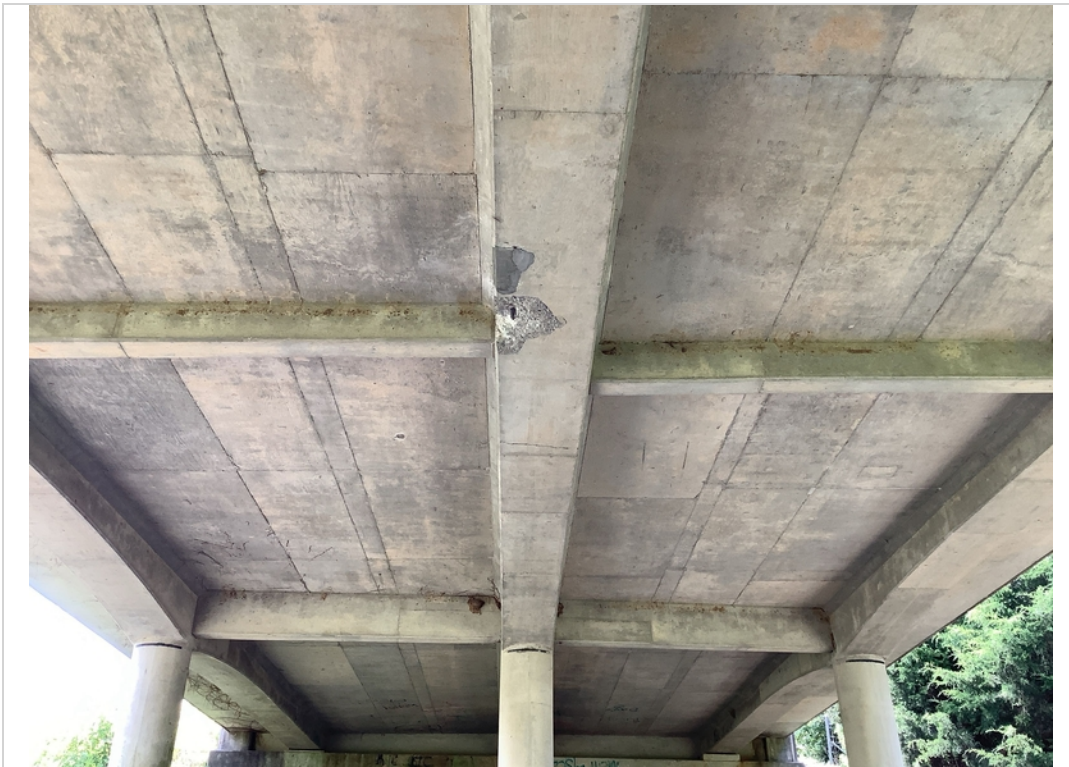
Typical bottom of deck

The deck is rated fair. The top of the deck is not visible due to the asphalt wearing surface. The bottom of the deck has isolated minor and moderate spalls in the overhangs. The concrete parapets are rated good and meet the current safety standards.

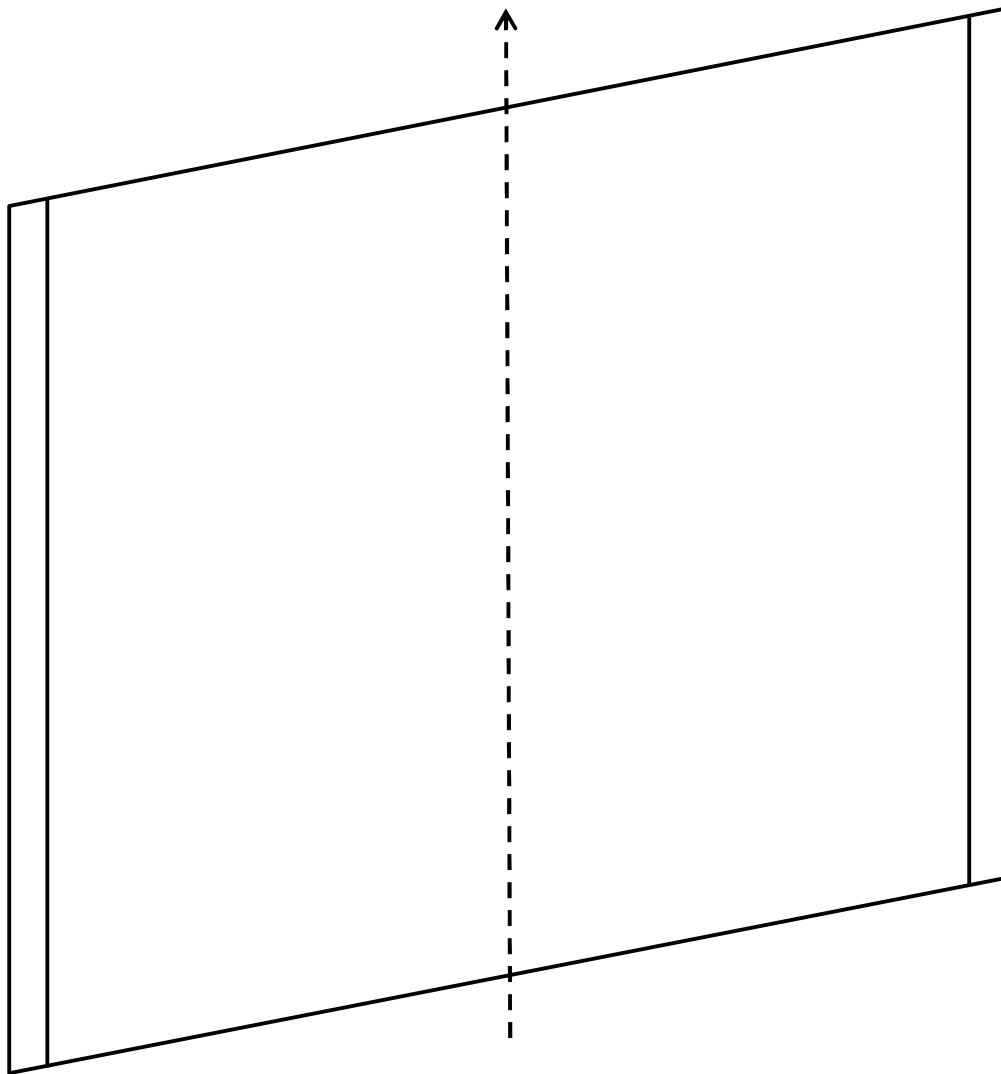
Bottom of Deck Span No. 1

| Wearing Surface Type | | Asphalt | Wearing Surface Depth | 6 |
|---|---|---|---|---|
| Deck - Structural Condition | (Fair) | Isolated minor and moderate spalls with exposed rebar in overhangs | | |

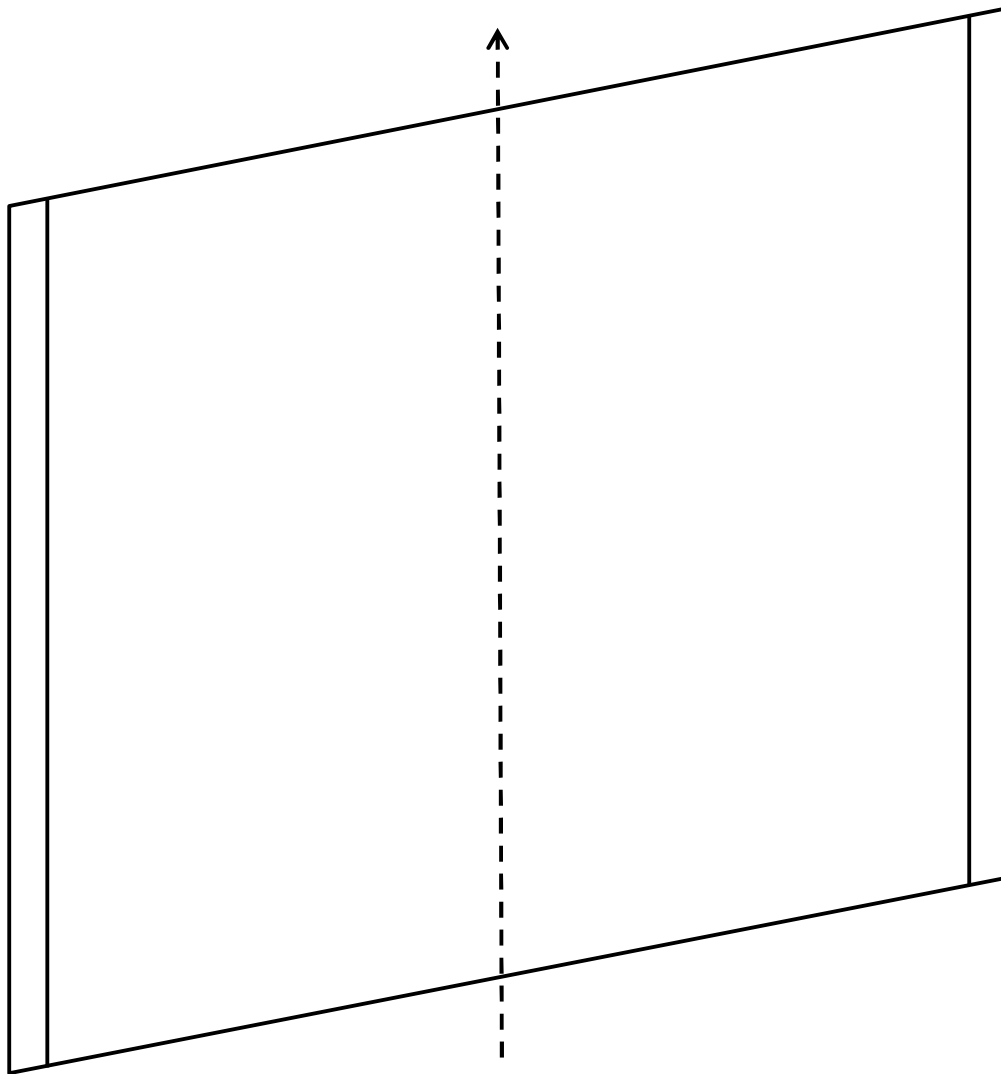
Bottom of Deck Span No. 2

cracks are small

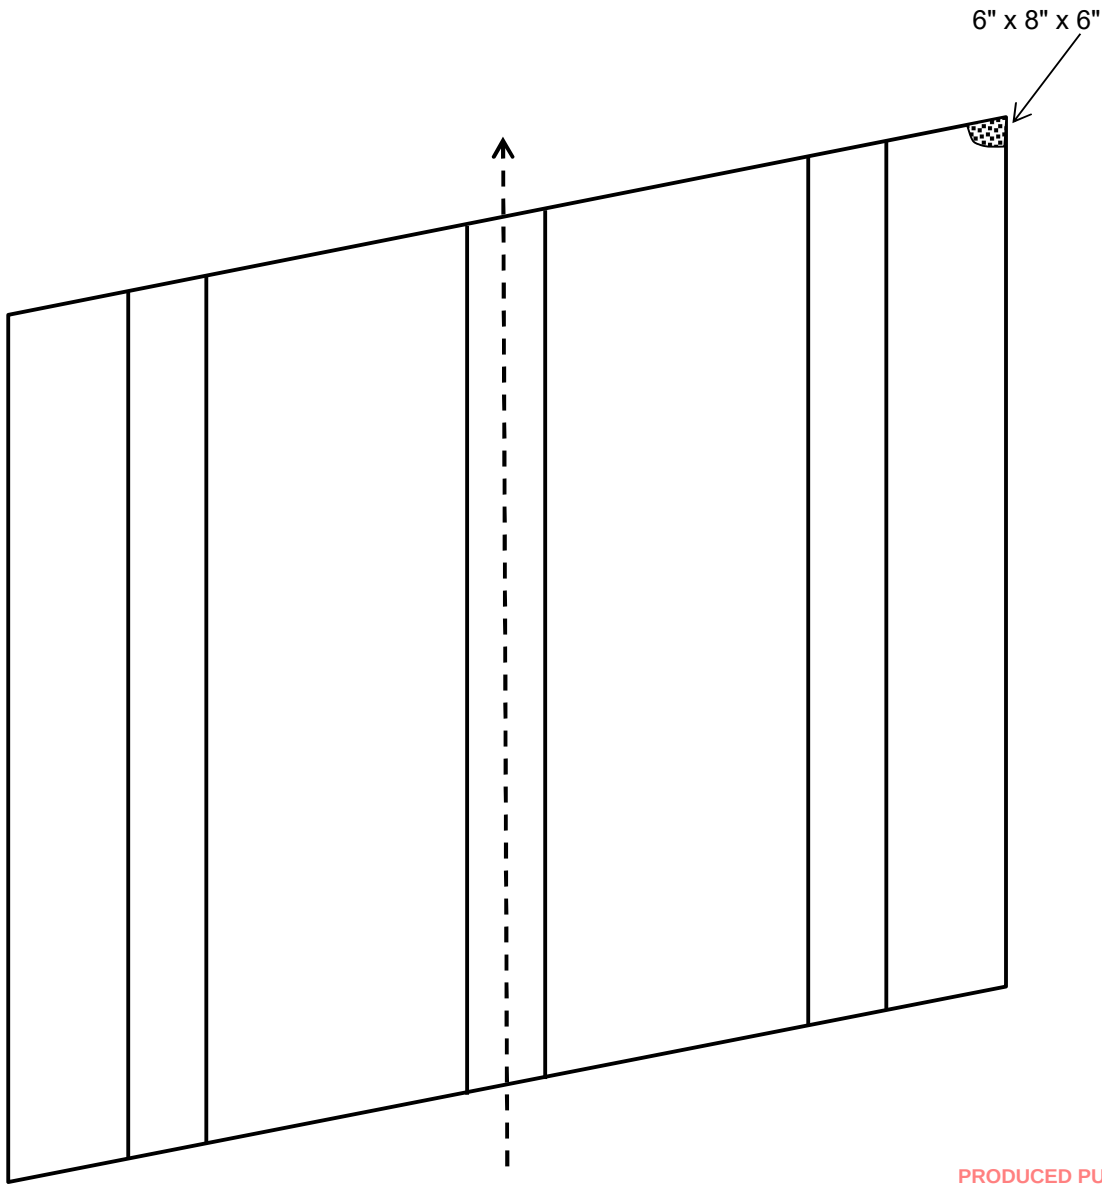
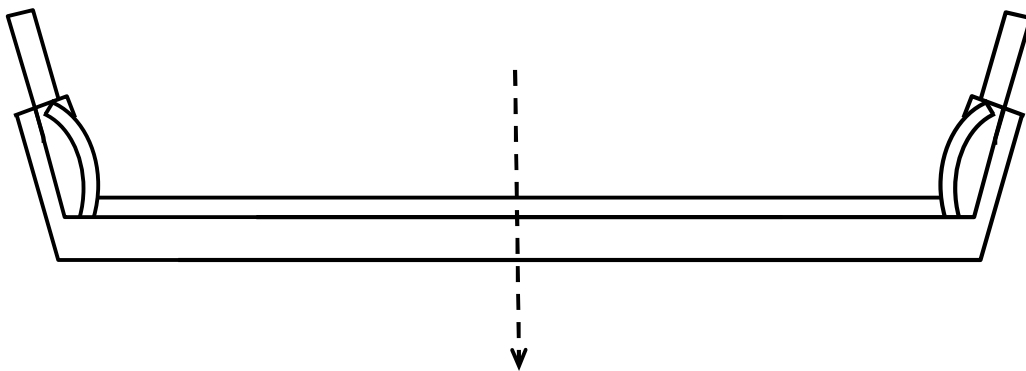
# Abutment No. 1

| Abutment Caps | (Good) | Some minor cracking |

cracks are hairline

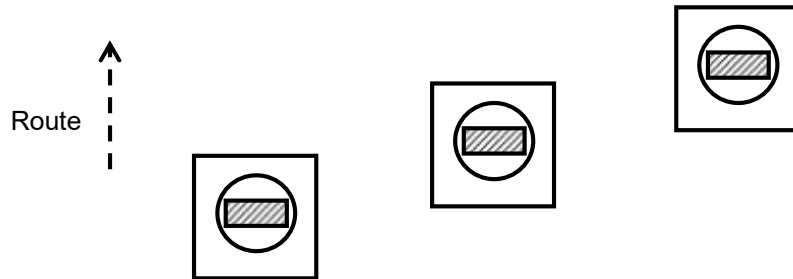
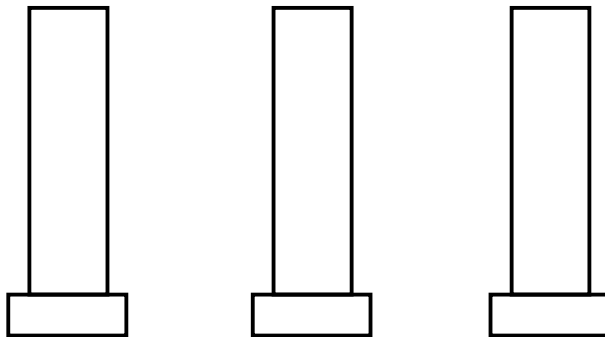
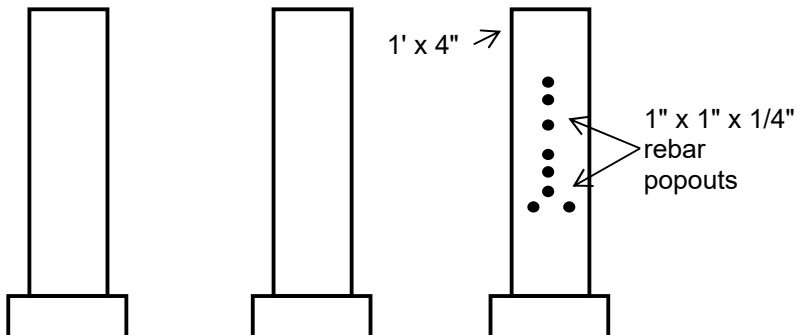
# Bent No. 2

The substructure is rated good. The abutment caps have some minor cracking. The backwall of abutment #1 and a few bent columns have minor delaminated areas. The concrete slope pavement is rated good but has vegetation growth between the slabs. The bent columns have some minor rebar pop-outs and delaminated areas.
