SHELLMOUND RD. Crossing SHELLMOUND RD. / I-24 EB

# Routine Bridge Inspection Report

| Marion County | |
|---|---|
| Description | Shellmound Road over Interstate 24 Eastbound Lanes, I-24 Milepost 157.29 |
| Date | 7/17/2024 |

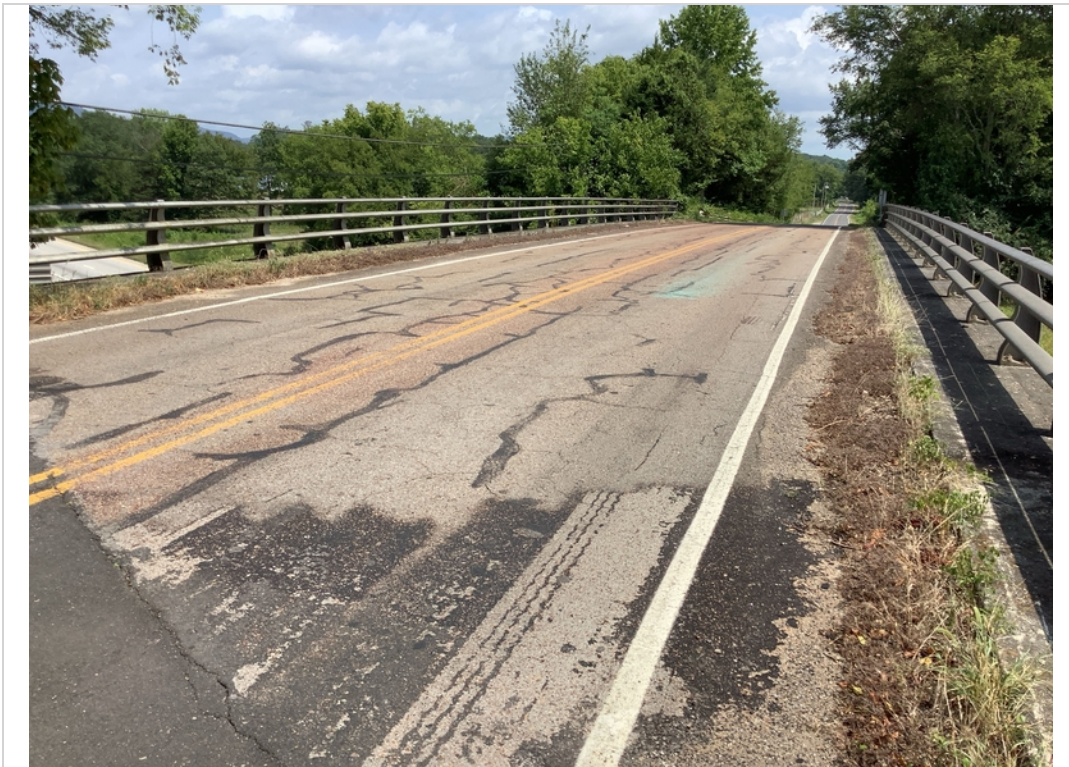
Top of deck

| Wearing Surface Type | | Asphalt | Wearing Surface Depth | 4 |
|---|---|---|---|---|
| Wearing Surface | (Fair) | Heavy vegetation at curblines; some moderate cracking | | |

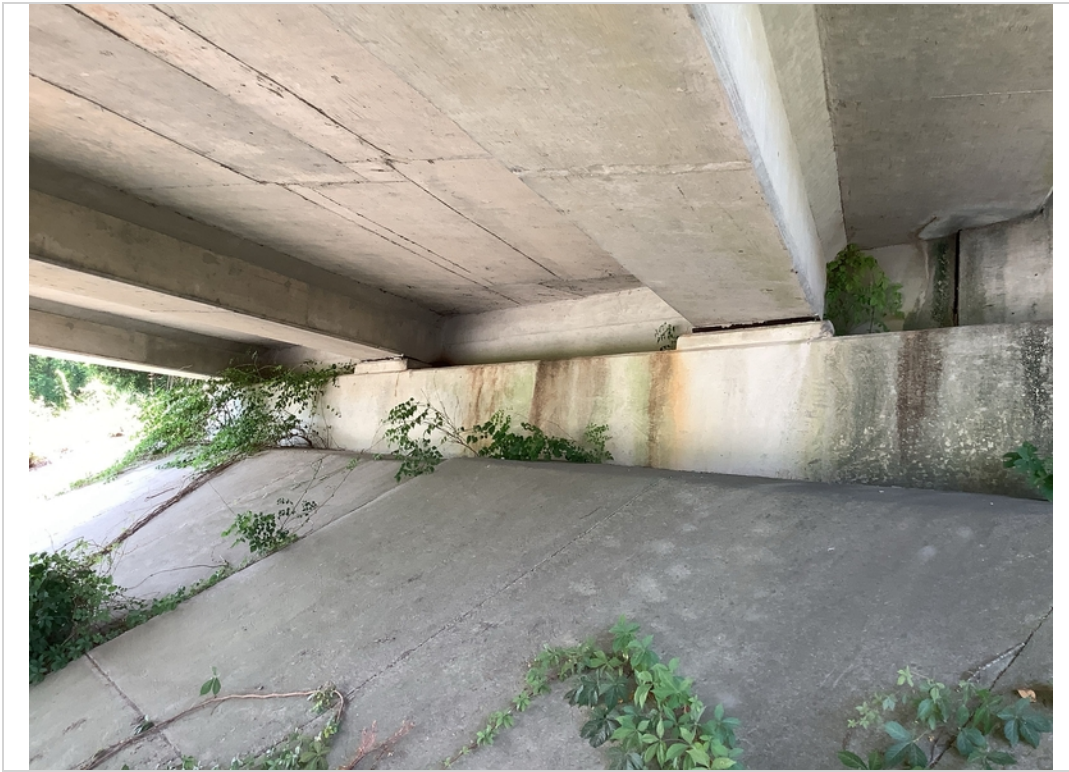
Typical abutment

| Wearing Surface Type | | Asphalt | Wearing Surface Depth | 4 |
|---|---|---|---|---|
| Expansion Joints | (NA) | Slight to moderate leakage on abutments | | |
