County: 75 - Rutherford, Route: 01044, Log mile: 0.480

Team Lead: Carlos Goncalves, **Inspection Date:** 06/14/2024

EPPS MILL RD. Crossing I24 35.72240, -86.32037

Inspection Team's Summary

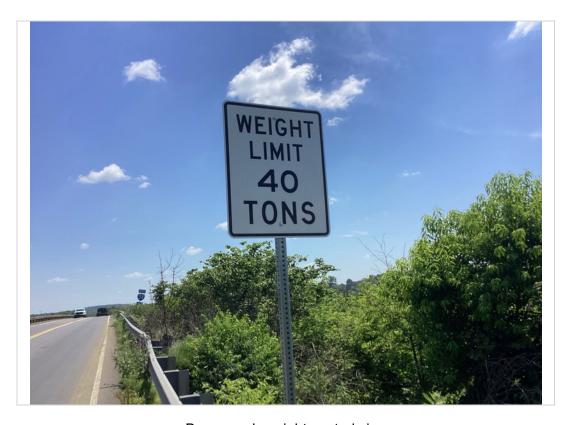
B approach weight posted sign

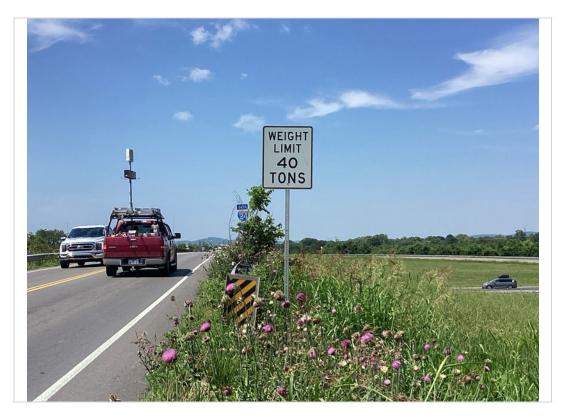
A approach weight posted sign

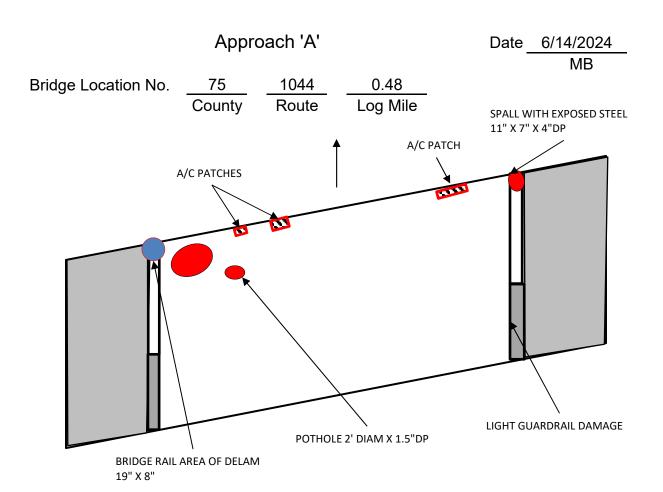
PAVEMENT	FAIR	AC PATCHES; POTHOLE
EMBANKS	GOOD	
DRAINS	FAIR	MOD. DEBRIS BLD-UP-RT SIDE
G-RAILS	GOOD	LIGHT DAMAGE
BR RAILS	GOOD	LIGHT SCALE, AREA OF DELAM., SPALL WITH EXPOSED STEEL

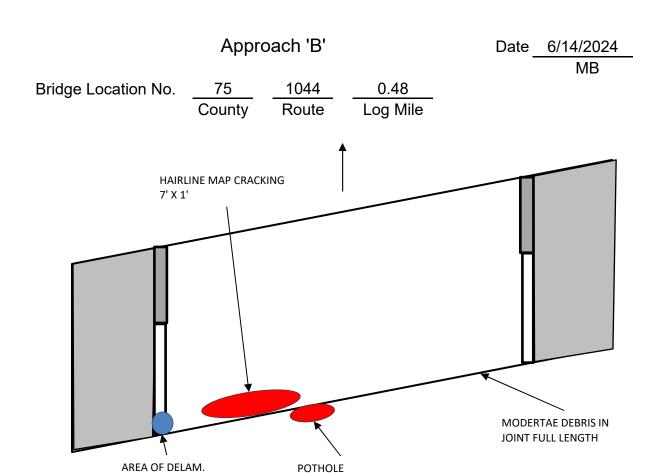
1.5' X 10"

PAVEMENT	FAIR	POTHOLE, HAIRLINE MAP CRACKING
EMBANKS	GOOD	
DRAINS	GOOD	
G-RAILS	GOOD	
BR RAILS	GOOD	LT SCALE

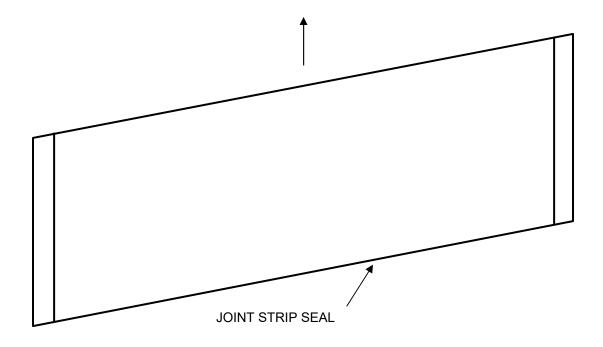
DECK	NV	A/C OVERLAY- GOOD
CURBS	GOOD	
RAILS	GOOD	LGH. SURFACE SCALE
JOINT	POOR	HVY. DEBRIS BUILD UP

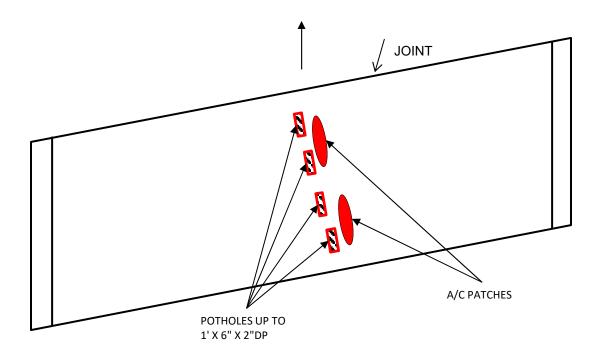
DECK	N/V	A/C OVERLAY-FAIR; AC PATCHES, POTHOLES
CURBS	GOOD	
RAILS	GOOD	LGH. SURFACE SCALE
JOINT	POOR	HVY. DEBRIS BUILD UP
