HAYWOOD COUNTY

38-SR087-0361

Crossing: LAGOON CREEK

Bridge Maintenance Recommendations

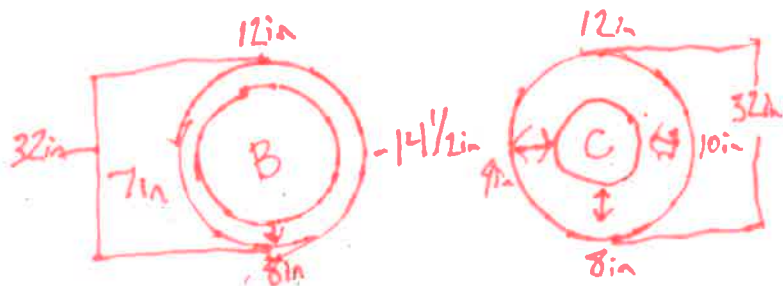
BENT NO. 1

- Spliced piling at 76in from bottom of cap
- Spliced piling at 80 in from bottom of cap

140	REPLACE _TIMBER _PILES _B, C _ AT BENT NO. _1 (08-26-21 Bridge Repair spliced piles "B" & "C" and poured concrete barrel around them)
140	REPLACE _TIMBER _PILES _C, D _ AT BENT NO. _2 (08-26-21 Bridge Repair added piles "B", "D", "F" & "H")
