BRIDGE MAINTENANCE RECOMMENDATIONS

LOCATION: 38-SR180-02.61-

CROSSING: OFFER CREEK

BRIDGE INSPECTION REPORT

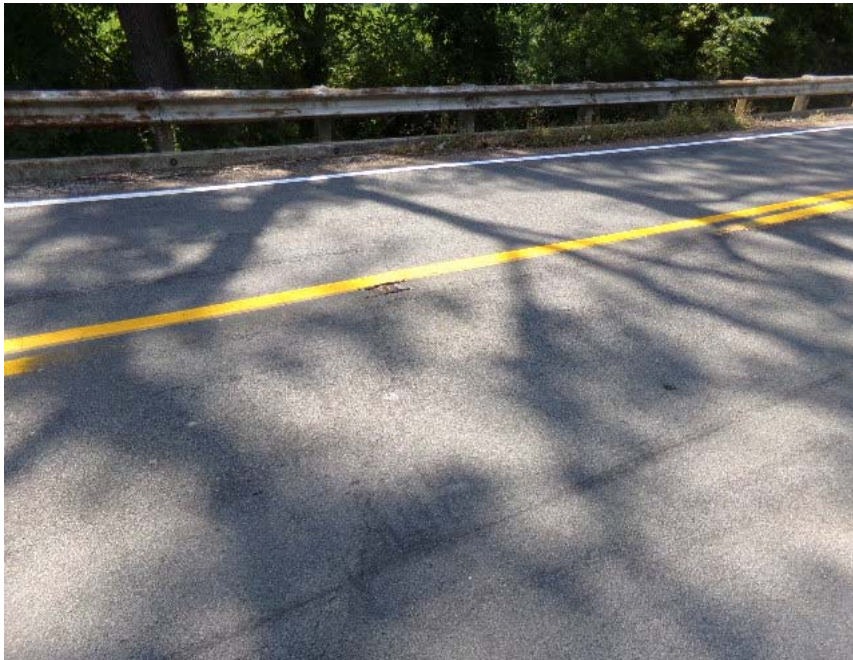
VIEW ACROSS TOP OF DECK

The asphalt wearing surfaces have up to 1/16" cracks.

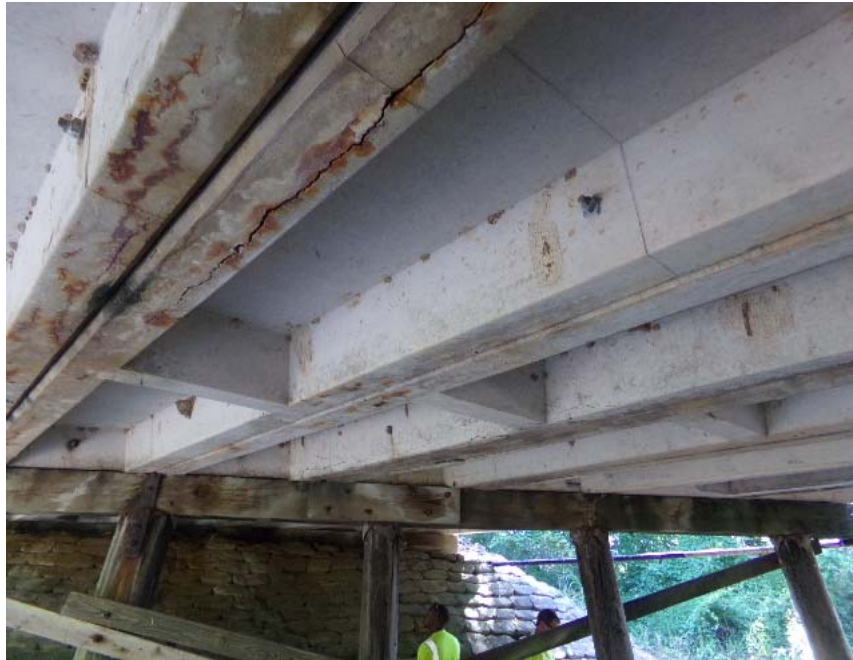
BOTTOM DECK

The p.c.c.s. have up to 1/16" cracks & spalling.

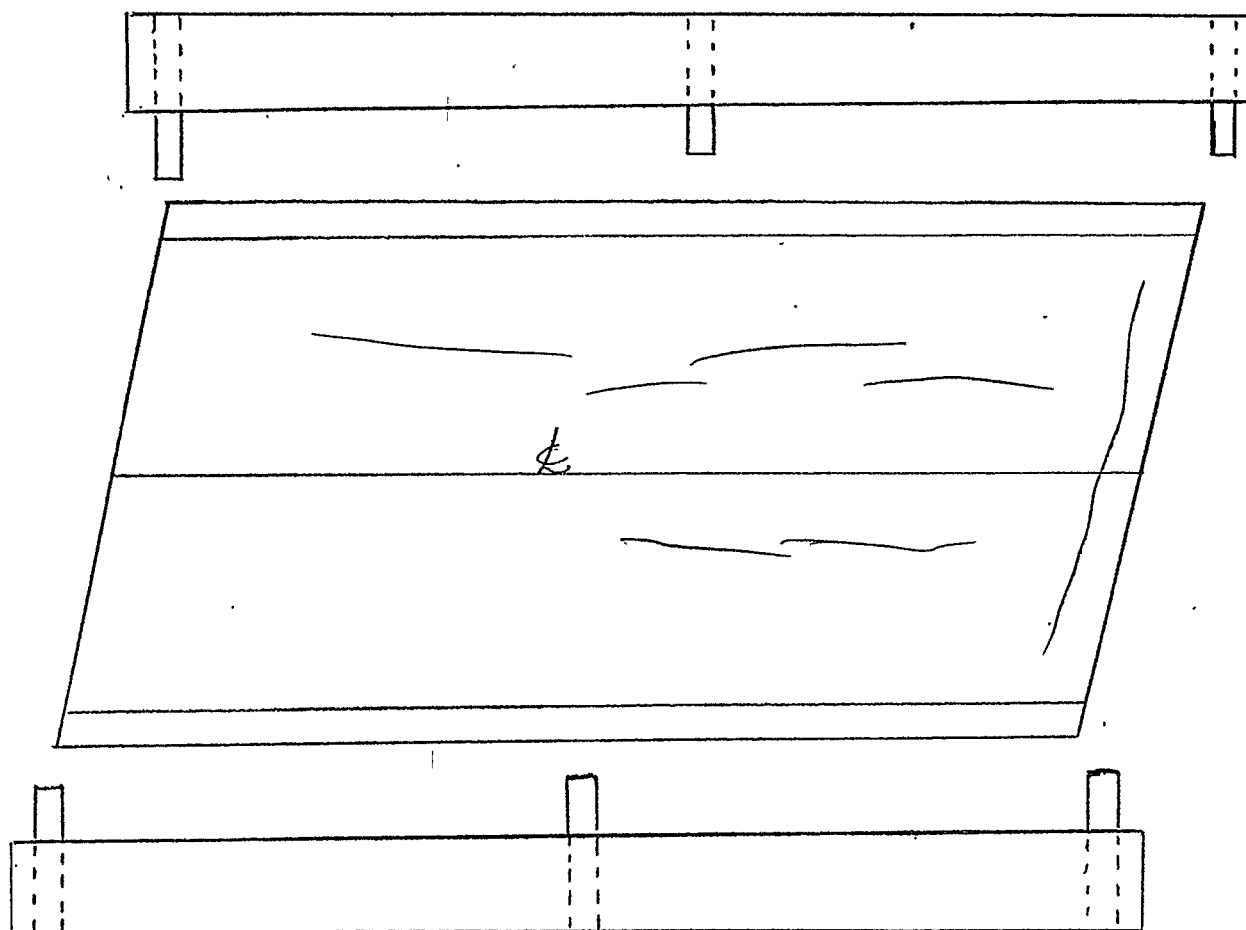
SKEW 75 SPAN NO. 1

Span # 1 slabs "a & b" & span # 2 slab "d" have heavy spall to steel areas.

ELEMENT	RATING				COMMENT
SLAB	A	G	F	(P) C	see 4,5
	B	G	F	(P) C	see 4,5
	C	G	(F)	P C	fine crack
	D	(G)	F	P C	
	E	(G)	F	P C	
	F	G	(F)	P C	fine cracks, see 1,2,3
	G	(G)	F	P C	
BOLTS	(G)	F	P	C

- ① 1' W x 5" H x 1 1/2" D
Spall to steel
- ② 1 1/2' L x 4" H x 1 1/2" D
Spall to steel
- ③ 2 1/2' L x 5" H x 2" D
Spall to steel
- ④ 6' L x 3" H x 4" W x 2" D
Spall to steel
- ⑤ 6' L x 3" H x 3" W x ? D
Impending spall

REPAIR OR REPLACE PRECAST CONCRETE CHANNEL SLAB "A, B" IN SPAN NO.1

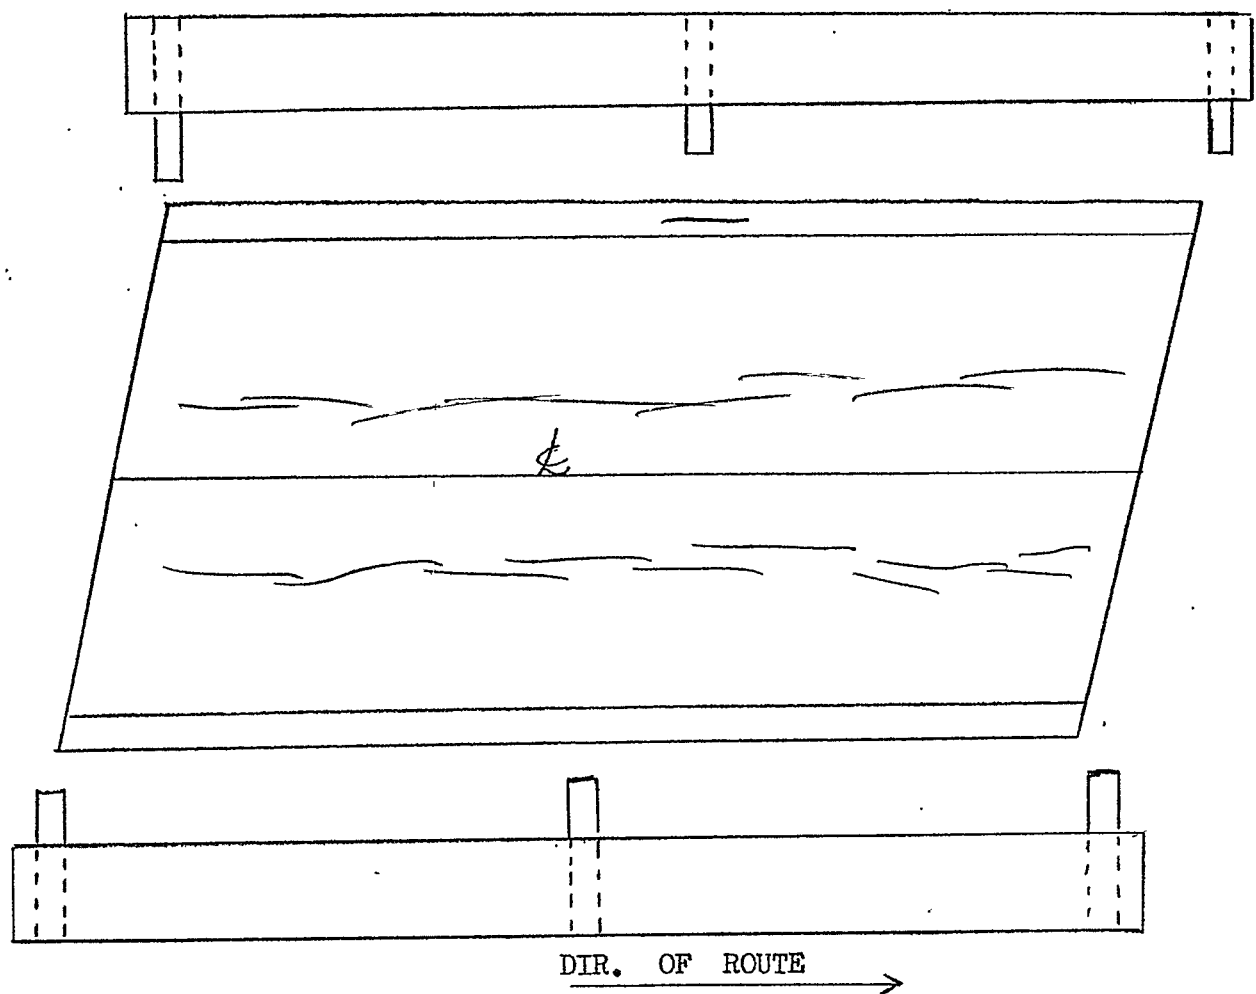
SKEW 75 SPAN NO. 2

ELEMENT	RATING	COMMENTS
TOP DECK	(G) F P C	1/16" cracks
CURB	(G) F P C	Vertical crack
RAIL&POST	(G) F P C	
PAINT	G F P C	
DRAINS	(G) F P C	
EXP. JOINT	G F P C

ELEMENT		RATING				COMMENT
SLAB	A	(G)	F	P	C	
	B	(G)	F	P	C	
	C	G	(F)	P	C	see 1,3
	D	G	F	(P)	C	see 2
	E	G	(F)	P	C	1/16" crack, see 4
	F	G	(F)	P	C	see 1
	G	G	(F)	P	C	1/16" crack
BOLTS		(G)	F	P	C

- ① 19'2x3"Hx4'Wx?D
Impending Spall
- ② 19'2x5"Hx4'Wx2"D
Spall to steel
- ③ 6'2x4'Wx2"Hx2"D
Spall to steel
- ④ 12'2x4'Wx3"Hx?D
Impending Spall

REPAIR OR REPLACE PRECAST CONCRETE CHANNEL SLAB "D" IN SPAN NO.2

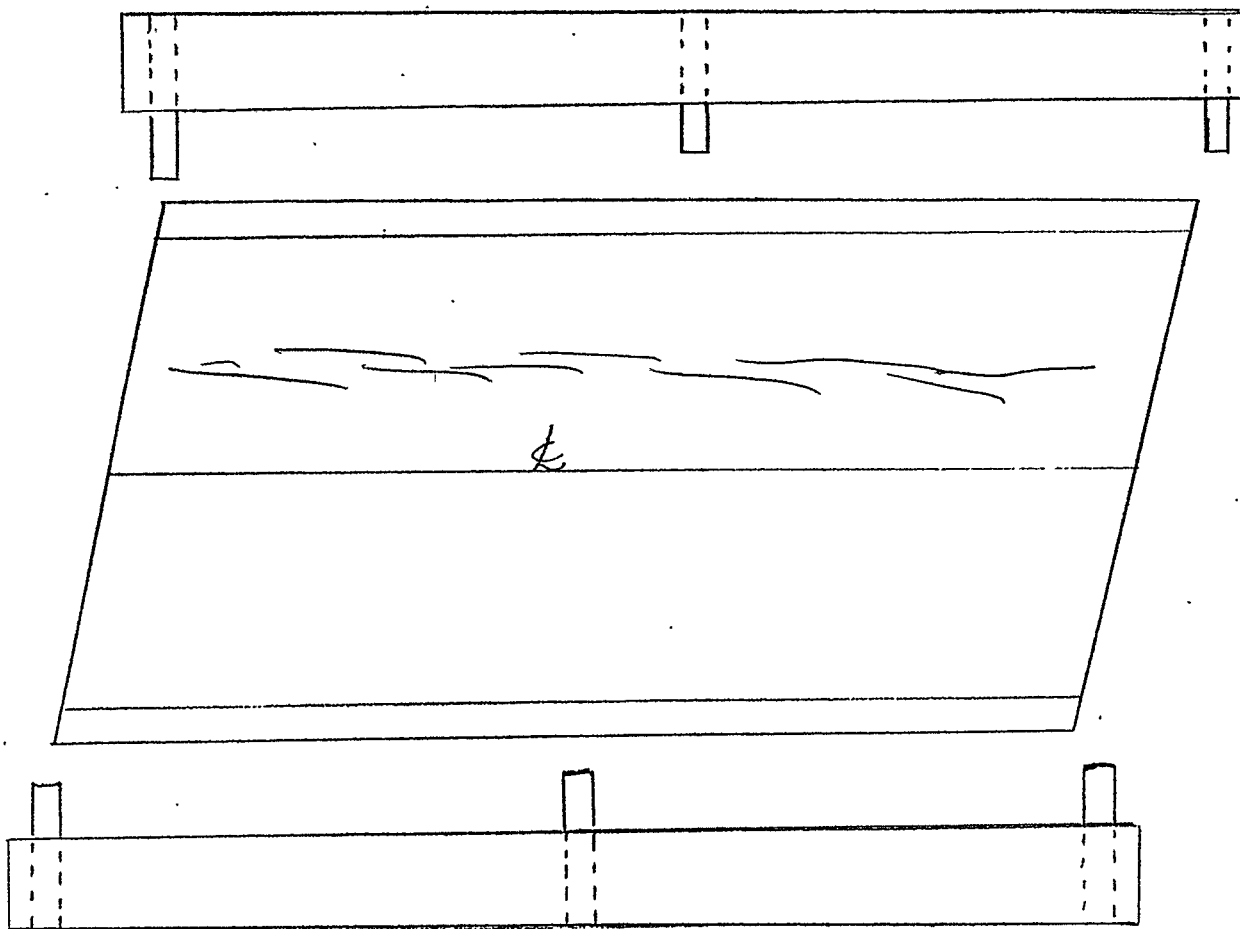
SKEW 75 SPAN NO. 3

ELEMENT	RATING	COMMENTS
TOP DECK	<u>G</u> F P C	1/16" cracks
CURB	<u>G</u> F P C	
RAIL&POST	<u>G</u> F P C	
PAINT	G F P C	
DRAINS	<u>G</u> F P C	
EXP. JOINT	G F P C

ELEMENT		RATING			COMMENT
SLAB	A	G	(F)	P C	1/16" cracks
	B	G	(F)	P C	1/16" cracks
	C	G	(F)	P C	see 1
	D	(G)	F	P C	
	E	(G)	F	P C	
	F	(G)	F	P C	
	G	G	(F)	P C	fine crack
BOLTS	G	(F)	P C		MISSING

1 8'0" x 3'0" x 3'0" x 2'
Spall to steel
