HAYWOOD COUNTY

38-SR180-0274

BRIDGE MAINTENANCE RECOMMENDATIONS

BRIDGE INSPECTION REPORT

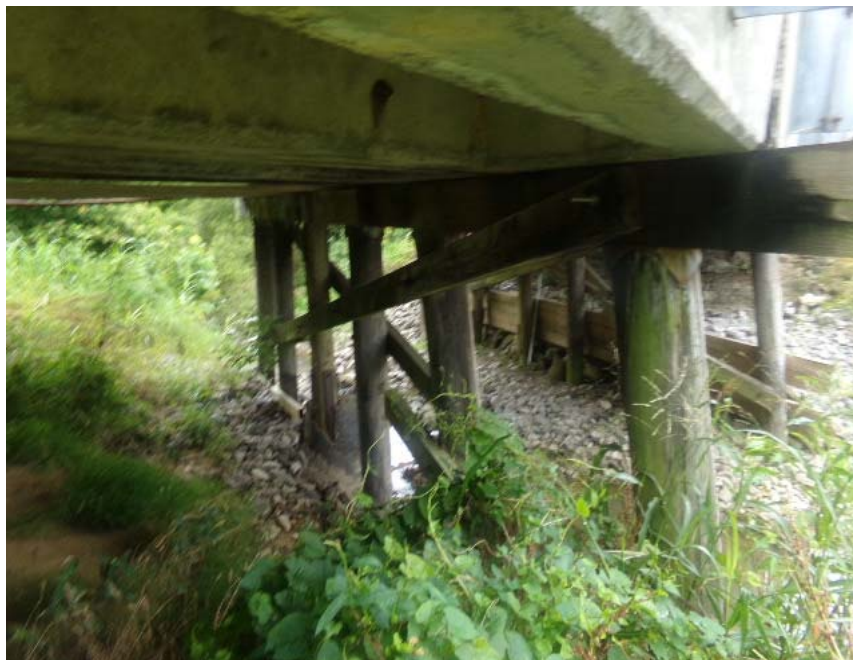
REAR SIDE BENT # 2

This is a four span PCCS bridge with timber substructure, metal bridge rails, and four paddleboards. This bridge is posted at Approach #1 only at 40/40 Tons. Approach #2 weight limit sign is missing. The asphalt approaches have settlement up to 1/2" and cracks up to 1/8". Approach #1 left embankment is washing behind wingwall. The asphalt wearing surface has cracks up to 1/16". Span #1 right bridge rail has heavy collision damage. Span #1 PCCS 'F' and 'G' have heavy spall to steel. Slab 'F' on span #3 has heavy cracking. The timber substructure has light to medium weathering and decay. Bent #1 pile 'A' has heavy decay. Bent #3 pile 'D' splice connection is broken. Bent #2 pile 'D' embankment is washing below concrete casing. Scour is fair

SUGGESTED ROUTINE MAINTENANCE AND COMMENTS
REPAIR OR REPLACE PRECAST CONCRETE CHANNEL SLAB "F" IN SPAN NO.3
REPAIR OR REPLACE PRECAST CONCRETE CHANNEL SLAB "F, G" IN SPAN NO.1
INSTALL SCOUR PROTECTION AT BENT NO.2
PROPERLY SPLICE PILE "D" AT BENT NO.3
REPAIR OR REPLACE PILE "A" AT BENT NO.1
REPAIR EMBANKMENT EROSION ON RIGHT SIDE OF APPROACH NO.1
APPROACH GUARDRAILS ARE NON-EXISTENT
BRIDGERAILS ARE SUBSTANDARD
REPAIR BRIDGERAIL ON RIGHT SIDE OF SPAN NO.1

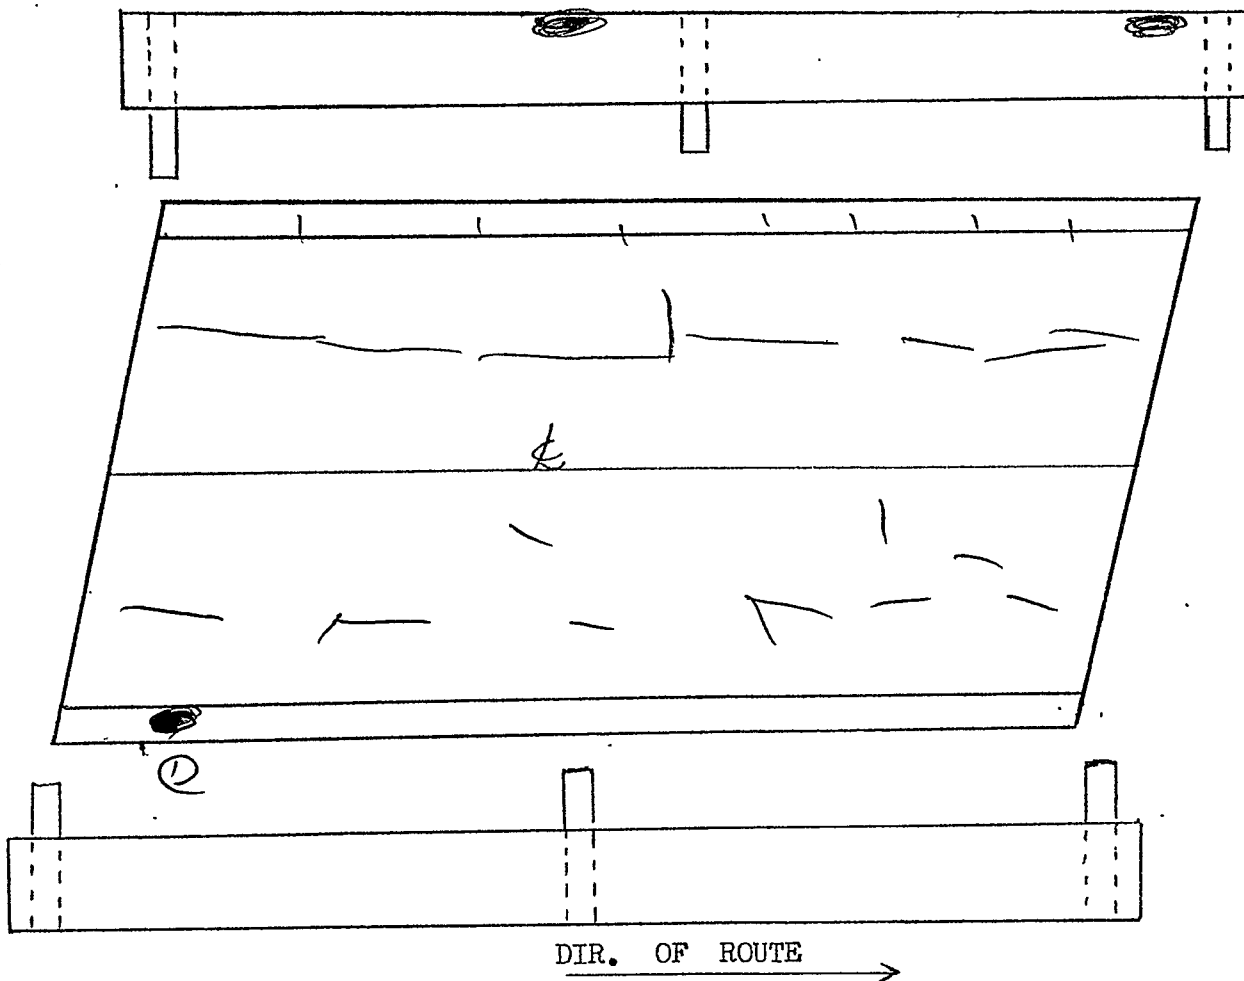
SKEW 60 SPAN NO. 2

ELEMENT	RATING	COMMENTS
TOP DECK	G (F) P C	up to 1/16" cracks
CURB	G (F) P C	Hairline cracks, see ①
RAIL&POST	G (F) P C	Minor collision damage, surface rust.
PAINT	G F P C	
DRAINS	(G) F P C	
EXP. JOINT	G F P C

① Spall to steel
1' x 6" w x 1/2" d

ELEMENT	RATING				COMMENT
SLAB	A	(G)	F	P C	
	B	(G)	F	P C	
	C	G	(F)	P C	1/16" crack
	D	G	(F)	P C	see 1, 2, 3, 4
	E	G	(F)	P C	see 5
	F	G	(F)	P C	see 6, fine crack
	G	G	(F)	P C	see 3
BOLTS	G	(F)	P C		MISSING 3

- ① 2' L x 8" W x 2" D
Spall to Steel
- ② 3 1/2' L x 4" H x 2" D
Spall to Steel
- ③ 19' L x 6" W x 4" H x ? D
Impending Spall
- ④ 4' L x 7" W x 4" H x ? D
Impending Spall
- ⑤ 8' L x 6" W x 3" H x ? D
Impending Spall
- ⑥ 9' L x 4" W x 4" H x ? D
Impending Spall

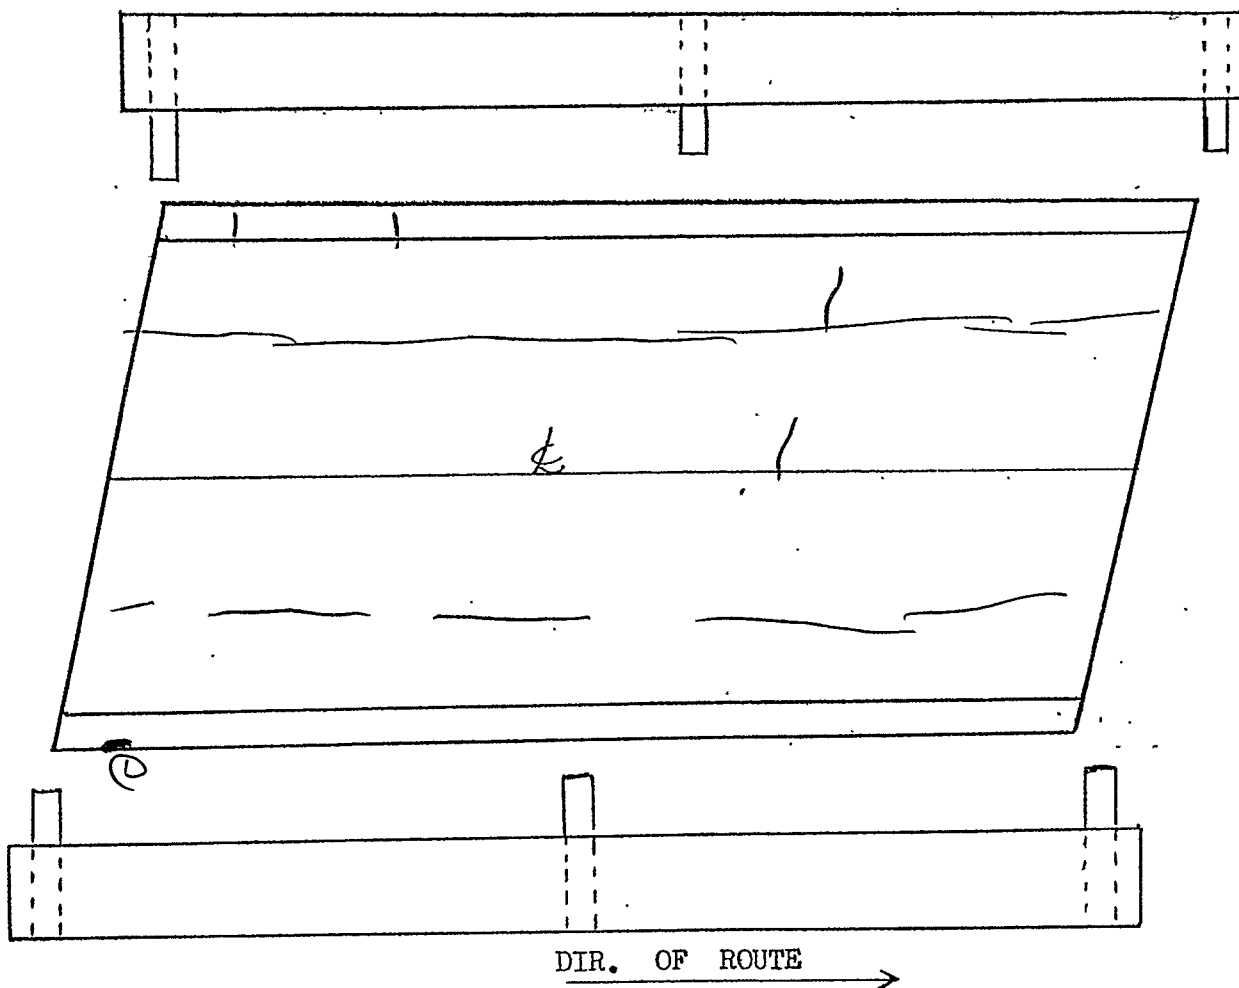
SKEW 60 SPAN NO. 3

ELEMENT	RATING	COMMENTS
TOP DECK	G <u>F</u> P C	up to 1/16" cracks
CURB	G <u>F</u> P C	thin line cracks, see ①
RAIL&POST	G <u>F</u> P C	surface rust
PAINT	G F P C	
DRAINS	<u>G</u> F P C	
EXP. JOINT	G F P C

① Spalling 6" L x 4" W x 1/2" D

ELEMENT	RATING	COMMENT
SLAB	A <u>G</u> F P C	
	B <u>G</u> F P C	
	C <u>G</u> <u>F</u> P C	① Spill tested 2.5' L 6" W 1" deep 1/16" crack
	D <u>G</u> <u>F</u> P C	Imp spill 3' L 6" W ②
	E <u>G</u> <u>F</u> P C	Imp spill 18' L 6" W
	F <u>G</u> <u>F</u> <u>P</u> C	Fine cracks with eff in valley
	G <u>G</u> F P C	
BOLTS	G <u>F</u> P C	2 missing

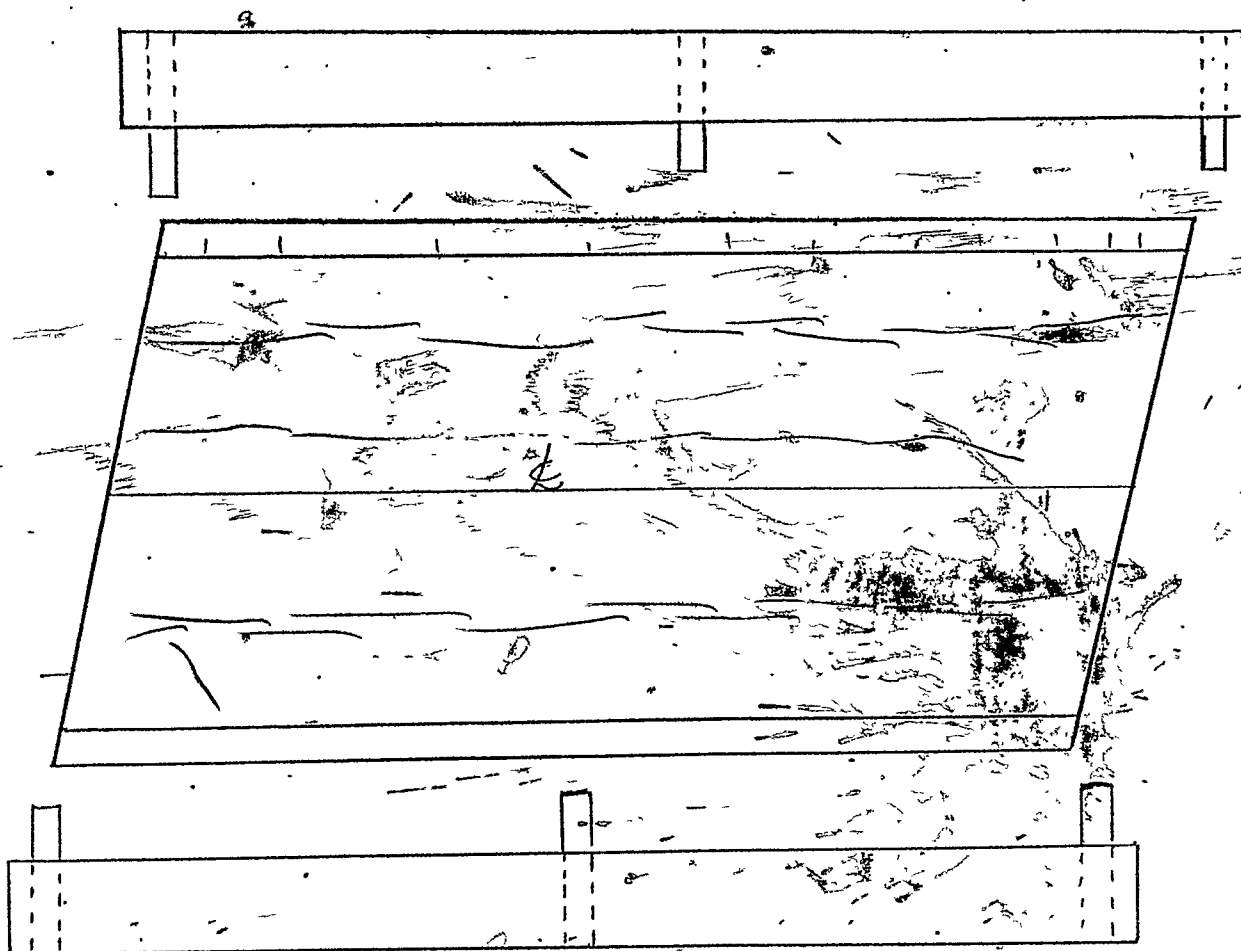
SKEW 60 SPAN NO. 4

ELEMENT	RATING	COMMENTS
TOP DECK	G <u>F</u> P C	up to 1/16" cracks
CURB	G <u>F</u> P C	hairline cracks
RAIL&POST	G <u>F</u> P C	surface rust
PAINT	G F P C	
DRAINS	<u>G</u> F P C	
EXP. JOINT	G F P C

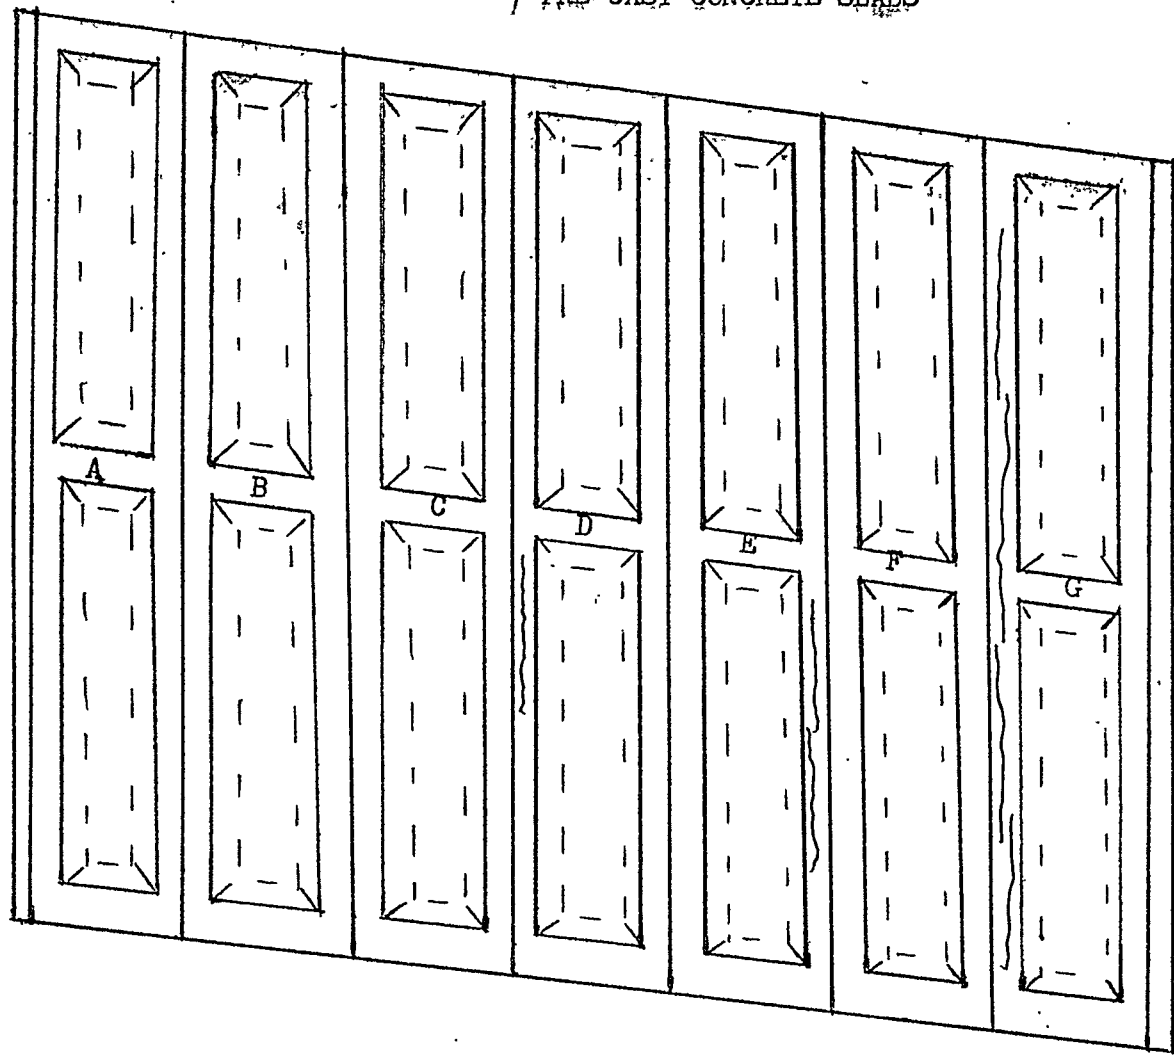
AUG 18 2021
SPAN NO. 4

ELEMENT		RATING				COMMENT
SLAB	A	(G)	F	P	C	
	B	(G)	F	P	C	
	C	(G)	F	P	C	
	D	G	(F)	P	C	fine cracks
	E	G	(F)	P	C	1/16" cracks
	F	(G)	F	P	C	
	G	G	(F)	P	C	1/16" cracks
BOLTS		(G)	F	P	C

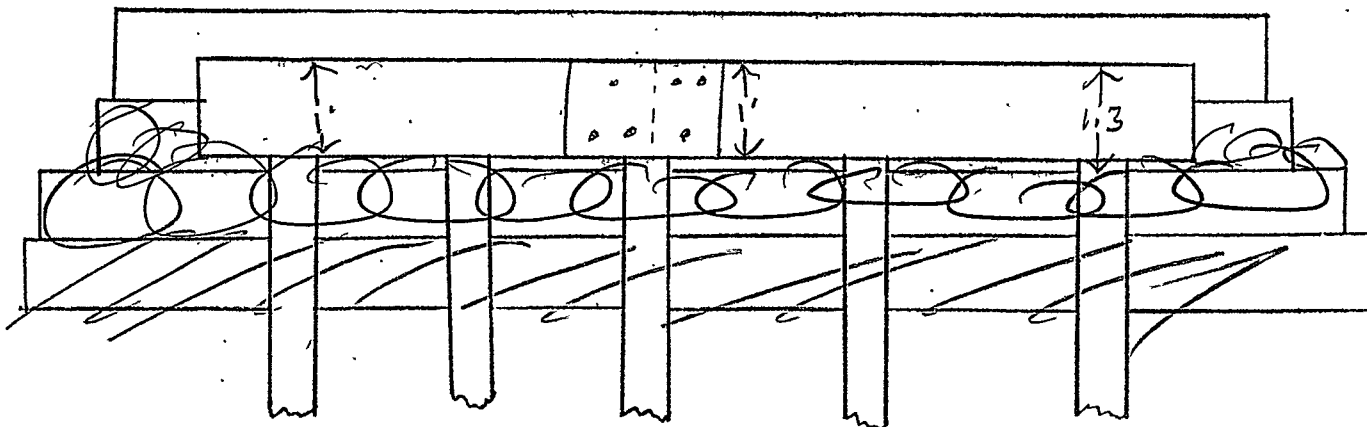
ABUT. NO. 1

ELEMENT		RATING	COMMENT
CAP		G (F) P C	light to med weathering
BREASTWALL		G F P C	NV
WINGS		G F P C	NV
PILING	A	G F P C	NV
	B	G F P C	
	C	G F P C	
	D	G F P C	
	E	G F P C	
RIP RAP		G (F) P C	
EMB.		G (F) P C	
VEG.		G (F) P C	med

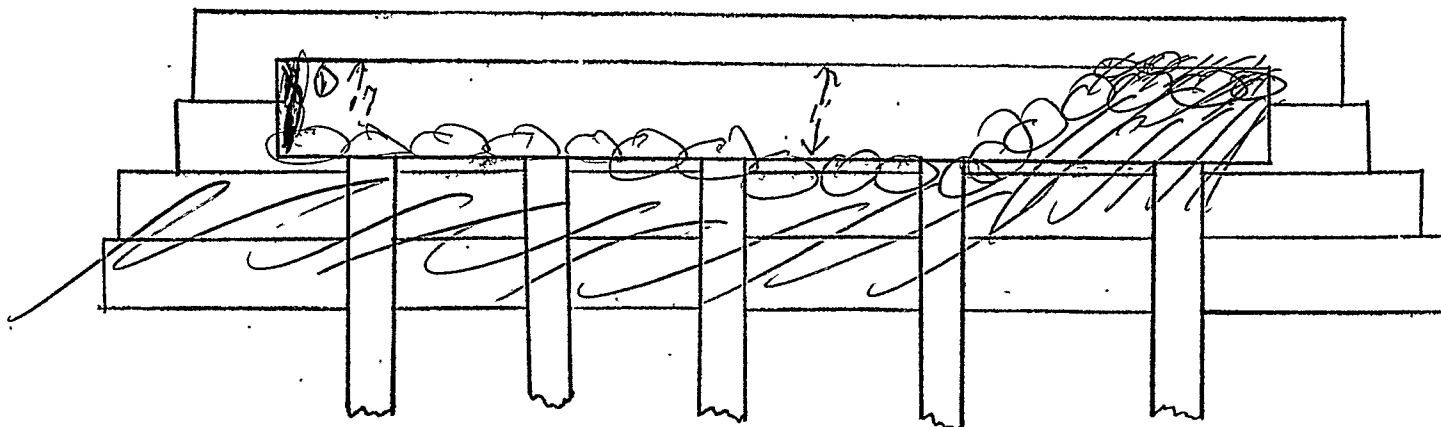
ABUT. NO. 2

ELEMENT		RATING	COMMENT
CAP		G <u>F</u> P C	1/8" to med weathering. Δ Decay 15" x 8" x 12" x 1/2"
BREASTWALL		G F P C	nv
WINGS		G F P C	nv
PILING	A	G F P C	
	B	G F P C	
	C	G F P C	
	D	G F P C	
	E	G F P C	
RIP RAP		G <u>F</u> P C	scattered
EMB.		<u>G</u> F P C	
VEG.		G <u>F</u> P C	med

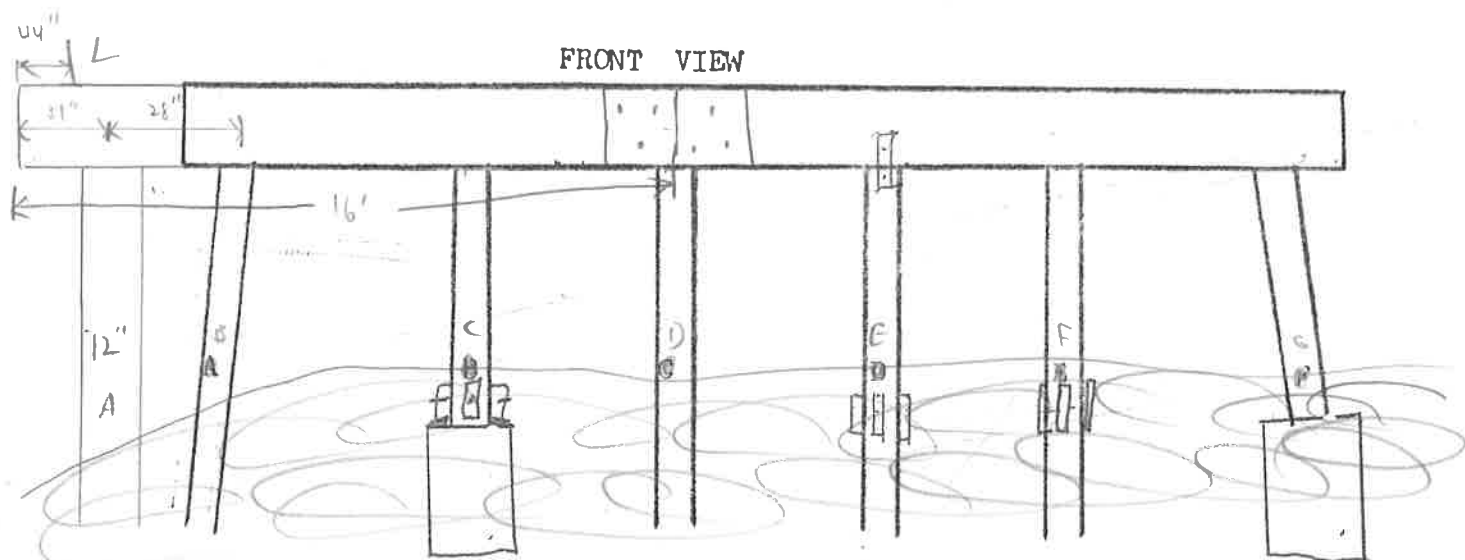
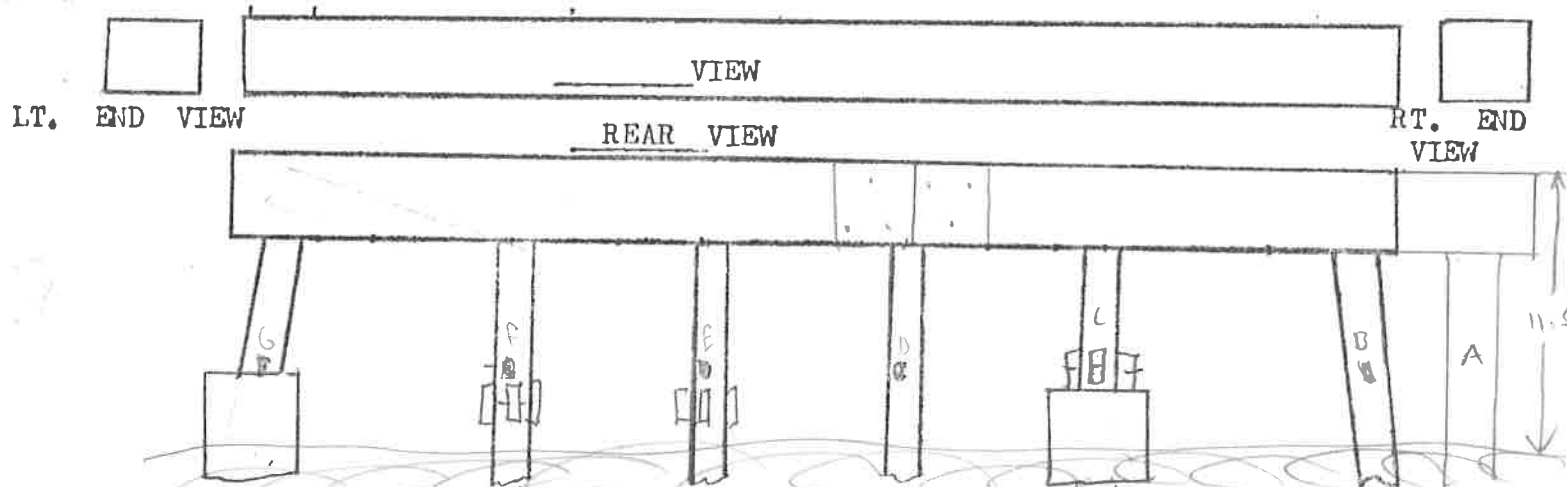
BENT NO. 2

Bent #2, pile "D" old splice plates have been replaced.

ELEMENT	RATING	COMMENTS
CAP	G (F) P C	Light to medium weathering
Piling	A G (F) P C	
	B G F P C	
	C G F P C	
	D G F P C	
	E G F P C	
	F G F P C	
BRACING	G F P C	
Conc. Casing	G F P C
