Bridge Maintenance Recommendations

Bridge Location No.: **49 - SR087 - 0518**

BRIDGE INSPECTION REPORT

Inspection Team's Summary

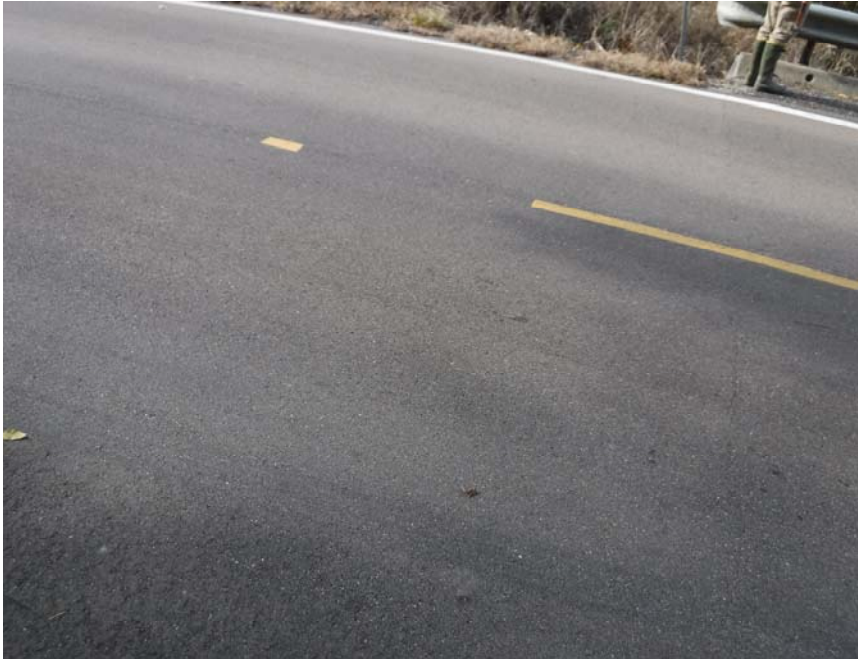
APPROACH # 1

Approaches # 1 & 2 a/c pavements have fine cracks.

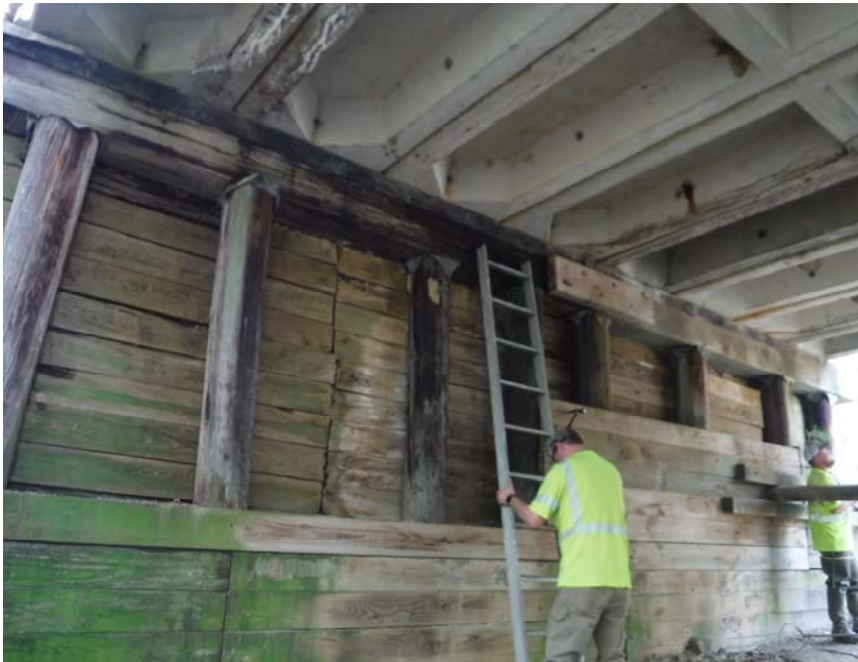
ABUTMENT # 1 BREAST BOARD DECAYED

238	BRIDGERAILS ARE SUBSTANDARD
229	APPROACH GUARDRAILS ARE NON-EXISTENT
241	REPLACE PRECAST CONCRETE CHANNEL SLAB _B_ IN SPAN NO. _1
167	REPAIR _TIMBER_ BREASTWALL AT ABUTMENT NO. _1 & 2 (repaired 11-22-21)
154	REPAIR WINGS AT ABUTMENT NO. _1 (repaired 11-22-21)
204	CUT VEGETATION

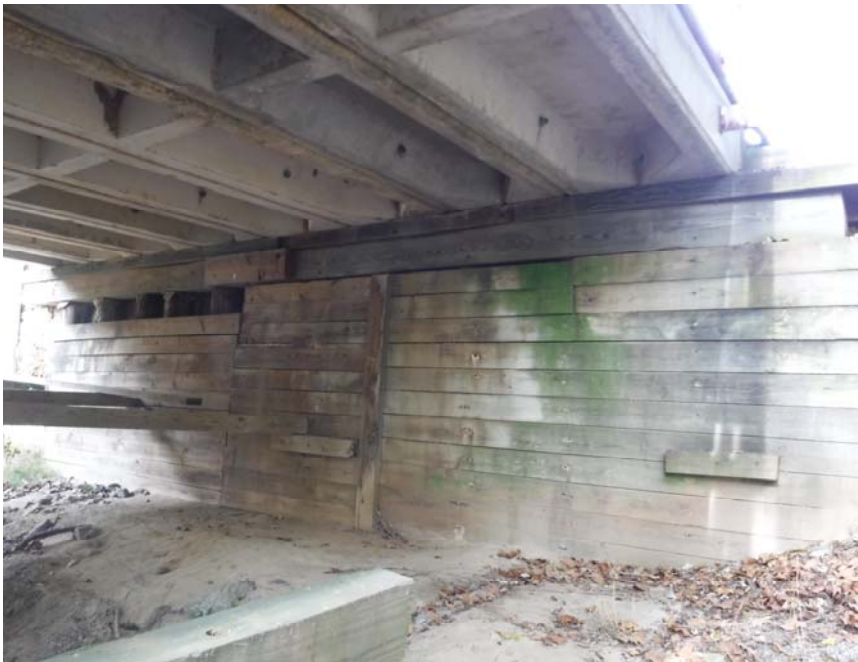
ABUTMENT # 2 BREAST BOARD DECAYED

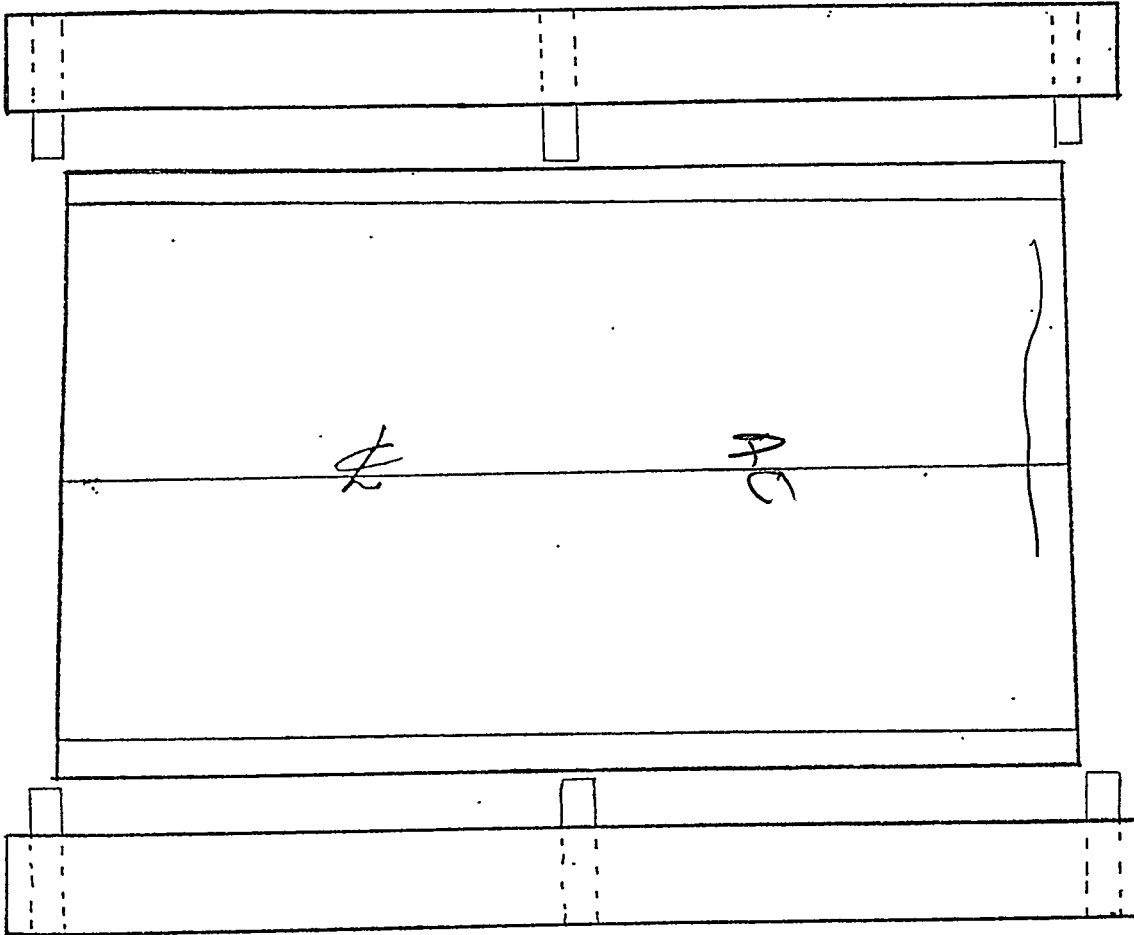
SPAN NO. 1

ELEMENT	RATING	COMMENTS
TOP DECK	G <u>F</u> P C	Five Cracks
RAIL & POST	G <u>F</u> P C	Minor Collision Damage
PAINT	G <u>F</u> P C	LT-RT Sides
DRAINS	<u>G</u> F P C	Light Scaling
EXP. JOINT	G F P C	
CURBS	<u>G</u> F P C

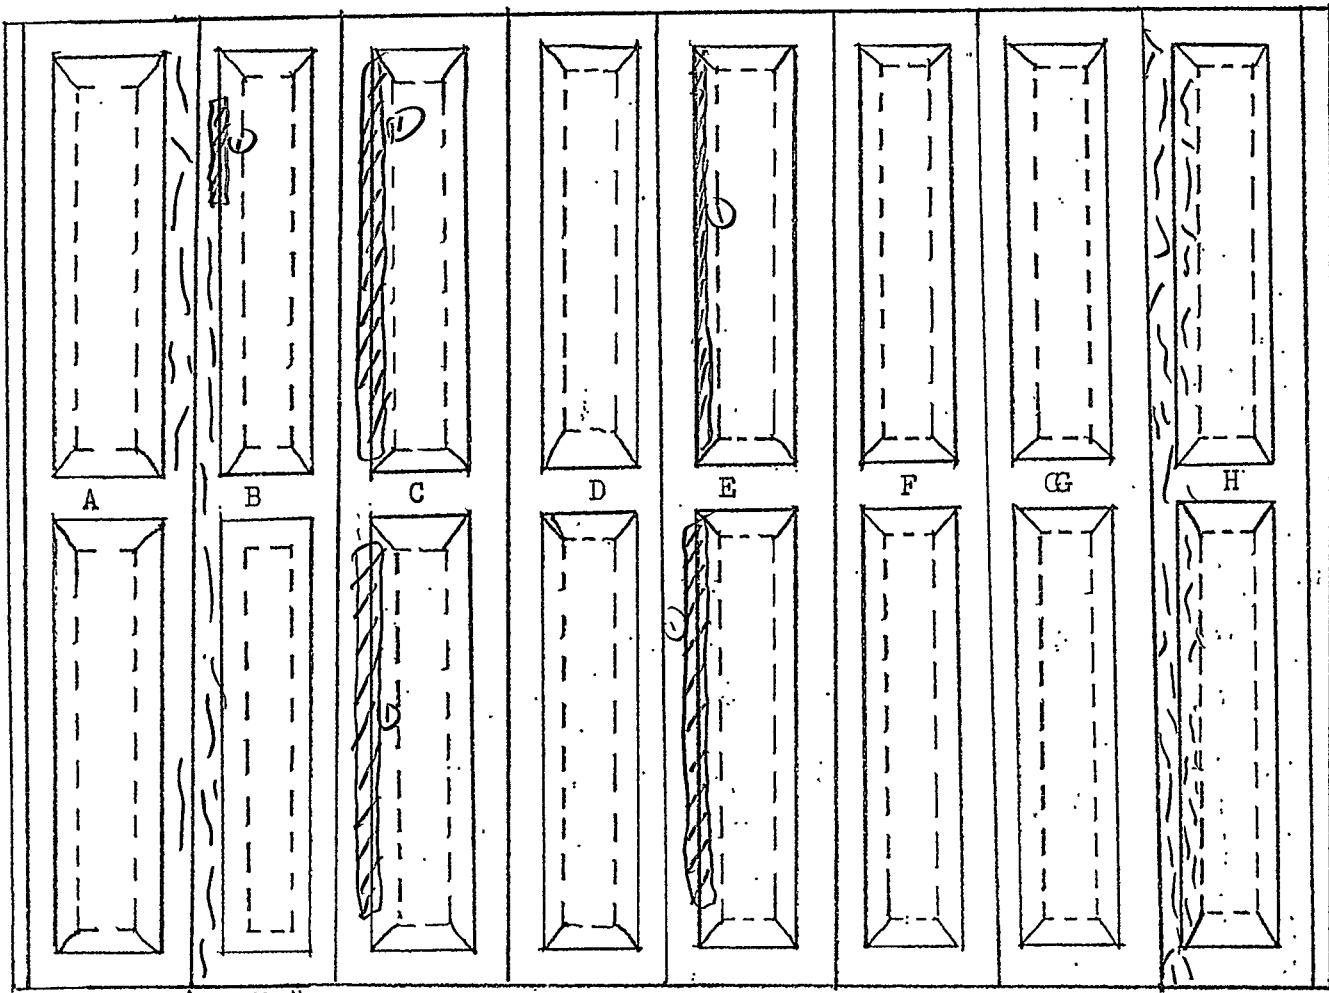
① Impending Spall
up to 7'4" x 2'4" x 5" w

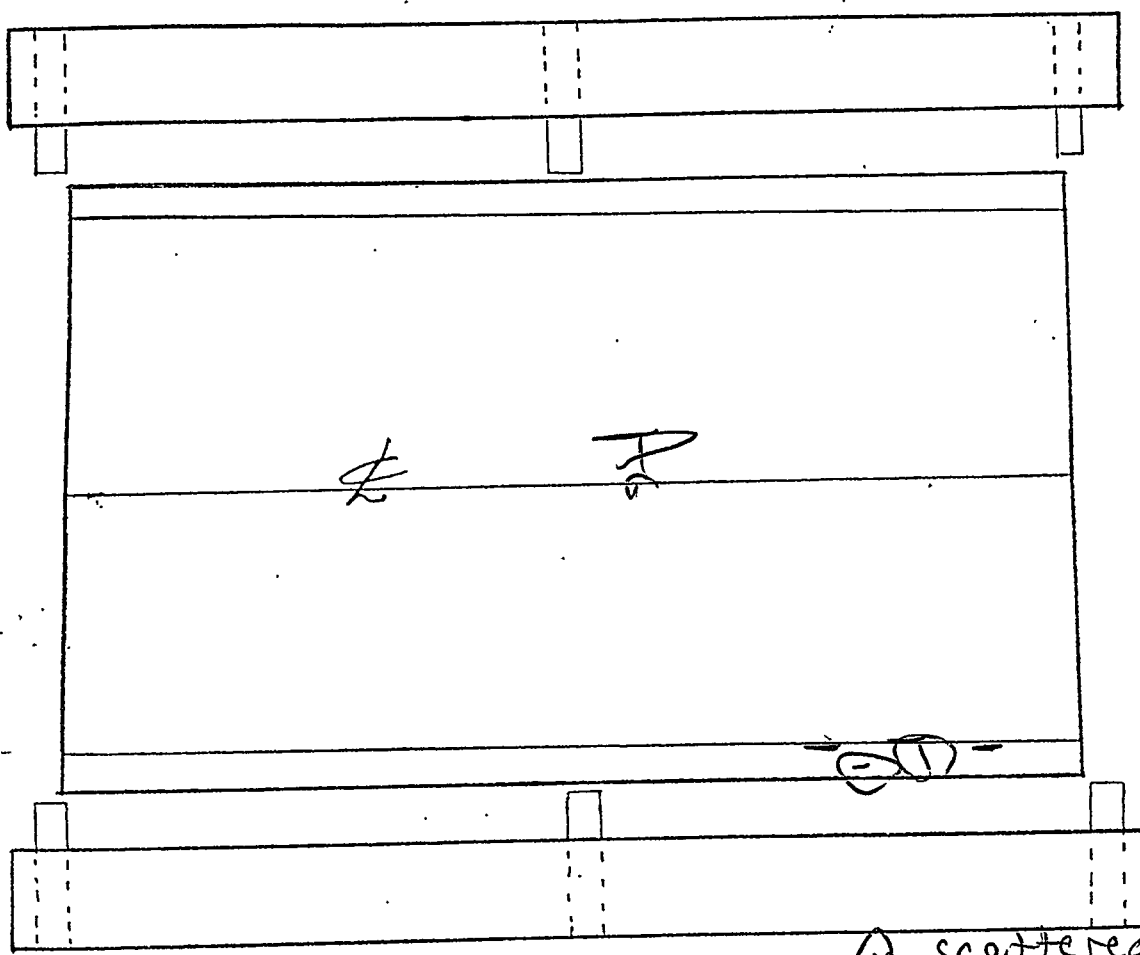
SPAN NO. 3

① scattered
spalling up
to 20' x 6' x 1'

ELEMENT	RATING	COMMENTS
TOP DECK	G F P C	
RAIL & POST	G <u>F</u> P C	Minor collision Damage LTRT Side & light scaling
PAINT	G <u>F</u> P C	
DRAINS	G F P C	
EXP. JOINT	G F P C	
CURBS	G F P C -	See <u>B</u>

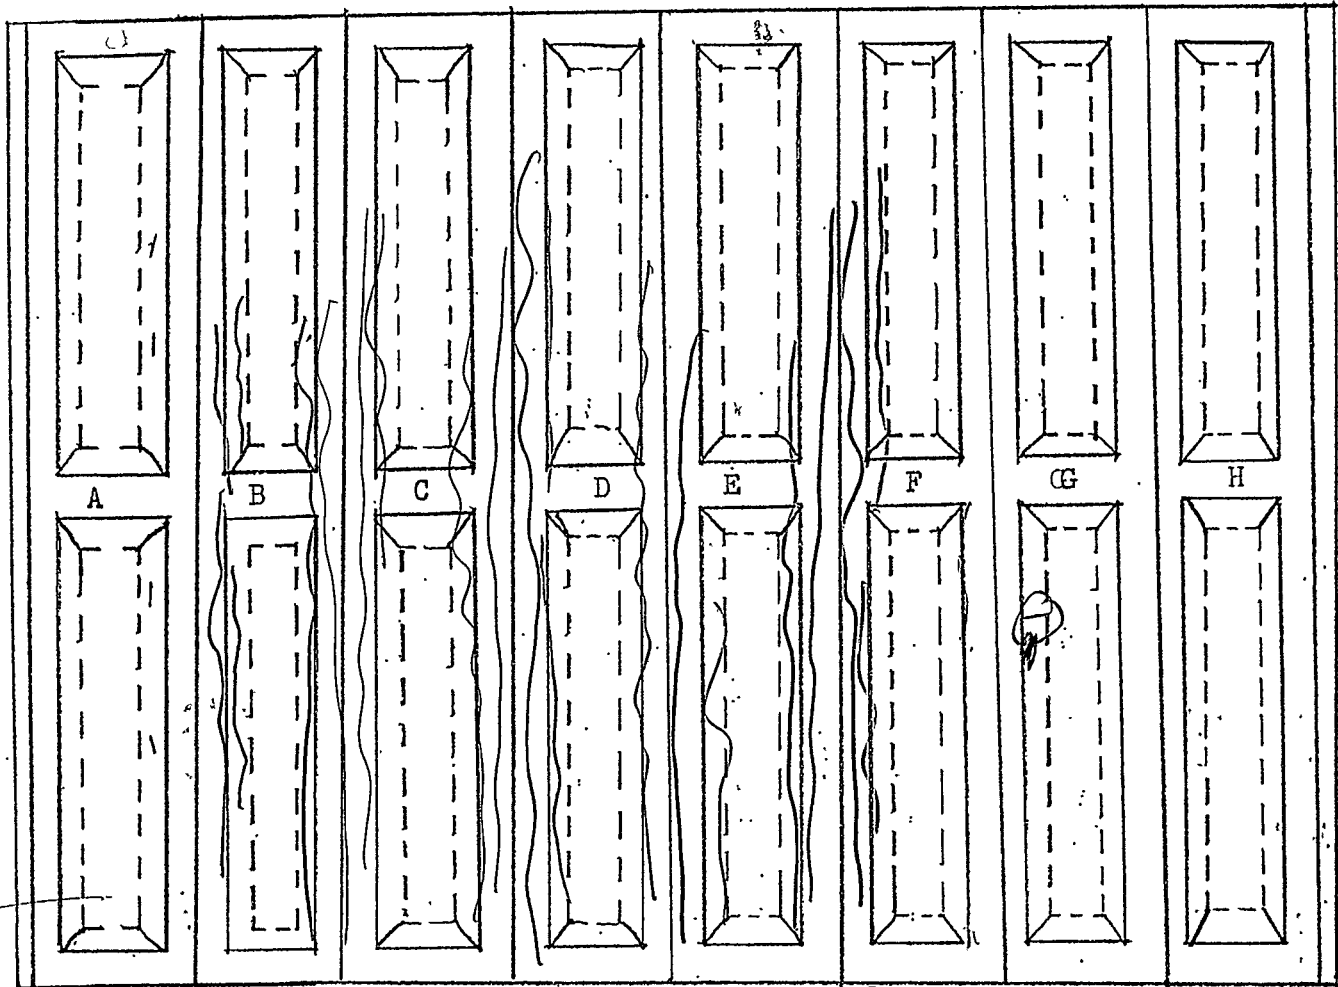
① Spotted area
8" L x 3" W x 1" D

ELEMENT	RATING	COMMENT
SLAB A	G F P C	scattered potters Five to 1/4" cracks Light ERF staining see ① Five cracks Light ERF staining Five cracks Light ERF staining
B	G F P C	
C	G F P C	
D	G F P C	
E	G F P C	
F	G F P C	
G	G F P C	
H	G F P C	
BOLTS	G F P C
