LAUDERDALE COUNTY

Bridge Loc. No: 49-SR087-06.44

BRIDGE MAINTENANCE RECOMMENDATIONS

BRIDGE INSPECTION REPORT

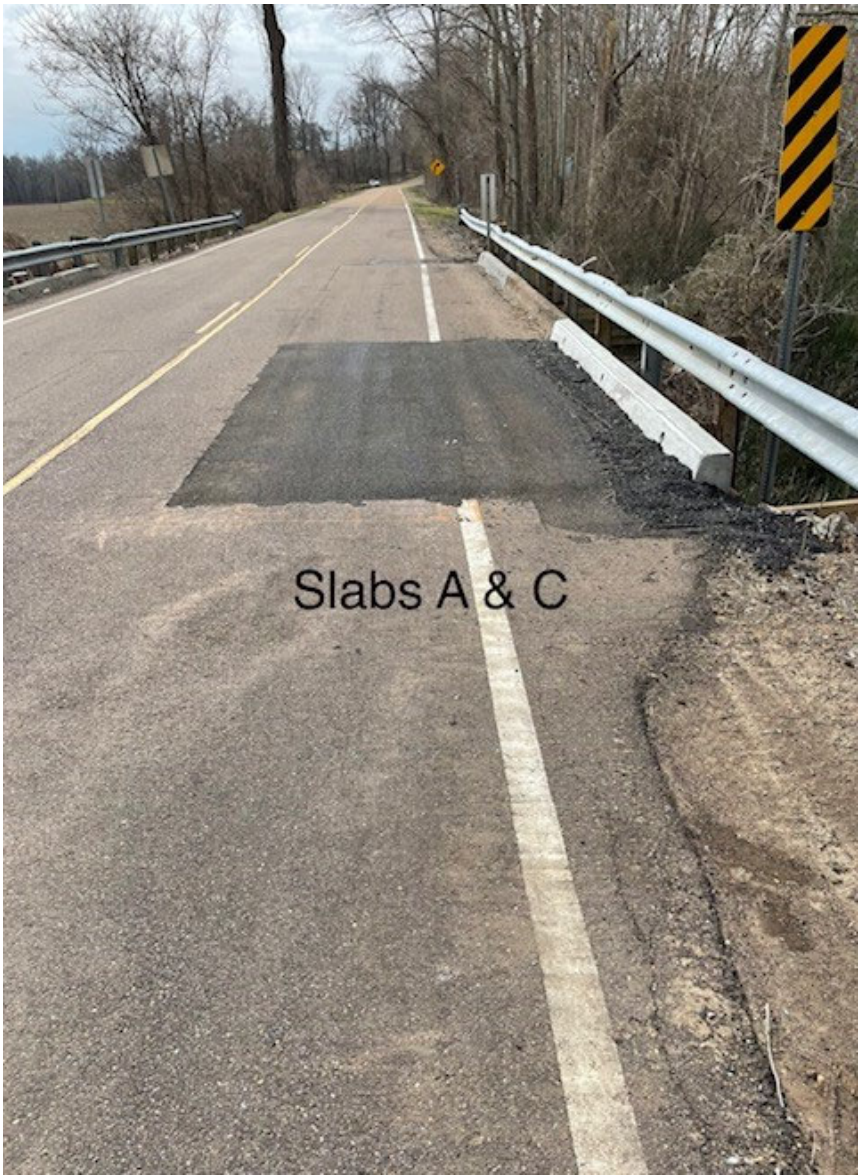
Span #3 Slabs 'A' and 'C' top

204	CUT VEGETATION				
COMMENTS: 1. Replaced channel slab A & C in span #3					
2. Repaired timber breastwall at abutment #2					
3. Repaired wingwall at abutment #2 right side. Completed					
H.B 02/21/23

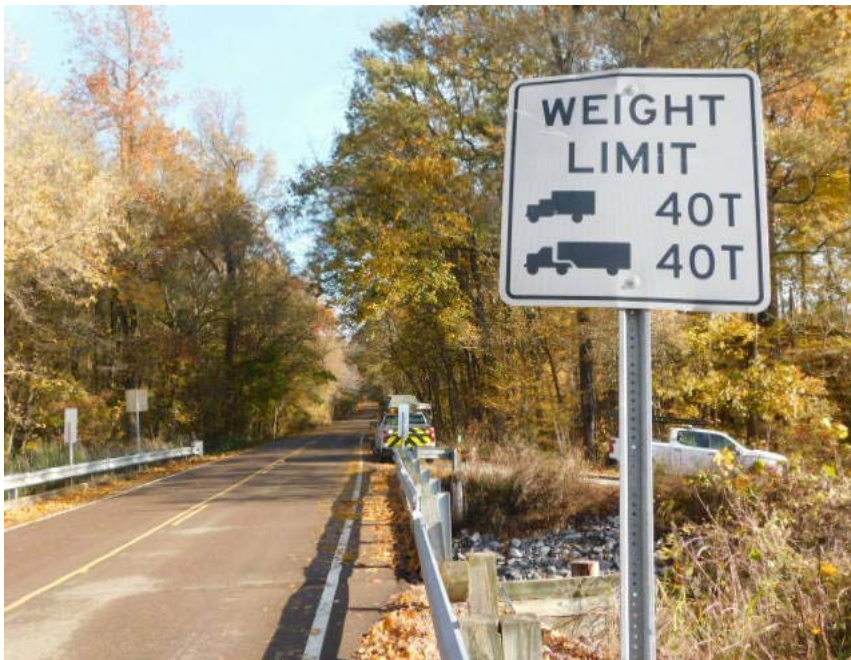
APPROACH #1 WITH 40 TON/40 TON WEIGHT LIMIT SIGN

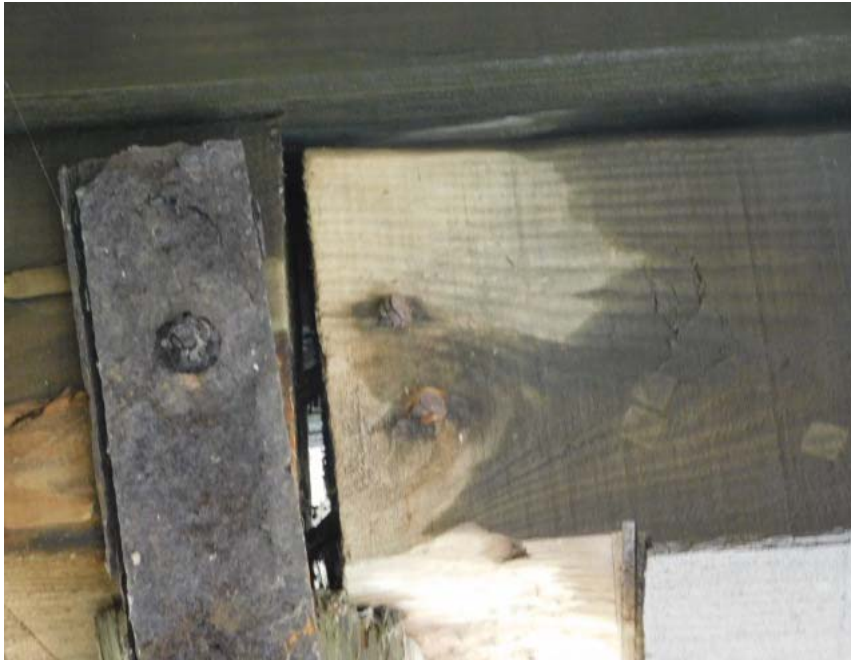
ALIGNMENT AT FRONT SIDE OF BENT #1, CAP "B"

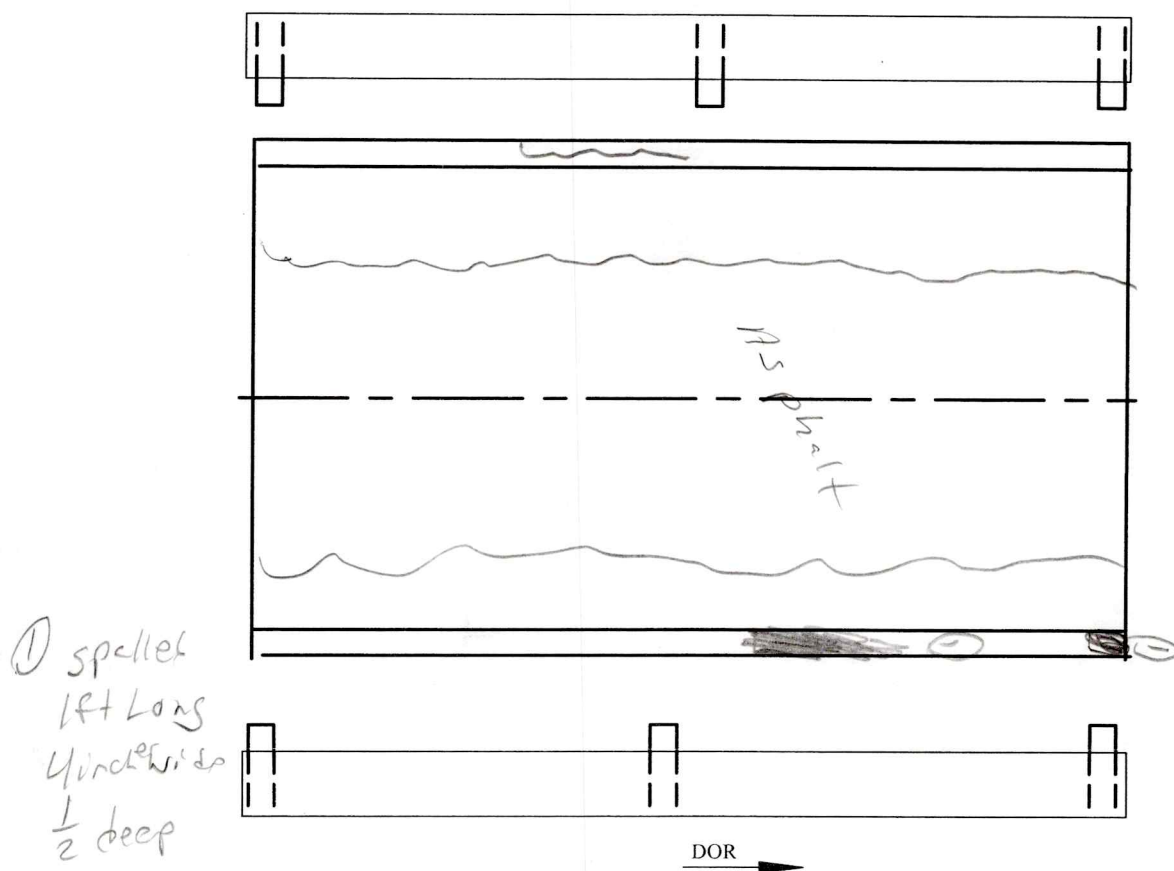
SPAN. NO. 1

ELEMENT	RATING	COMMENT
TOP DECK	G (F) P C	Fine Cracks
CURBS	G (F) P C	see ① and Fine Cracks
RAIL & POST	G (F) P C	Light collision Damage
PAINT	G F P C	N/A
DRAINS	G (F) P C	
JOINT	G F P C	N/A

⑤ spalling up to 12" dia x 2" deep

① spalling areas up to 14" dia x 1" deep

③ spalling up to 7" dia x 1" deep

ELEMENT	RATING	COMMENT
SLABS A	G (F) P C	see (4+5) + Fine cracks
B	G (F) P C	see (1+2) + up to 1/16" cracks + light EFF
C	G (F) P C	Fine cracks + light EFF
D	G (F) P C	see (3) + Fine cracks + light EFF
E	G (F) P C	up to 1/16" cracks
F	G (F) P C	see (1) + Fine cracks + light EFF
G	G (F) P C	HL cracks
H	G (F) P C	HL cracks
BOLTS	(C) F P C

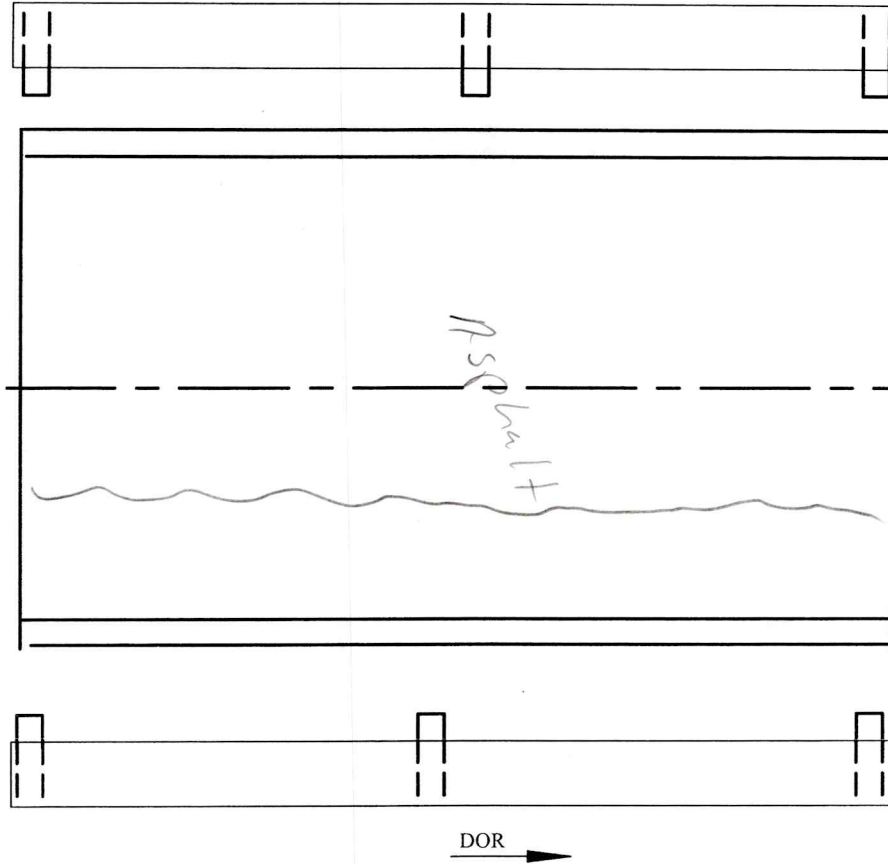
SPAN. NO. 2

ELEMENT	RATING	COMMENT
TOP DECK	G <u>F</u> P C	Fine Creek
CURBS	<u>G</u> F P C	
RAIL & POST	G <u>F</u> P C	Light Collision Damage
PAINT	G F P C	N/A
DRAINS	<u>G</u> F P C	
JOINT	G F P C	N/A

① spalling area up to 16" L x 24" W x 2" deep

② spalling area up to 9" dia x 1/2" deep

ELEMENT	RATING	COMMENT
SLABS A	G F P C	
B	G F P C	see ① + fine cracks w/ EFF
C	G F P C	up to 1/16" cracks
D	G F P C	see ② + HL cracks
E	G F P C	HL cracks
F	G F P C	up to 1/16" cracks w/ EFF
G	G F P C	HL cracks
H	G F P C	HL cracks
BOLTS	G F P C

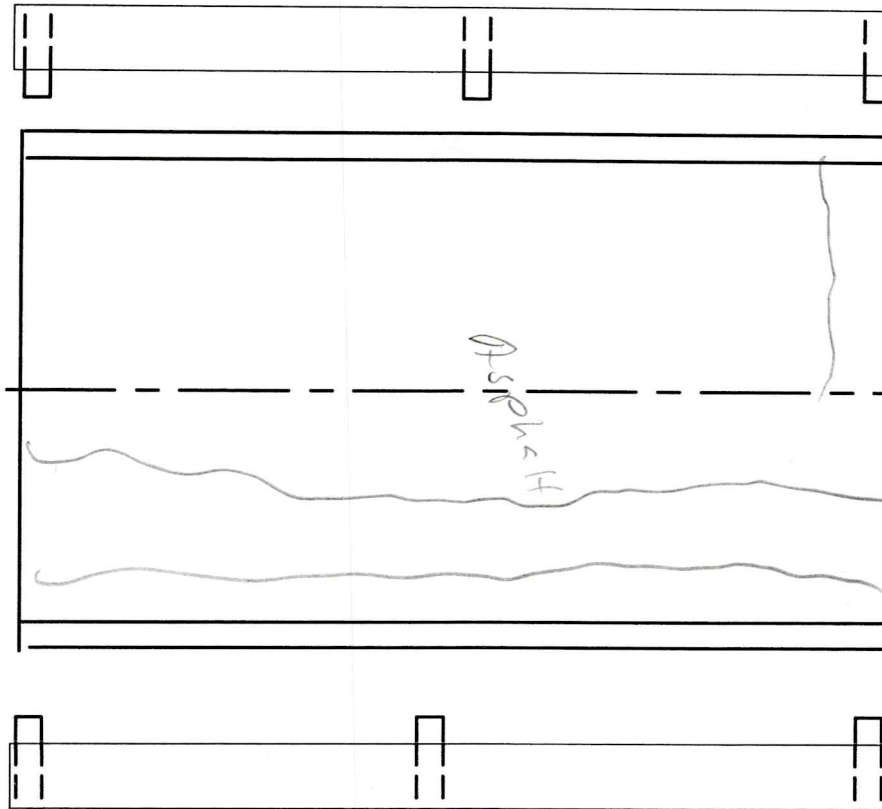
SPAN. NO. ~~X~~3

ELEMENT	RATING	COMMENT
TOP DECK	G (F) P C	Fine cracks
CURBS	(G) F P C	
RAIL & POST	G (F) P C	Light Collision Damage
PAINT	G F P C	N/A
DRAINS	(G) F P C	
JOINT	G F P C	N/A

④ spalling up to 8'2" x 6" w x 1" deep ⑤ spalling to steel up to 20'2" x 6" h x 3" deep + up to 1/8" section loss on steel

① spalling to steel areas up to 8'2" x 6" h x 3" deep + up to 1/8" section loss on steel

② spalling up to 14" dia x 1" deep

ELEMENT	RATING	COMMENT
SLABS A	G F P C	see (1+3) + HL cracks
B	G F P C	see (4) + fine cracks w/ EFF
C	G F P C	see (1+2) + up to 1/8" cracks
D	G F P C	see (2) + HL cracks
E	G F P C	HL cracks
F	G F P C	see (2+6) + 1/8" cracks
G	G F P C	see (5) + up to 1/8" cracks + light EFF
H	G F P C	see (5) + fine cracks w/ EFF
BOLTS	G F P C

REPAIR OR REPLACE PRECAST CONCRETE CHANNEL SLAB "A & C" IN SPAN NO.3

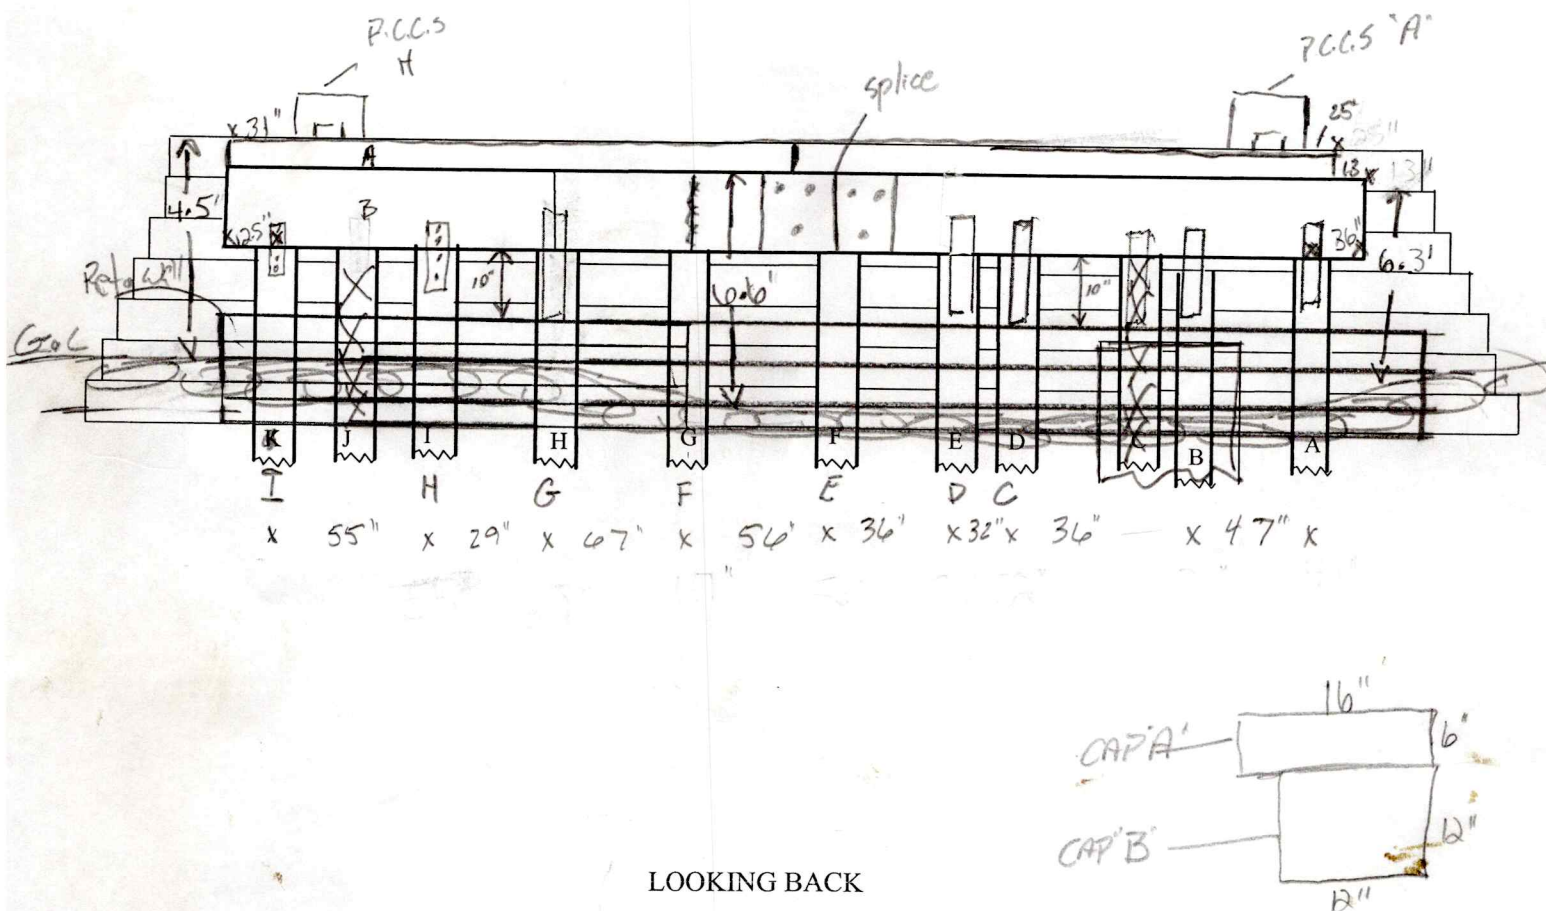
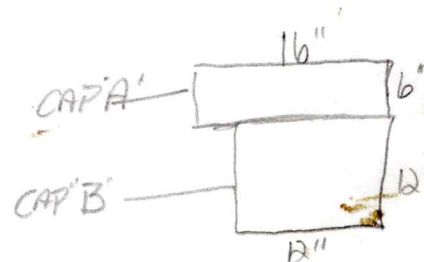
ABUT. NO. 1

ELEMENT	RATING	COMMENT
CAP A+B	G F P C	Medium weathering CAP'S Appear to Be New
WINGS	G F P C	" "
PILES A-I	G F P C	light to med. weathering
	G F P C	
	G F P C	
Retaining wall	G F P C	light weathering
CONC. CASING	G F P C	
BREASTWALL	G F P C	med to light weathering
EMB.	G F P C	
VEG.	G F P C	med growth
RIP-RAP	G F P C	
	G F P C	
Piles EFGHK	G F P C	
J	G F P C

Pile A-13" DIA
 B-10" DIA
 C-12" DIA
 D-12" DIA
 E-12" DIA
 F-14" DIA
 G-12" DIA
 H-12" DIA
 I-14" DIA

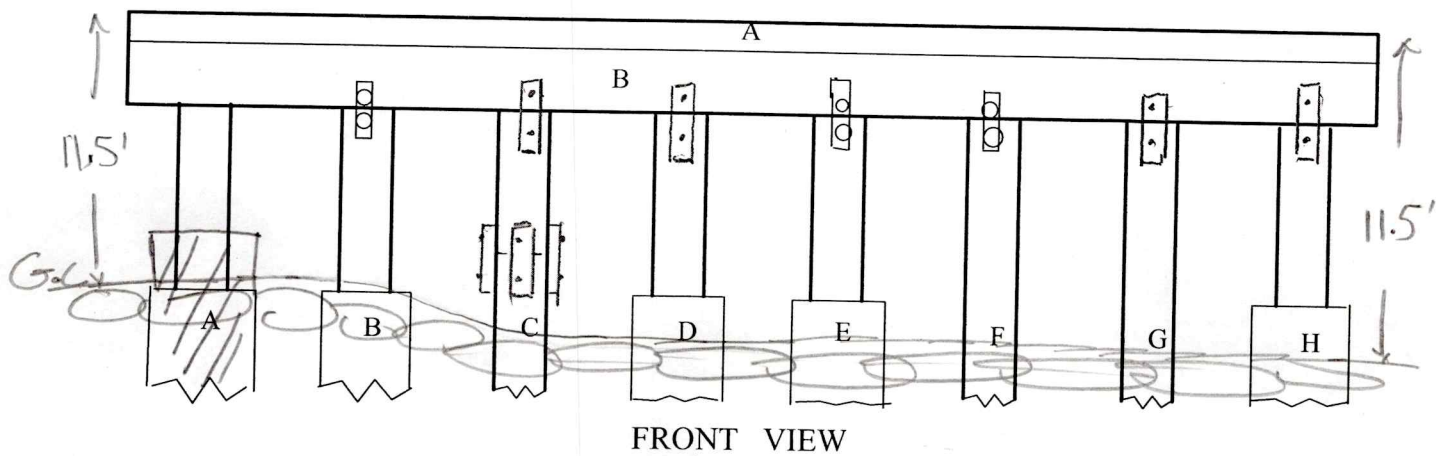
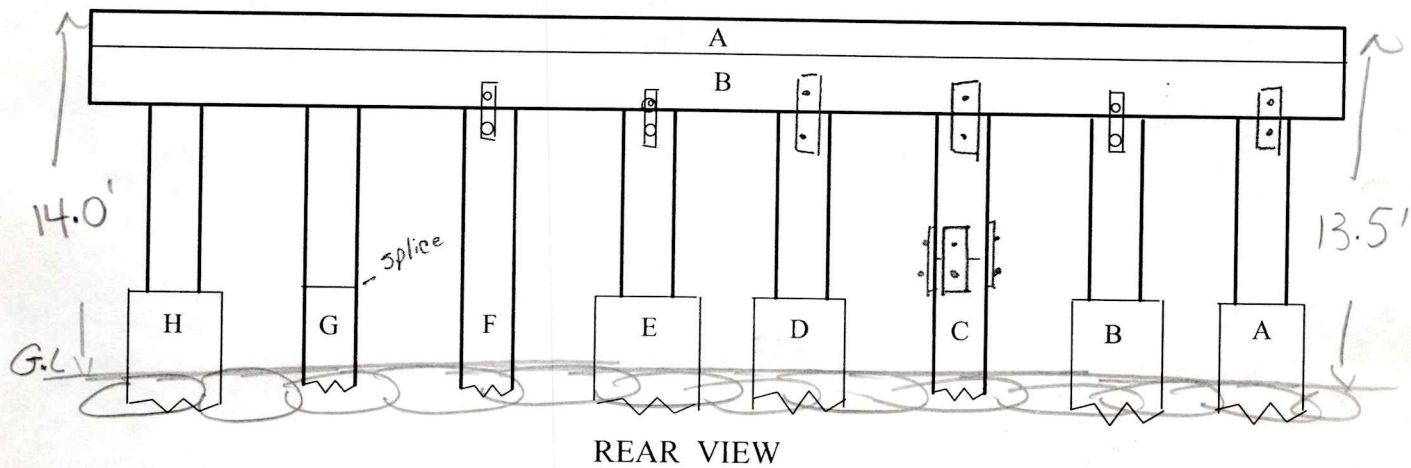
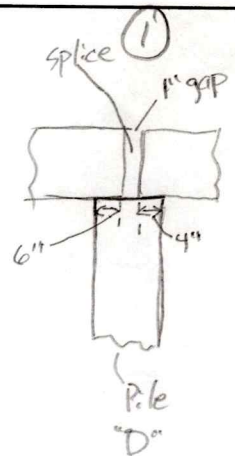
BENT. NO. 1

ELEMENT	RATING	COMMENT
BEARINGS	G F P C	—
CAP A	G (F) P C	light weathering Appear New
B	G (F) P C	" " " "
PILES A	G (F) P C	medium weathering
B	G (F) P C	
C	G (F) P C	
D 11" dia	G (F) P C	
E	G (F) P C	
F	G (F) P C	
G	G (F) P C	
H	G (F) P C	
BRACING	G (F) P C	medium weathering + Bolted
CONC. CASING	(G) F P C	
RIP RAP	(G) F P C	
Alignment	(F)	See (A)
