## LAUDERDALE COUNTY

# Bridge Maintenance Recommendations

Bridge Location No.: **49 - SR087 - 1911**

Bridge Number: **49SR0870033**

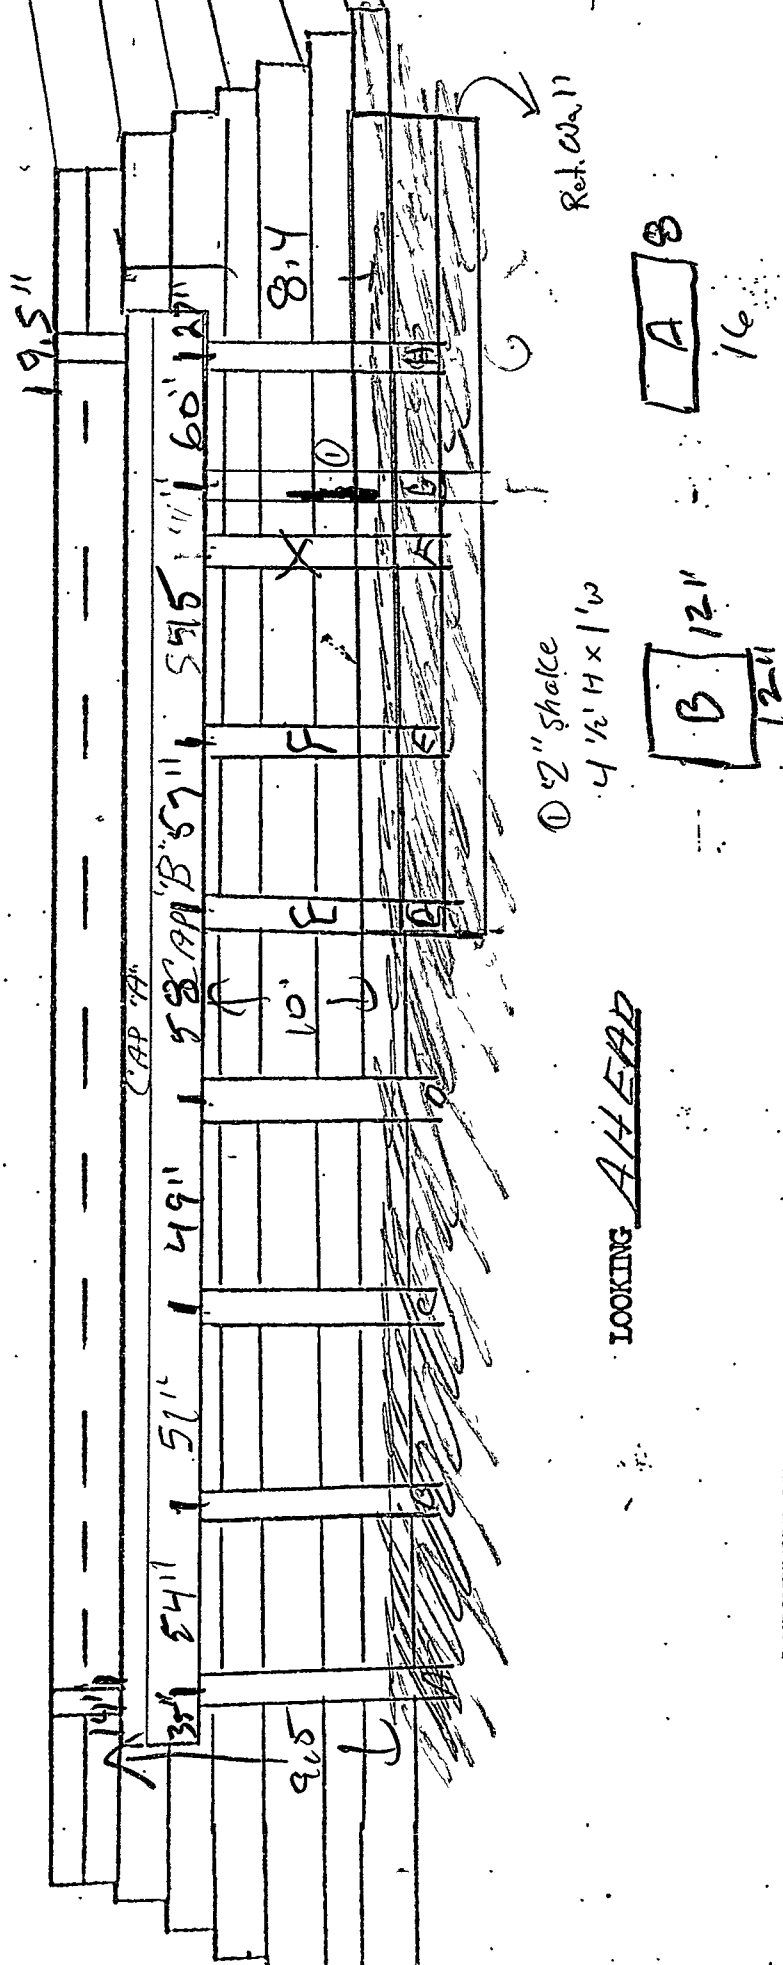
ADUT. NO. 2

ELEMENT	RATING	COMMENT
CAP CAP	G F P C G F P C	light to med. weathering
PILING	G F P C	1
BREASTHALL	G F P C	7
WINGS & PILE	G F P C	see D
EEB.	G F P C	light to med. weathering
VEG.	G F P C	light to med. weathering
ROCK	G F P C	light growth
	G F P C	med. weathering
	G F P C
