Region 04, 38 - Haywood County

CHARLESTON RD. Crossing OVERFLOW

Inspection Date(s): 07/08/2025 - 07/09/2025

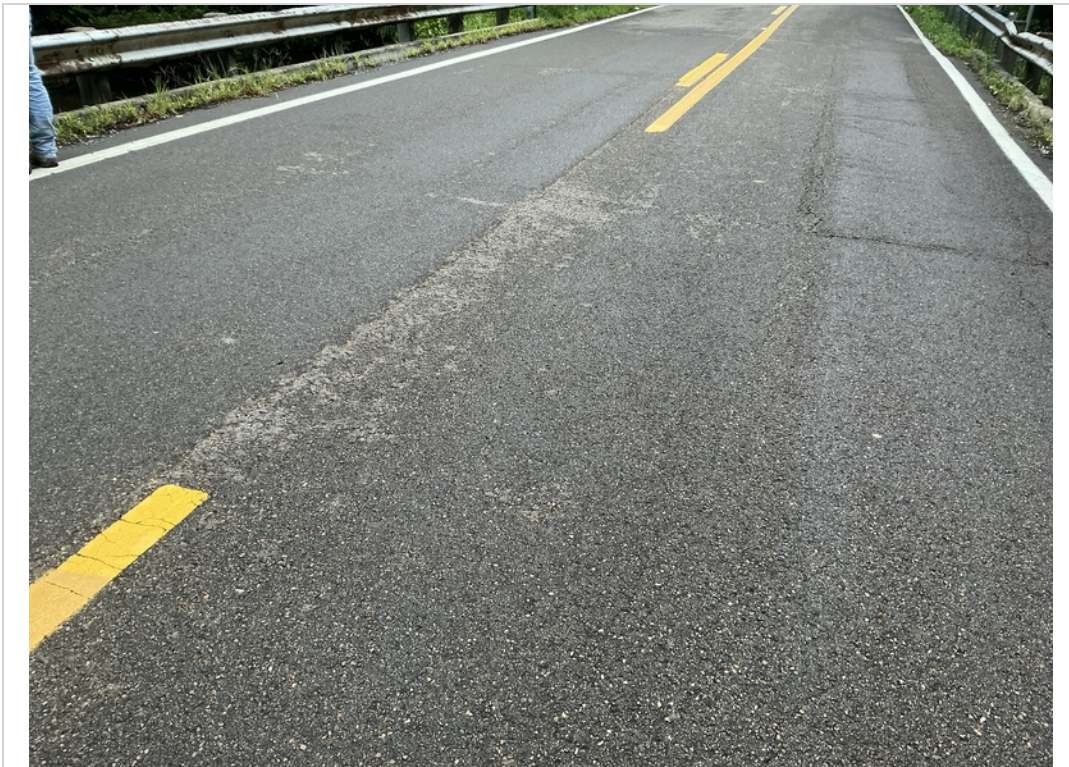
View across Top Deck

| Wearing Surface Type | | Asphalt | Wearing Surface Depth | 2in. |
|---|---|---|---|---|
| Wearing Surface | (Fair) | Settlement/Raveling between beam edges in spans 2 and 3 | | |

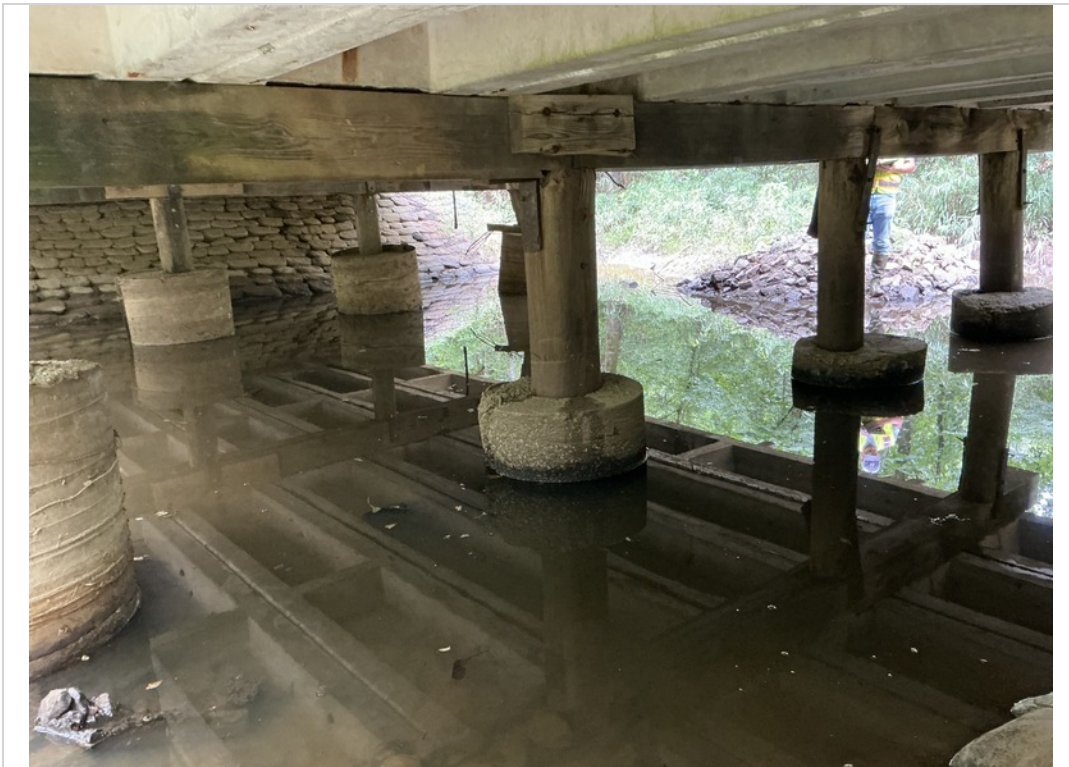
Bent 1 Looking Ahead

| Bent Caps | (Fair) | Decay, splintering, checks up to 1/16"<br>Bent 1 cap section split/shake at bearing on Pile C<br>Bent 2 Cap has been Replaced |

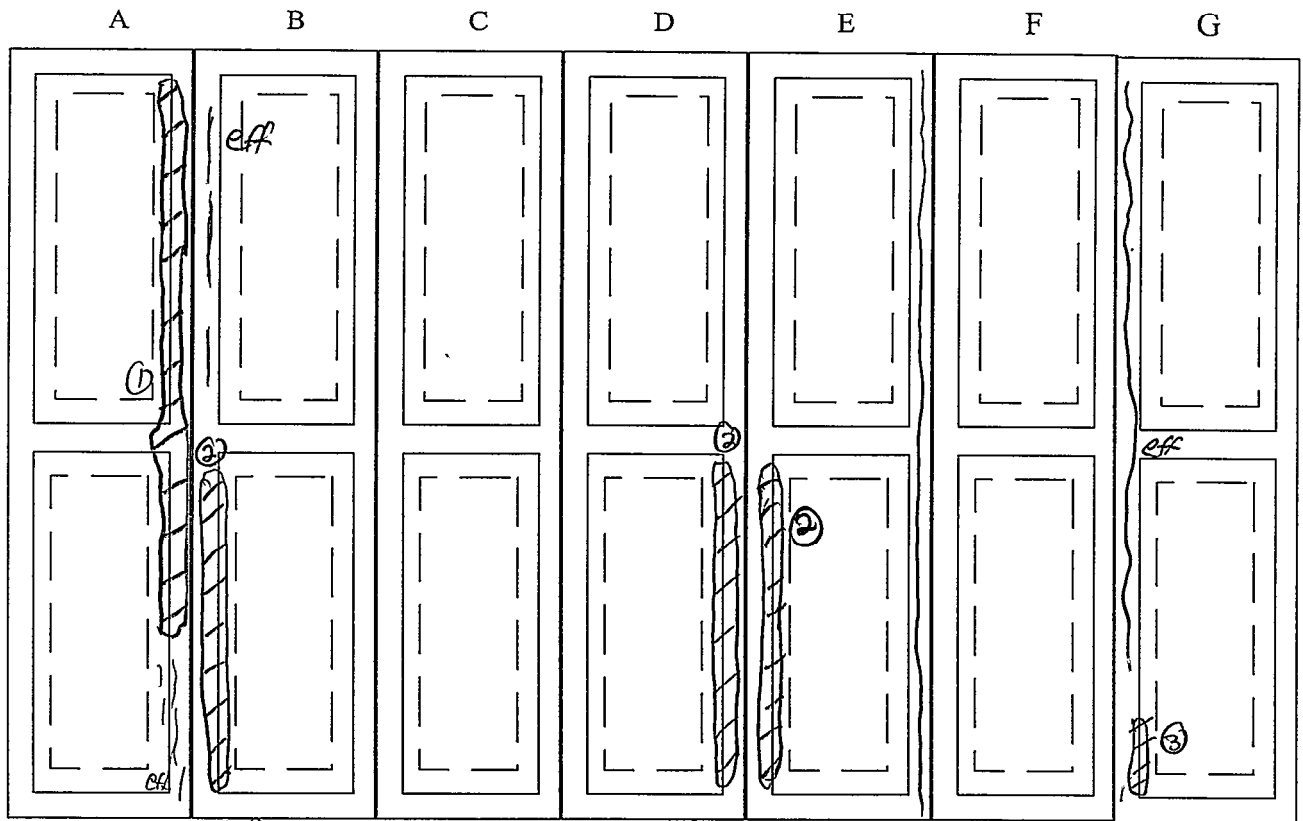
SPAN. NO. 3

① imp spall 15' long 8' wide ② imp spall 8' long 4' wide 3' tall ③ imp spall 24" long 2" wide 6" tall

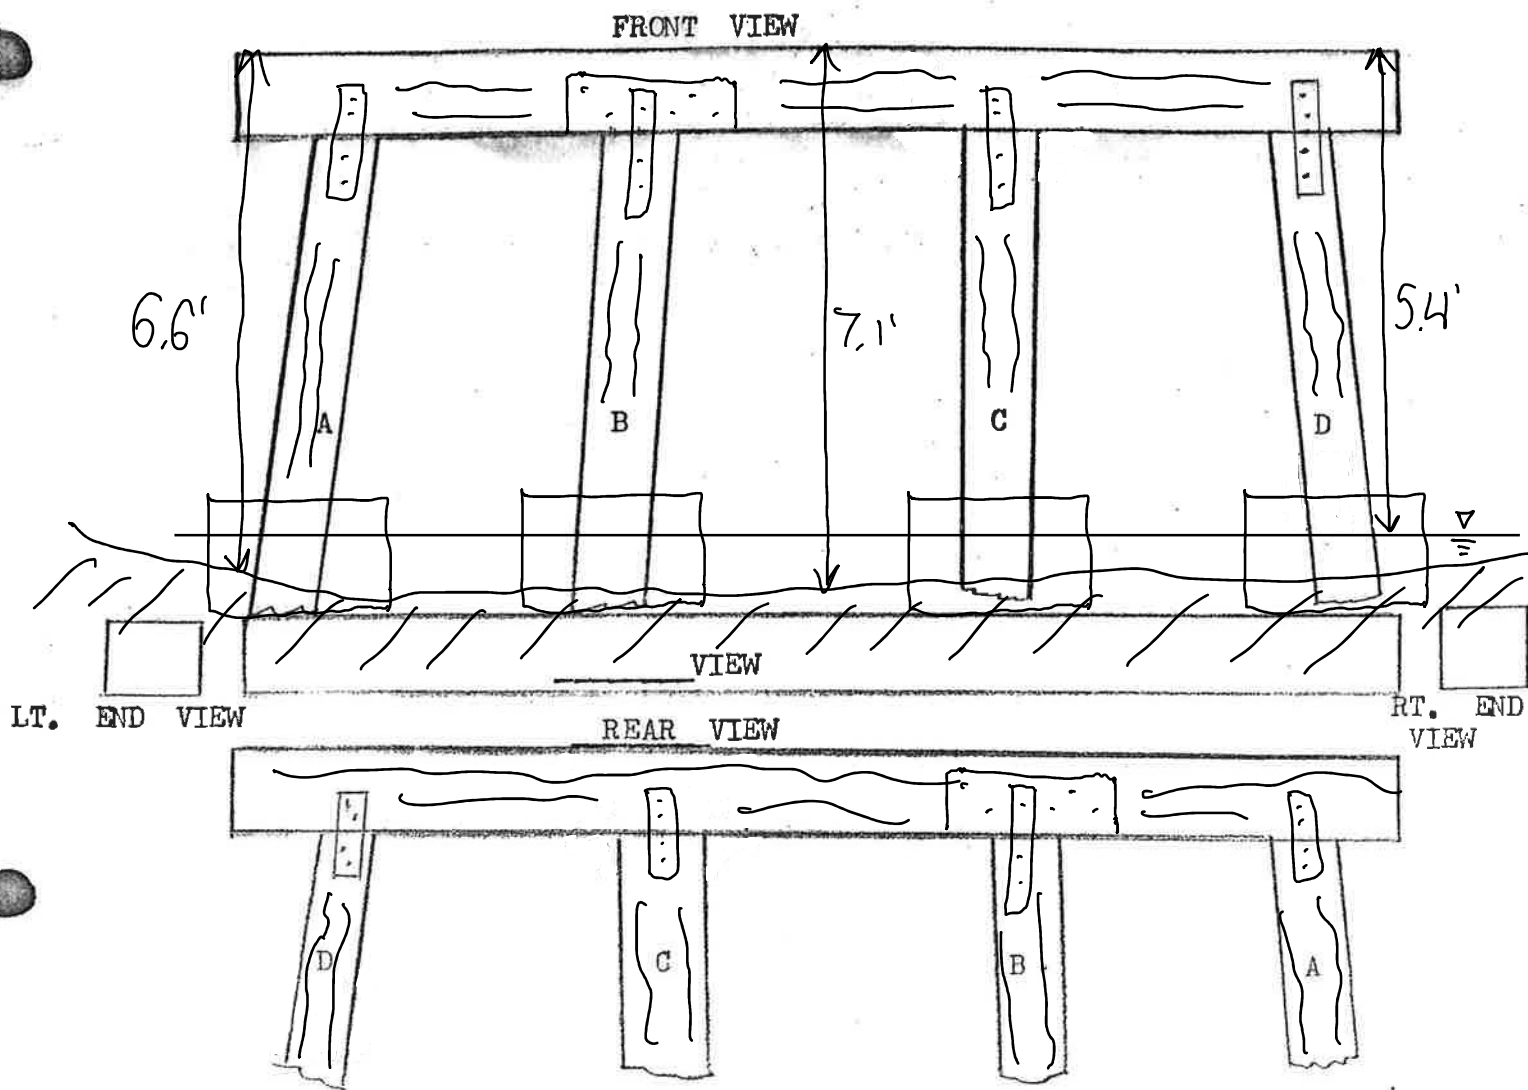
- ① Decay  
12" L x 11" T x 1/4" W
- ② Spall to steel  
18" T x 2" W x 2" D
- ③ Decay/splitting  
18" x 2" x 2" D  
at end of cap  
section above pile
