Region 04, 39 - Henderson County

NATCHEZ TRACE RD. Crossing SR-114 / I-40 EBL

90 - LAST INSPECTION DATE 06/03/2024

| IDENTIFICATION | |
|---|---|
| (8) Structure Number | 39I00400031 |

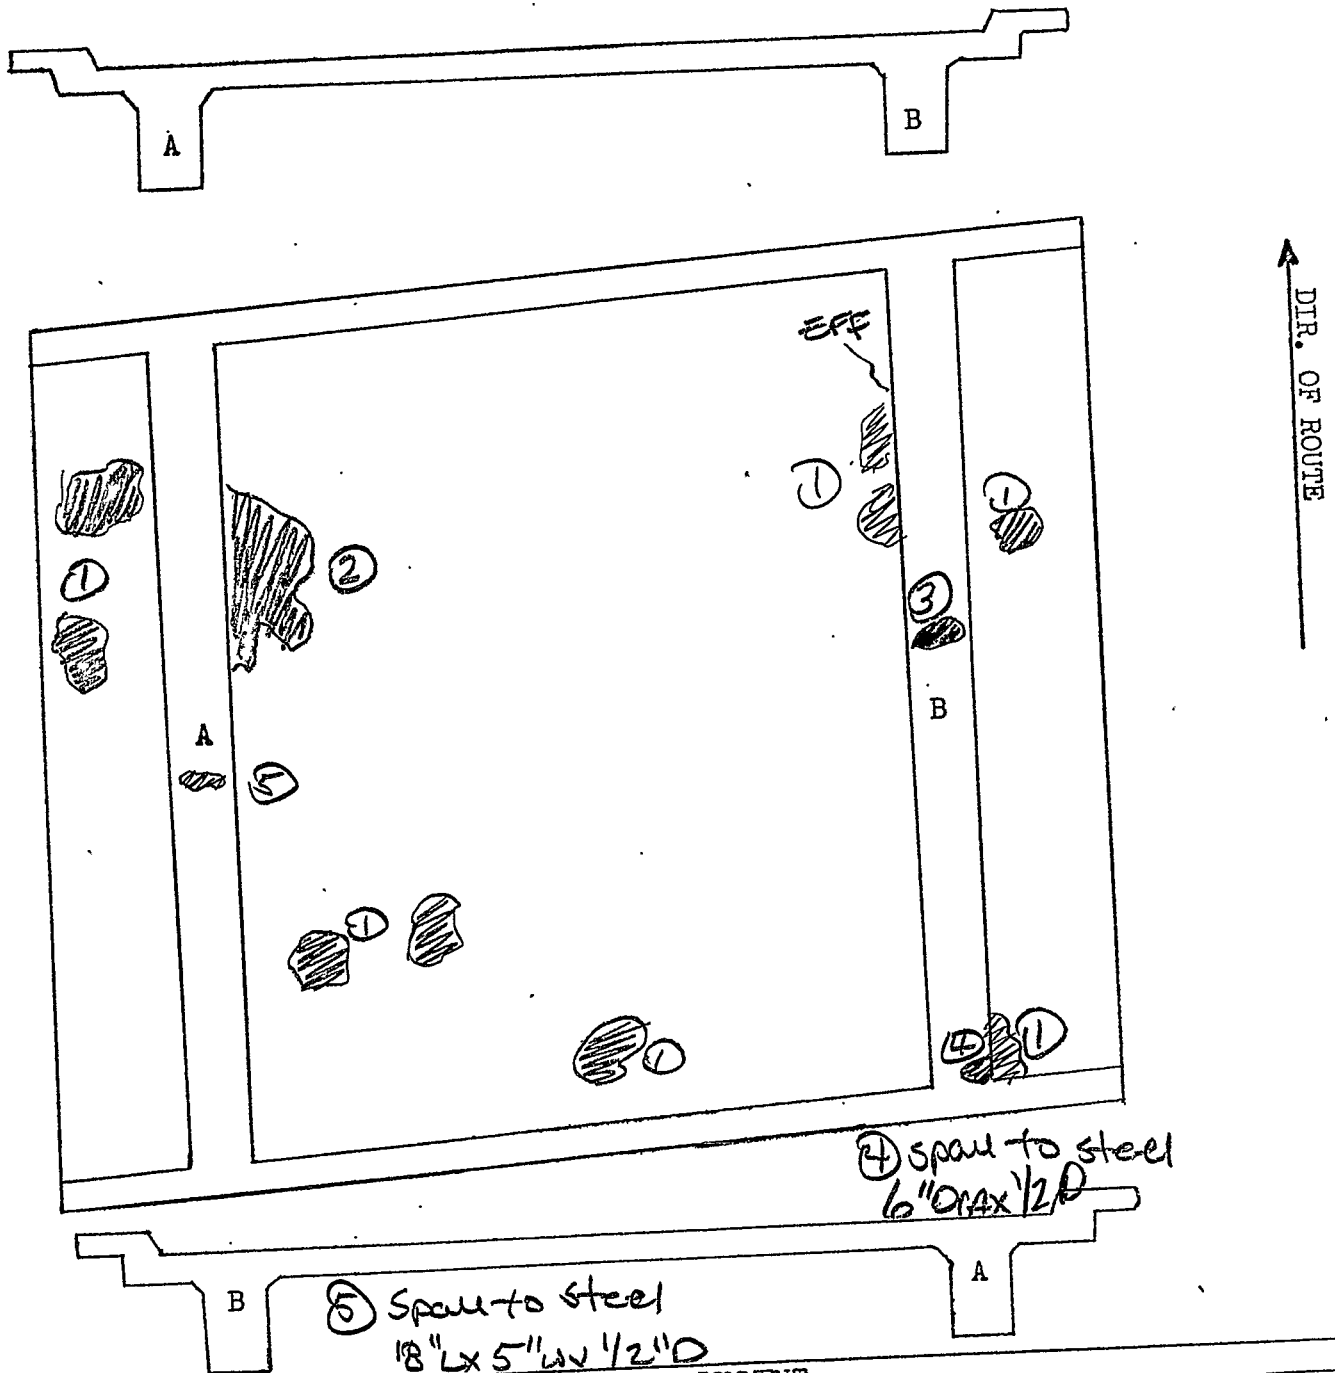
| ELEMENT | | RATING | COMMENT |
|---|---|---|---|
| BOTTOM DECK | | G (F) P C | ①② HL EFF Crack |

① Imp. spall  
15"-18" D x ? D  
② Imp. spall  
4' DIA x ? D.  
③ Imp. spall  
15" L x 5" W x ? D

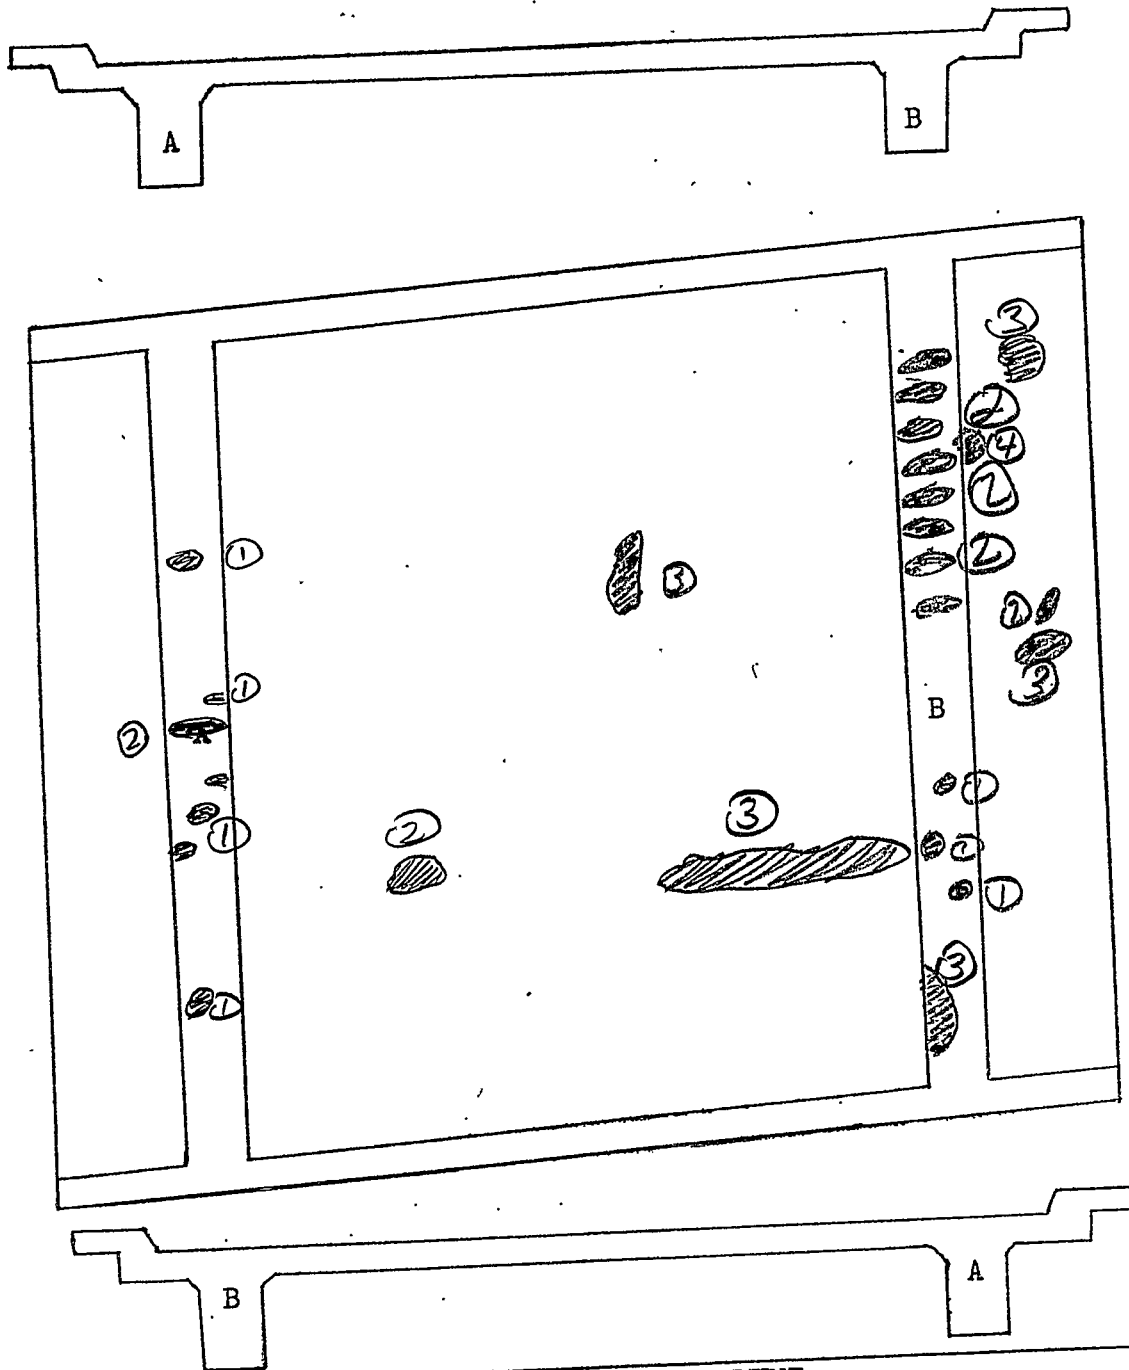
| ELEMENT | | RATING | COMMENT |
|---|---|---|---|
| BOTTOM DECK | | G F P C (2) (3) (4) | (1) Splice to steel<br>≤ 8" DIA x 1" O |
| BACKWALLS | | G F P C | (4) Splice to steel / Impending<br>18" DIA x 2" O |

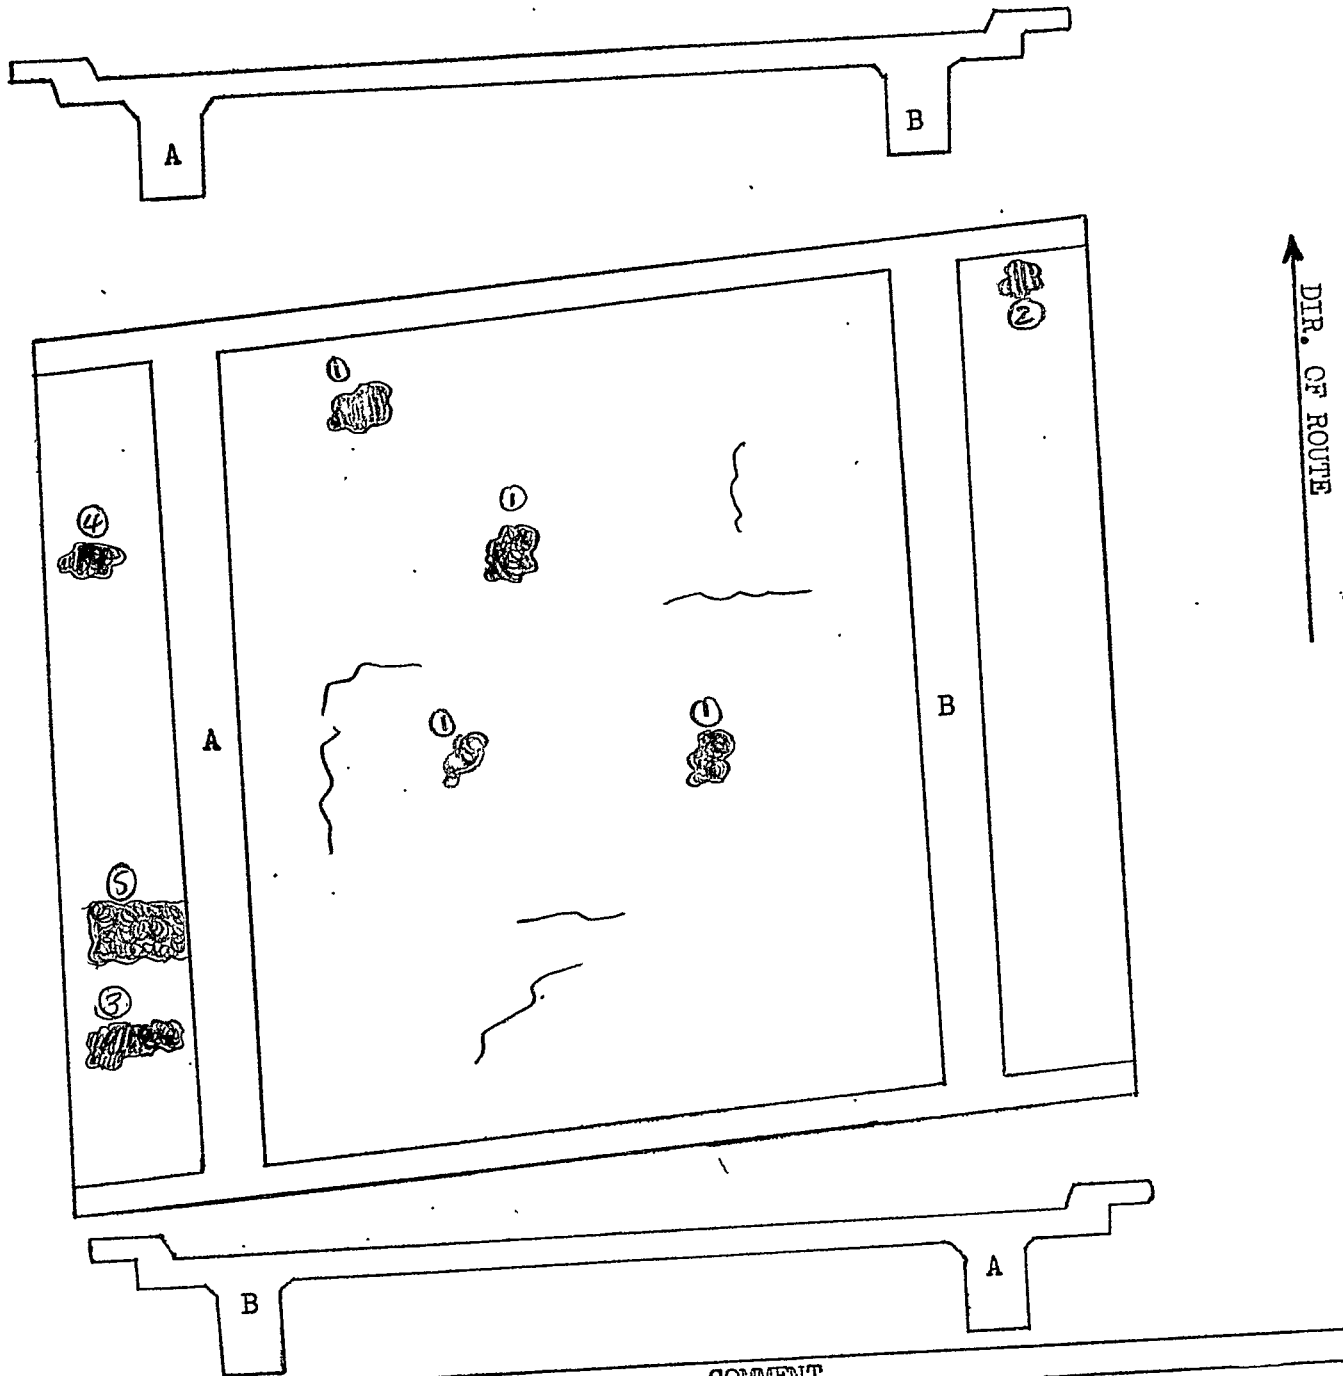
| ELEMENT | | RATING | COMMENT |
|---|---|---|---|
| BOTTOM DECK | | G (F) P C | see 1-5, hairline cracks |

- ① 2' in dia x ? D  
Impending Spall
- ② 1' in dia x 2" D  
Spall to Steel
- ③ 4' w x 2' L x ? D  
Impending Spall
- ④ 3' in dia x ? D  
Impending Spall
- ⑤ 3' w x 4' L x ? D  
Impending Spall
