Region 04, 39 - Henderson County

NATCHEZ TRACE RD. Crossing SR-114 / I-40 WBL

90 - LAST INSPECTION DATE 06/04/2024

| IDENTIFICATION | |
|---|---|
| (8) Structure Number | 39I00400041 |

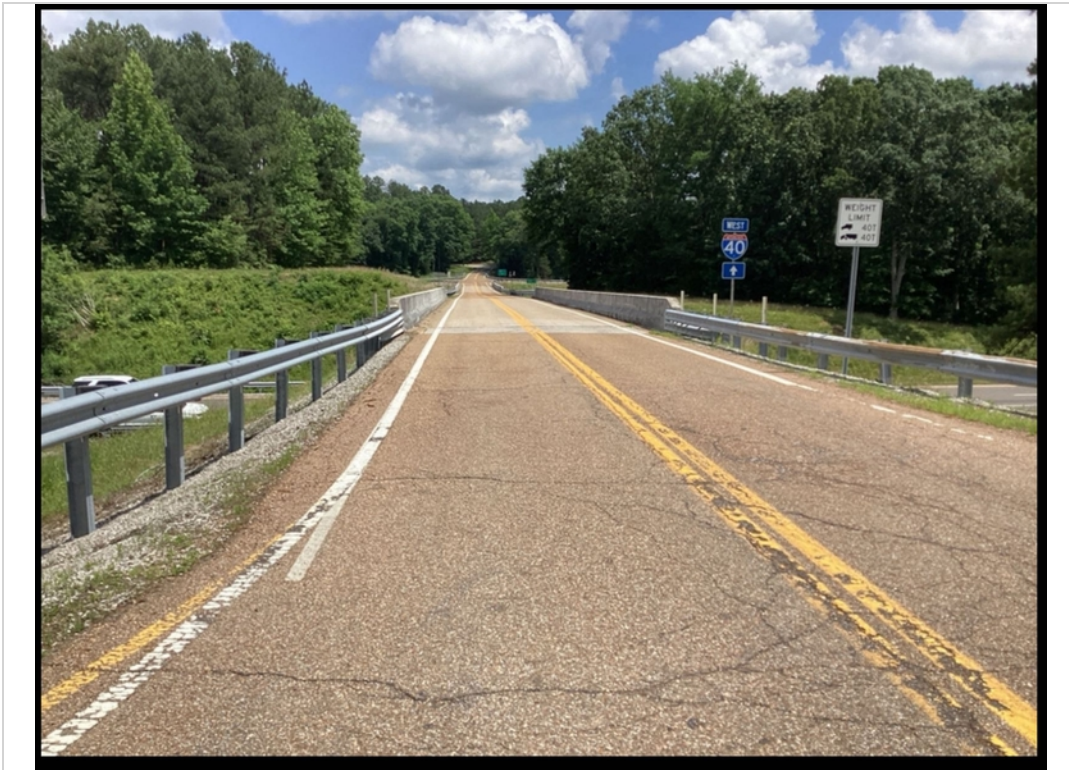
Approach 1 weight limit sign @ 26.47 bridge

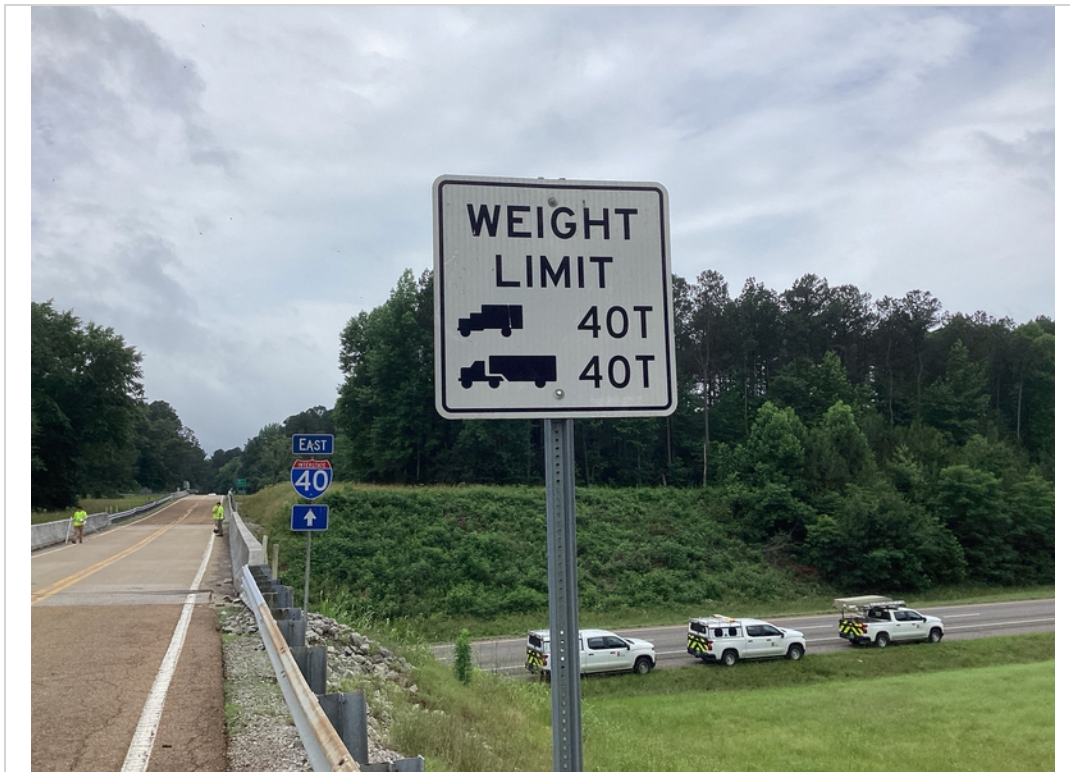
Approach 2 weight limit sign

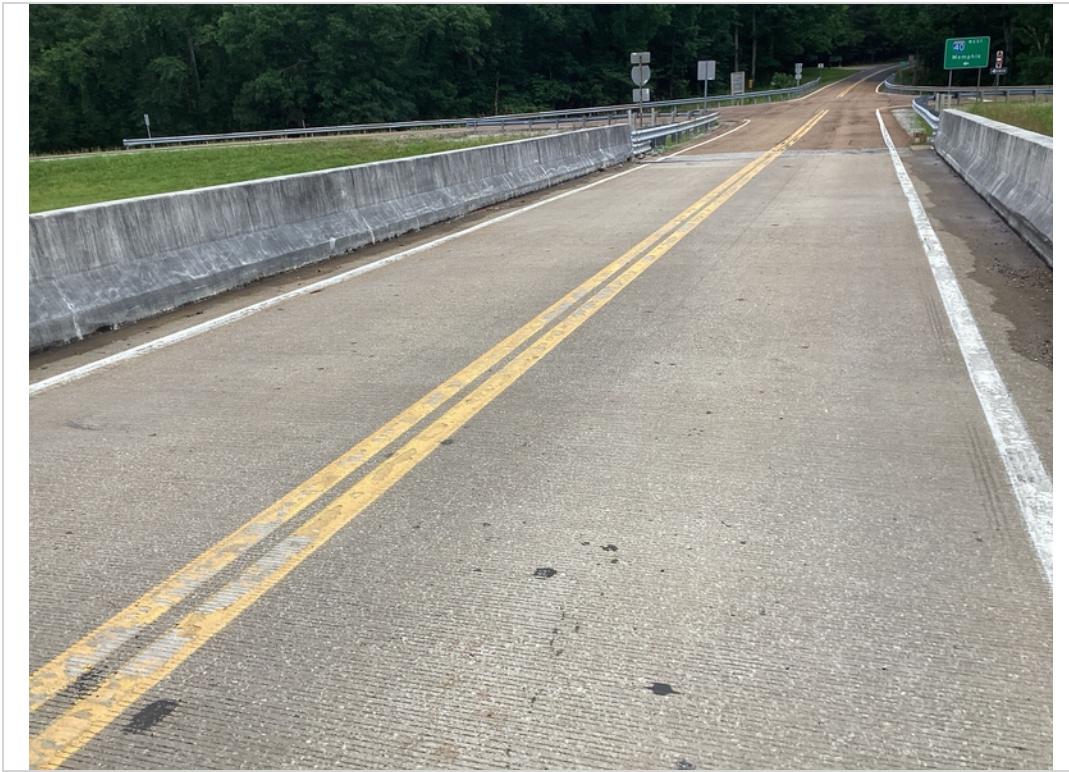
View across top deck

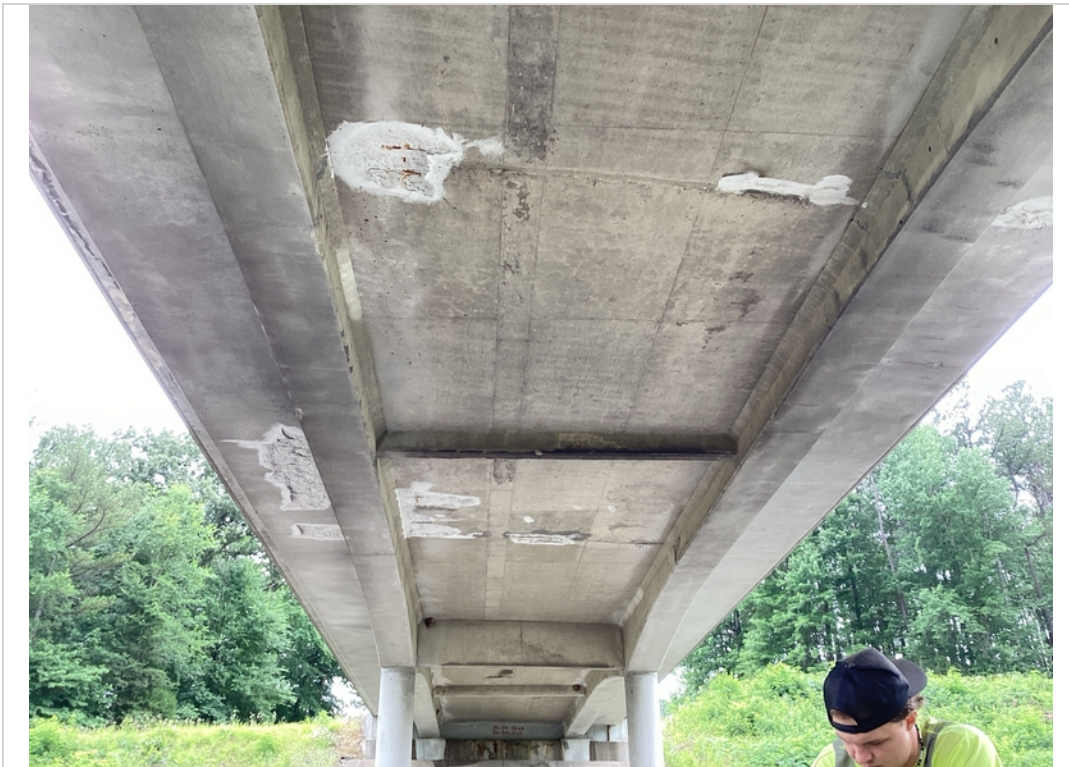
Bottom deck of span #2

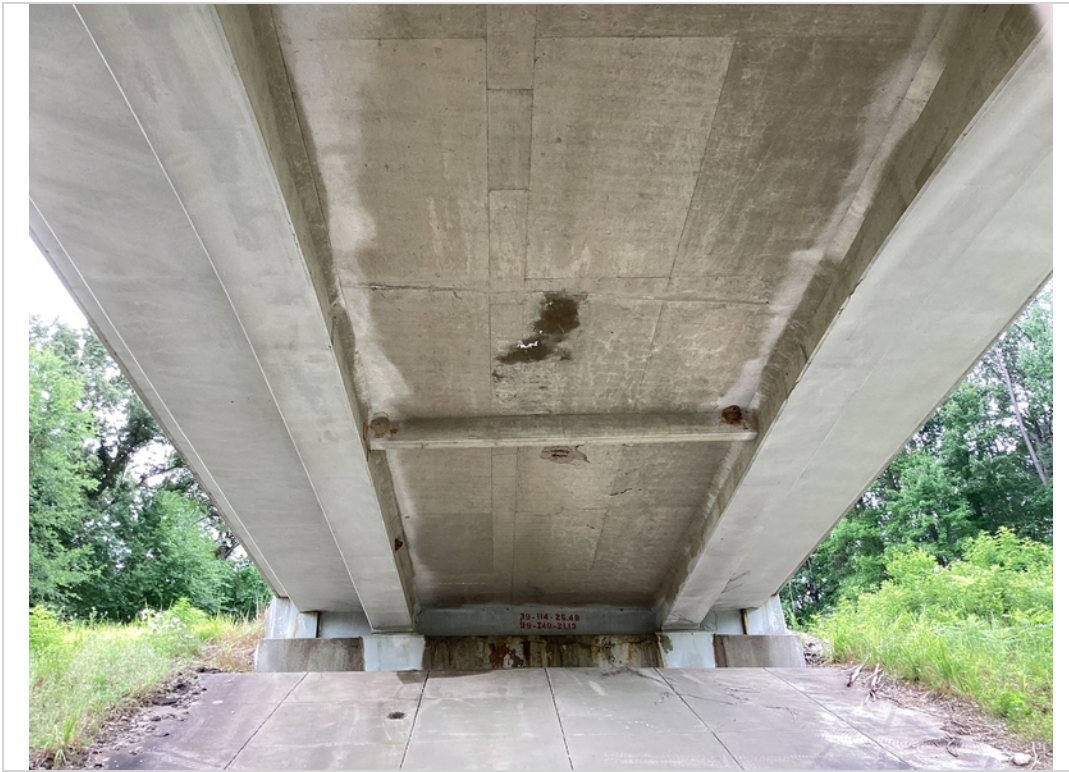
Span 1 bottom deck typical

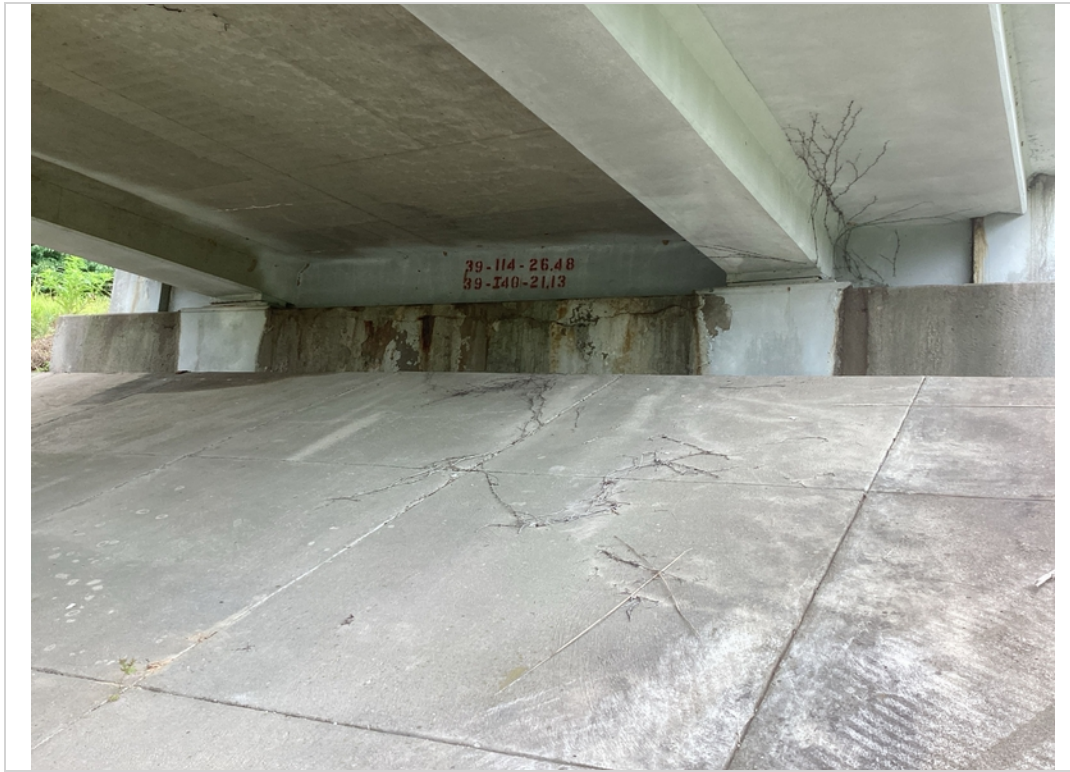
Abutment #1

| Abutment Caps | (Fair) | Spalling & 1/32" cracks |

| Date Added | Recommendation | Priority |
|---|---|---|
| 06/04/2024 | REPAIR BOTH ABUTMENT CAPS | |

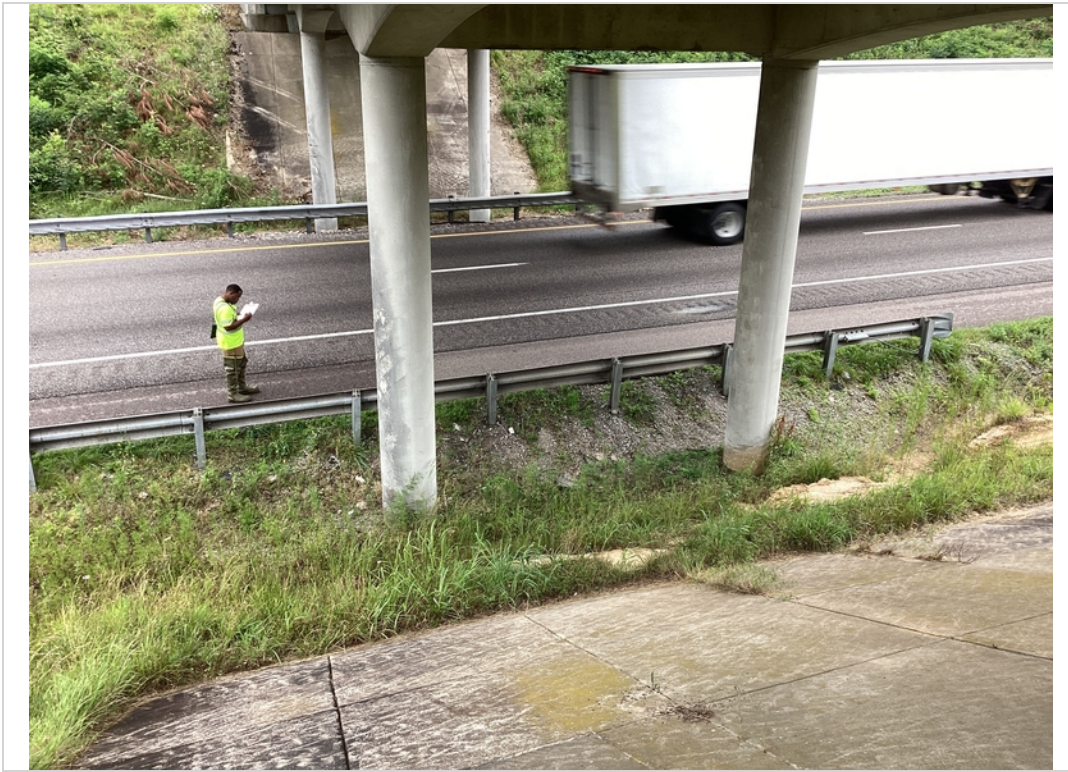
Bent 2

| Bent Columns | (Fair) | Spalling |

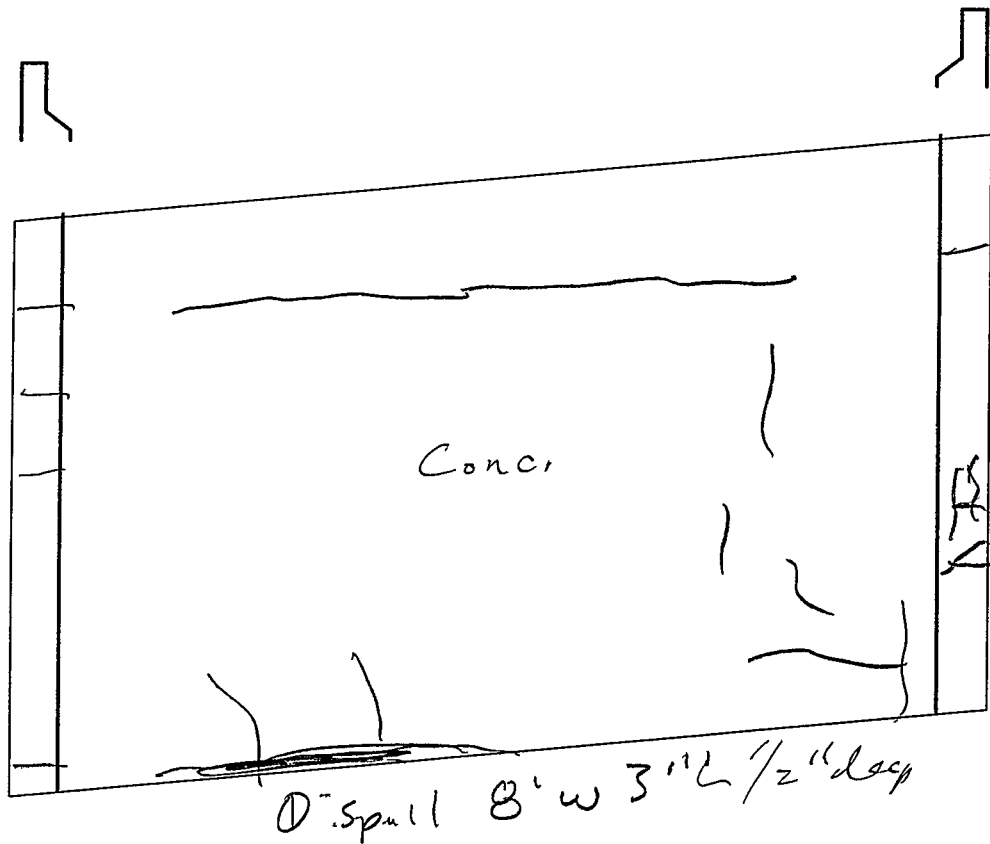
SPAN. NO. 1

| ELEMENT | RATING | COMMENT |
|---|---|---|
| TOP DECK | G <del>F</del> P C | Hairline cracks ① |
| PARAPET | G <del>F</del> P C | up to 1/16" cracks with asphalt |

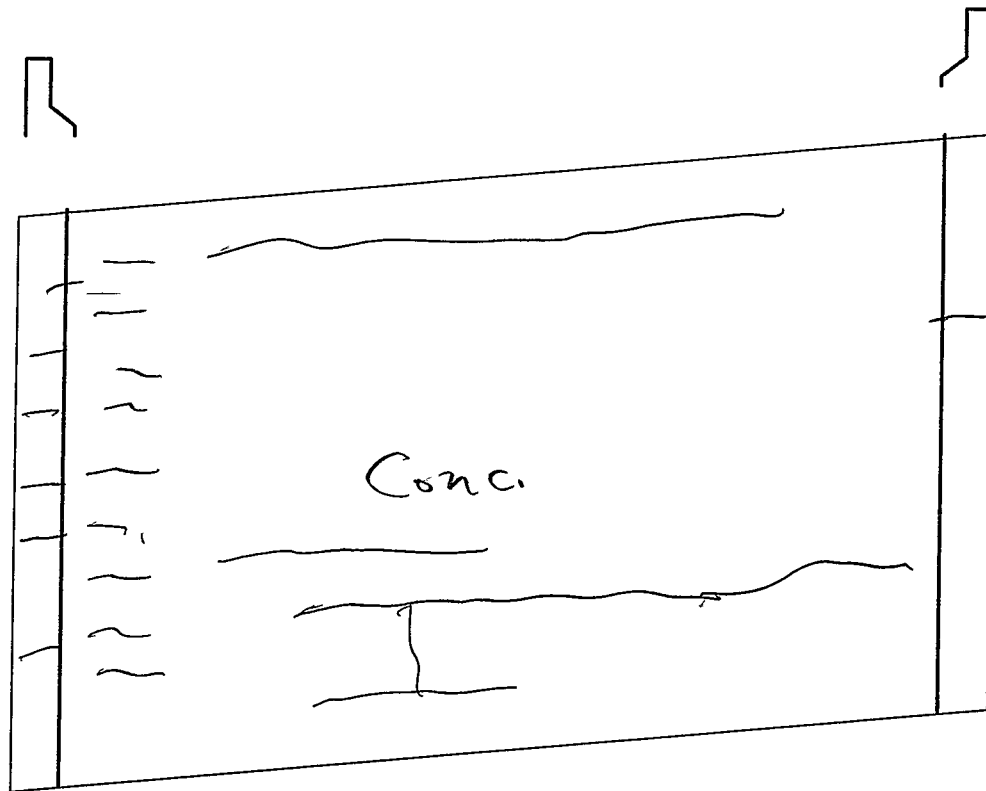
SPAN. NO. 2

| ELEMENT | RATING | COMMENT |
|---|---|---|
| TOP DECK | G <sup>F</sup> P C | Hamline cracks |
| PARAPET | G <sup>F</sup> P C | Up to 1/16" cracks with eff |

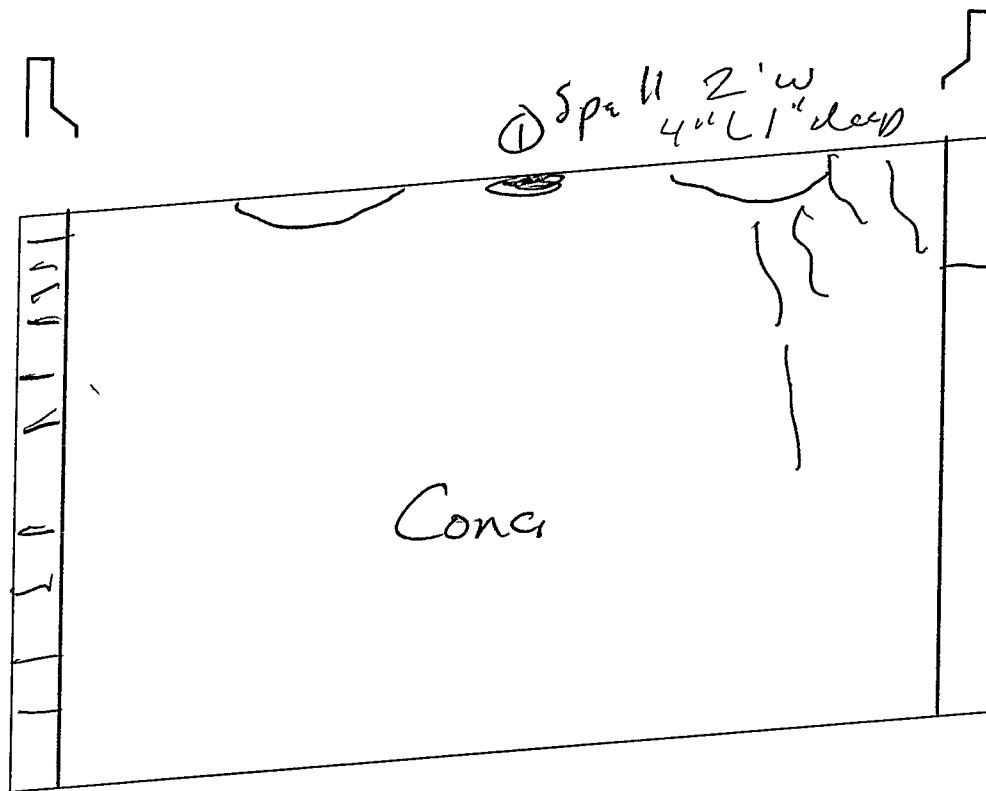
SPAN. NO. 3

| ELEMENT | RATING | COMMENT |
|---|---|---|
| TOP DECK | G <del>F</del> P C | Hairline cracks |
| PARAPET | G <del>F</del> P C | Up to 1/16" cracks with eff |

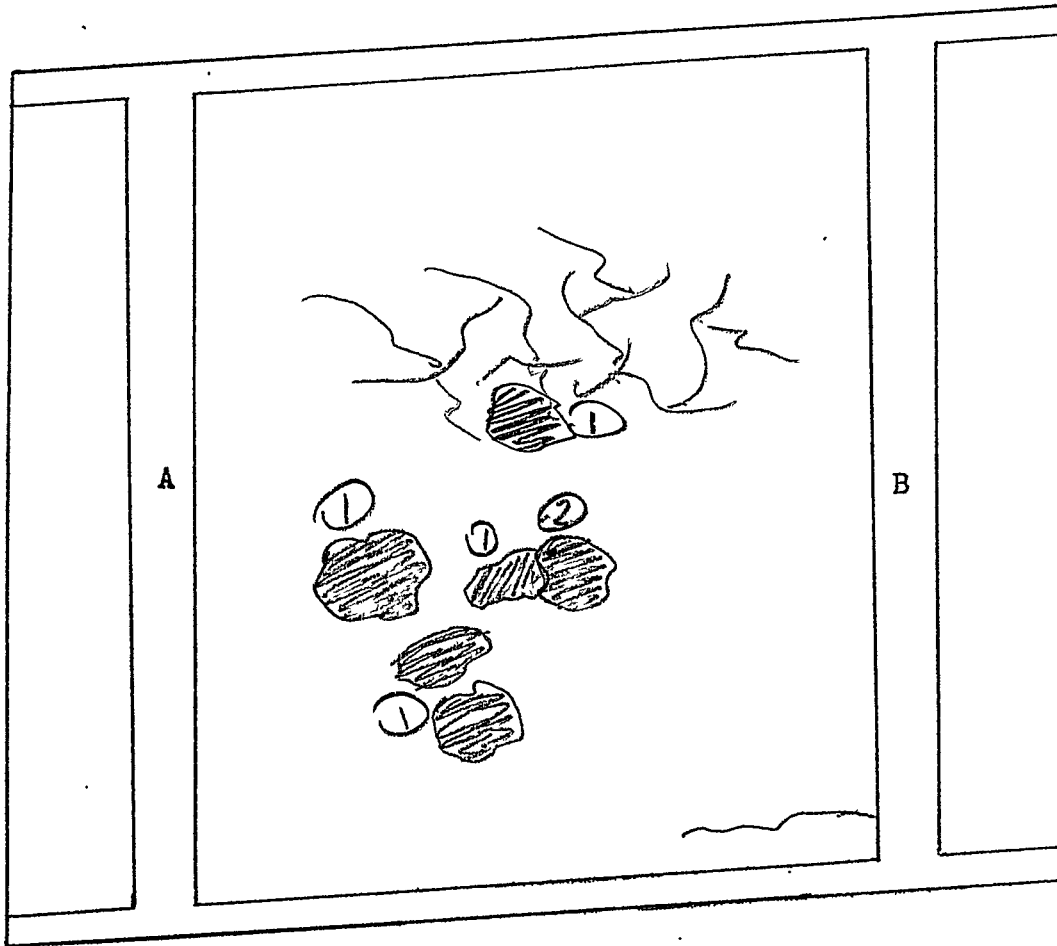
1 2 HL map Cracks w/ EFF

| ELEMENT | RATING | COMMENT |
|---|---|---|
| BOTTOM DECK | G (F) P C | hairline cracks w/eff, see 1-5 |
| | | ① 4' L x 2' W x 1 1/2" D<br>Spall to steel |
| | | ② 2' in dia x 1 1/2" D<br>Spall to steel |
| | | ③ 5' L x 2' W x 1 1/2" D<br>Spall to steel |
| | | ④ 3' L x 1 1/2" D<br>Spall to steel |
| | | ⑤ 3' in dia x 1 1/2" D<br>Spall to steel |

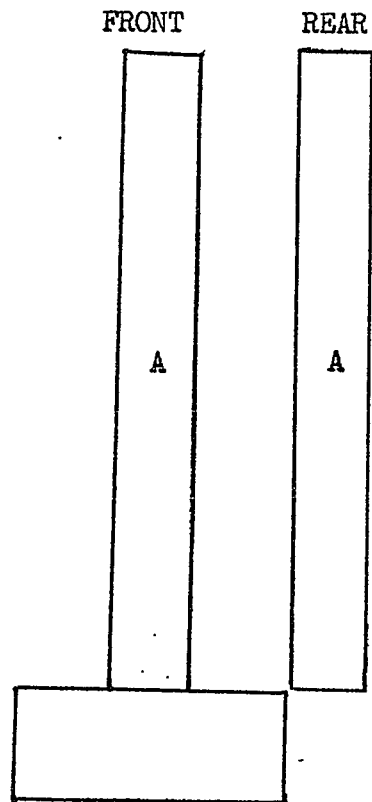
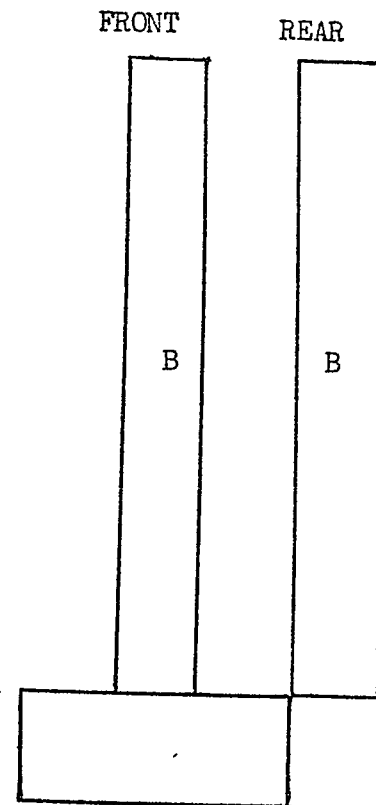
| ELEMENT | RATING | COMMENT |
|---|---|---|
| BEARINGS | G $\textcircled{F}$ P C | rust |
| CAP | G $\textcircled{F}$ P C | see $\textcircled{1}$ $\frac{1}{32}$ " cracks |
