Region 04, 57 - Madison County

LOWER BROWNSVILLE RD. Crossing I40

Inspection Date(s): 04/09/2025 - 04/09/2025

Structure 57I00400011 is in poor condition with the substructure being the limiting component. The structure consists of a simply supported, four span, multi-beam superstructure consisting of a cross section containing five prestressed concrete I-Beams of varying depths.

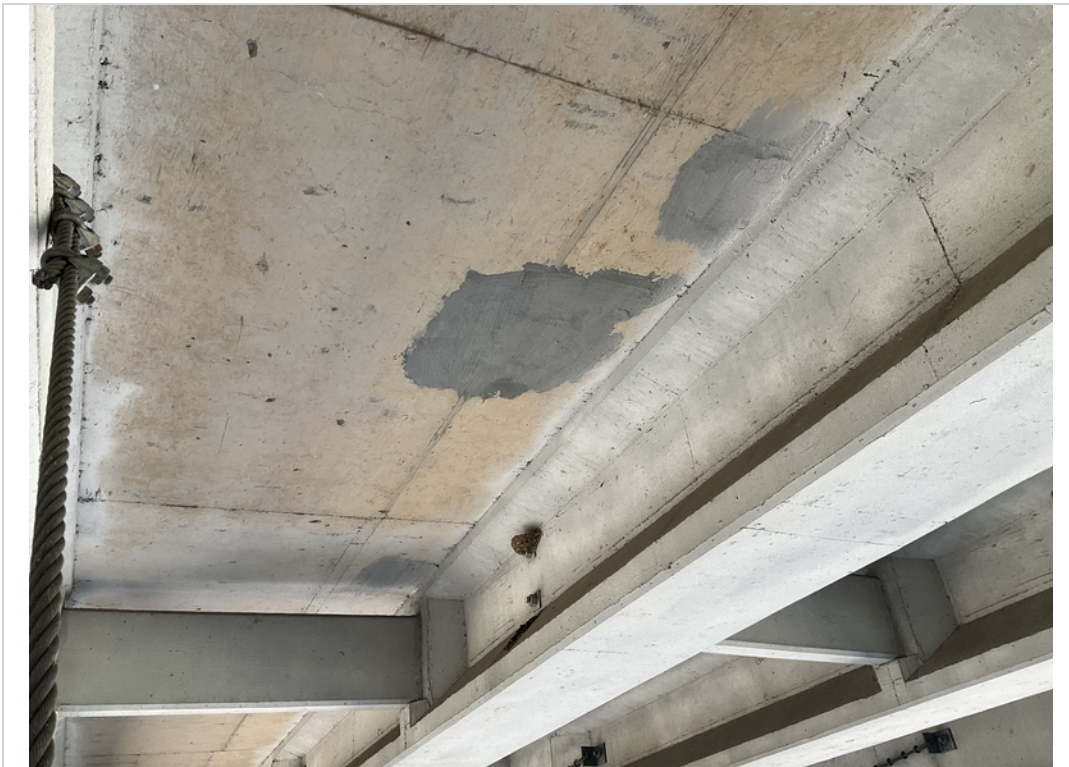
Span 1, deck underside, Bay B adjacent to Beam C, (3) patches (1'x1', 3'x3', 1'x1')

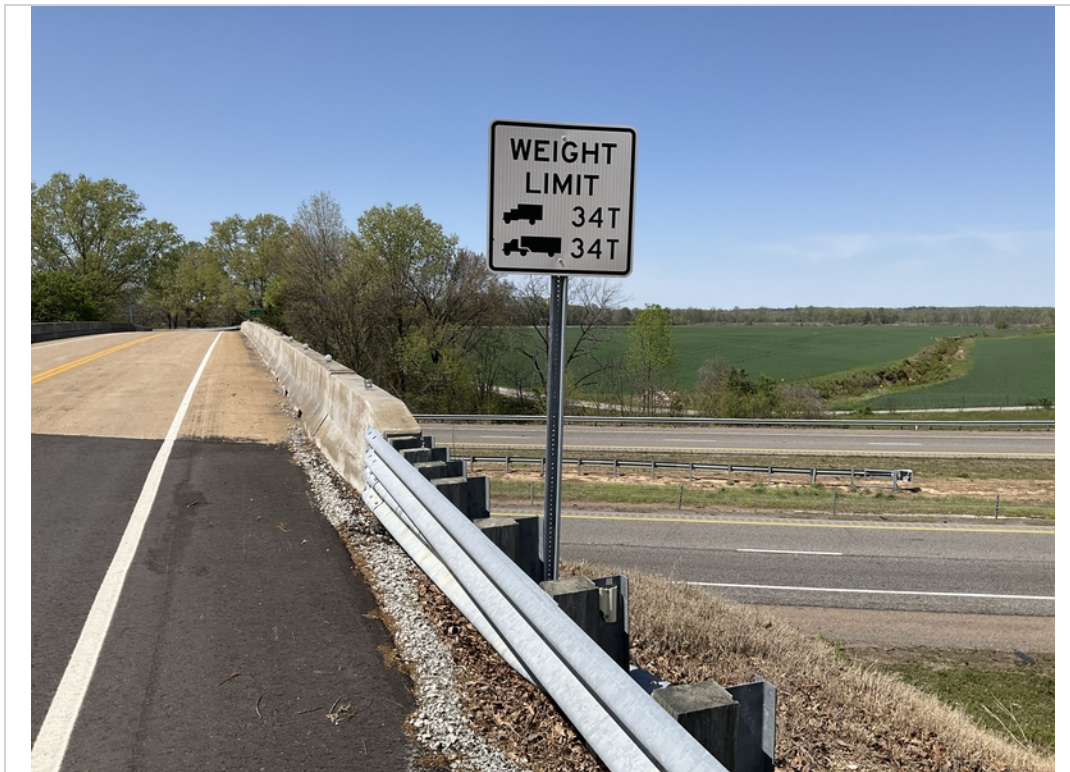
Approach 1, right corner, weight limit sign (34T restriction)

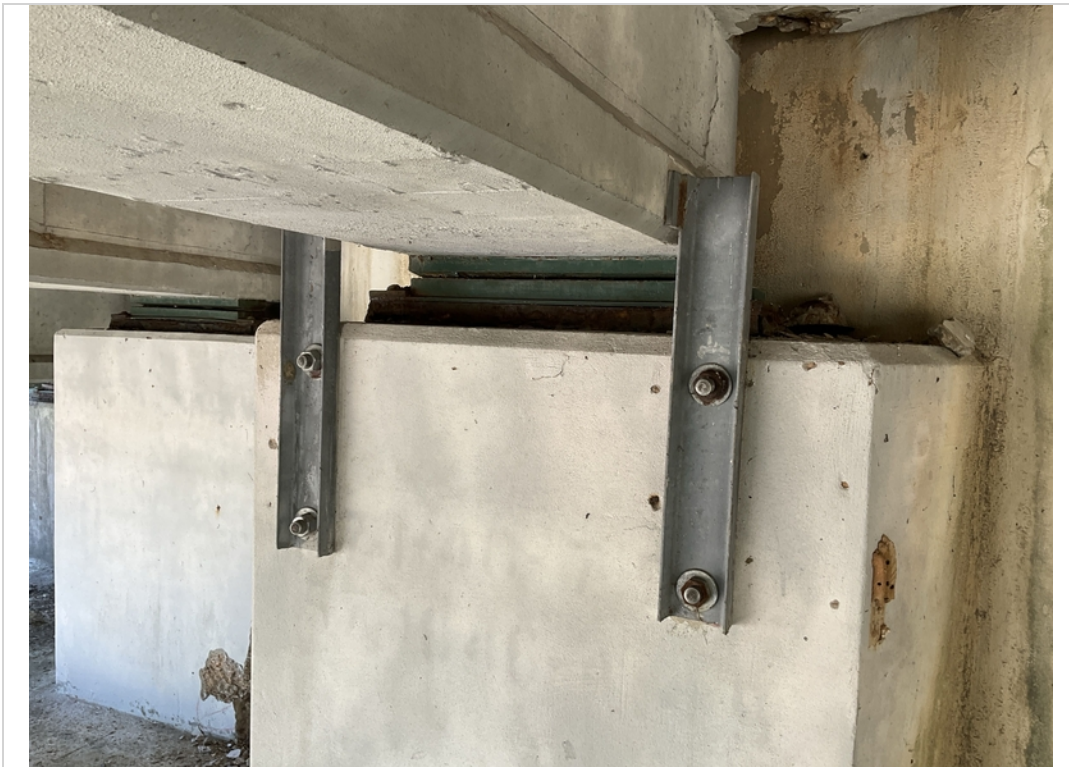
Span 1, abutment 1, Beam C, lateral keepers installed for beam alignment

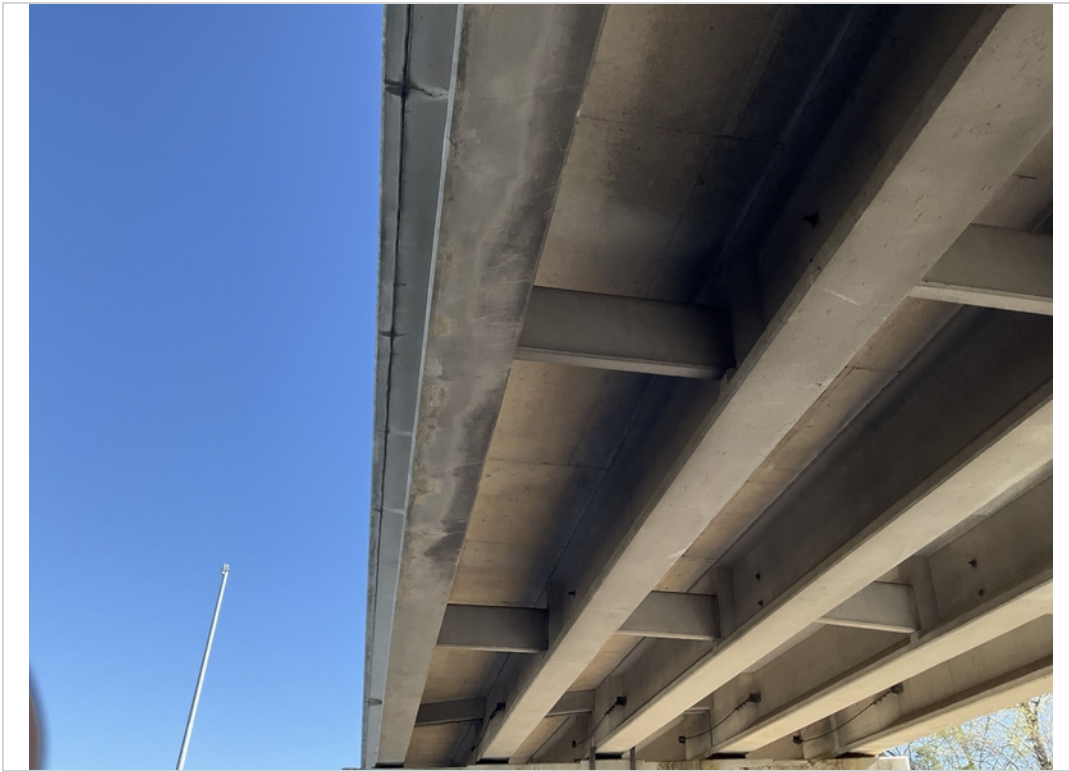
Beam E, Span 3, over right travel lane, surface scrapes on beam underside

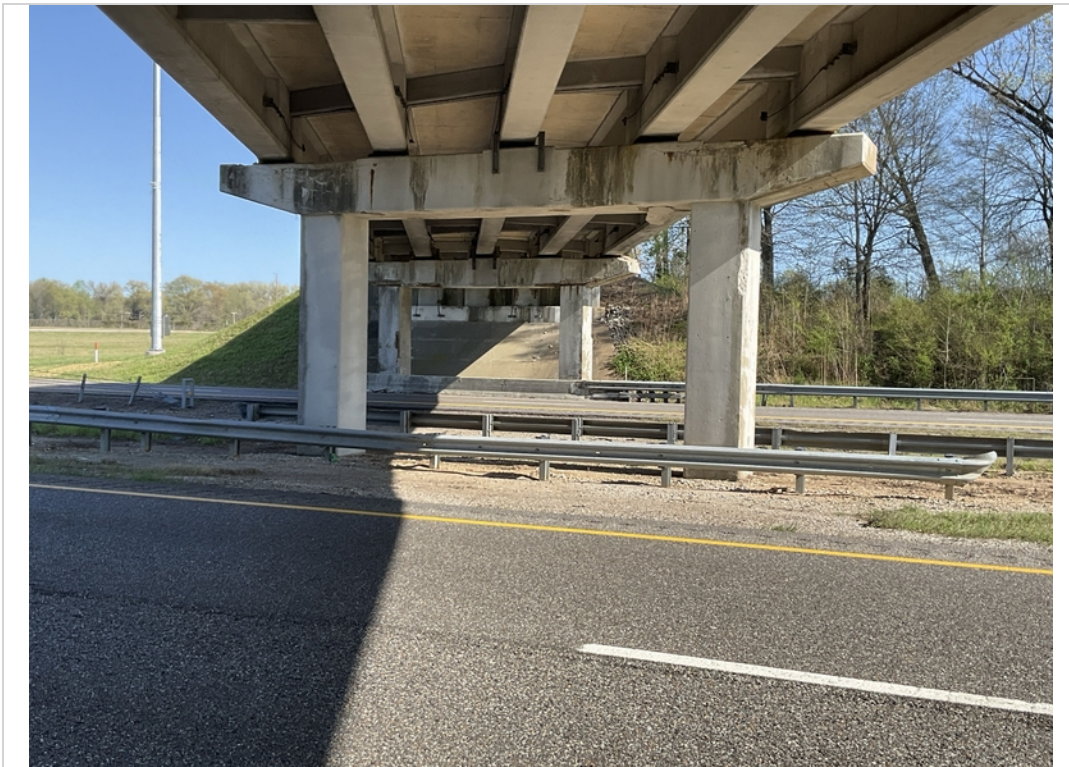
The reinforced concrete bents typically have widespread moderate spalling along the caps and columns throughout with several exposed corroded rebar reinforcement. Bent pedestals at Bents 1 and 3 exhibit spalling with exposed corroded rebar.

The caps exhibit cracks up to 1/8" wide with random delaminations. Abutment backwalls exhibit isolated minor spalling and isolated delaminations. The pedestals at the abutments, specifically Abutment 1, exhibit widespread spalling with exposed and corroded reinforcement.

Bent 2 back face (Span 3 side)

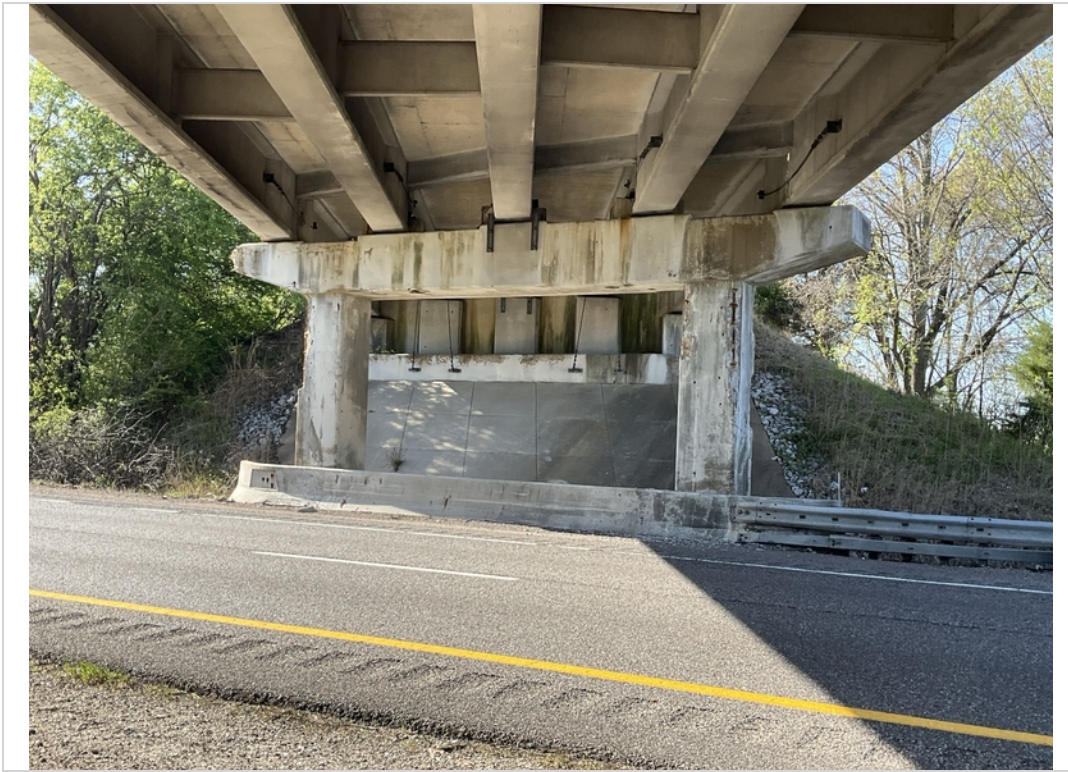
Bent 3, front face (Span 3)

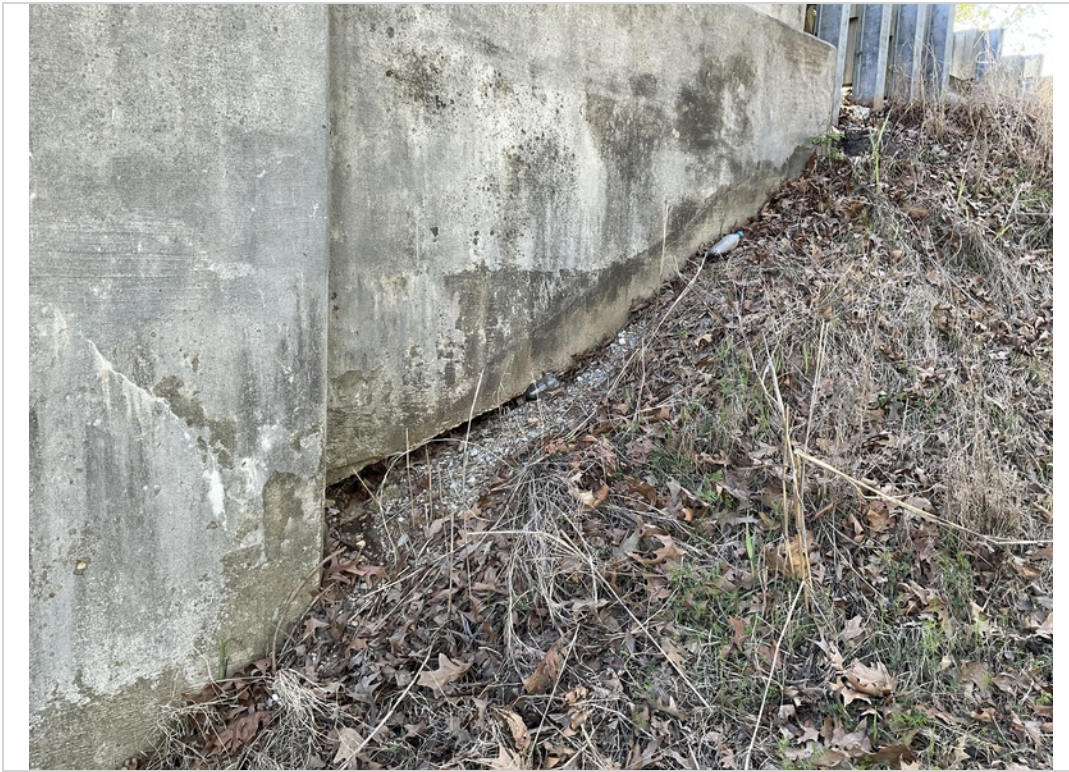
Abutment 2 right wing wall with undermining

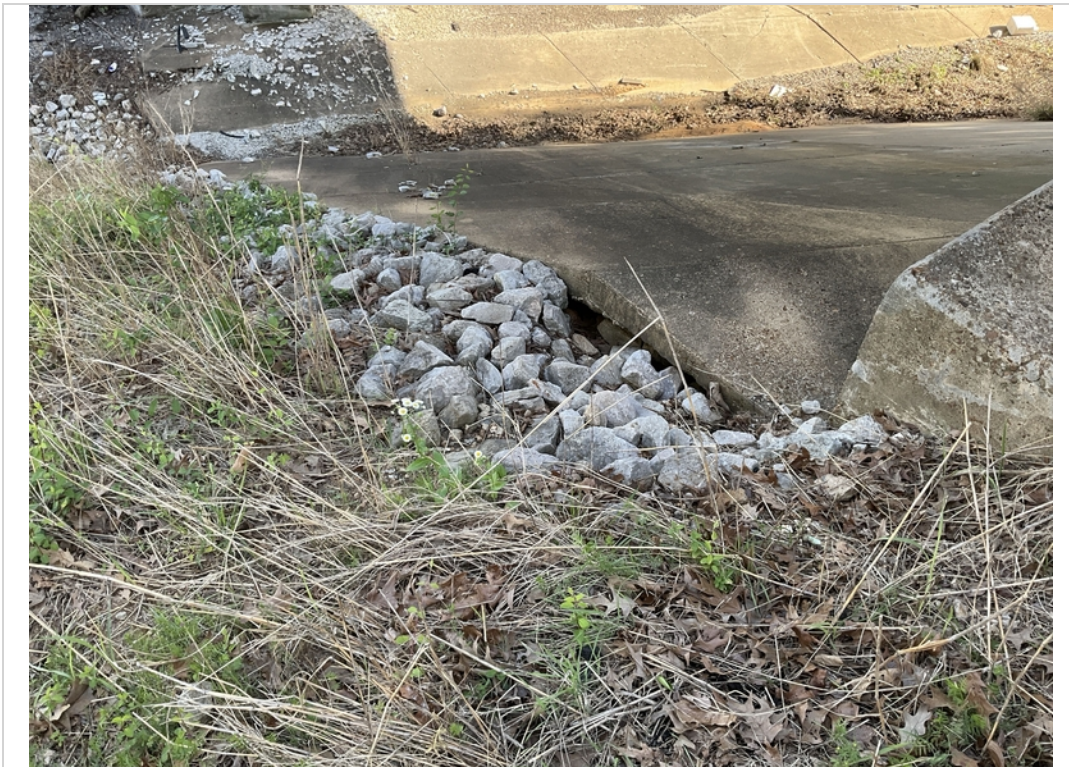
Abutment 2 right slope protection, undermining adjacent to placed rock

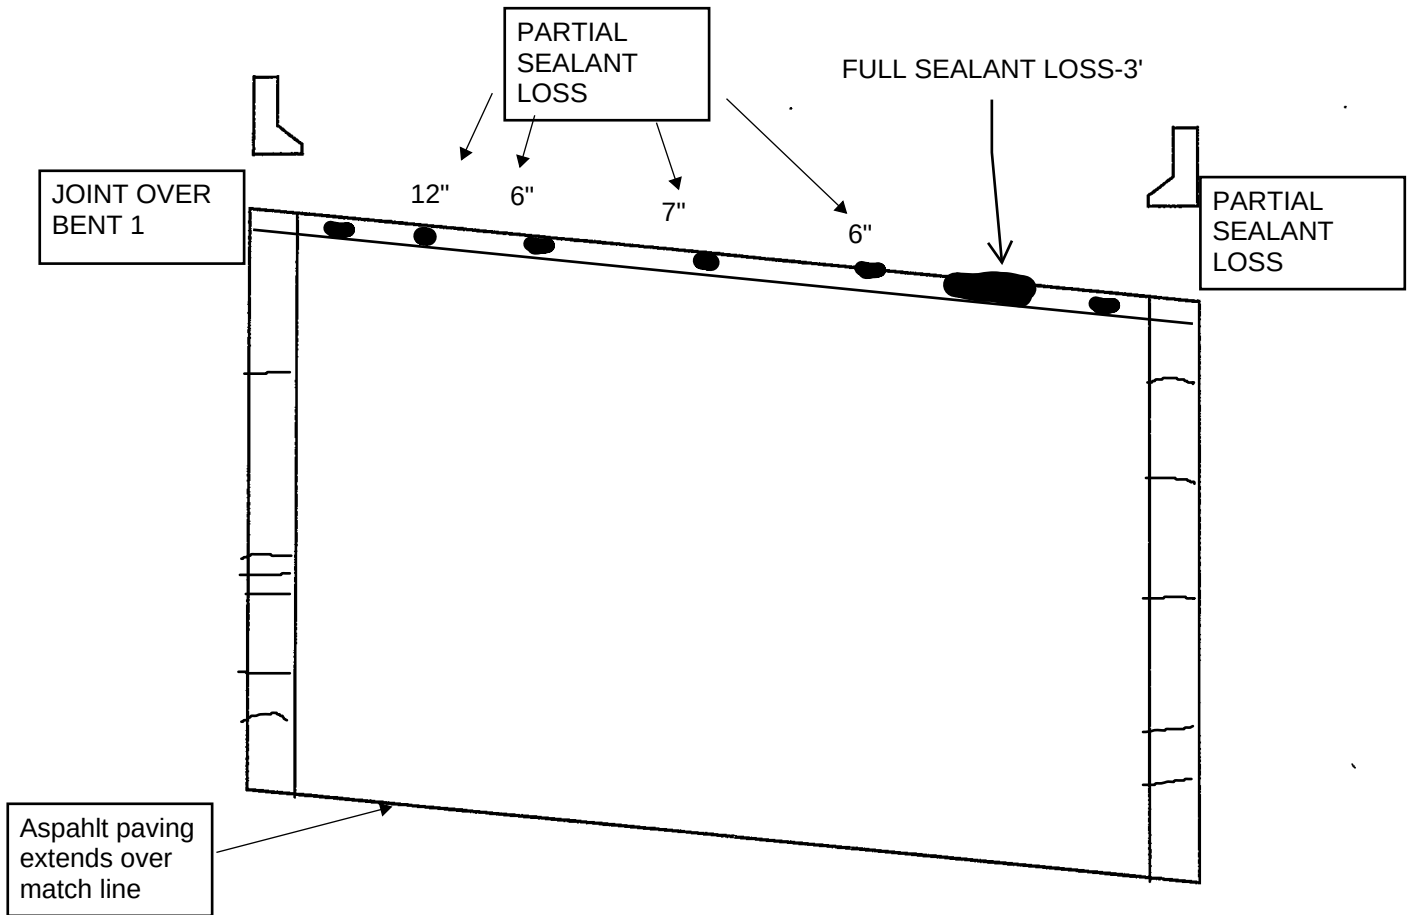
SPAN. NO. 1

| ELEMENT | RATING | COMMENT |
|---|---|---|
| TOP DECK | (G) F P C | Widespread minor abrasion, isolated moderate abrasion, isolated inherent hairline cracking |

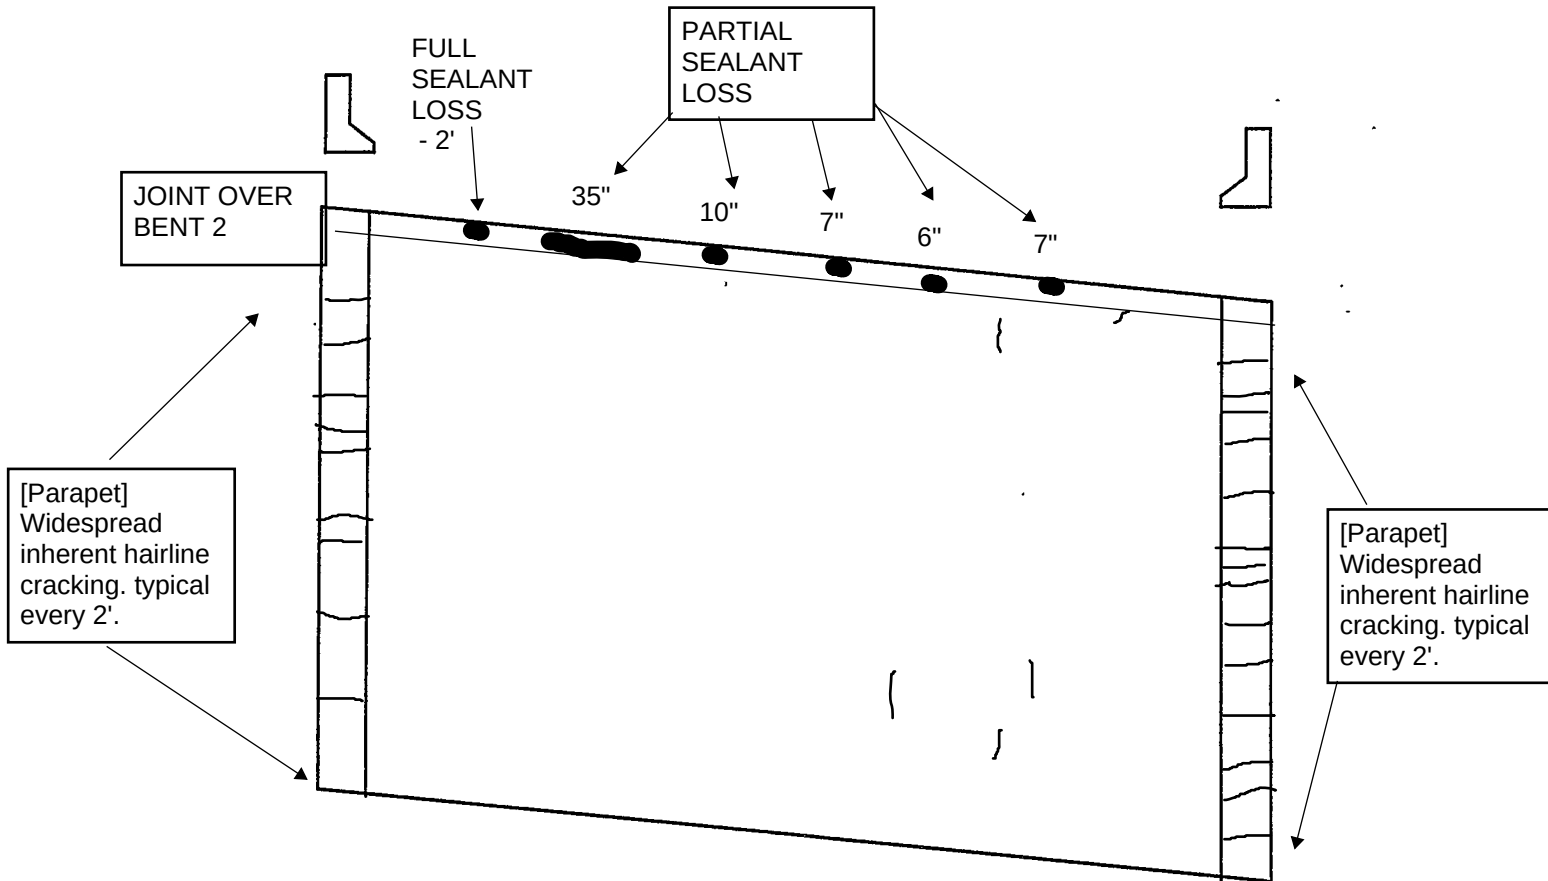
SPAN. NO. 2

| ELEMENT | RATING | COMMENT |
|---|---|---|
| TOP DECK | (G) F P C | Widespread minor abrasion, isolated moderate abrasion, isolated inherent hairline cracking (up to 2' long) |

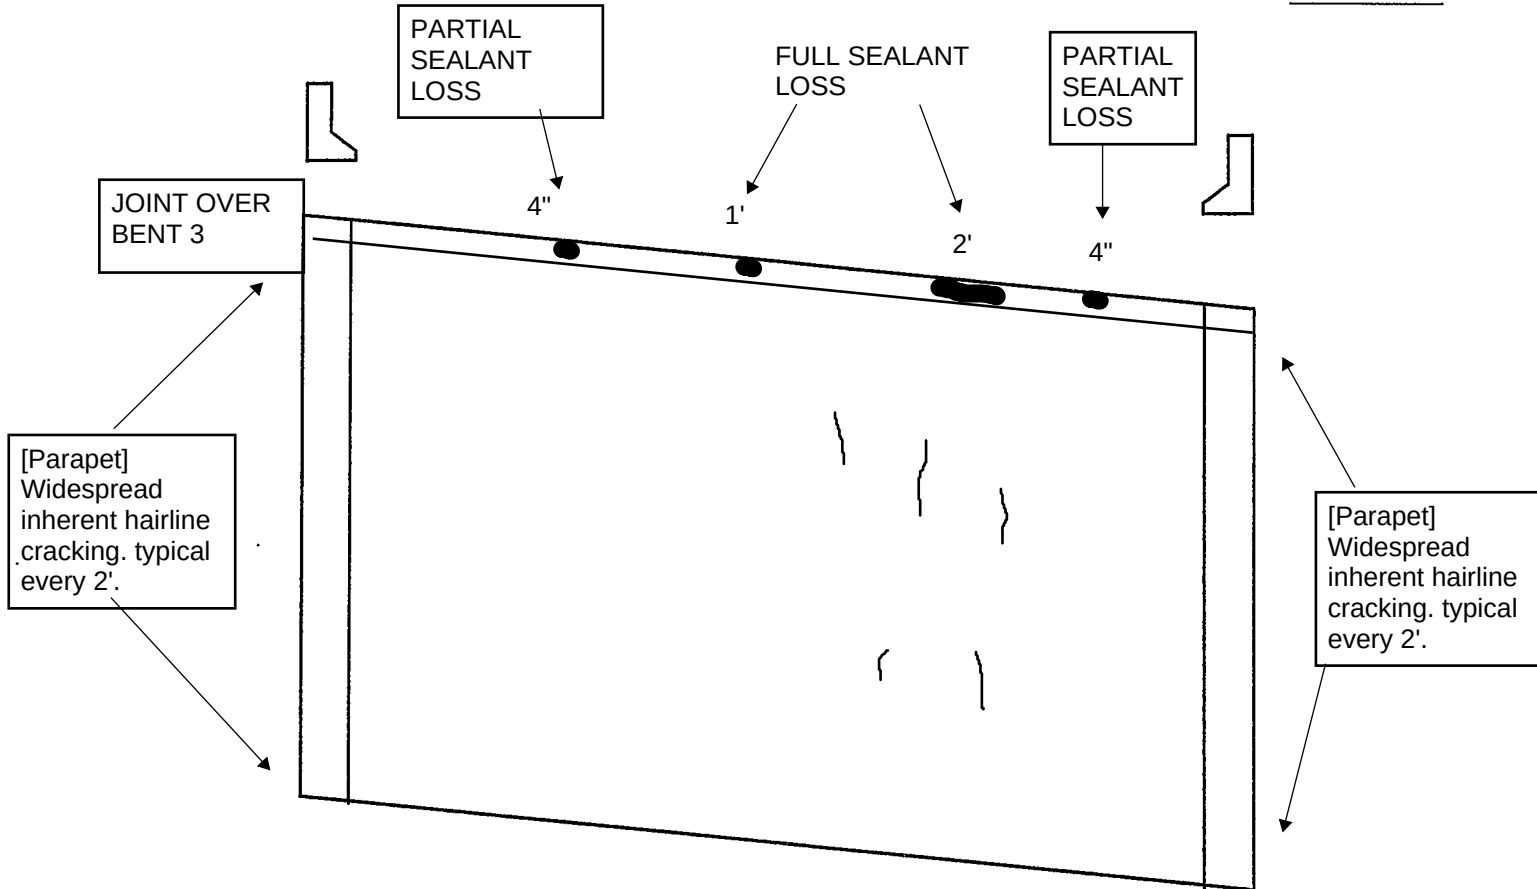
SPAN. NO. 3

| ELEMENT | RATING | COMMENT |
|---|---|---|
| TOP DECK | (G) F P C | Widespread minor abrasion, isolated moderate abrasion, isolated inherent hairline cracking (up to 2' long) |

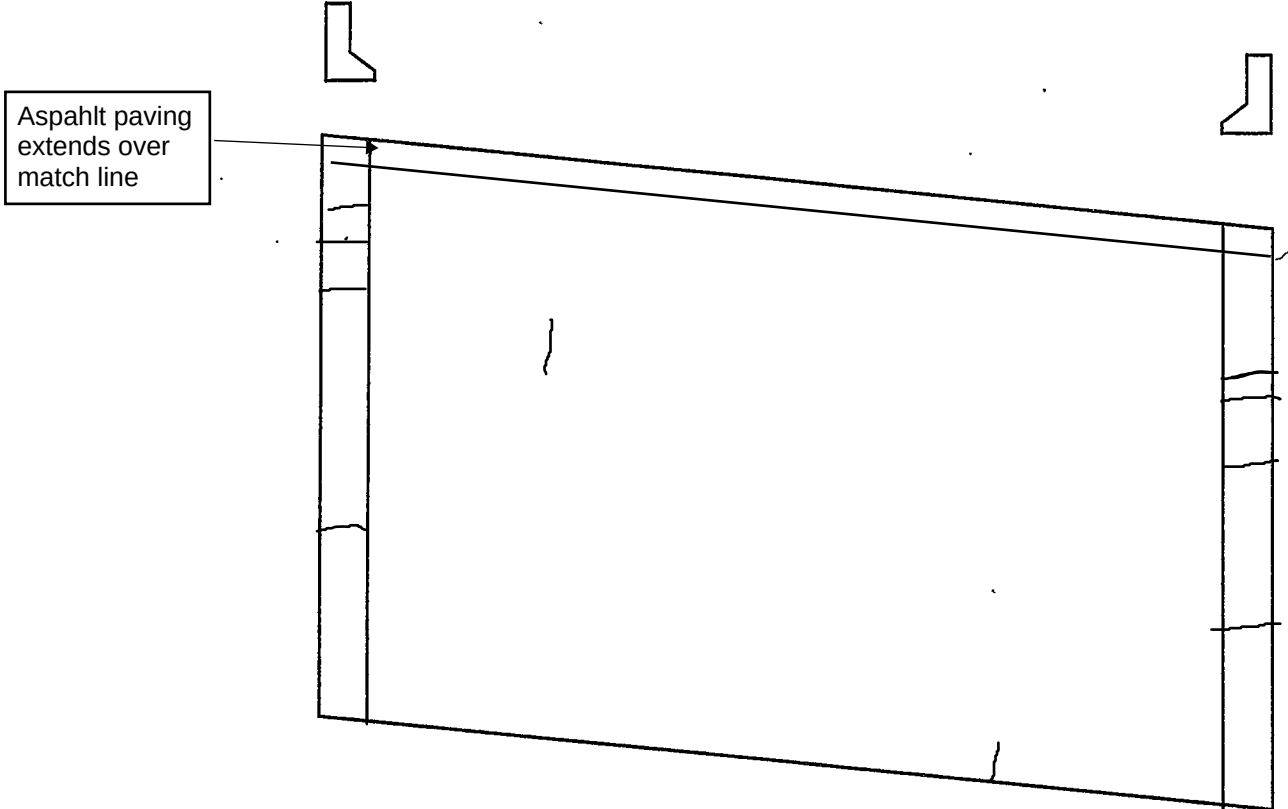
SPAN, NO. 4

| ELEMENT | RATING | COMMENT |
|---|---|---|
| TOP DECK | (G) F P C | Widespread minor abrasion, isolated moderate abrasion |

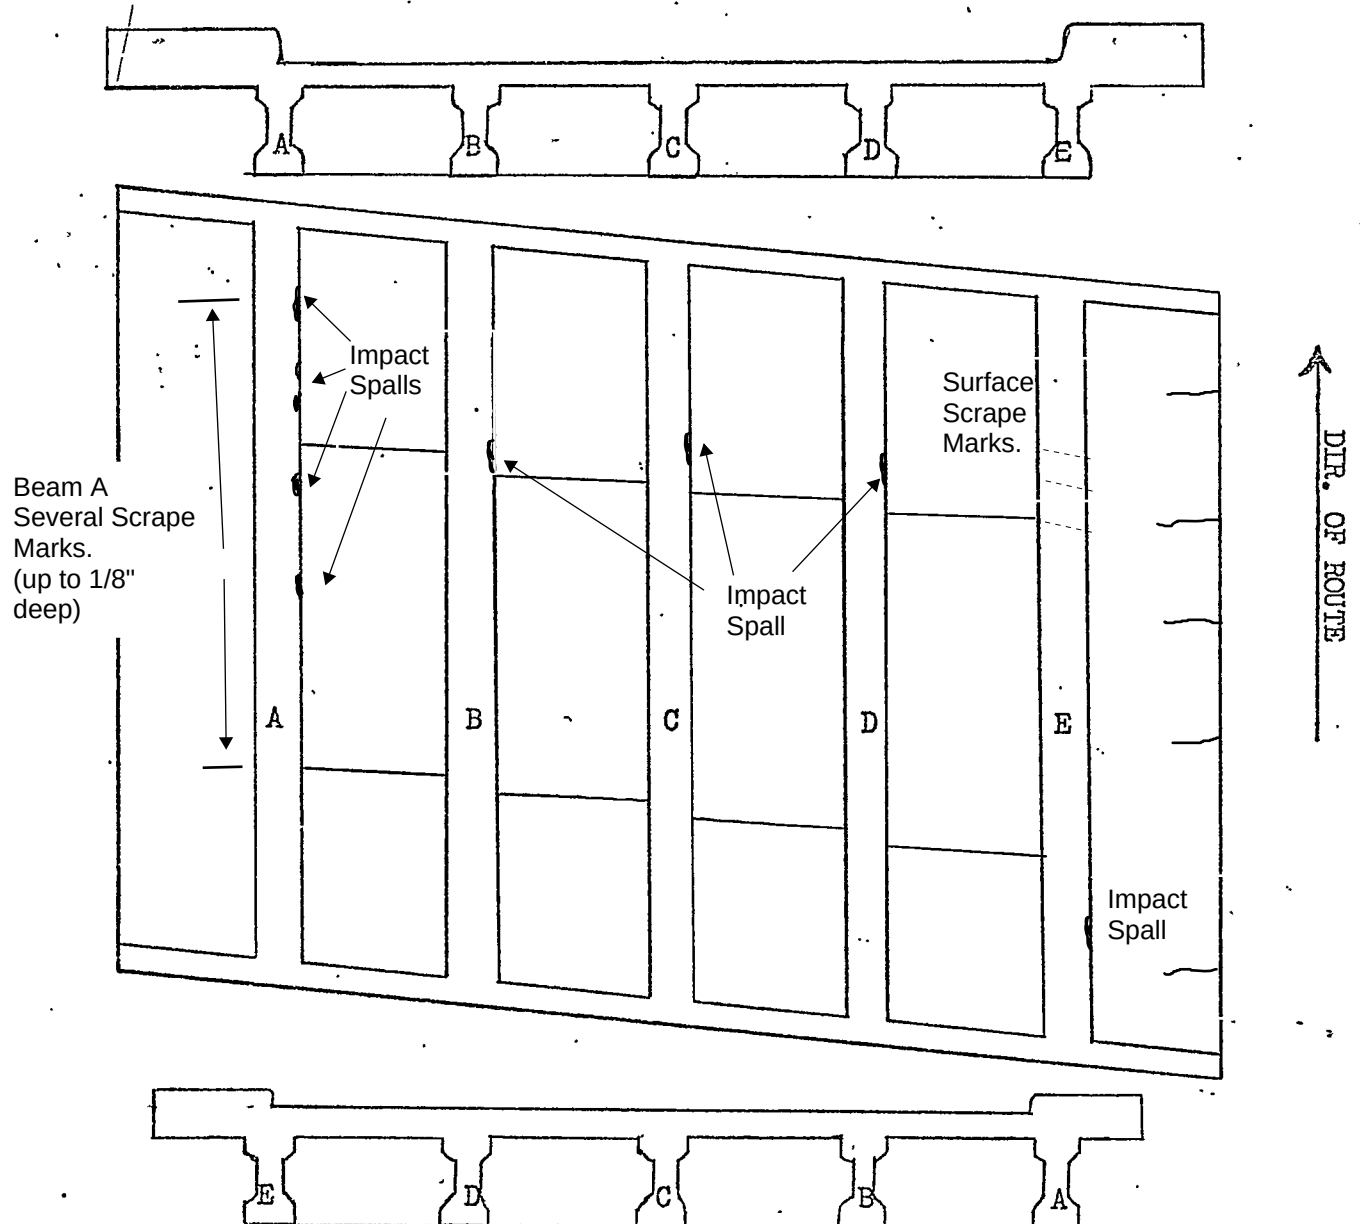
BR. NO. 57 E-40 7.54 SK. 62° LT. SPAN NO. 3

| ELEMENT | RATING | COMMENT |
|---|---|---|
| BOTTOM DECK | (G) F P C | Isolated Inherent hairline cracking with efflorescence |

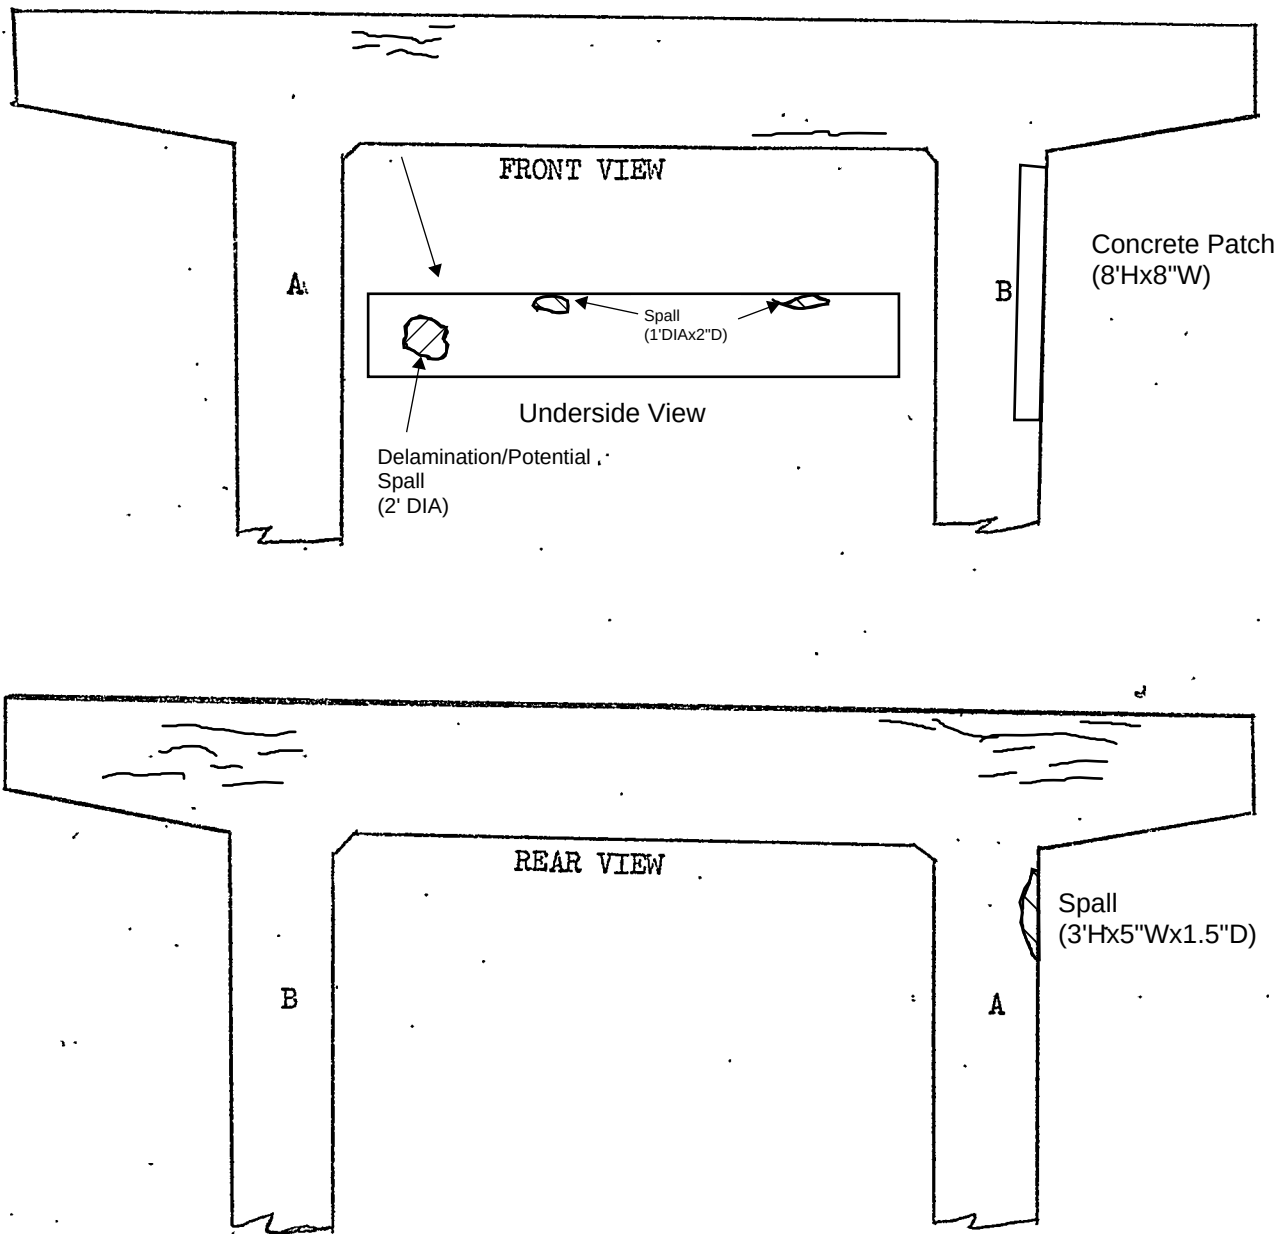
| ELEMENT | | RATING | COMMENT |
|---|---|---|---|
| BEARINGS | | G F <b>P</b> C | Bent bearings typically exhibit moderate pack rust between mating surfaces causing lift at select bearings. Moderate to laminated corrosion typical all bearings |
| CAP | | G F <b>P</b> C | Cap bottom edges and underside have major spalling with several corroded reinforcing bars exposed. Isolated rebars are debonded. |
| COLUMNS | A<br>B | G F <b>P</b> C<br>G F <b>P</b> C | Column A exhibits major spalling with several corroded reinforcing bars exposed. Column B exhibits isolated spalling with up to several corroded reinforcing bars exposed |
| Crashwall | | G <b>F</b> P C | Isolated vertical cracking (up to 1/16"). |

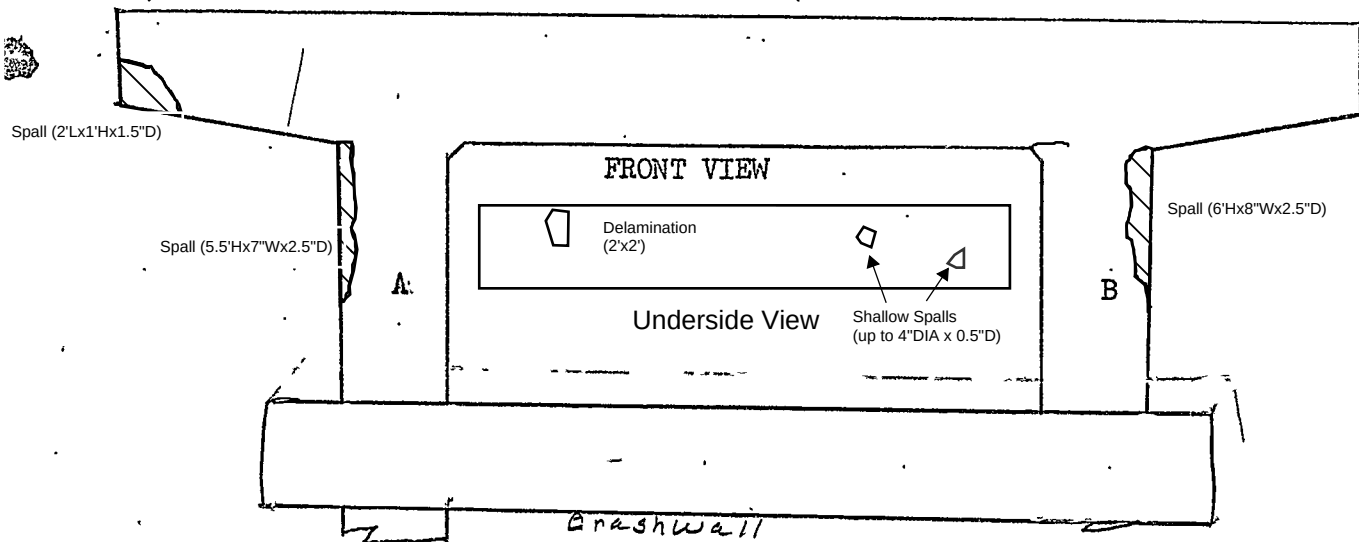
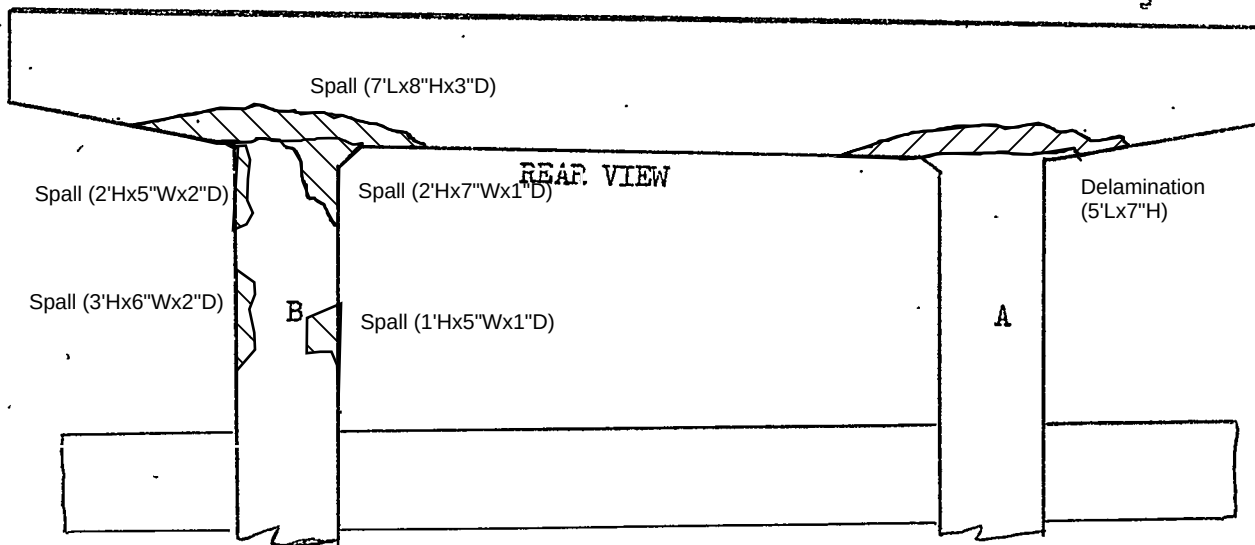
| ELEMENT | | RATING | COMMENT |
|---|---|---|---|
| BEARINGS | | G F P C | Bent bearings typically exhibit moderate pack rust between mating surfaces causing lift at select bearings. Moderate to laminated corrosion typical all bearings |
| CAP | | G F P C | Underside has an isolated delamination with two isolated spalls, top of cap over columns typically has widespread inherent longitudinal cracking with efflorescence. There is rust and water staining present along the cap face |
| COLUMNS | A | G F P C | Columns typically are in fair condition. There is a concrete patch on column B and a spall on column A |

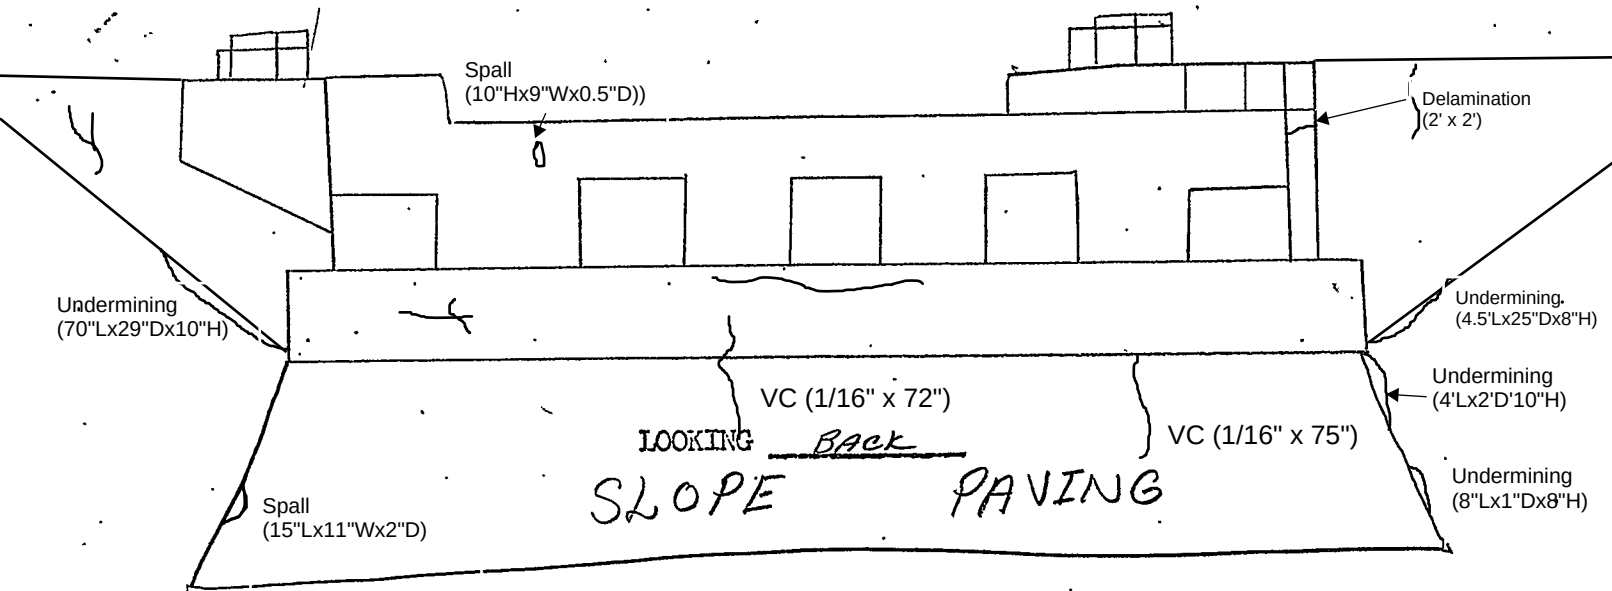
BR. NO. 57 I-40 2.54 sk 62°<sup>th</sup> ABUT NO. 2

Abutment bearings typically exhibit moderate to major pack rust between mating surfaces causing lift at select bearings. Moderate to laminated corrosion typical all bearings

Widespread minor scaling across cap from top to midheight, pedestal pop out spalls typical, inherent isolated cracking at random locations (up to 1/16")

Undermining is present along both wingwalls adjacent to the abutment (up to 70" L x 29" D x 10" H). Inherent isolated cracking at random (up to 1/16")

Undermining of the slope paving is present (up to 4'Lx2'Dx10"H), embankment at stem is separating (2" gap). Slope paving has an isolated spall.
