Region 01, 53 - Loudon County

I-75 Crossing HOPE CREEK

90 - LAST INSPECTION DATE 09/16/2024

521 - OVERALL CONDITION 2 - Fair

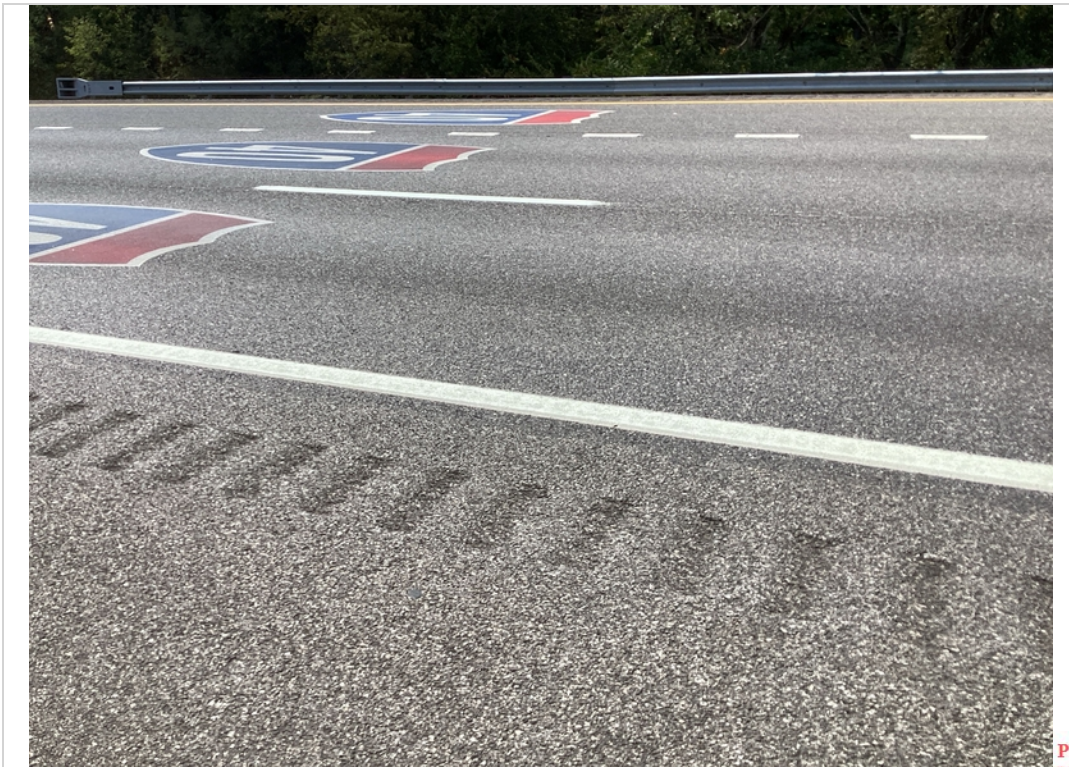
View across culvert wearing surface - northbound lanes

Approach roadway alignment is good. Approach and culvert wearing surface is good, asphalt overlay. Approach rails are good, substandard, and minor collision damage on right. Paddleboard decals are in place at rail terminals.
