Region 03, 94 - Williamson County

THOMPSON STATION RD. E. Crossing NFA 1928 / I65

INSPECTION TEAM'S SUMMARY  
BRIDGE NUMBER 94-1928-0.97  
NON-FA ROUTE 1928 OVER I-65

FEBUARY 03, 2025

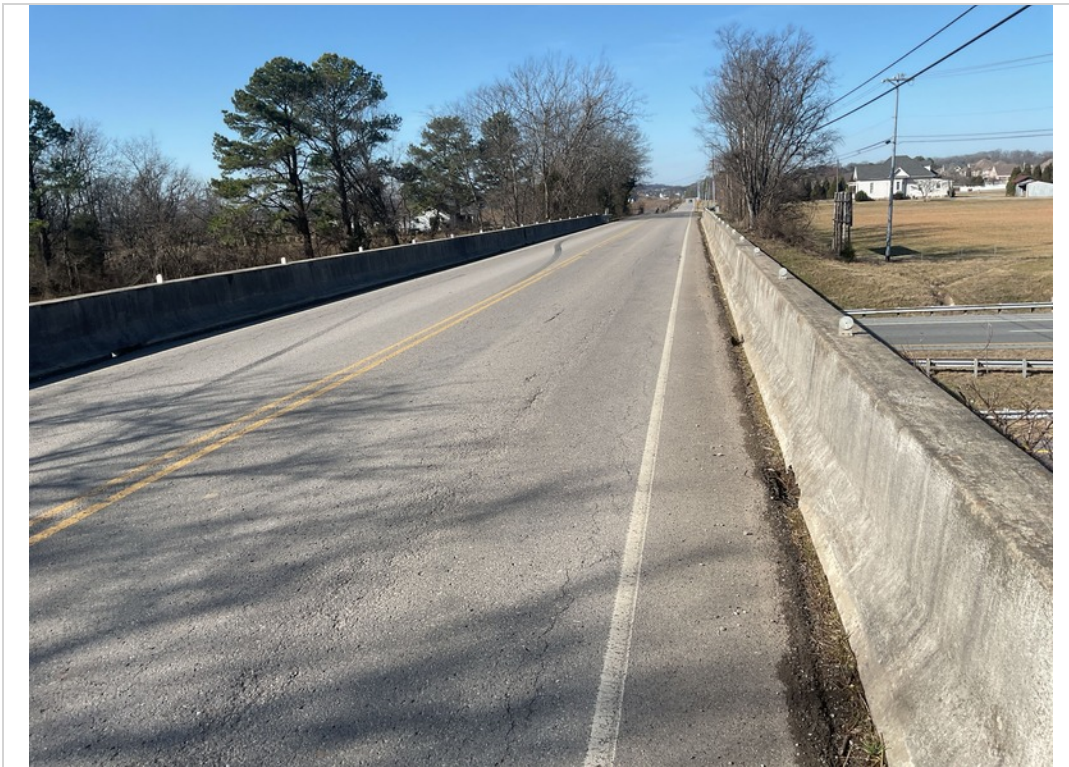
ACROSS TOP DECK

The wearing surface is good with hairline cracks . The parapets are rated good with a few hairline cracks. The deck is rated good.
