I-65 Crossing I65 / SR106 & HARPETH RV

90 - LAST INSPECTION DATE 02/14/2025

| IDENTIFICATION | |
|---|---|
| (8) Structure Number | 94I00650005 |

Bridge 94I00650005 is a 4-span bridge on a 70 degree skew composed of a cast-in-place concrete deck supported by prestressed AASHTO Type II beams. The bridge has a total length of 193'-10.25", an out-to-out width of 44'-0", a roadway width of 40'-5", and carries 2 lanes of traffic. The maximum span length is 52'-10.125". On February 14, 2025 a Michael Baker inspection team performed a 1-day Routine Inspection on the bridge. Korbin Hinson and Sean Bonner inspected the top of deck, superstructure, and substructure from the ground. The weather conditions were sunny and 28 degrees.

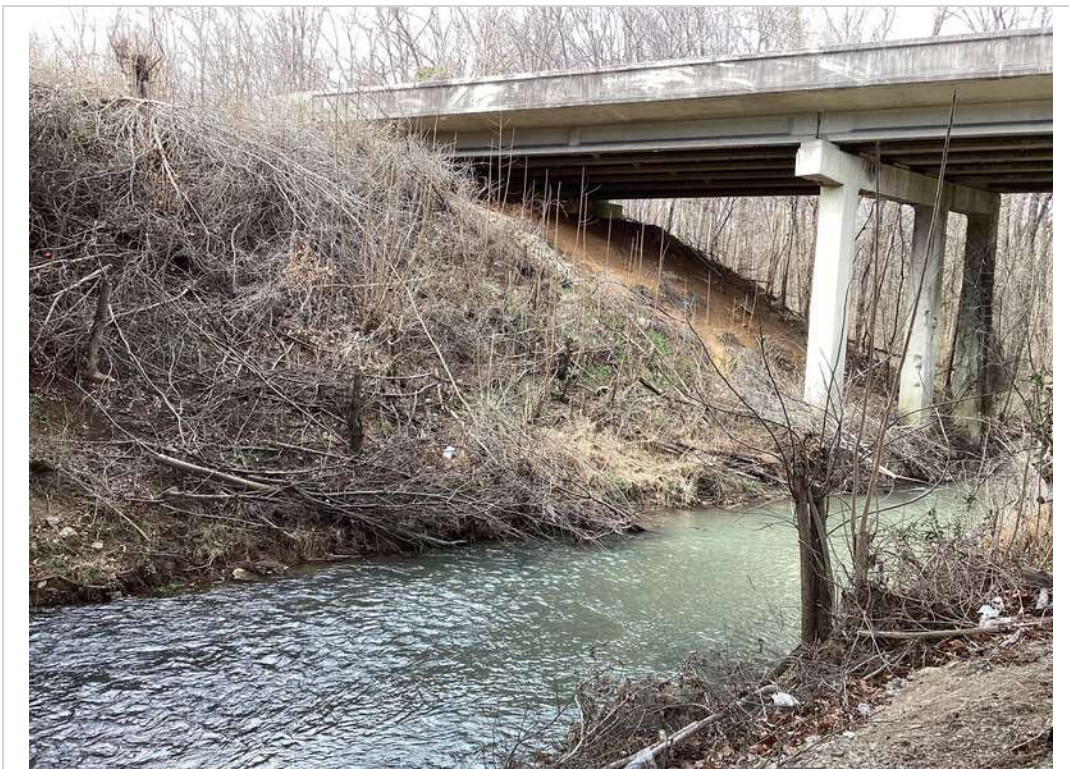
Dead timber debris on Abutment 1 slope

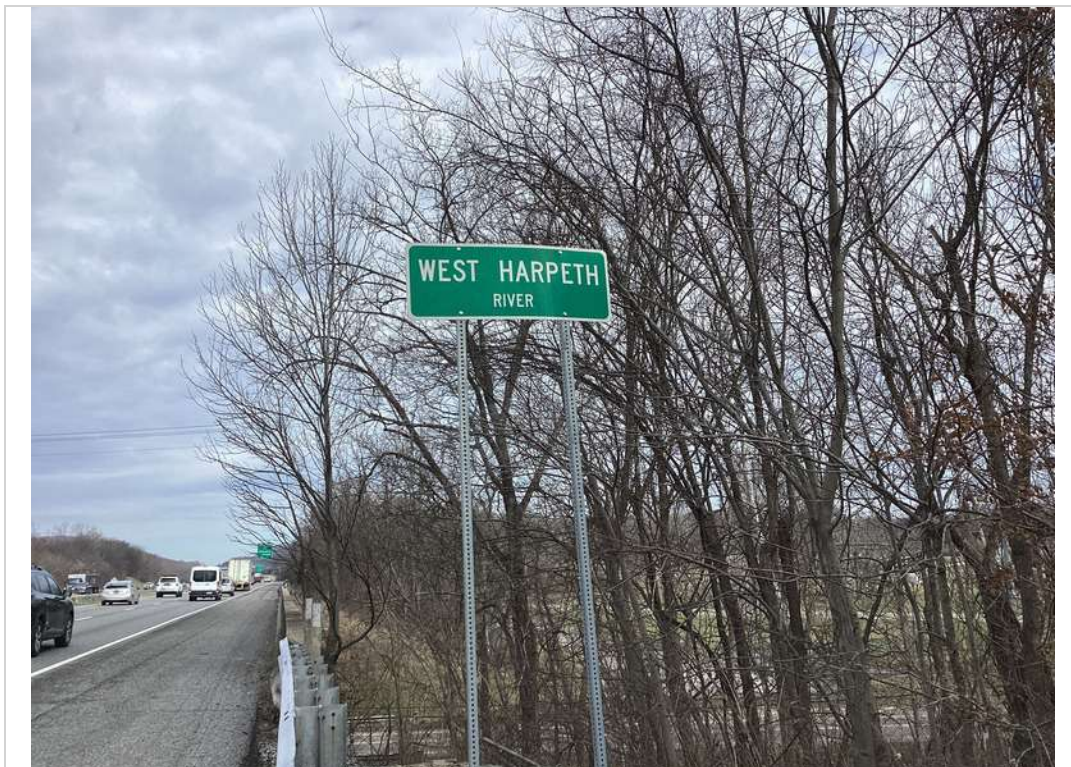
Approach 1 right side sign

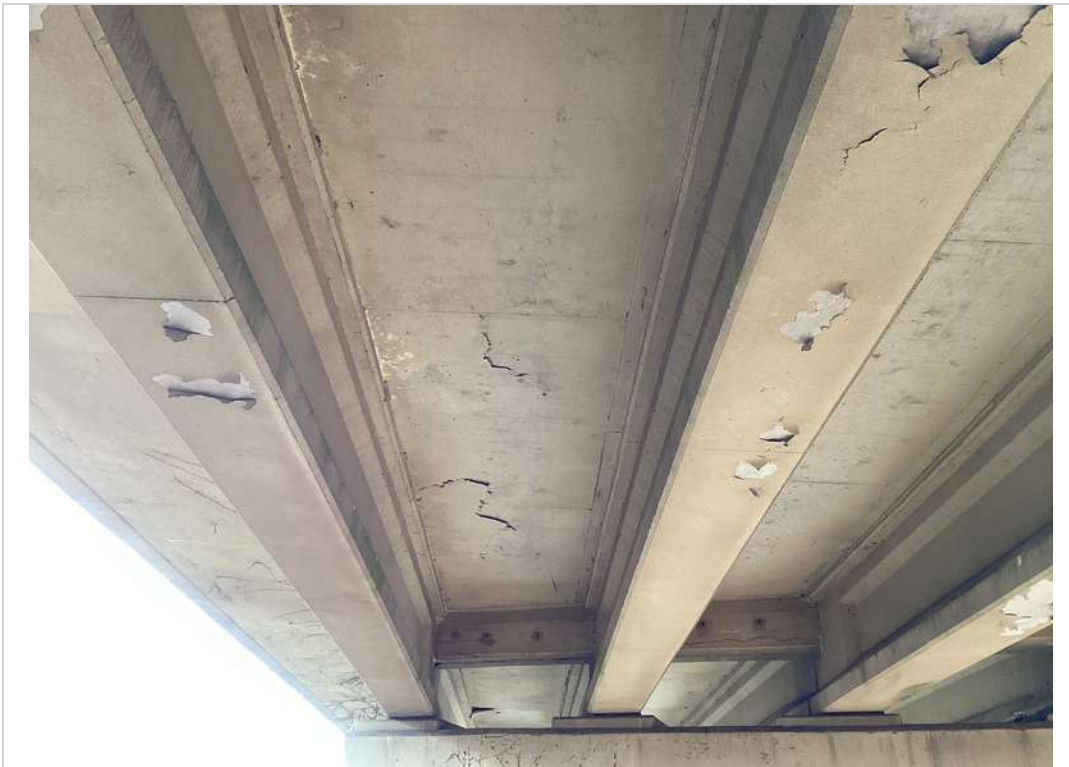
| Wearing Surface Type | | Asphalt | Wearing Surface Depth | 3 |
|---|---|---|---|---|
| <b>Deck - Structural Condition</b> | (Fair) | Span 1 Bay A exhibits widespread major delamination, and Bays B and D have isolated minor delaminations. Span 2 exhibits an isolated spall with exposed rebar in Bay C, and Bays A and D have isolated concrete patches with the timber formwork still in place. The Span 3 left and right overhang exhibit hairline cracks at the beginning and end of the span. The Span 3 left overhang exhibits some spalls with exposed rebar and an isolated area of water staining. Span 3 Bays A and D have some minor delaminations. The Span 4 left overhang exhibits some hairline cracks with efflorescence at the end of the span, and Bay D has an isolated spall with exposed rebar. | | |

Span 1 Bay A delam from midspan to Bent 1

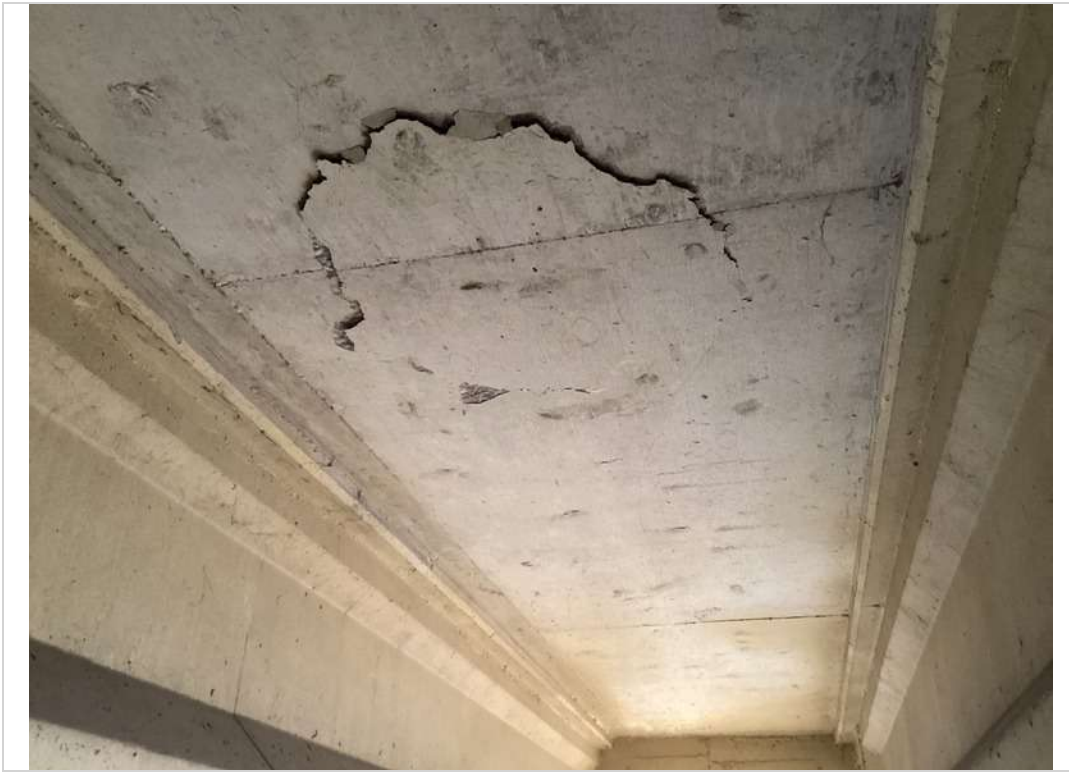
Span 1 Bay B near Abutment 1 delam

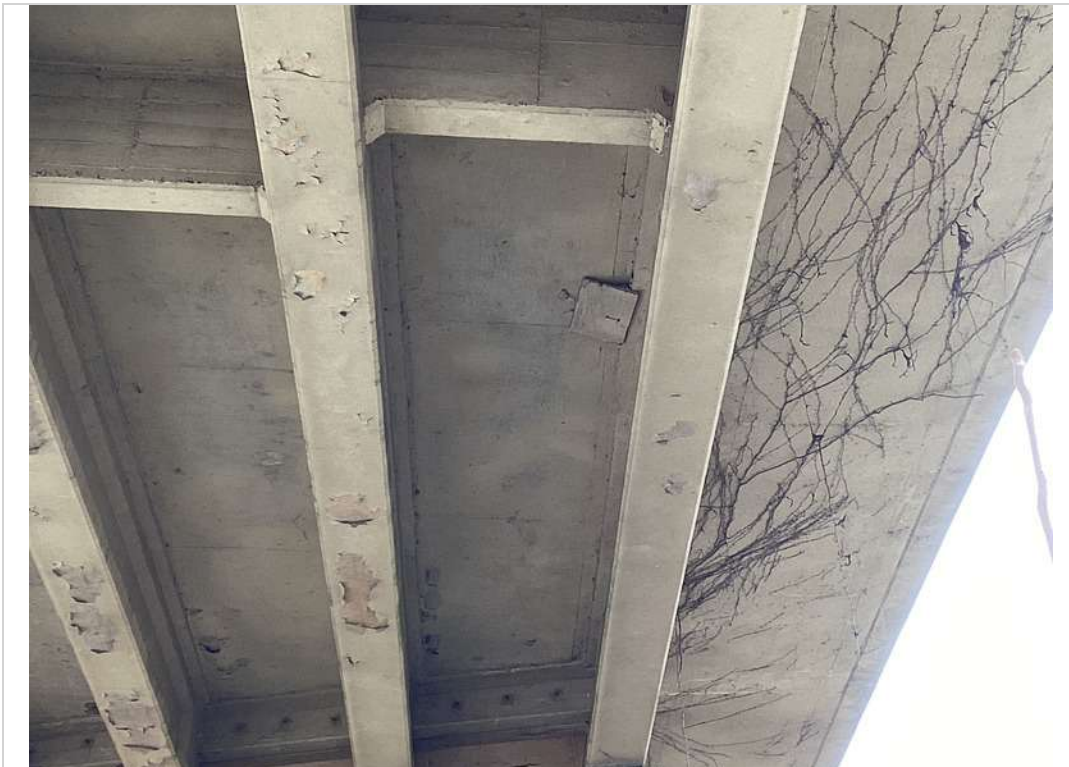
Span 2 Bay A patch with formwork still present. Typical patch for Span 2

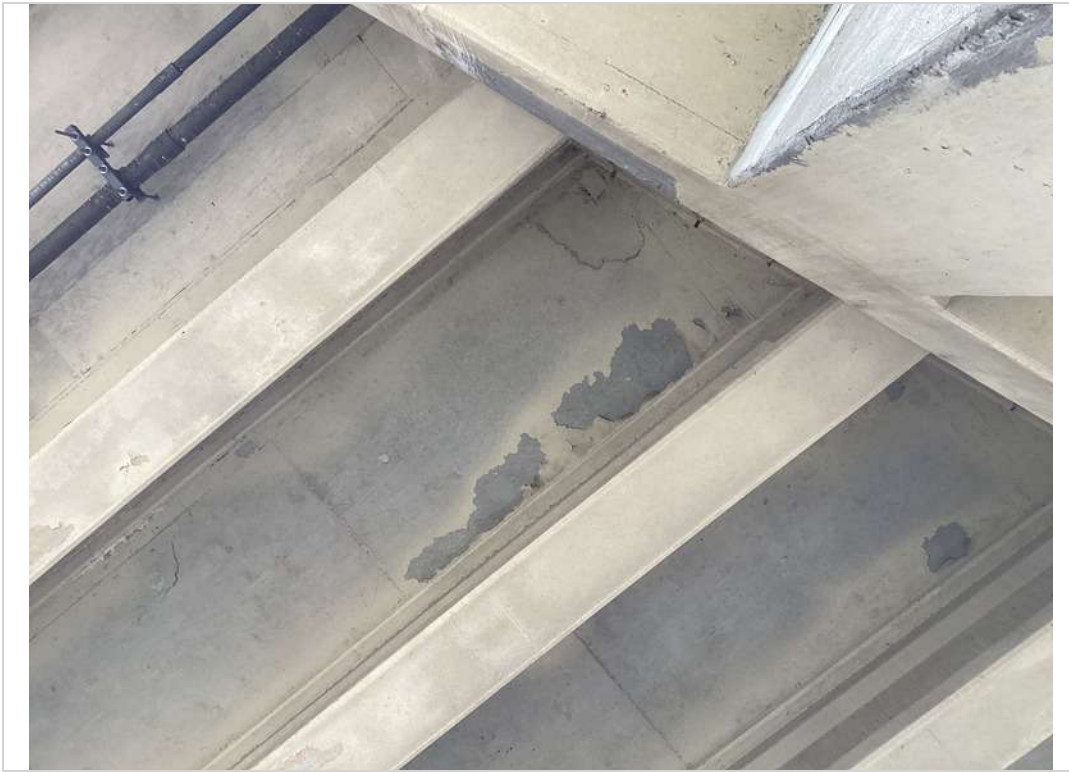
Span 3 Bay D delam

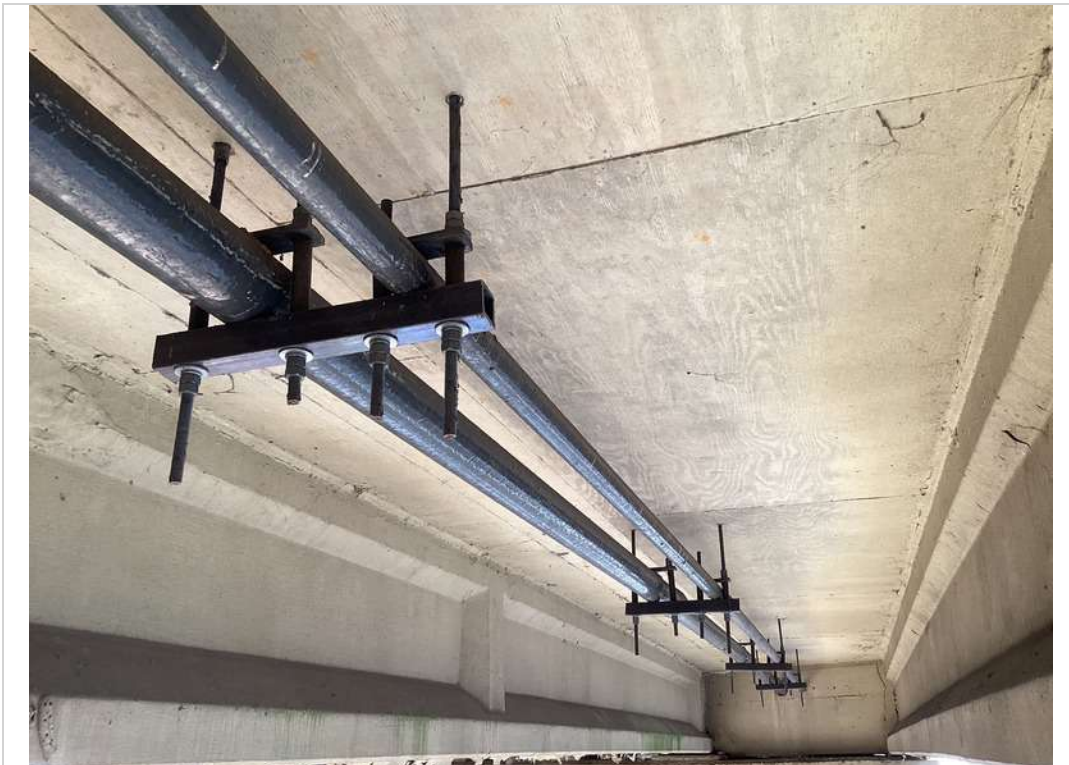
Utility line in Bay E typical all spans

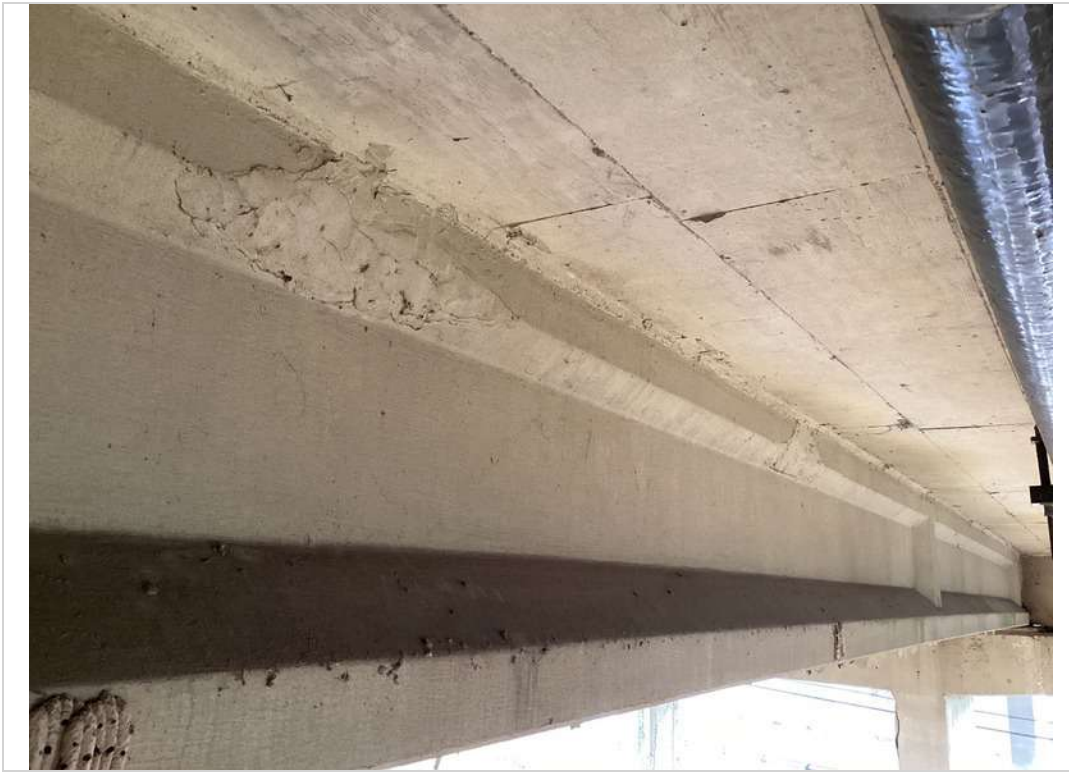
| <b>Girders</b> | (Good) | Beams in Spans 1, 2, and 4 exhibit widespread texture coat failure. Span 1 Beam E has 2 concrete patches on the right face of the beam. Span 3 Beams D, E, and F exhibit light collision scrapes on the bottom flange near midspan. Span 4 Beam E at Bent 3 exhibits an unsound patch on the right web and bottom flange. |

Span 1 Beam E right side top flange patches

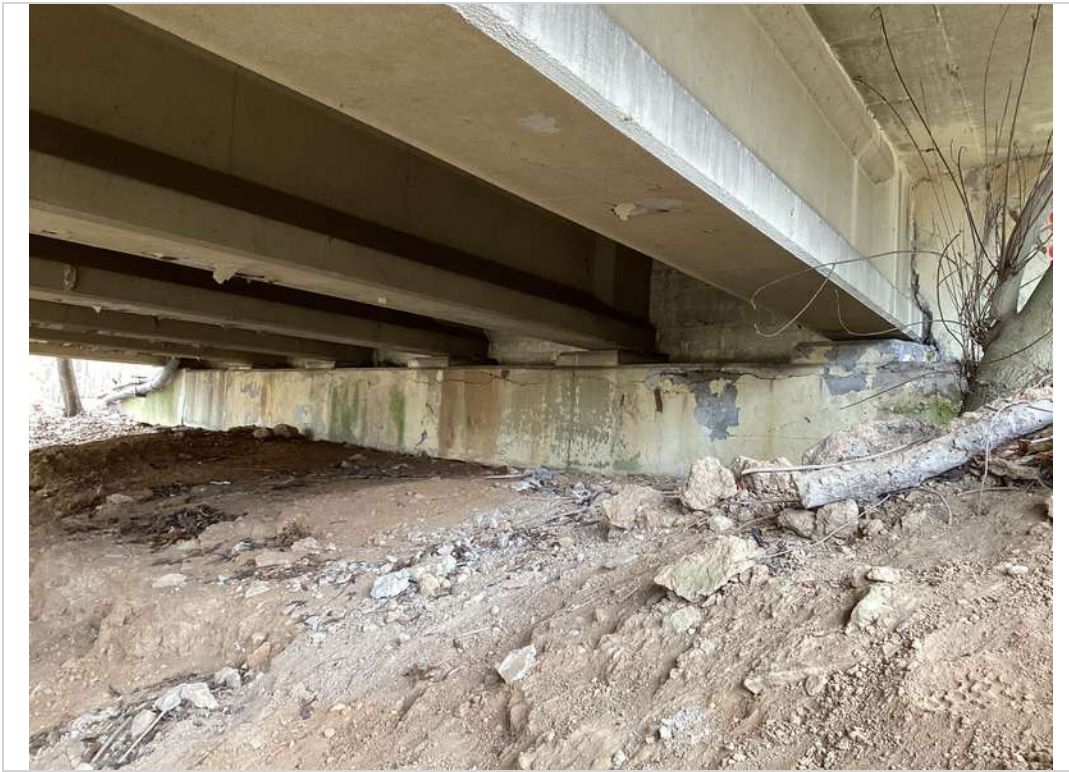
| <b>Abutment Caps</b> | (Poor) | Abutment 1 cap exhibits widespread delamination, some moderate spalls in the top of cap, an isolated wide crack near the widening joint, and isolated honeycombing with exposed rebar. Riser block C at Abutment 1 has a wide crack. Abutment 2 cap exhibits widespread delamination and some wide cracks. |

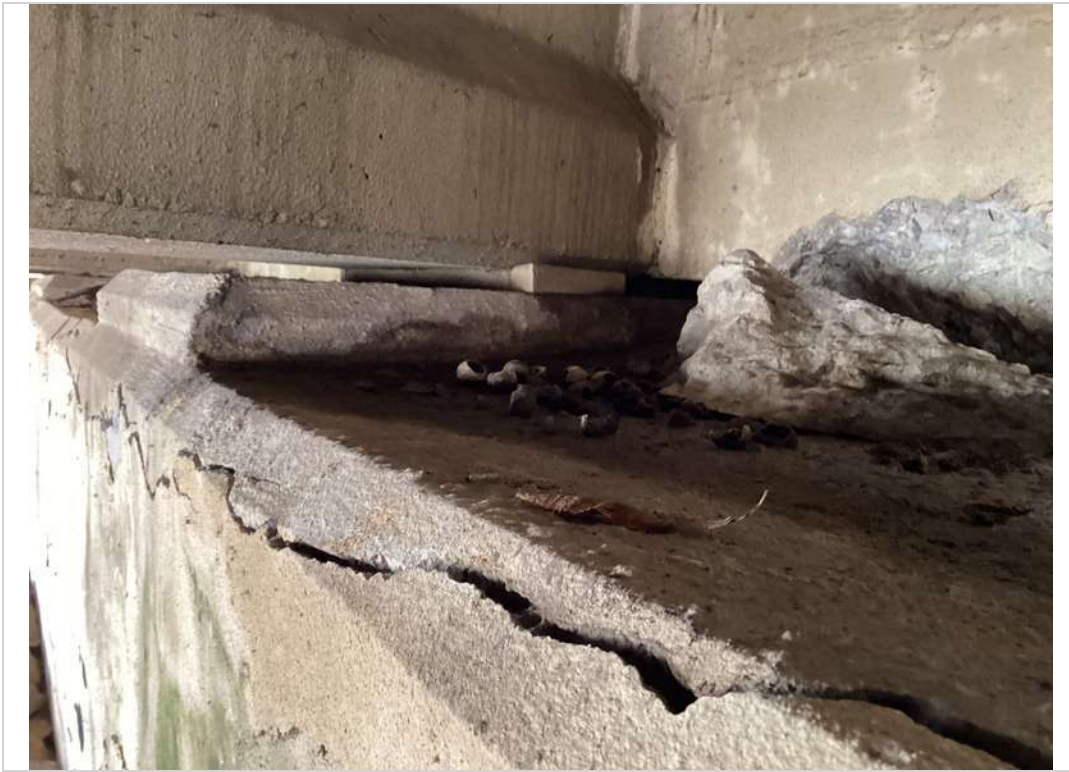
Typical abutment bearing pad

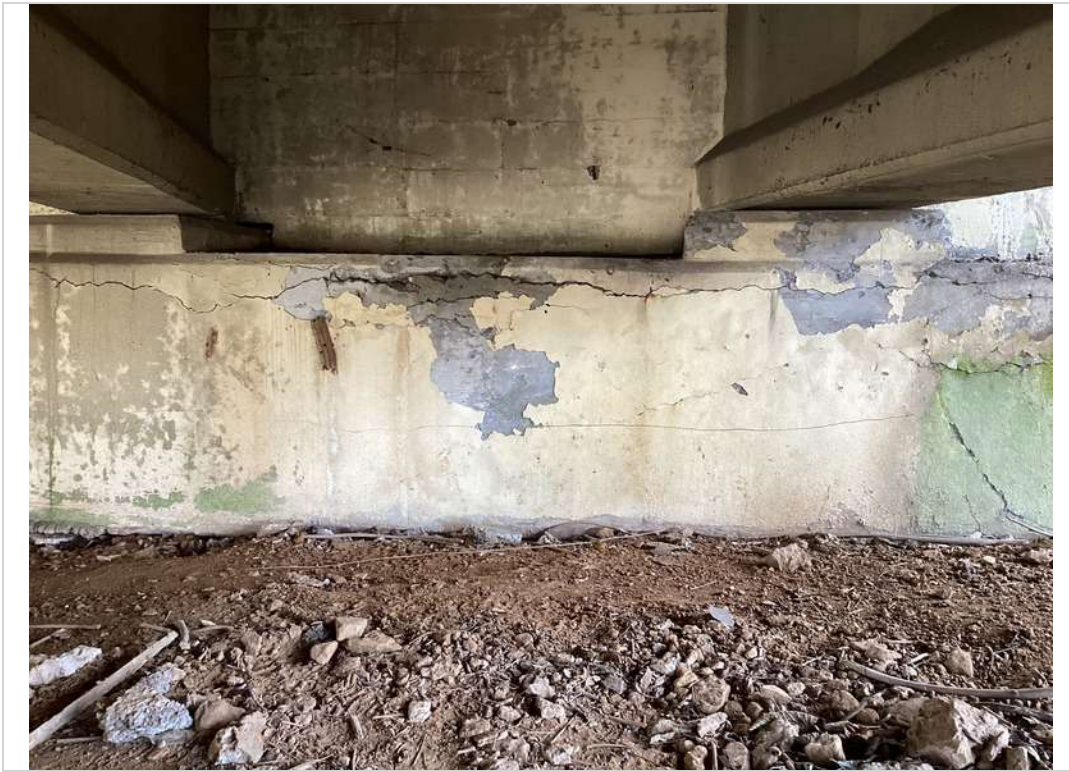
Abutment 1 delam on abutment cap typical throughout

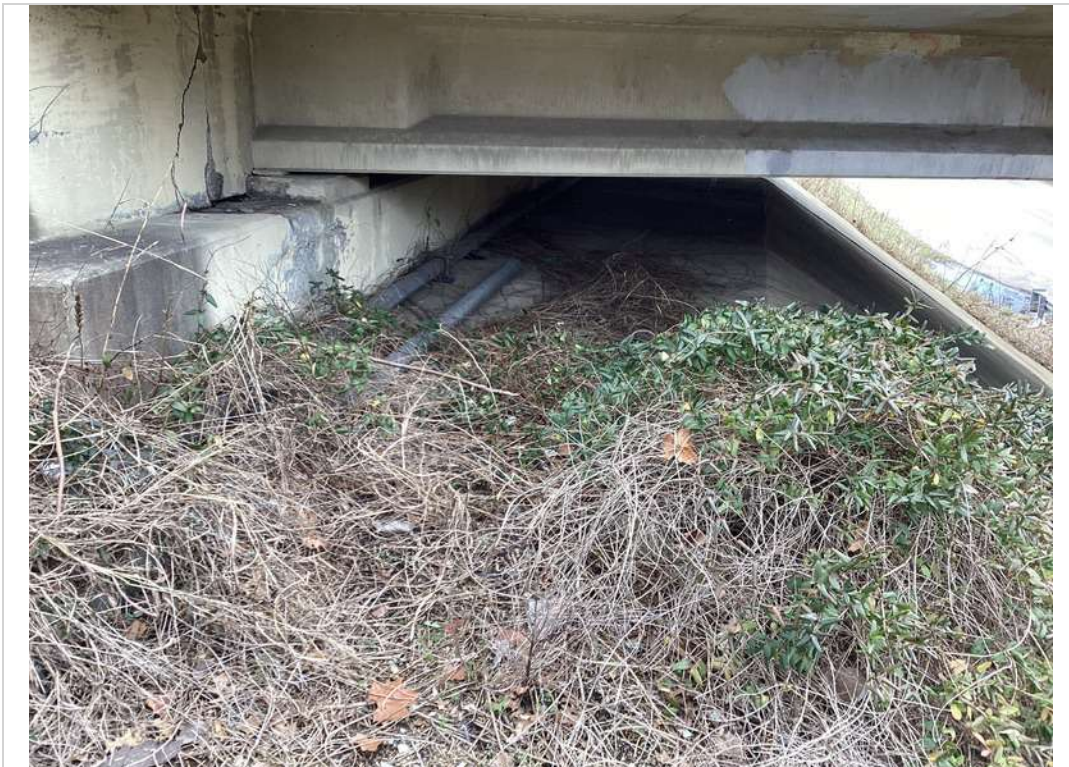
Abutment 2 left end slope paving vegetation growth

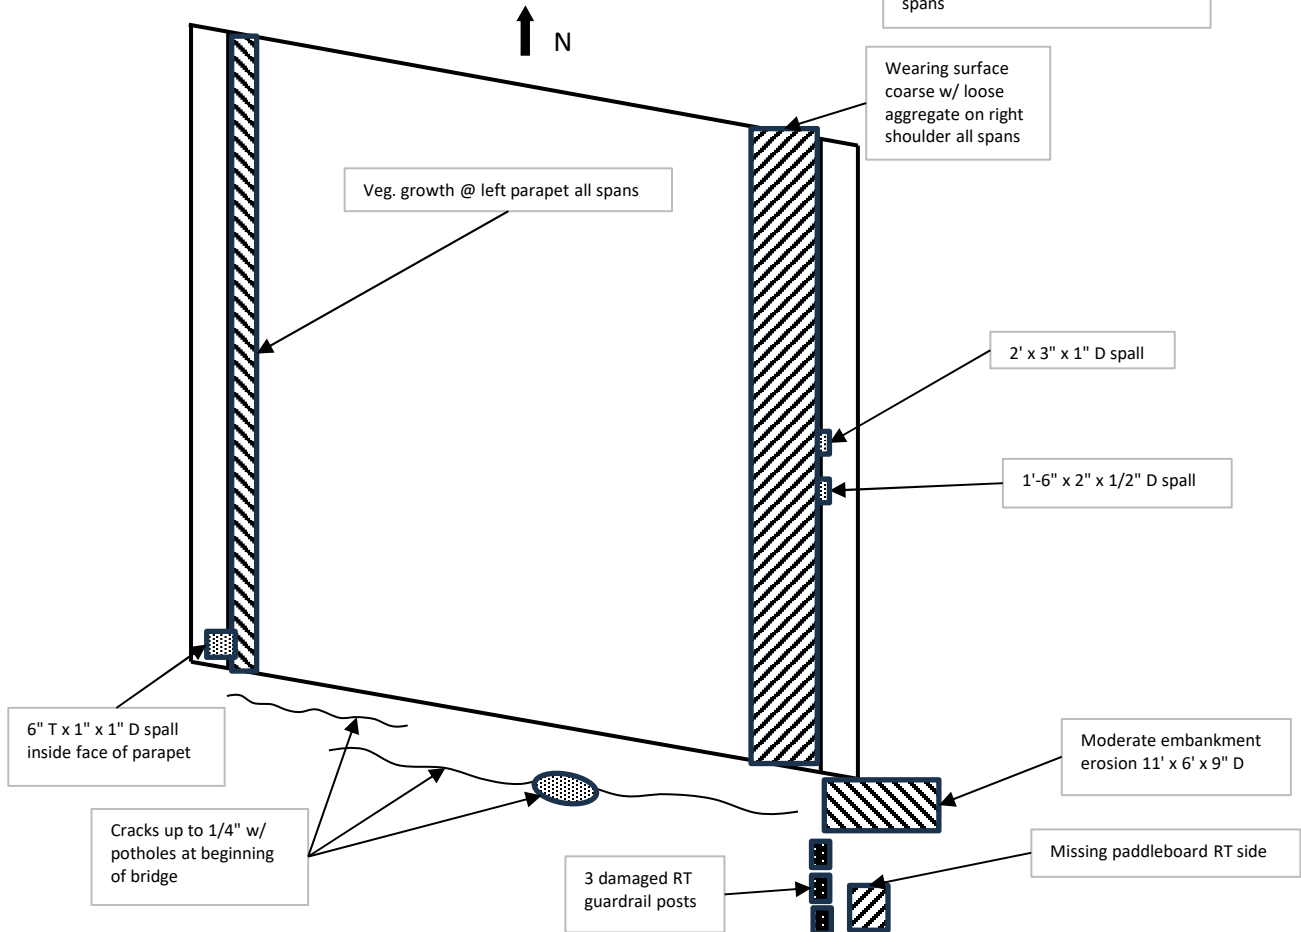
# Top Span No. 1

| W. SURFACE | FAIR | SOME WIDE CR AND ISO POTHLES @ APPROACH |
| | | LOOSE AGG. ON SHOULDER |
| PARAPETS | FAIR | WIDESPREAD WEAR W/ EXP. AGG. |
| | | WIDESPREAD HL CR, SOME MOD SPALLS |

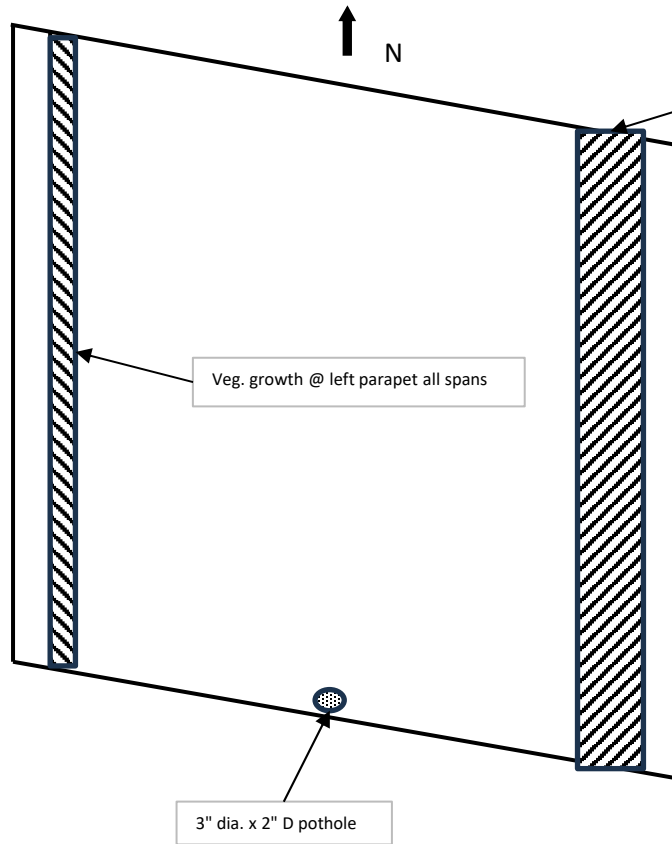
-Widespread wear w/ exp. agg. both parapets all spans  
-Widespread HL cracks in both parapets spaced 1'-6" on avg. all spans

Wearing surface coarse w/ loose aggregate on right shoulder all spans

| | | LOOSE AGGREGATE ON SHOULDER |
| PARAPETS | FAIR | WIDESPREAD WEAR W/ EXP. AGG. |

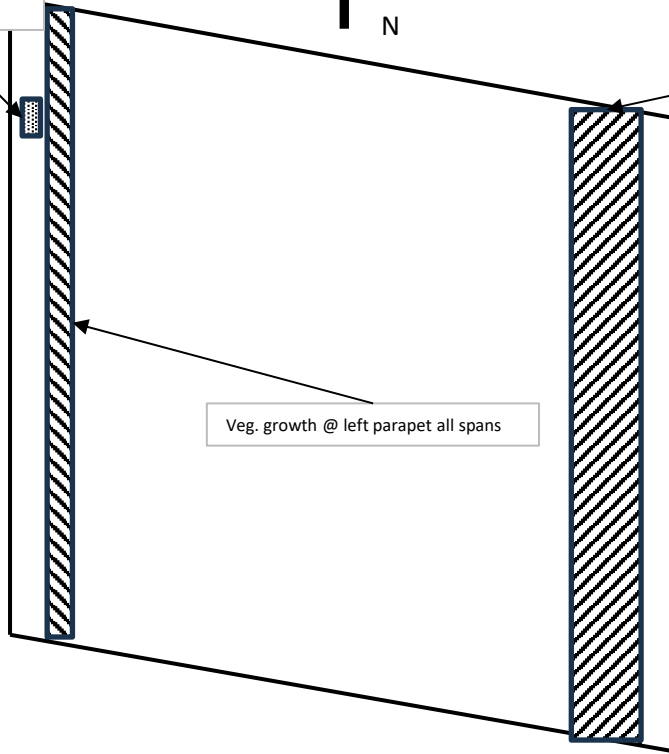
2' X 1' unsound patch  
at top of inside face of  
parapet

Veg. growth @ left parapet all spans

-Widespread wear w/ exp. agg. both  
parapets all spans  
-Widespread HL cracks in both  
parapets spaced 1'-6" on avg. all  
spans

Wearing surface  
coarse w/ loose  
aggregate on right

| W. SURFACE | GOOD | LOOSE AGGREGATE ON SHOULDER |
| PARAPETS | FAIR | WIDESPREAD WEAR W/ EXP. AGG. |

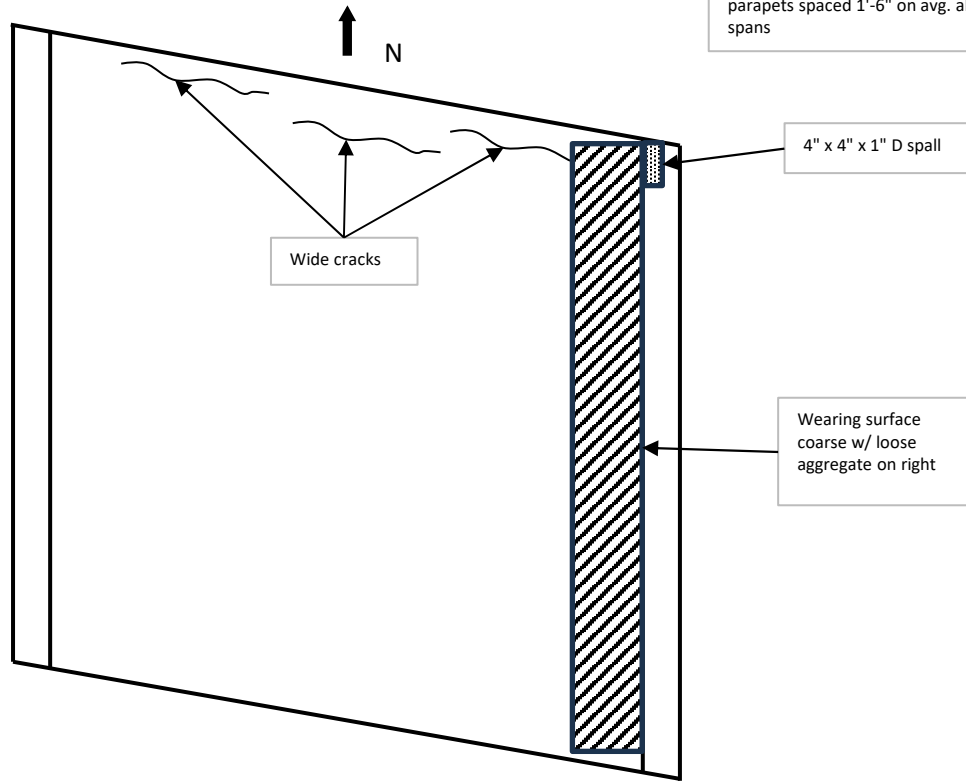
-Widespread wear w/ exp. agg. both  
parapets all spans  
-Widespread HL cracks in both  
parapets spaced 1'-6" on avg. all  
spans

4" x 4" x 1" D spall

Wearing surface  
coarse w/ loose  
aggregate on right

| W. SURFACE | FAIR | SOME WIDE CRACKS |
| | | LOOSE AGGREGATE ON SHOULDER |
| PARAPETS | FAIR | WIDESPREAD WEAR W/ EXP. AGG. |
| | | WIDESPREAD HL CR AND ISO MINOR SPALL |

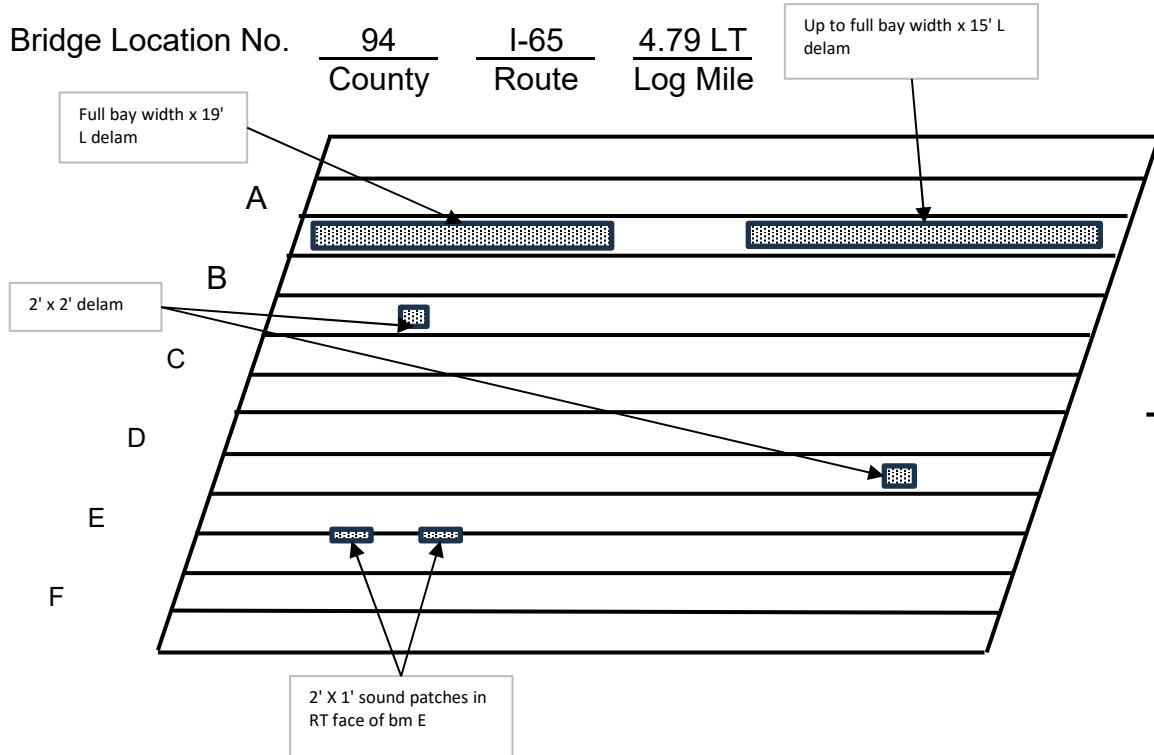
| DECK | | FAIR | SOME DELAMS |
| BEAM | A | GOOD | WIDESPRED TXT COAT FAILURE ALL BEAMS |
| | BACK | POOR | WIDESPREAD DELAMS, SOME SPALLS |
| | AHEAD | FAIR | SOME WIDE CRACKS IN BAYS A,B,C,E |

| Date Added | Recommendation | Priority |
|---|---|---|
| 02/14/2025 | REPAIR DECK DELAMINATION IN SPAN NO. 1 BAY "A" | 3 |

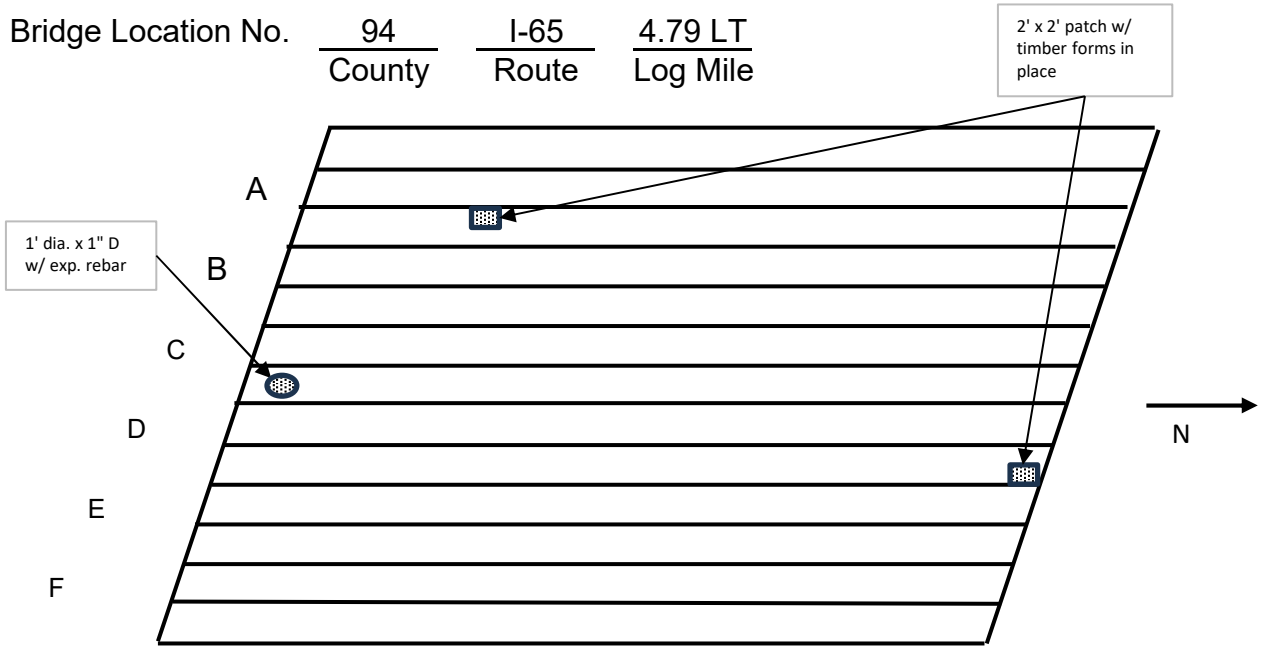
| DECK | FAIR | ISO MOD. SPALL |
| | | SOME FAINT FAILURE |
| BACK | FAIR | SOME SPALLS W/ EXP. REBAR |
| AHEAD | FAIR | SOME WIDE CRACKS |

6" x 3" x 1" D spalls w/  
exp. rebar

4' x 2' water staining

Scrapes from  
collision damage on  
bms D, E and F

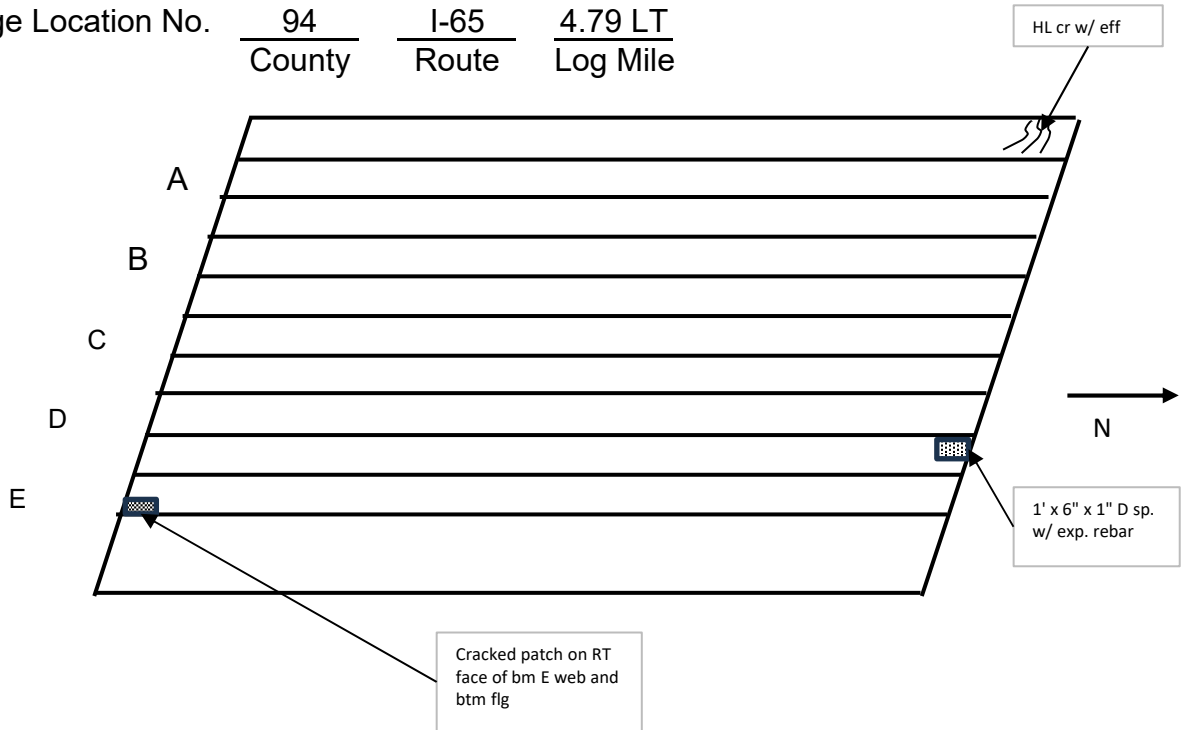
| DECK | FAIR | ISO SP. W/ EXP. REB. & ISO HL CR W/ EFF |

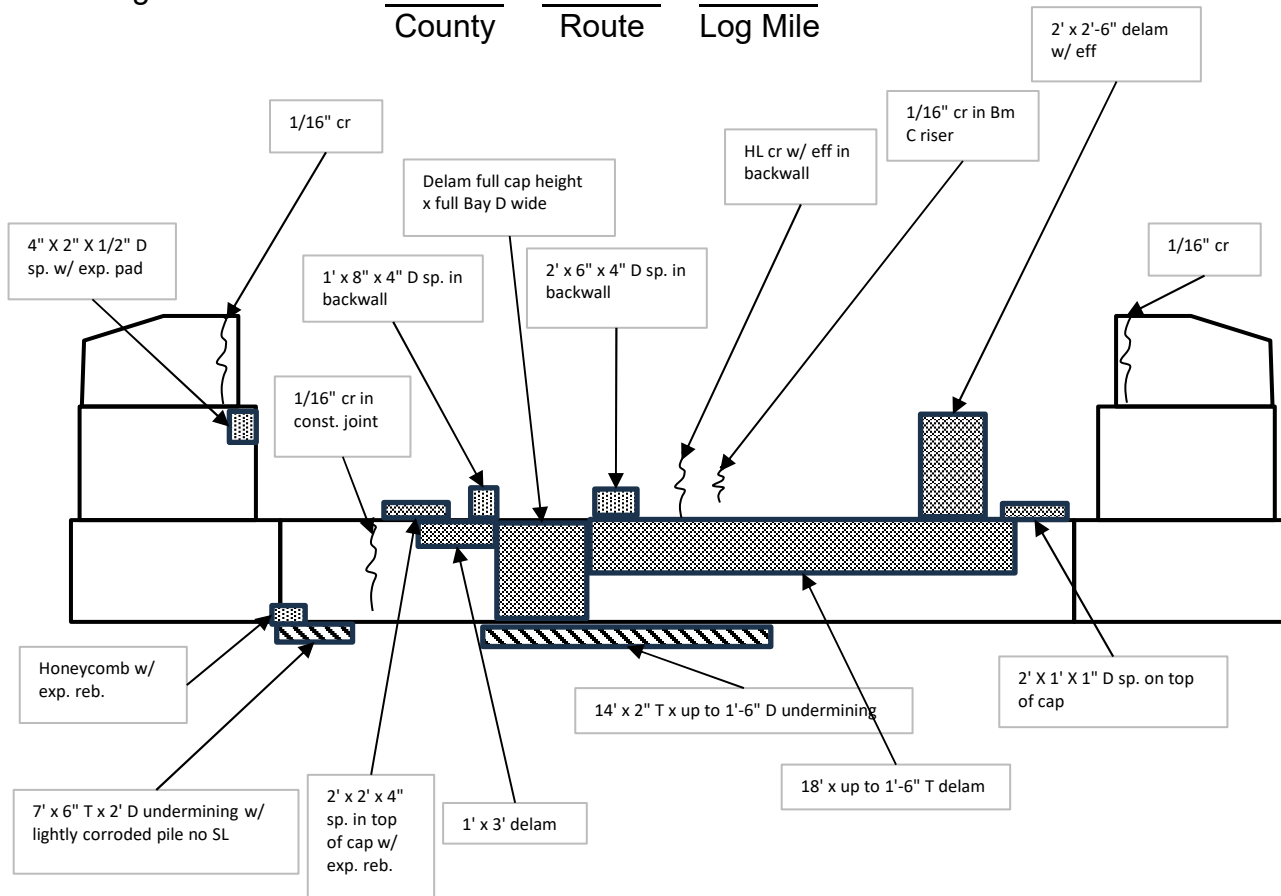
| BEARINGS | GOOD | ELASTOMERIC |
| CAP | POOR | WIDESPRED MOD DELAM,SOME MOD SPALL, ISO WIDE CR |
| LT WING | FAIR | ISO WIDE CRACK |
| RT WING | FAIR | ISO WIDE CRACK & SPALL W/ EXP. FIBERBOARD PAD |
| PILE | FAIR | 1 EXPOSED PILE W/ SURFACE CORROSION |

| Date Added | Recommendation | Priority |
|---|---|---|
| 07/11/2005 | REPAIR CAPBEAM AT ABUTMENTS NO.1 AND 2 | 2 |
| 02/14/2025 | REPAIR UNDERMINING AT ABUTMENT NO. 1 | 3 |

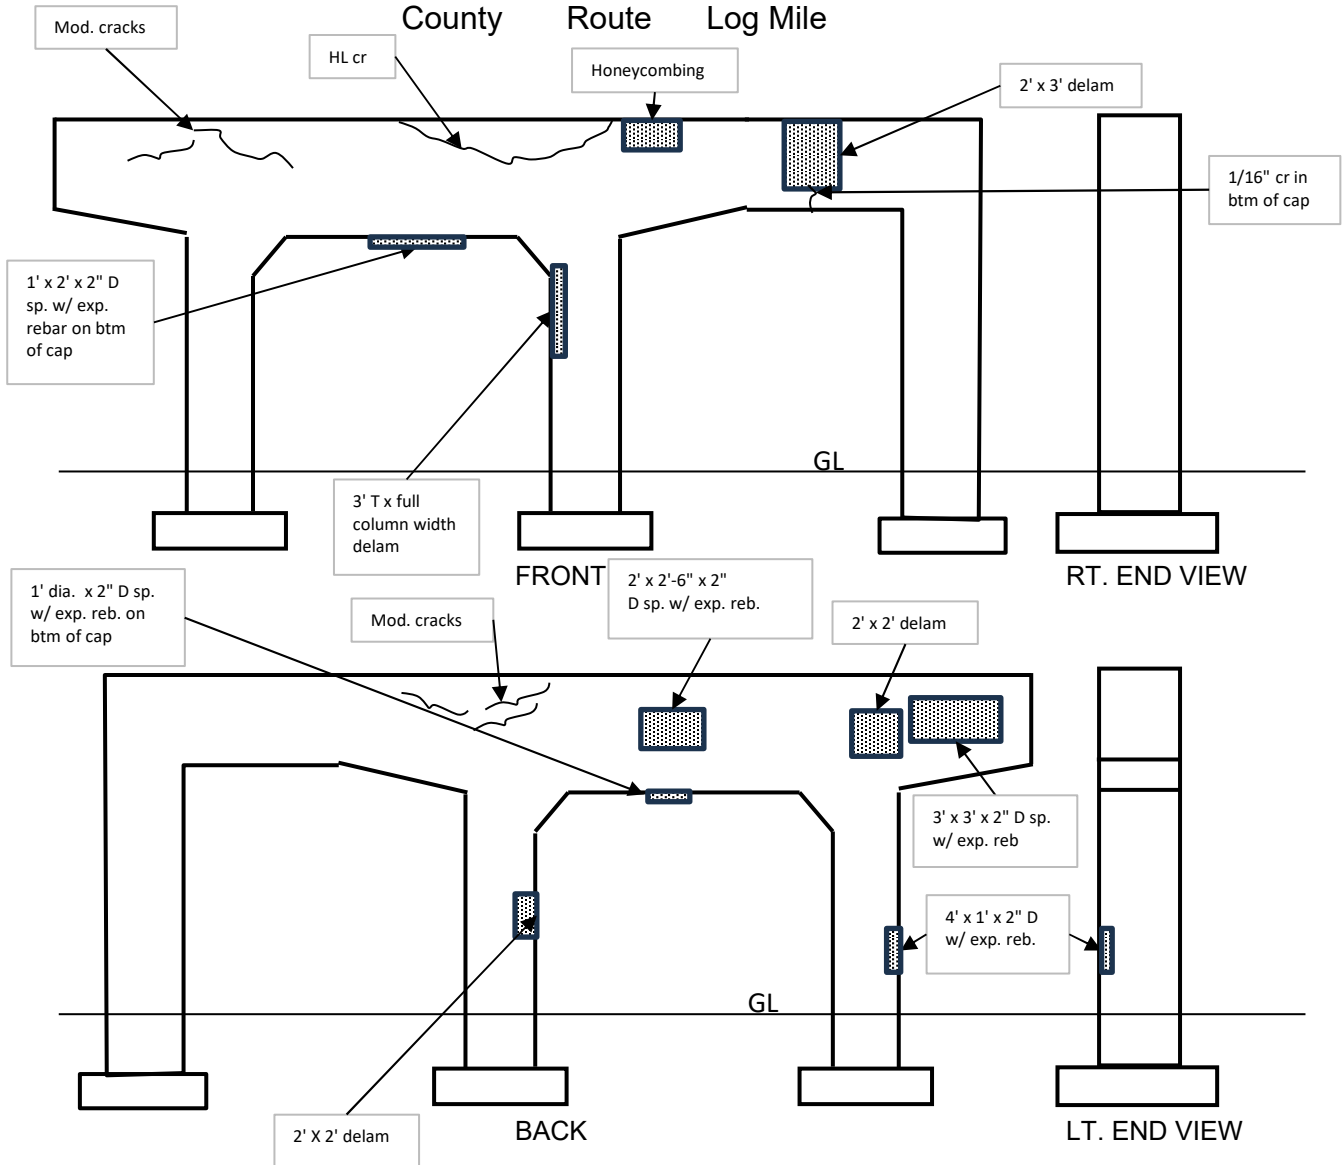
| CAP | FAIR | SOME MOD SP. W/ EXP. REB. & MOD DELAM |
| | | SOME MOD CR AND HL CR |
| COLUMN A | FAIR | ISO MOD SPALL W/ EXP. REBAR |

| Date Added | Recommendation | Priority |
|---|---|---|
| 07/11/2005 | REPAIR CAPBEAM AT ALL BENTS. | 3 |
| 02/14/2025 | REPAIR COLUMN "B" AT BENT NO. 1 | 3 |

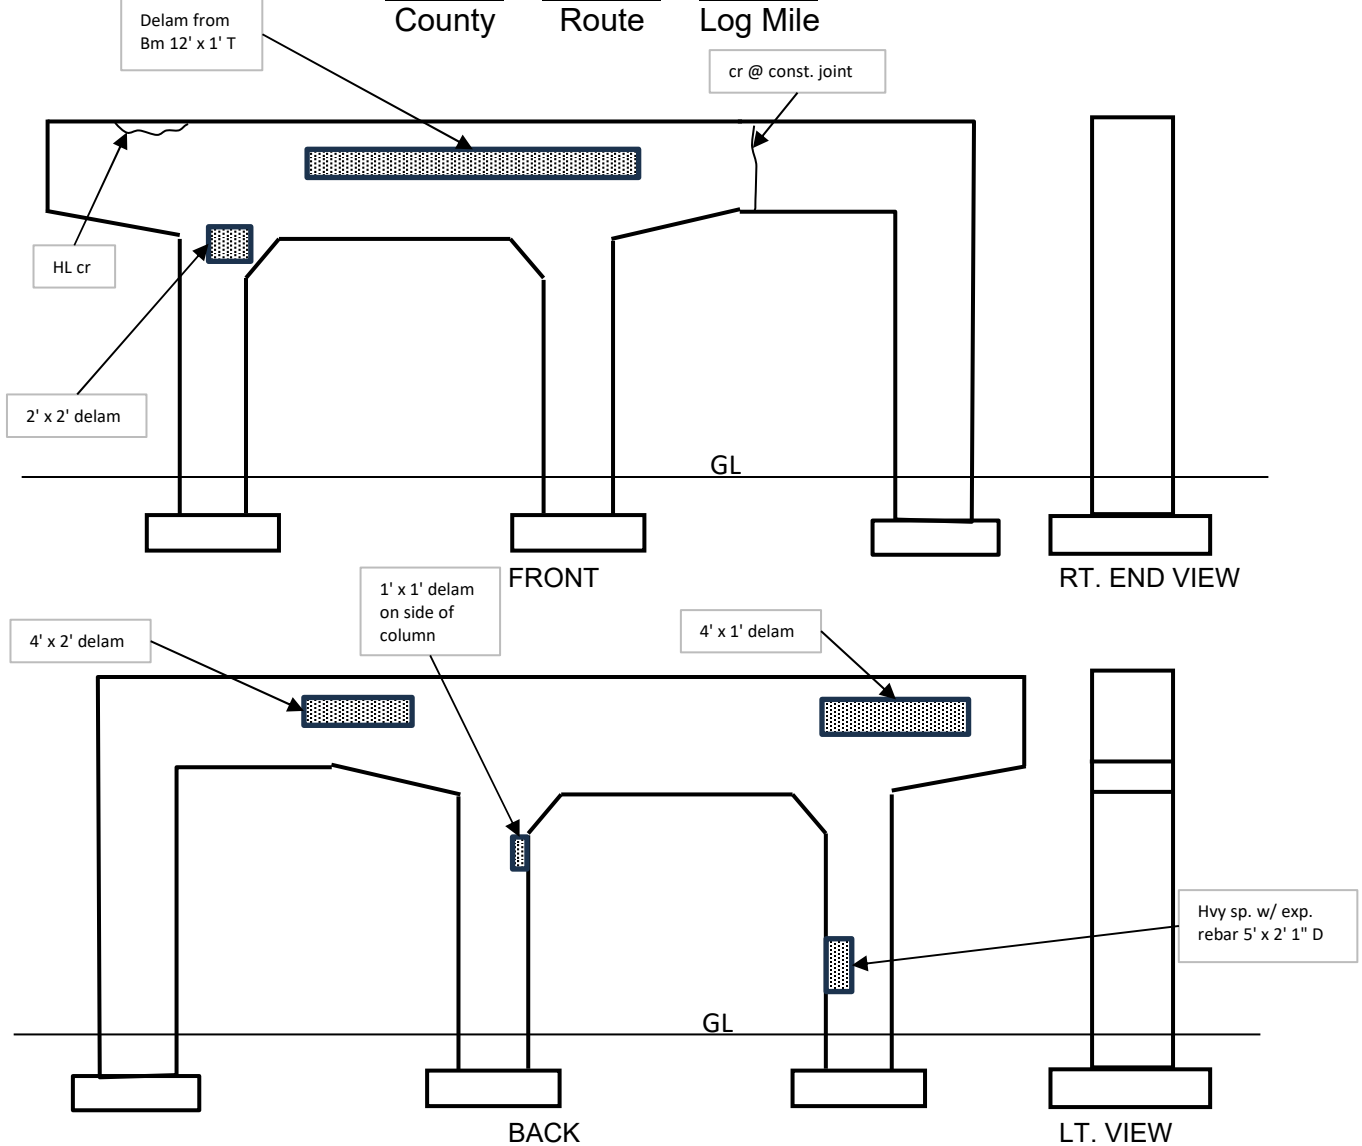
| CAP | FAIR | SOME MOD DELAM |
| | | ISO WIDE CR AND HL CR |

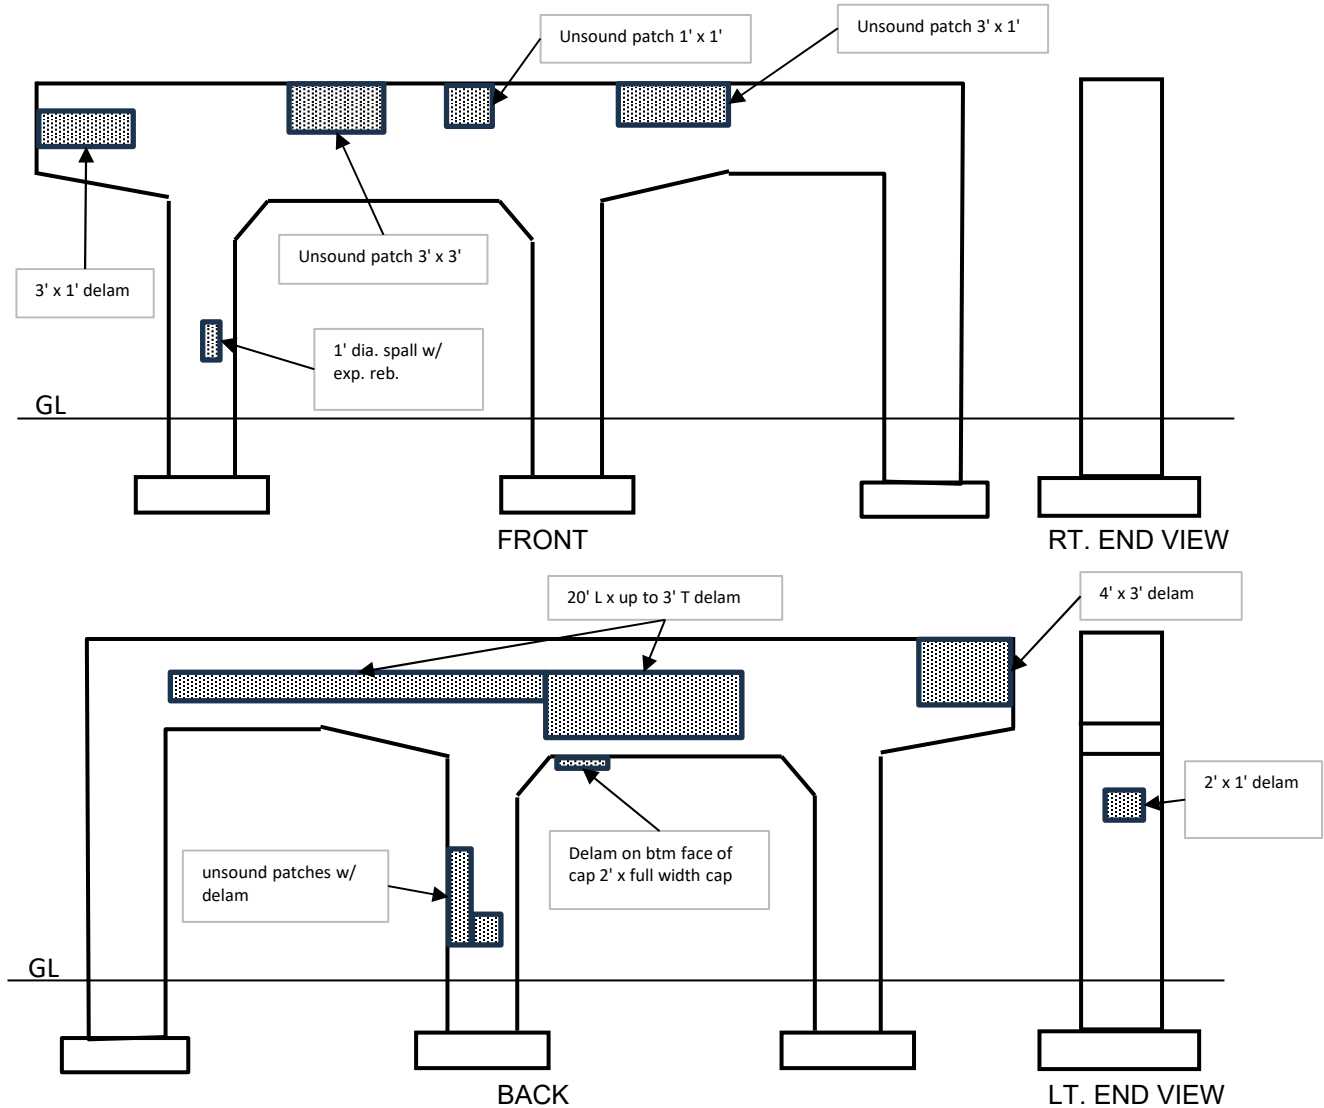
| CAP | FAIR | WIDESPREAD MOD DELAM |
| COLUMN A | FAIR | ISO MOD SP. W/ EXP. REBAR |

| Date Added | Recommendation | Priority |
|---|---|---|
| 02/14/2025 | REPAIR COLUMN "A" AND "B" AT BENT NO. 3 | 3 |
