I-65 Crossing I65 / SR106 & HARPETH RV

90 - LAST INSPECTION DATE 02/14/2025

| IDENTIFICATION | |
|---|---|
| (8) Structure Number | 94I00650005 |

Bridge 94I00650005 is a 4-span bridge on a 70 degree skew composed of a cast-in-place concrete deck supported by prestressed AASHTO Type II beams. The bridge has a total length of 193'-10.25", an out-to-out width of 44'-0", a roadway width of 40'-5", and carries 2 lanes of traffic. The maximum span length is 52'-10.125". On February 14, 2025 a Michael Baker inspection team performed a 1-day Routine Inspection on the bridge. Korbin Hinson and Sean Bonner inspected the top of deck, superstructure, and substructure from the ground. The weather conditions were sunny and 28 degrees.

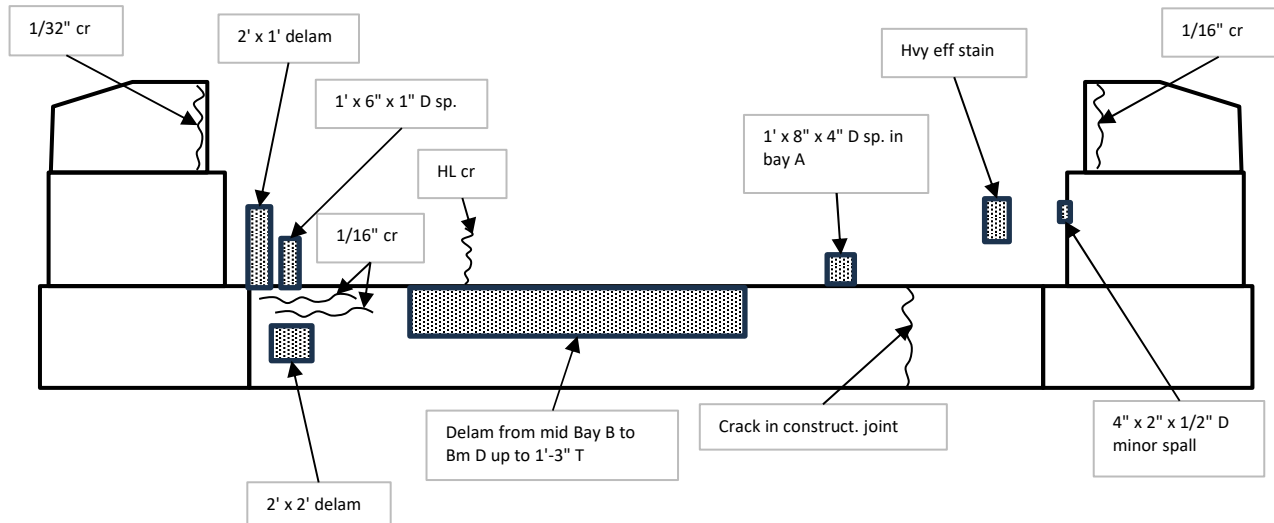
| BEARINGS | GOOD | ELASTOMERIC |
| CAP | POOR | WIDESPREAD MOD DELAM, ISO WIDE CR |
| LT WING | FAIR | ISO MOD CRACK |
| RT WING | FAIR | ISO WIDE CRACK, ISO MINOR SPALL |
| SLOPE | FAIR | SOME WIDE CRACKS AND MOD SPALLS |
| BACKWALL | FAIR | ISO MOD SPALLS & DELAM, ISO HVY EFF |

| Date Added | Recommendation | Priority |
|---|---|---|
| 07/11/2005 | REPAIR CAPBEAM AT ABUTMENTS NO.1 AND 2 | 2 |
