I-65 Crossing I65 / SR106 & HARPETH RV

90 - LAST INSPECTION DATE 02/14/2025

| IDENTIFICATION | |
|---|---|
| (8) Structure Number | 94I00650006 |

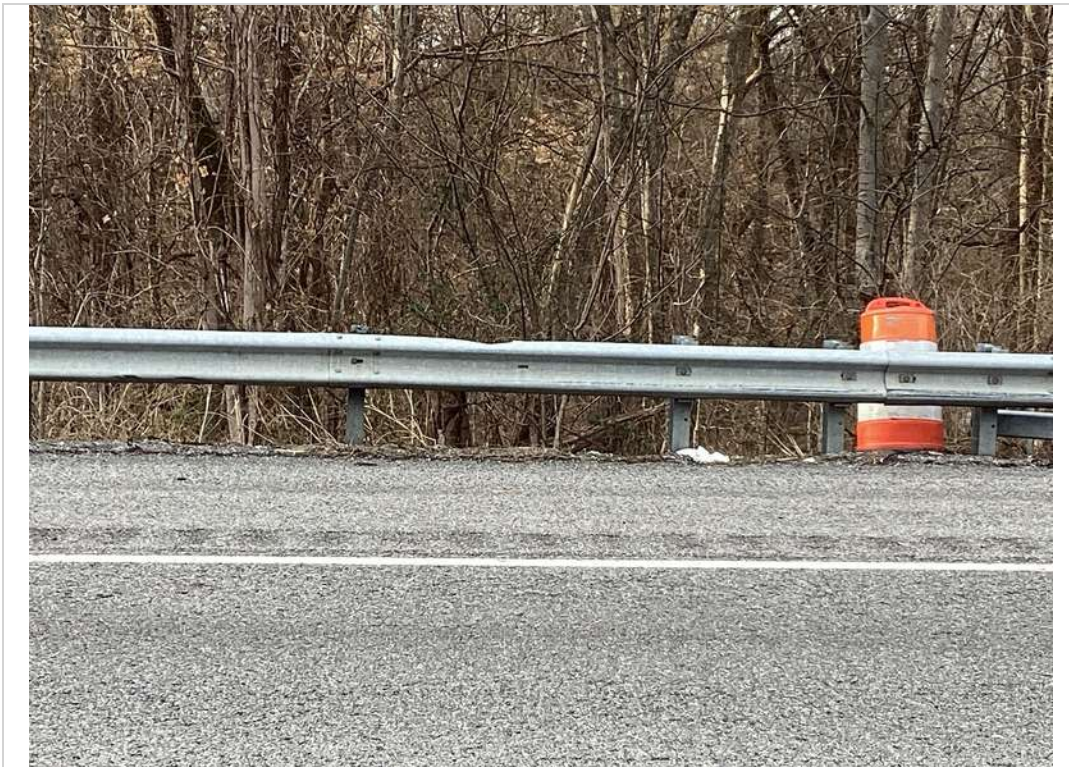
Approach 1 distortion in left side guardrail

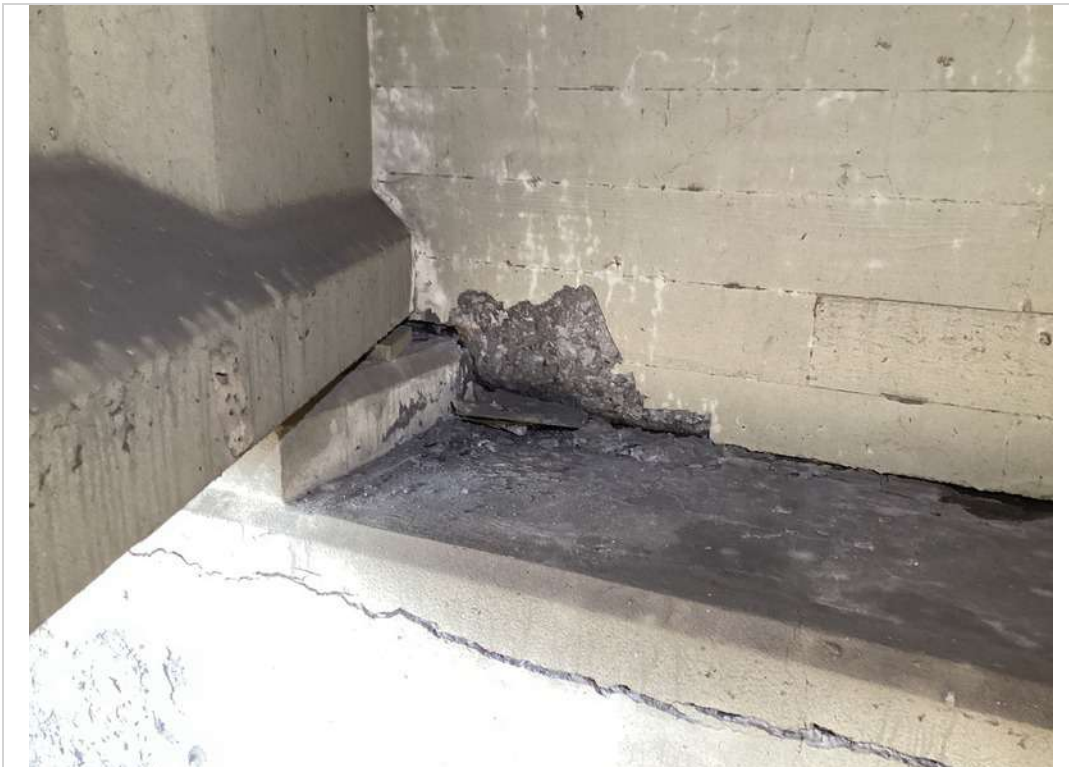
| <b>Abutment Caps</b> | (Poor) | Abutment 1 cap exhibits widespread large delaminations and isolated large spalls with exposed rebar. Abutment 2 cap has a wide crack that runs the entire length of the cap and widespread moderate spalls with exposed rebar. There are also areas of delamination, honeycombing, and heavy water staining in the Abutment 2 cap. |

Abutment 1 spall on backwall under Bay E

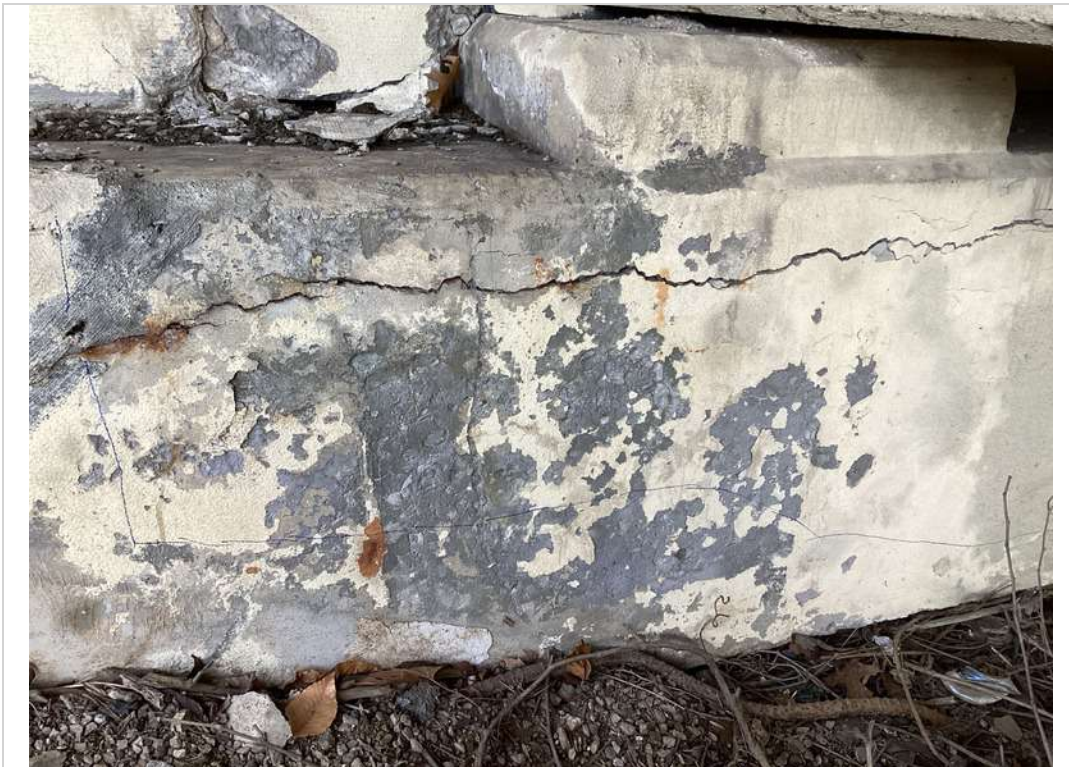
Abutment 1 delam on cap under right overhang

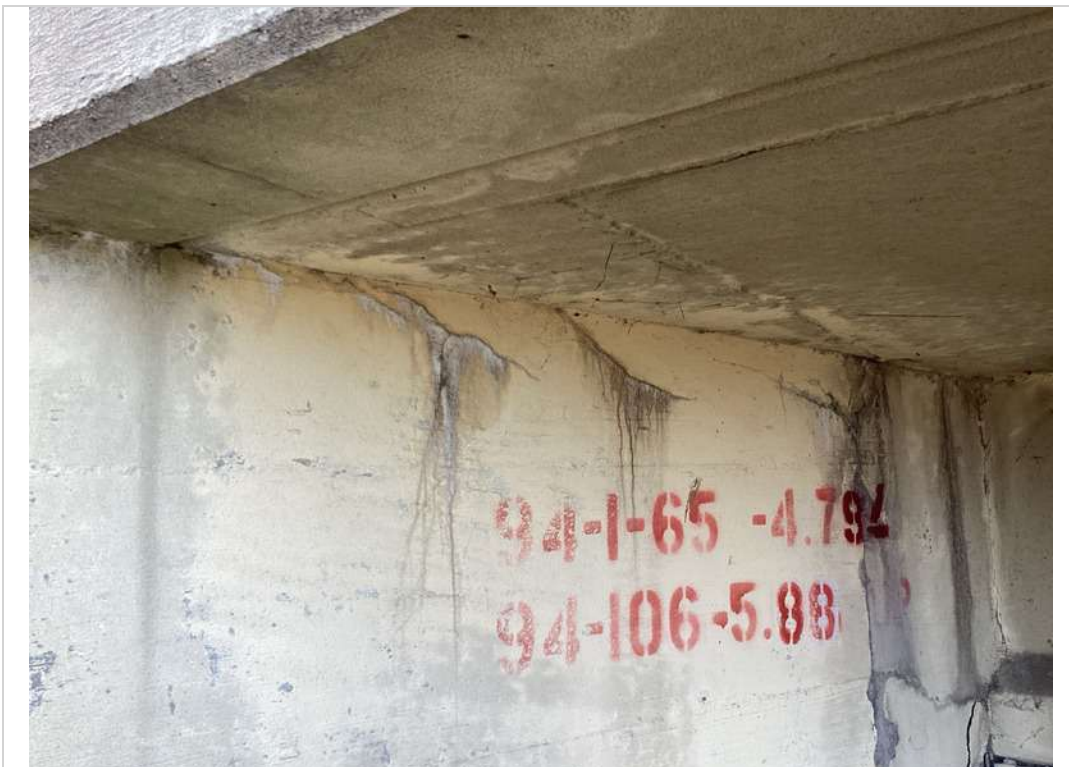
Abutment 1 cracks w/ hvly eff on backwall under right overhang

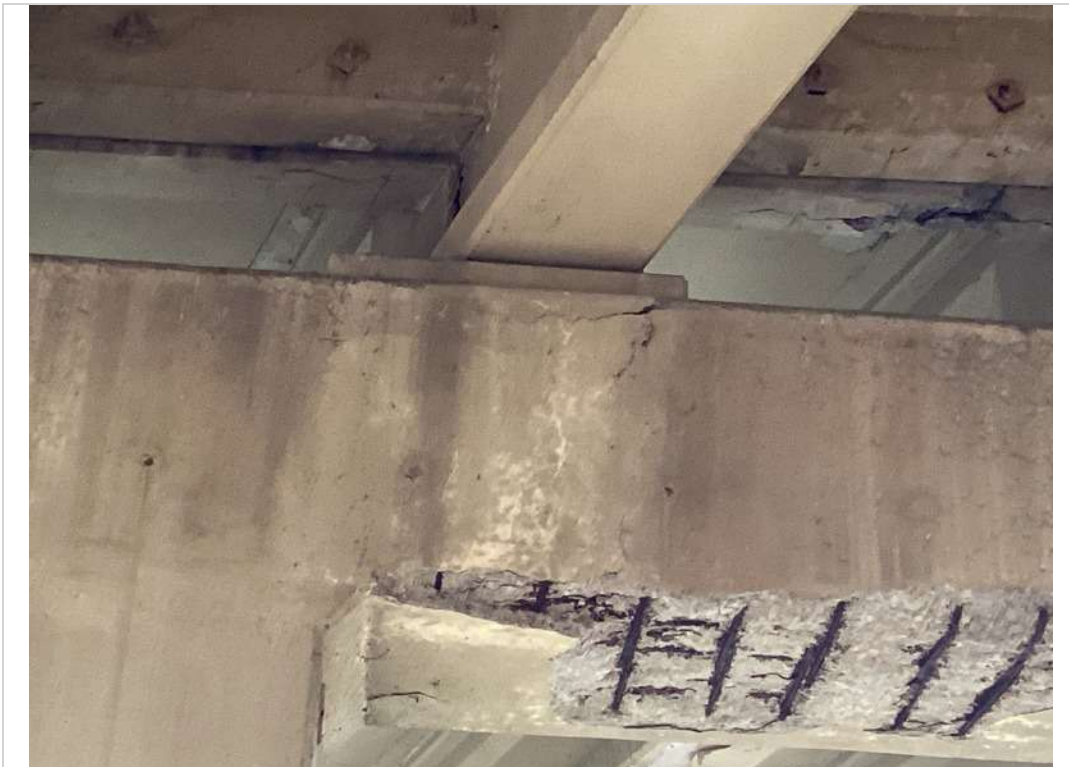
| <b>Bent Caps</b> | (Poor) | Bent 1 cap exhibits isolated wide cracking and widespread moderate spall with exposed rebar. Bent 2 cap exhibits some moderate spalls with exposed rebar and widespread delamination. Bent 3 cap exhibits isolated wide cracking, isolated areas of honeycombing, and widespread areas of delamination. |

Bent 1 delam on front of cap under Beam C

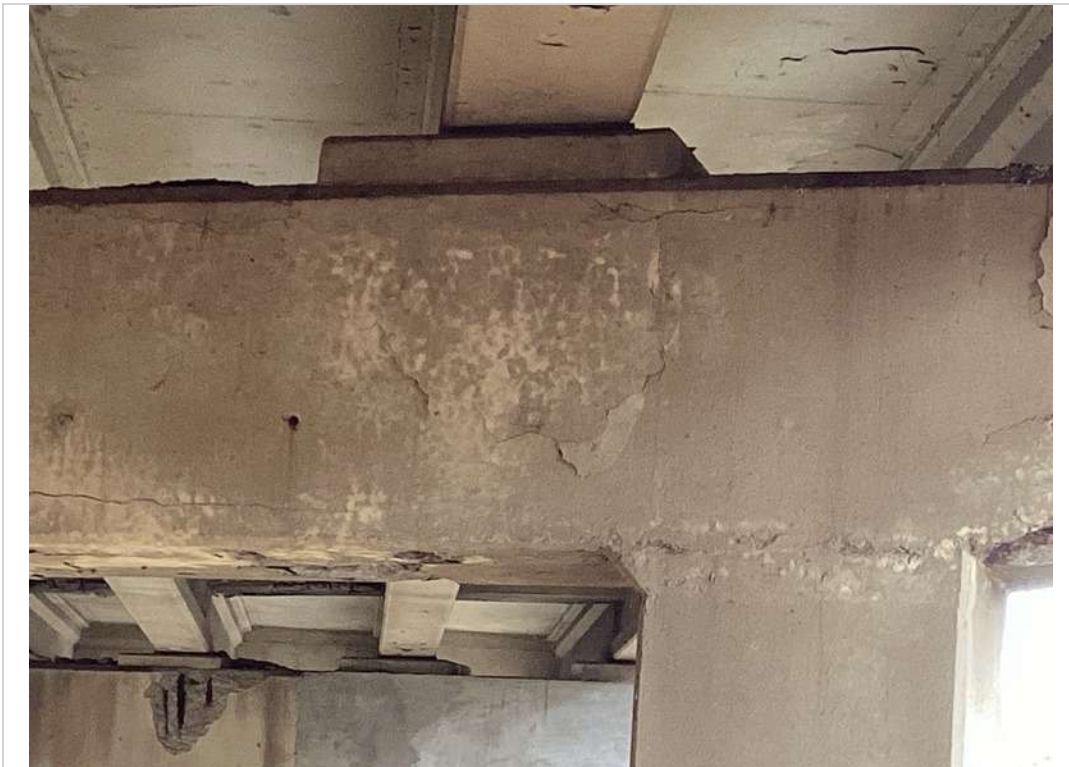
Bent 1 delam on front face of cap under Beam E

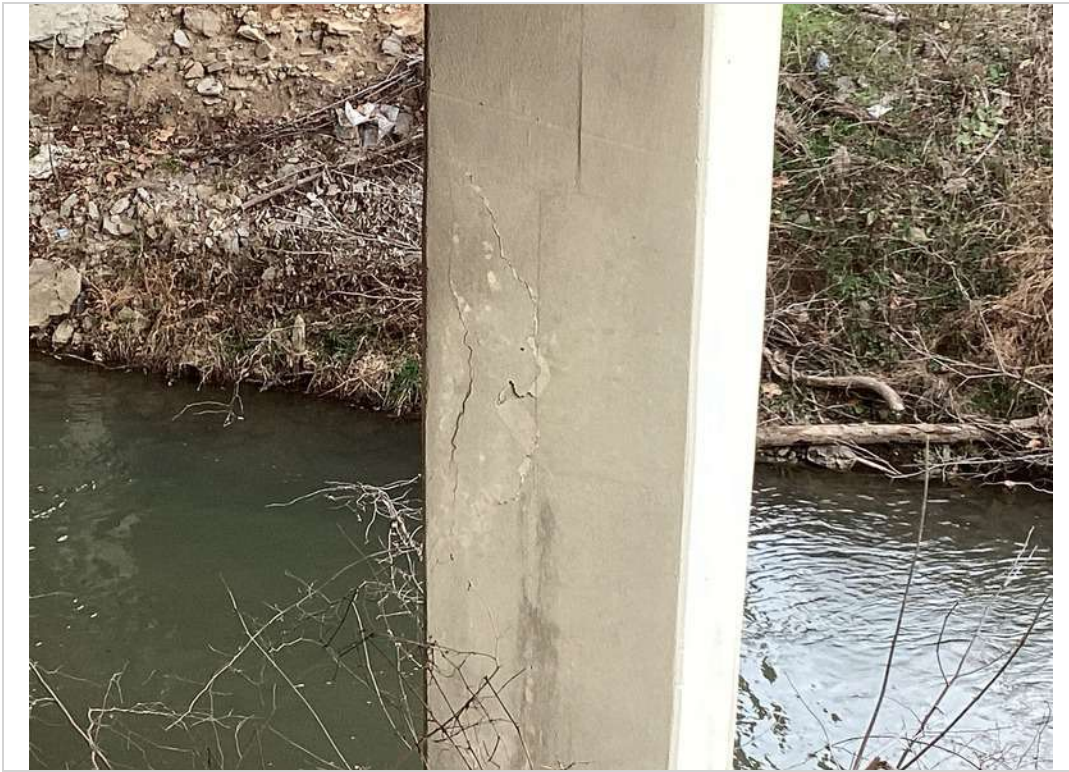
Bent 1 delam on front face of Column C

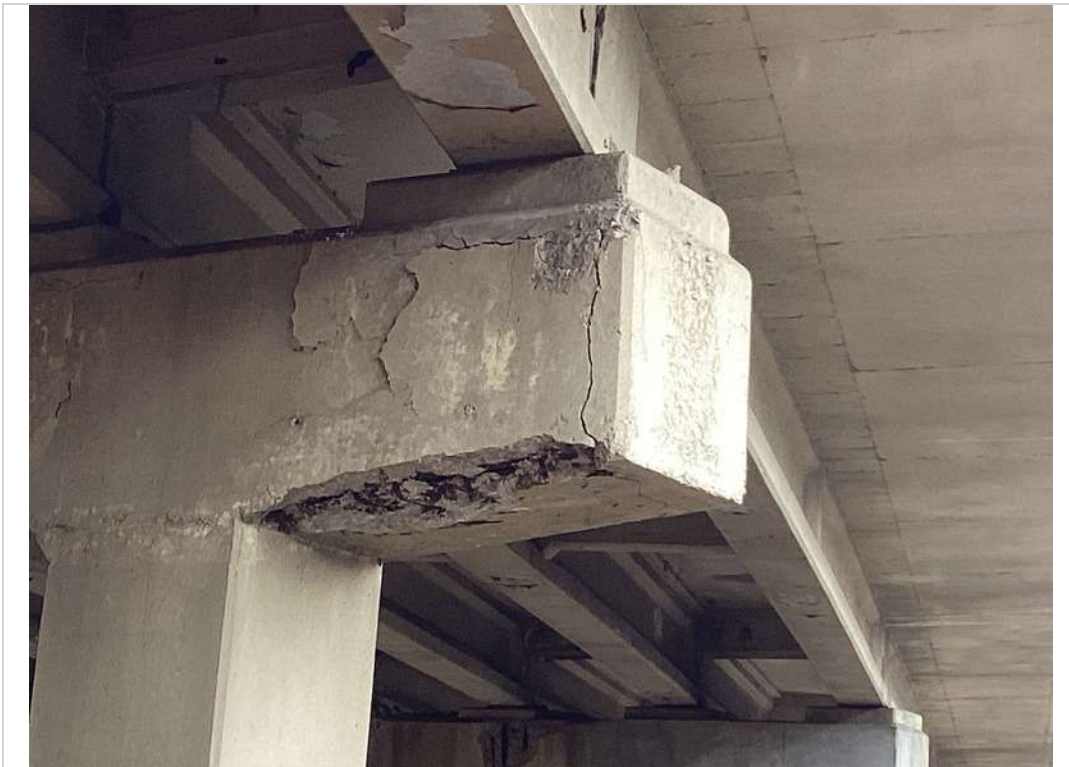
Bent 1 delam in cap front to the right of Column C

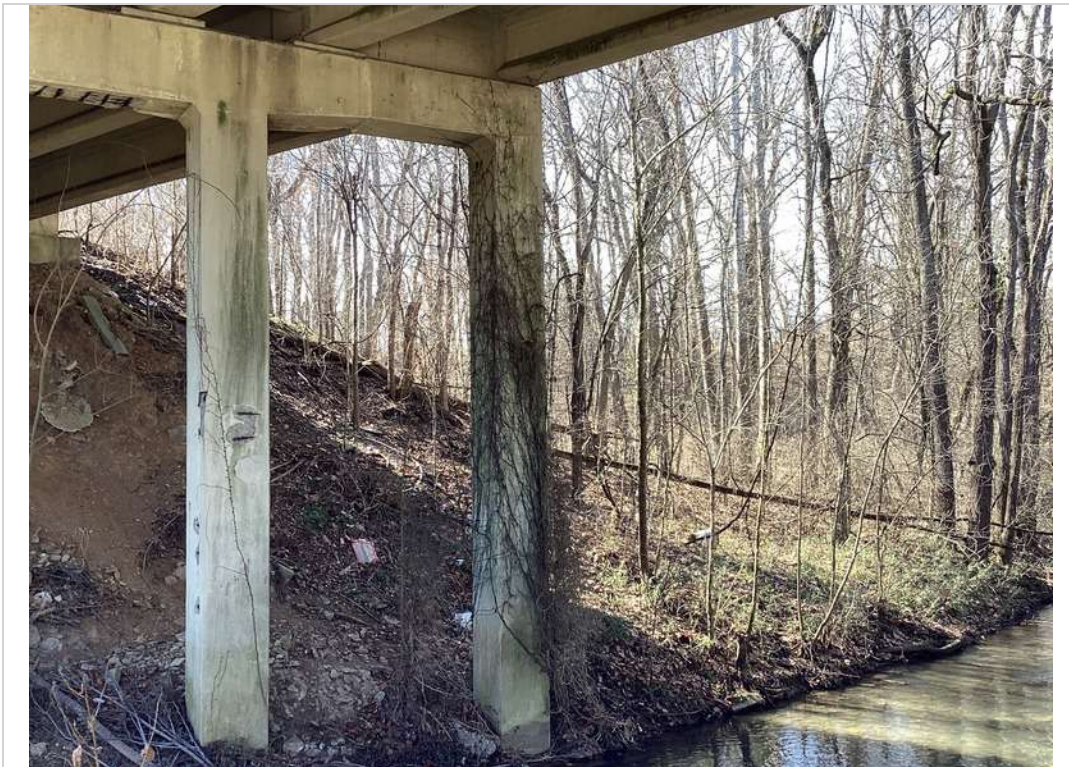
Bent 1 vegetation growth on Column A

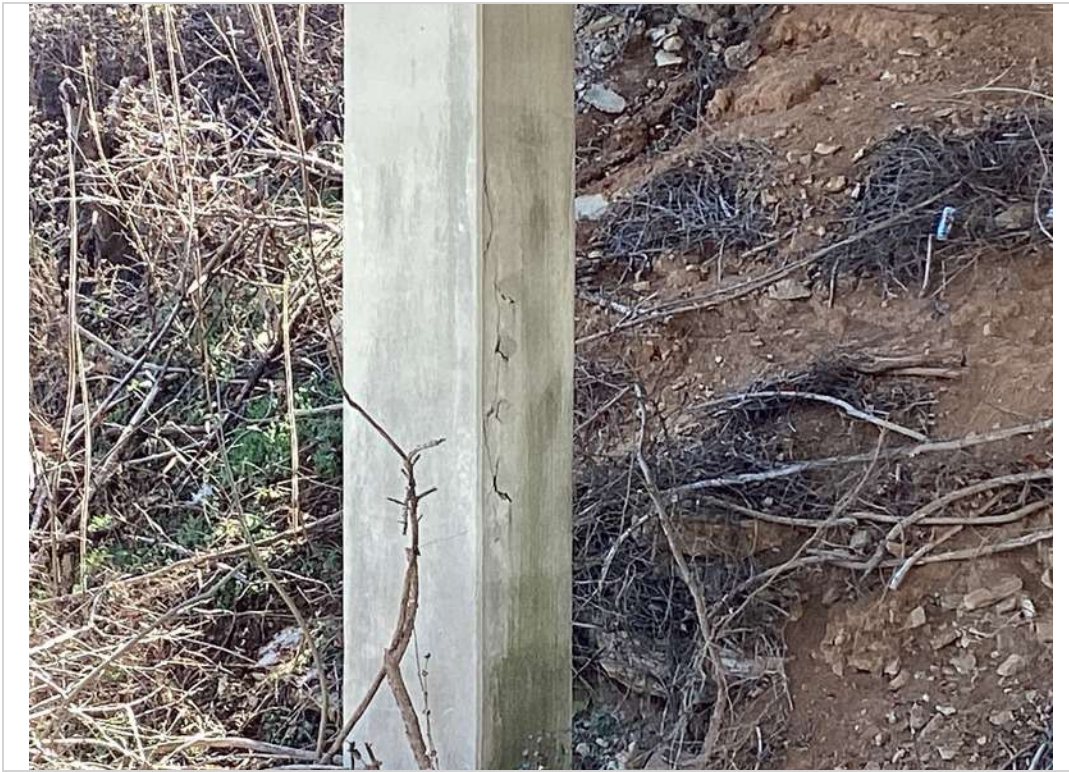
Bent 1 delam in Column C

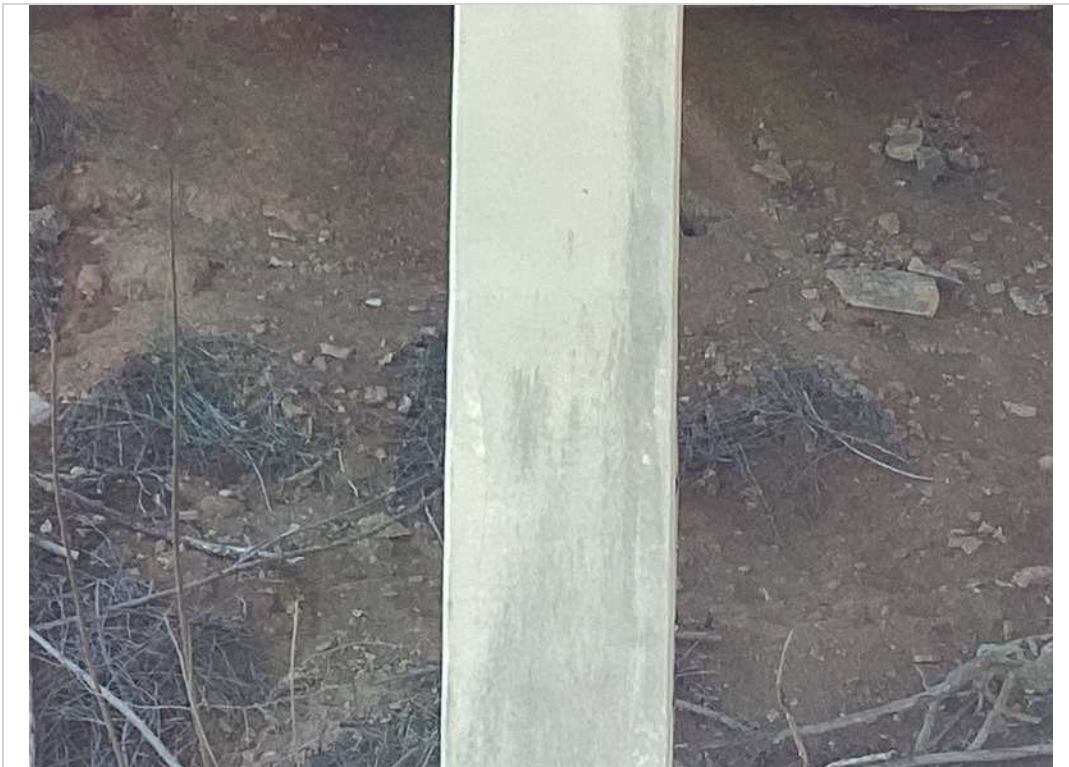
Bent 1 HL crack in Column C

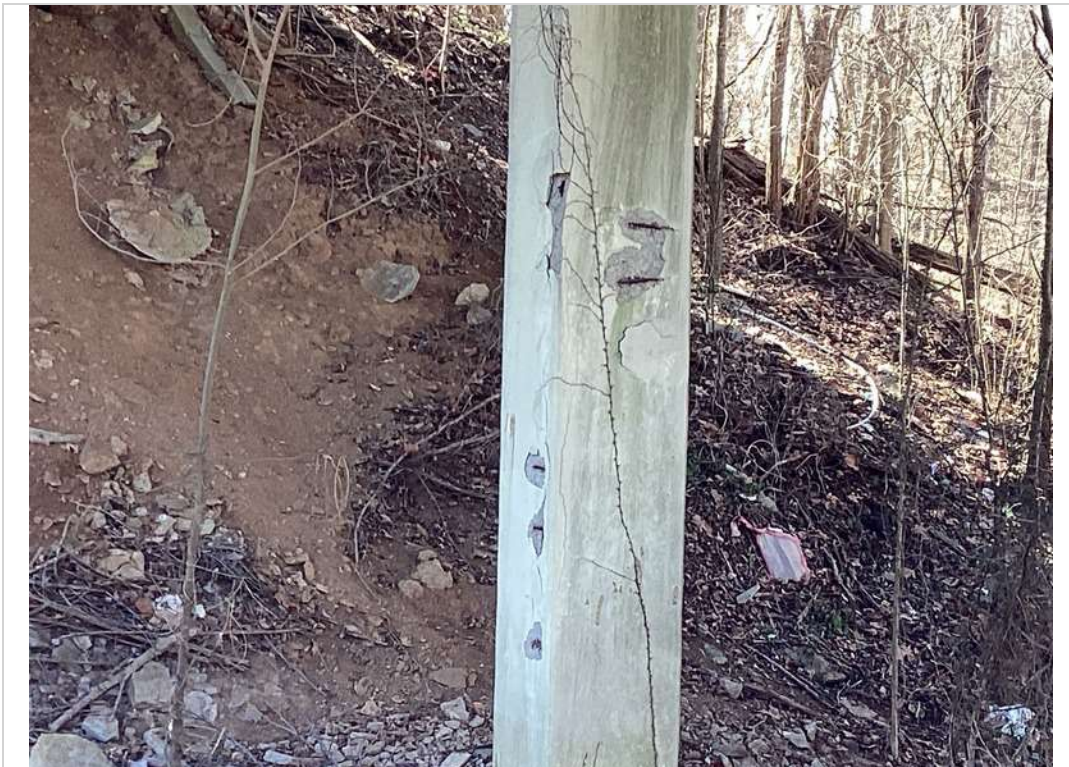
| <b>Bent Columns</b> | (Fair) | Bent 1 Column A has delaminated areas. Bent 1 Column B exhibits widespread moderate spalls. Bent 1 Column C has vegetation growth covering it. Bent 2 Column A has a large patch with hairline cracks in it along with hairline map cracking. Bent 2 Column B exhibits widespread delamination, isolated moderate spalls, and insignificant cracks. Bent 3 Column A exhibits widespread moderate cracking. Bent 3 Column B has isolated wide cracking. Bent 3 Column C has isolated moderate spalls. |

Bent 1 spalls w/ exposed rebar on right face of Column B

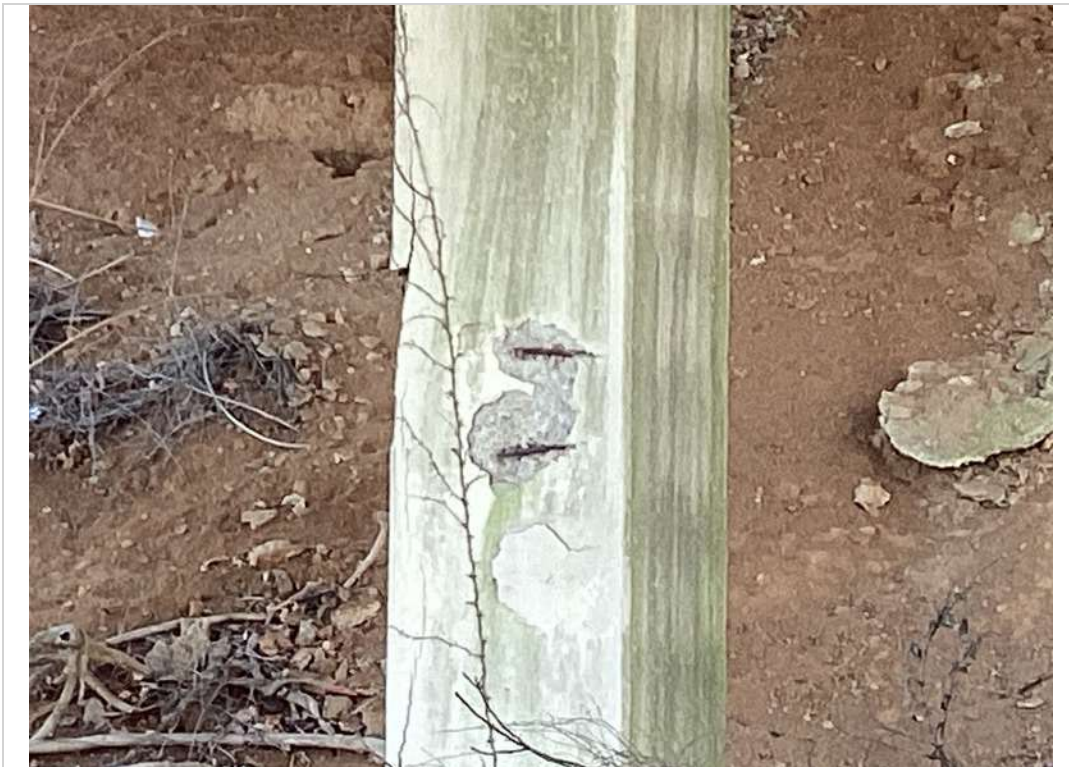
Bent 1 spall w/ exp. rebar on Column B

| Date Added | Recommendation | Priority |
|---|---|---|
| 02/04/2021 | REPAIR COLUMNS "B" & "C" AT BENT NO. 1 | 3 |

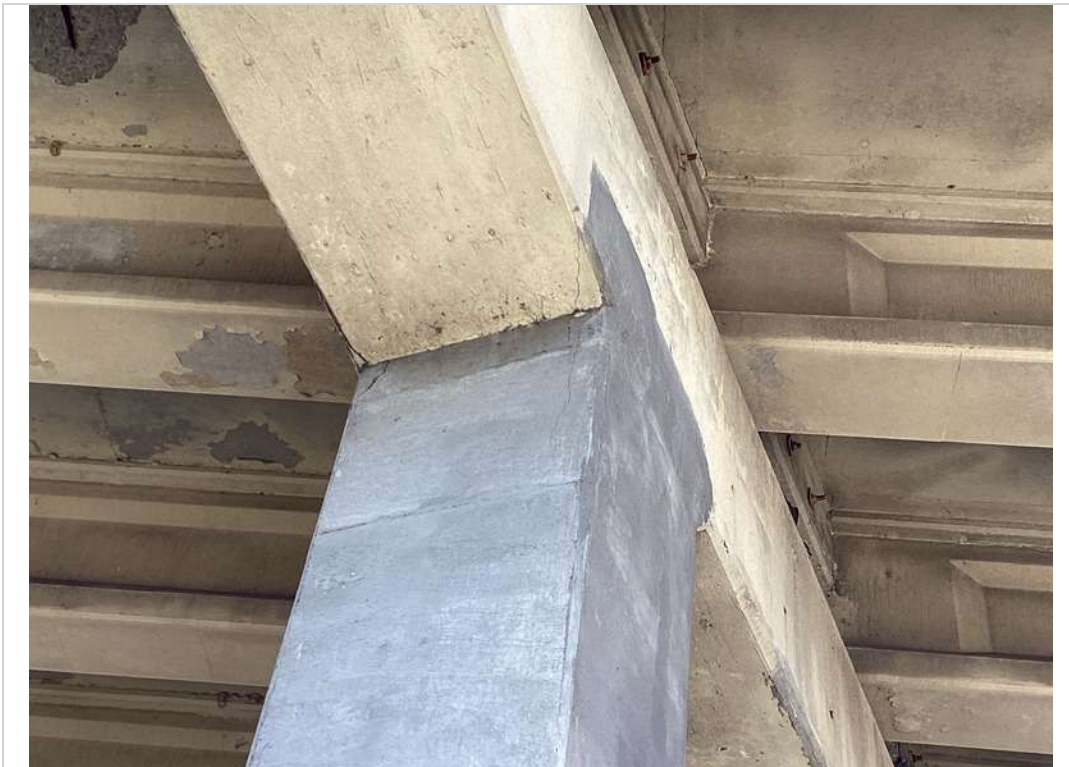
Bent 2 1/32" cracks in right face of Column C

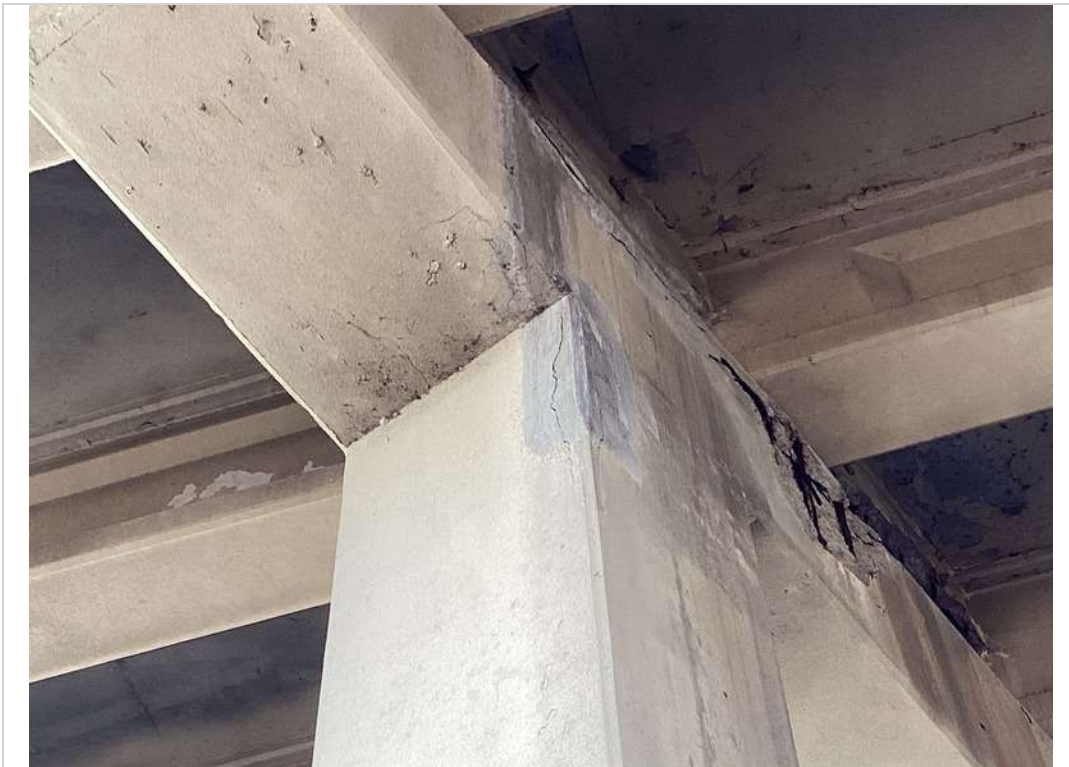
Bent 2 delam in front and left faces of Column B

| Date Added | Recommendation | Priority |
|---|---|---|
| 02/14/2025 | Repair Columns A & B in Bent 2 | 3 |

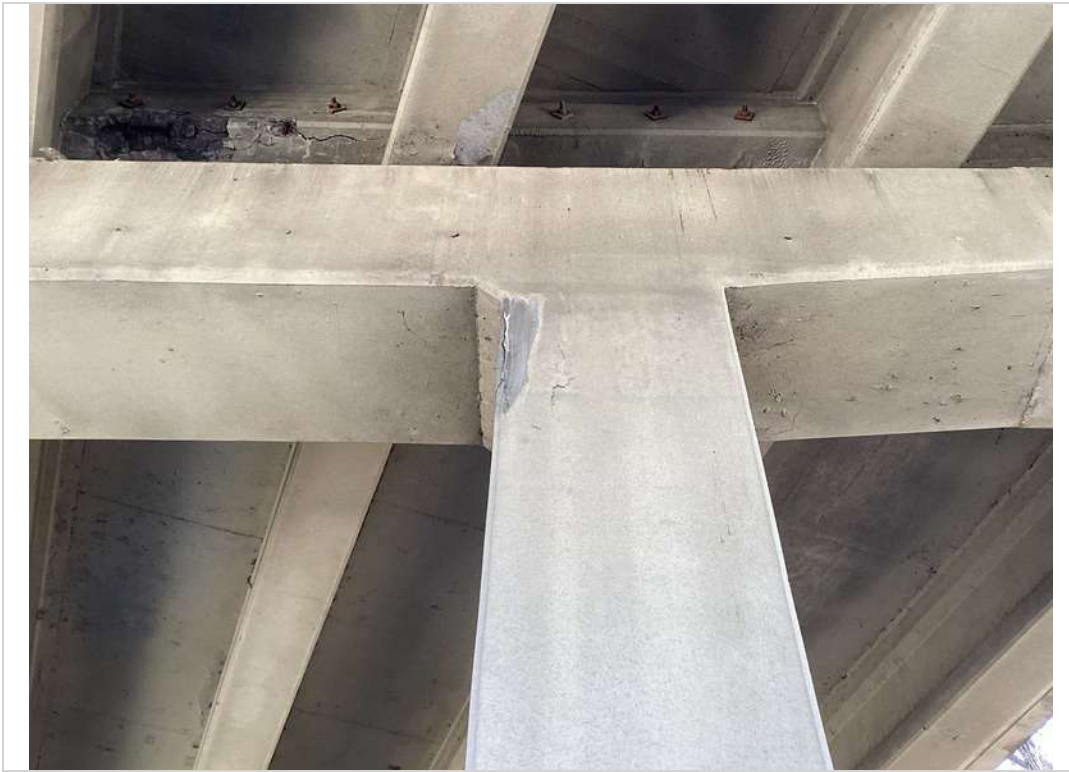
Bent 2 delam in back face of Column B

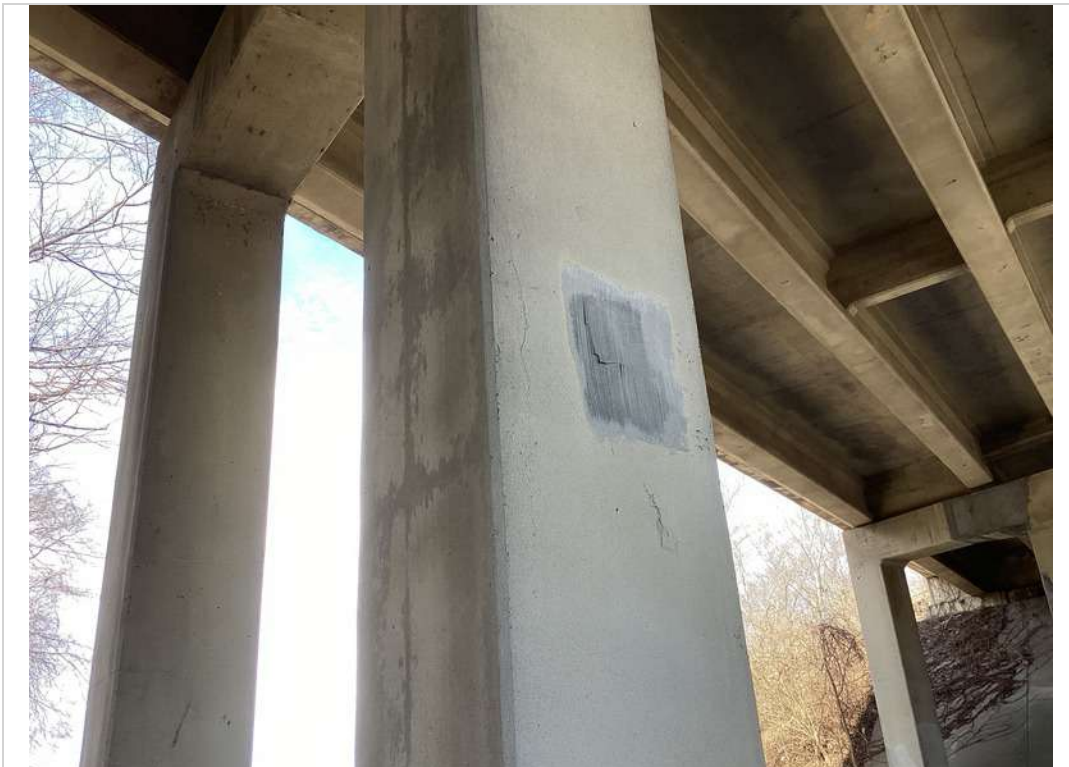
Bent 2 1/32" crack and failed patch on right face of Column B

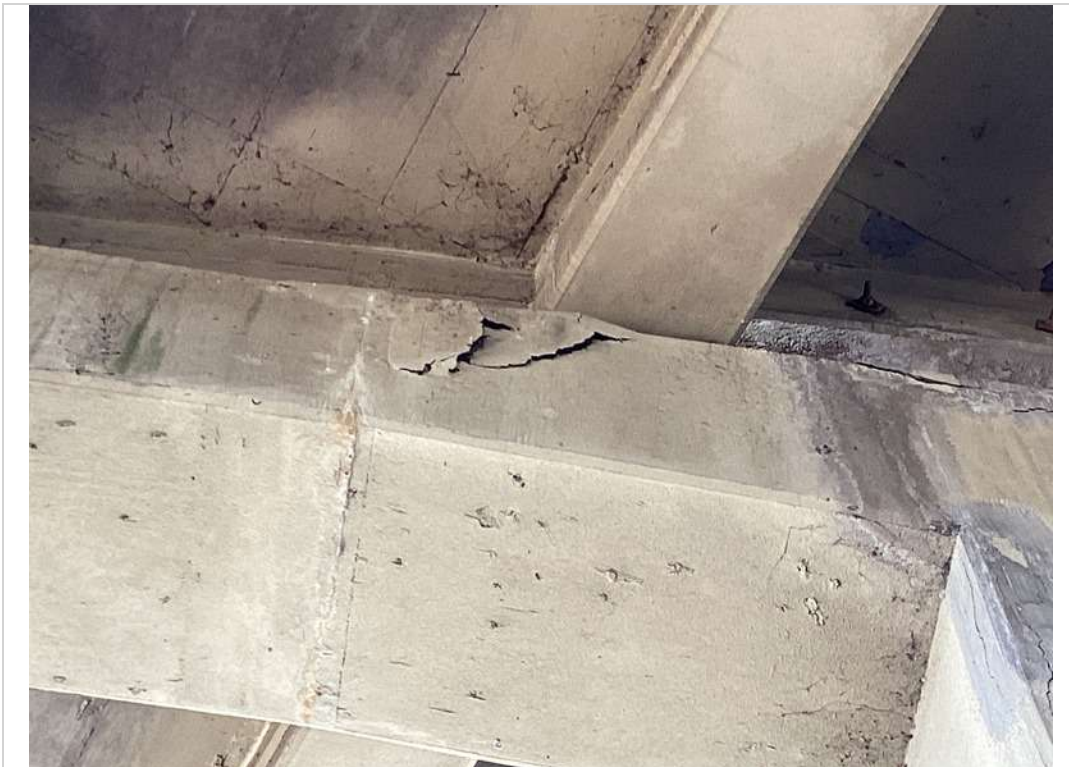
Bent 2 delam in front face of cap

| Date Added | Recommendation | Priority |
|---|---|---|
| 02/04/2021 | REPAIR CAPBEAM AT BENTS NO. 1 AND 2 | 2 |

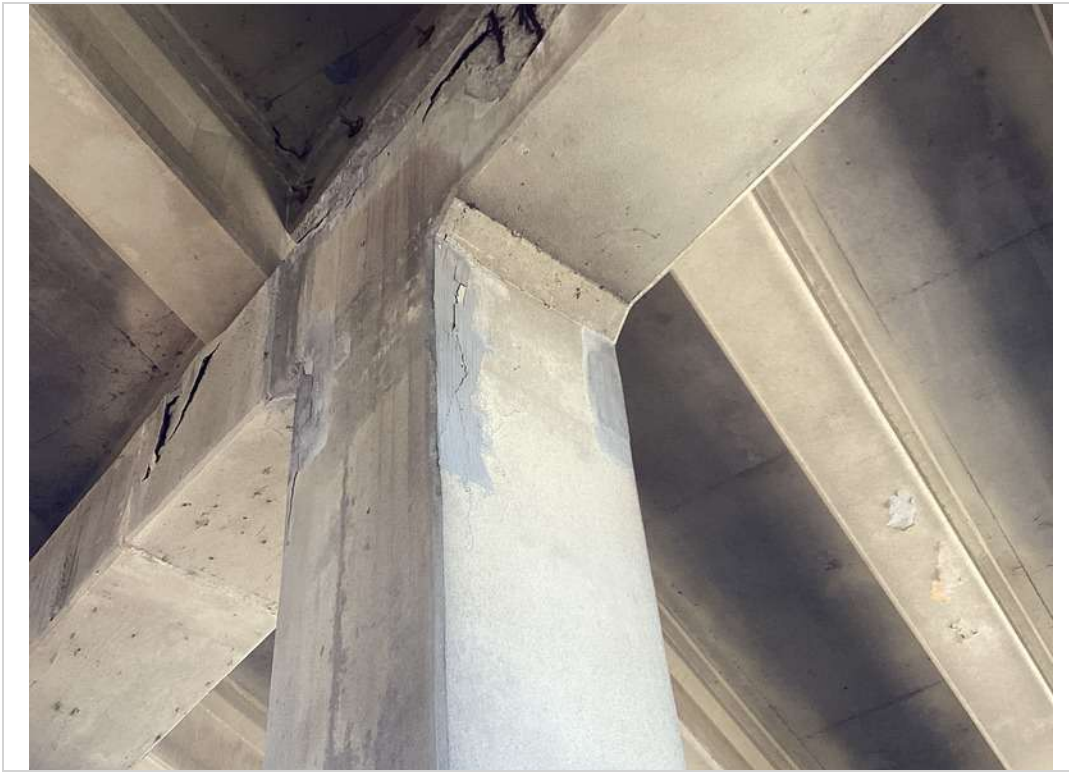
Bent 2 delam in right face of Column B

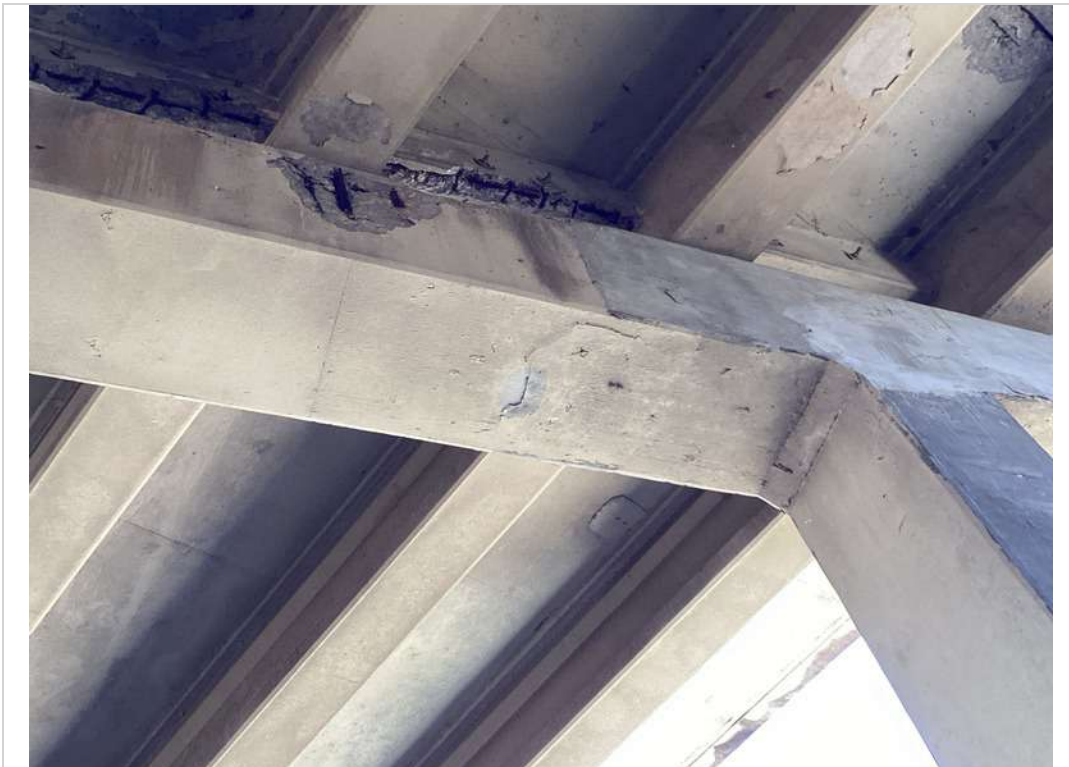
Bent 2 delam in bottom of cap

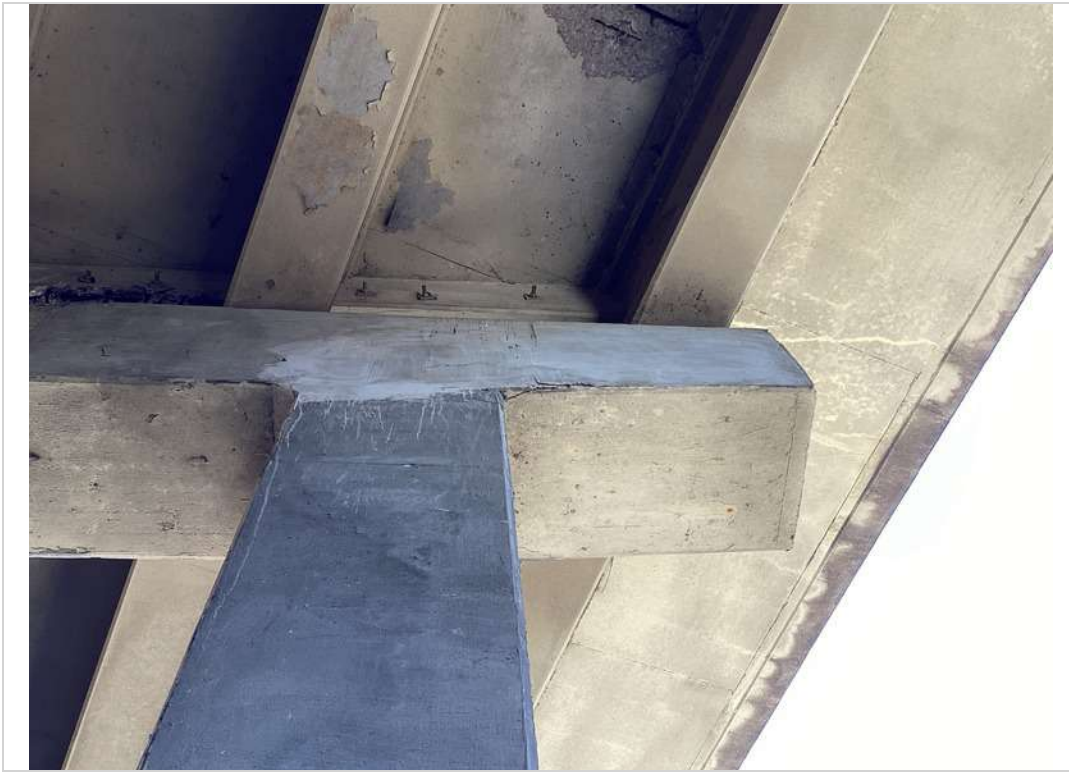
Bent 2 delam in cap above column C

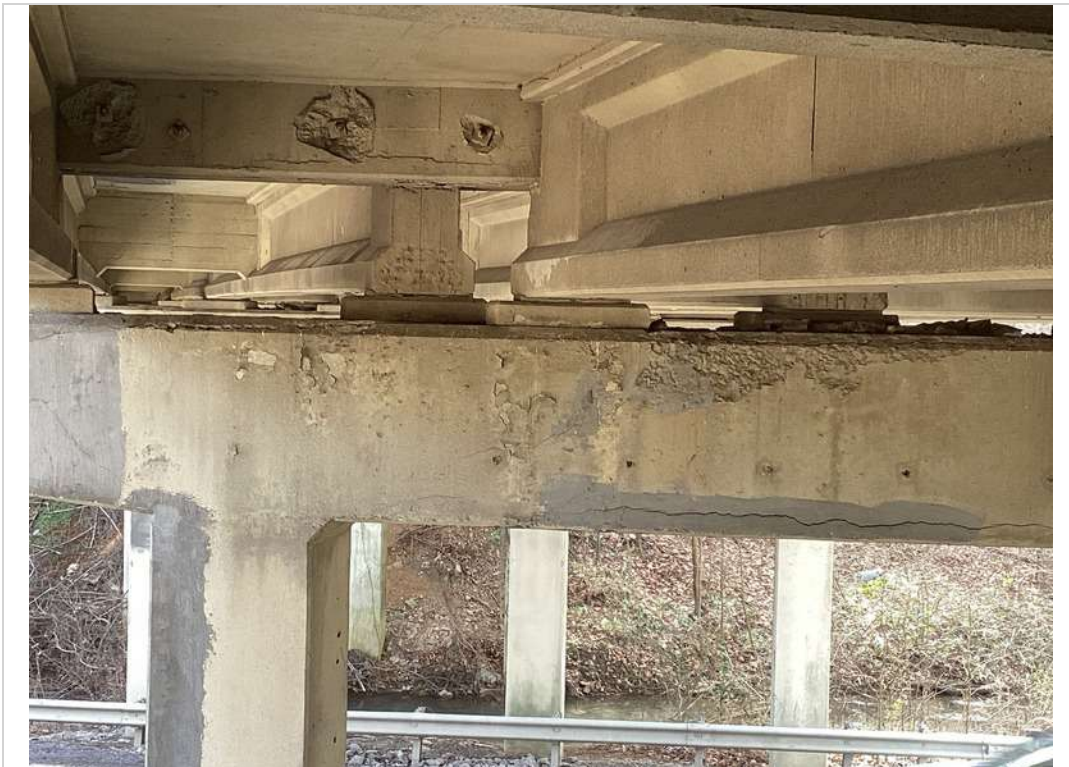
Bent 3 delams along top of cap between Beams C and E of Span 4

| Date Added | Recommendation | Priority |
|---|---|---|
| 02/14/2025 | Repair Cap and Columns A & B in Bent 3 | 3 |

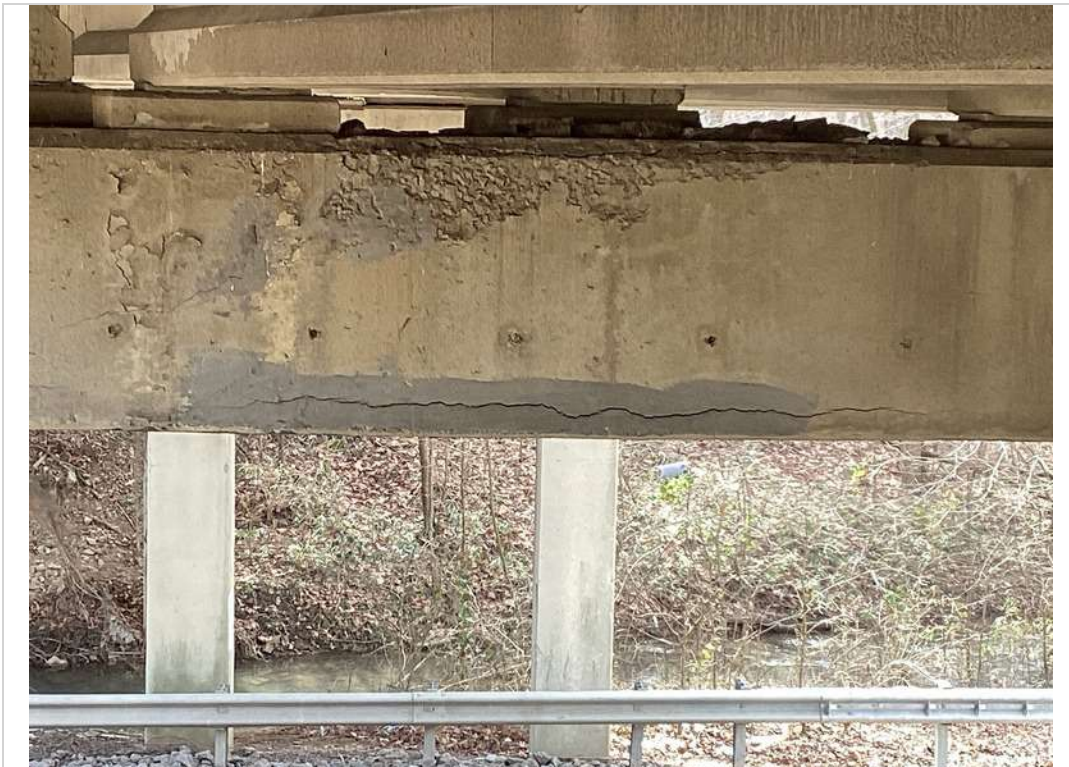
Bent 3 delam and honeycombing on back of cap between Columns B and C

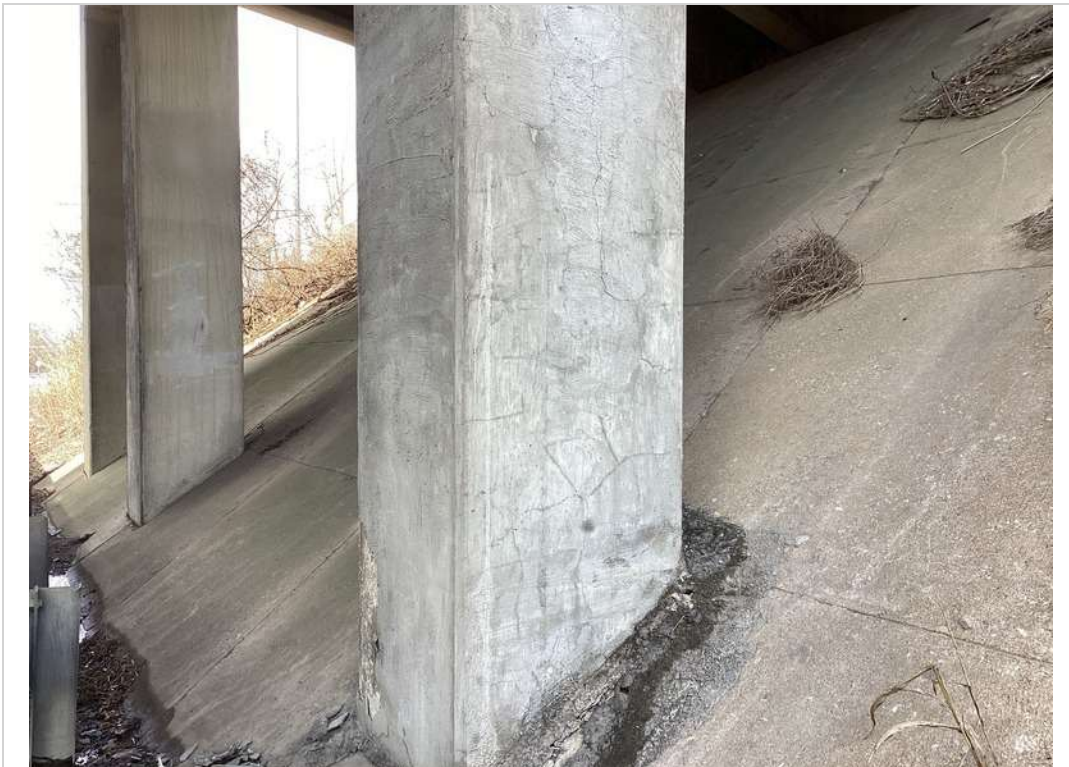
Bent 3 HL map cracking w/ iso 1/32" cracks in right face of Column C

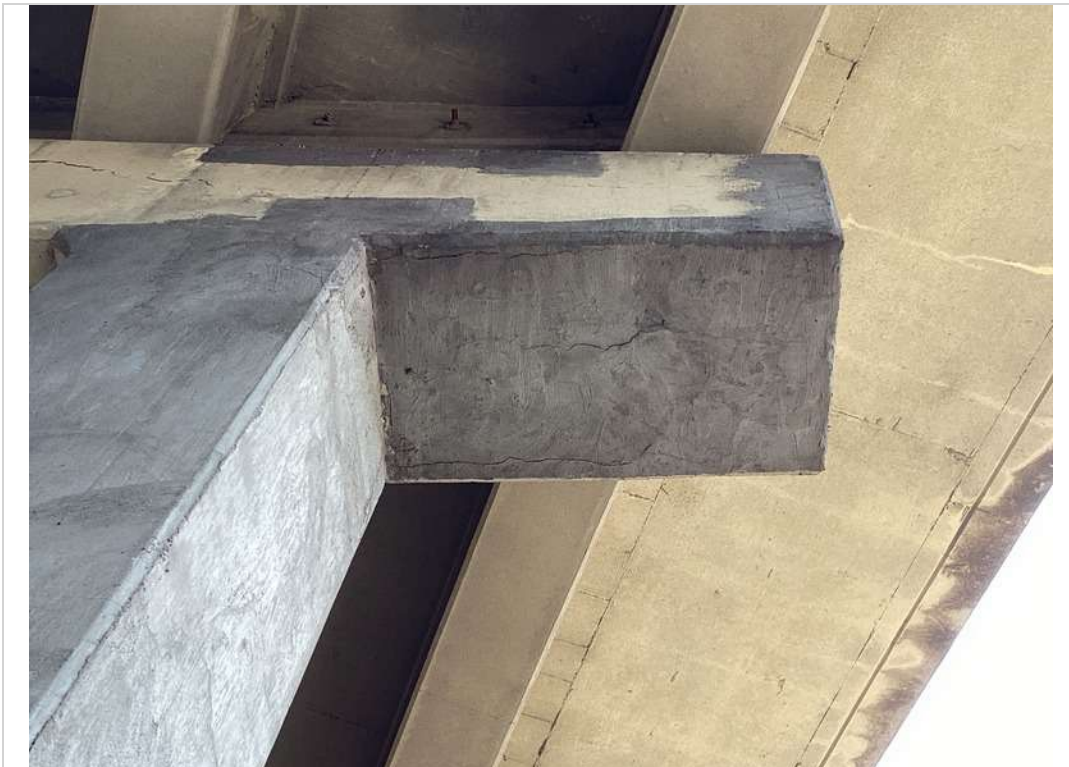
Bent 3 delam on underside of cap to the right of Column C

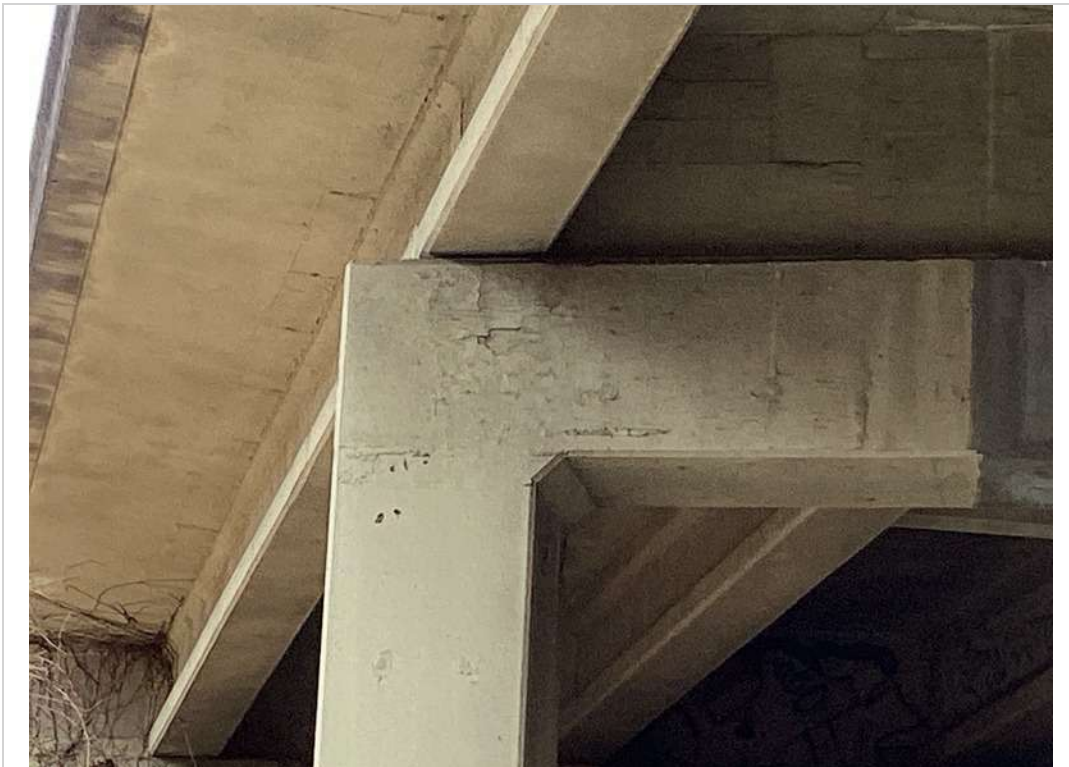
Bent 3 delam on front of cap over Column A

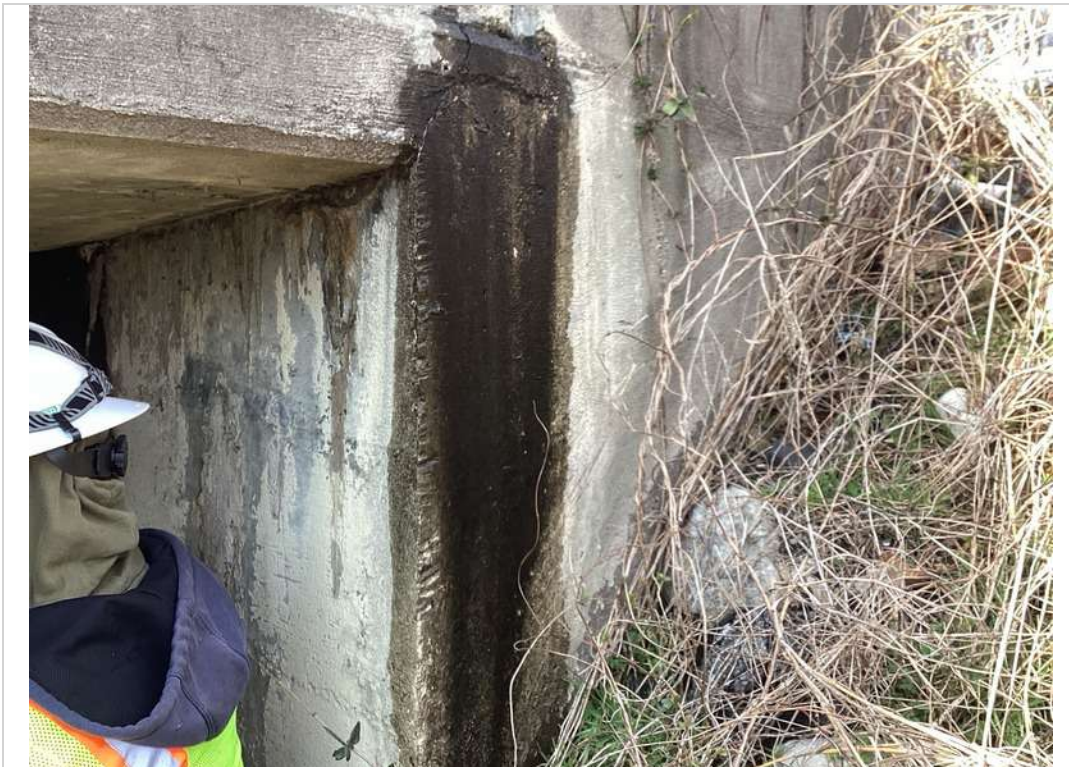
Abutment 2 1/16" crack w/ water leakage and staining in right wingwall
