I-65 Crossing I65 / SR106 & HARPETH RV

90 - LAST INSPECTION DATE 02/14/2025

| IDENTIFICATION | |
|---|---|
| (8) Structure Number | 94I00650006 |

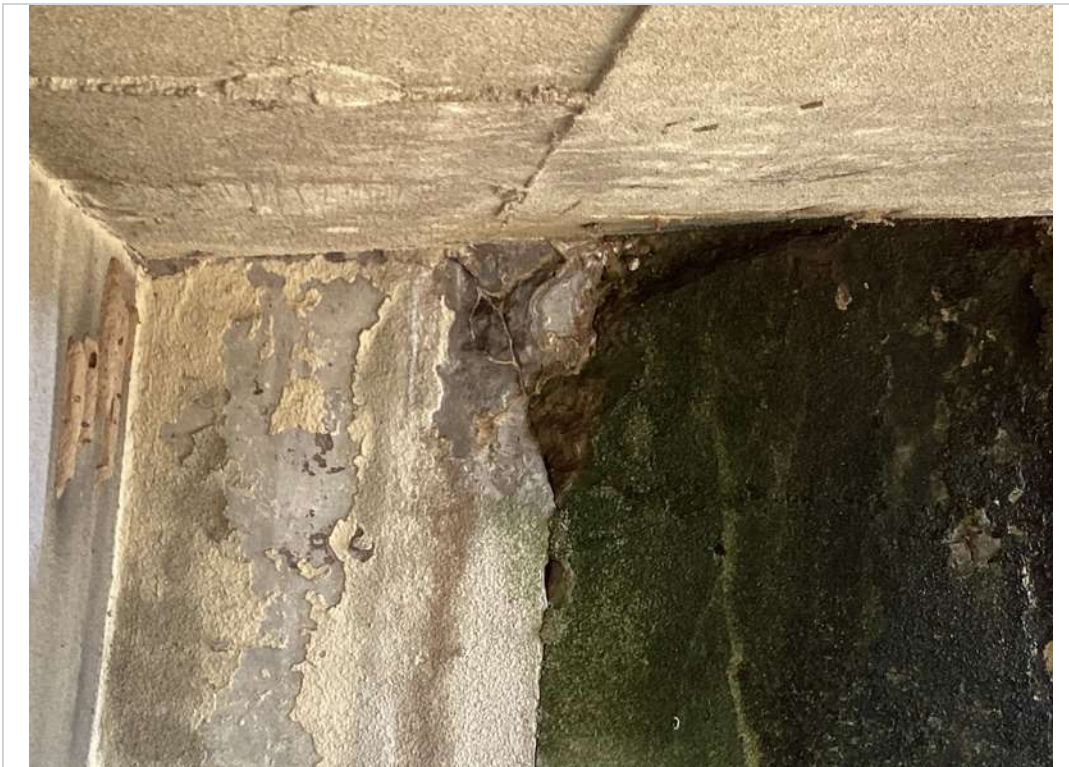
Abutment 2 spall on backwall under right overhang

| Date Added | Recommendation | Priority |
|---|---|---|
| 02/14/2025 | Repair the backwalls at Abutments 1 and 2. | 3 |

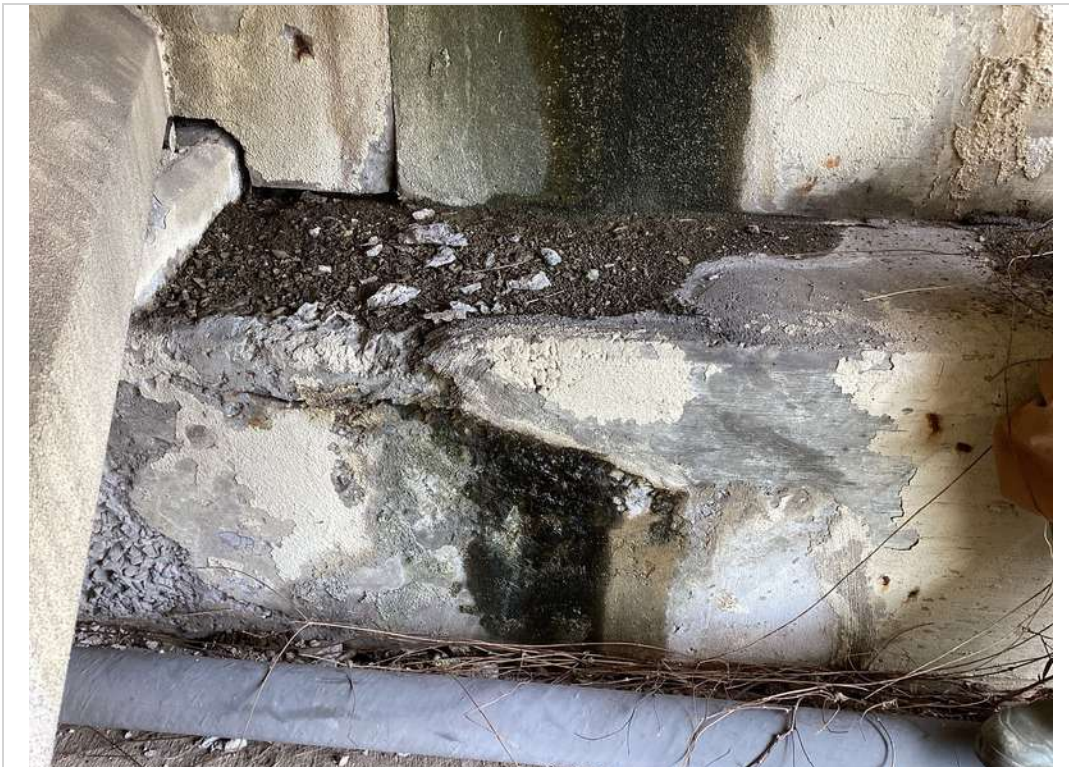
Abutment 2 spalling on top of cap under right overhang

| Date Added | Recommendation | Priority |
|---|---|---|
| 02/04/2021 | REPAIR CAPBEAM AT ABUTMENT NO. 1 AND 2 | 2 |

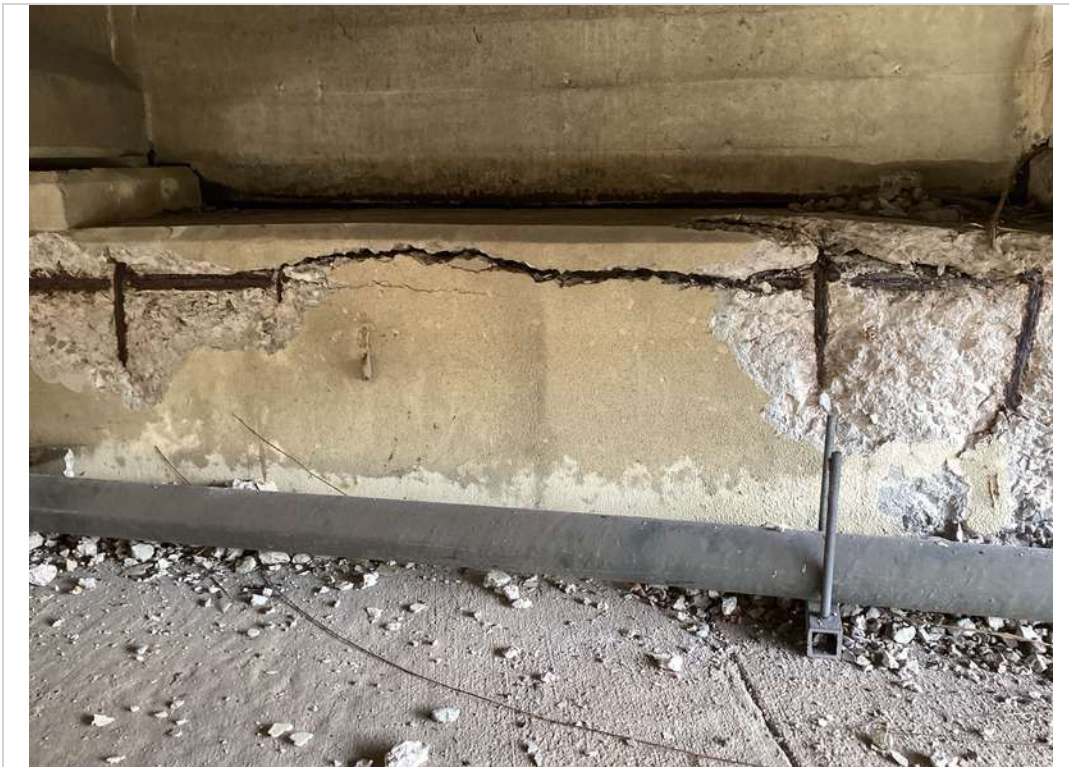
The substructure is in overall Poor condition. The abutment caps are in Poor condition. Abutment 1 cap exhibits widespread large delaminations and isolated large spalls with exposed rebar. Abutment 2 cap has a wide crack that runs the entire length of the cap and widespread moderate spalls with exposed rebar. There are also areas of delamination, honeycombing, and

Abutment 2 spalling w/ exposed rebar and delam of top of cap under Bay D

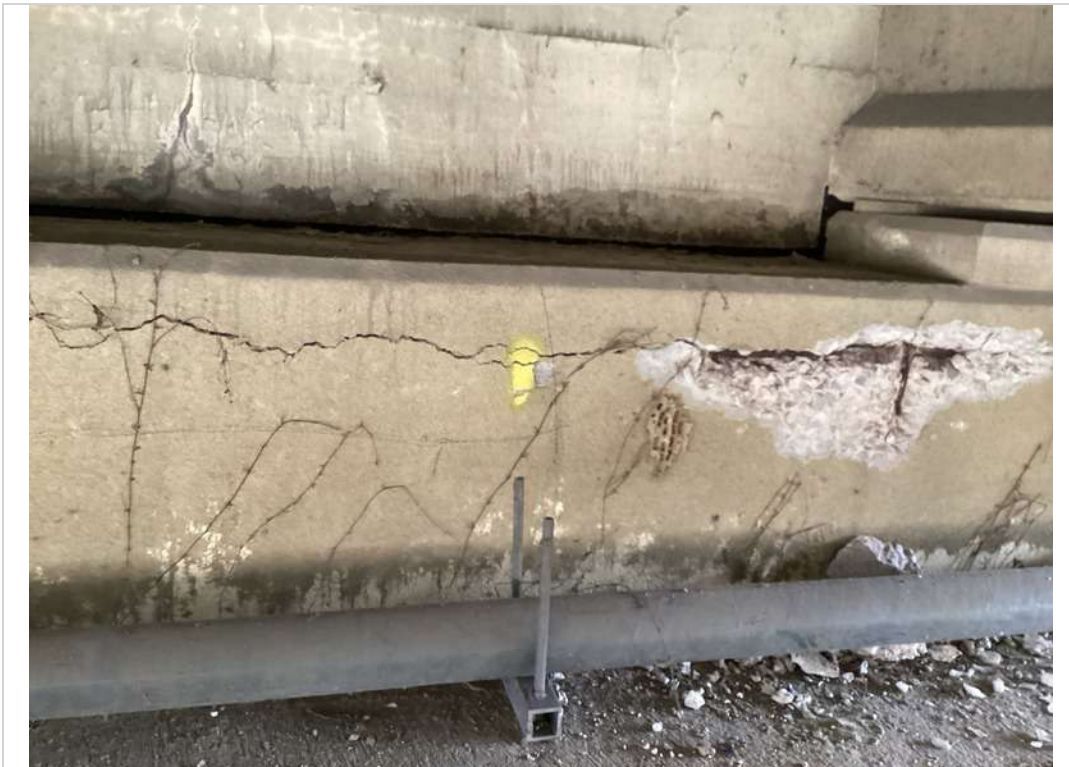
Abutment 2 spalling w/ exposed rebar and wide crack on cap under Bay C

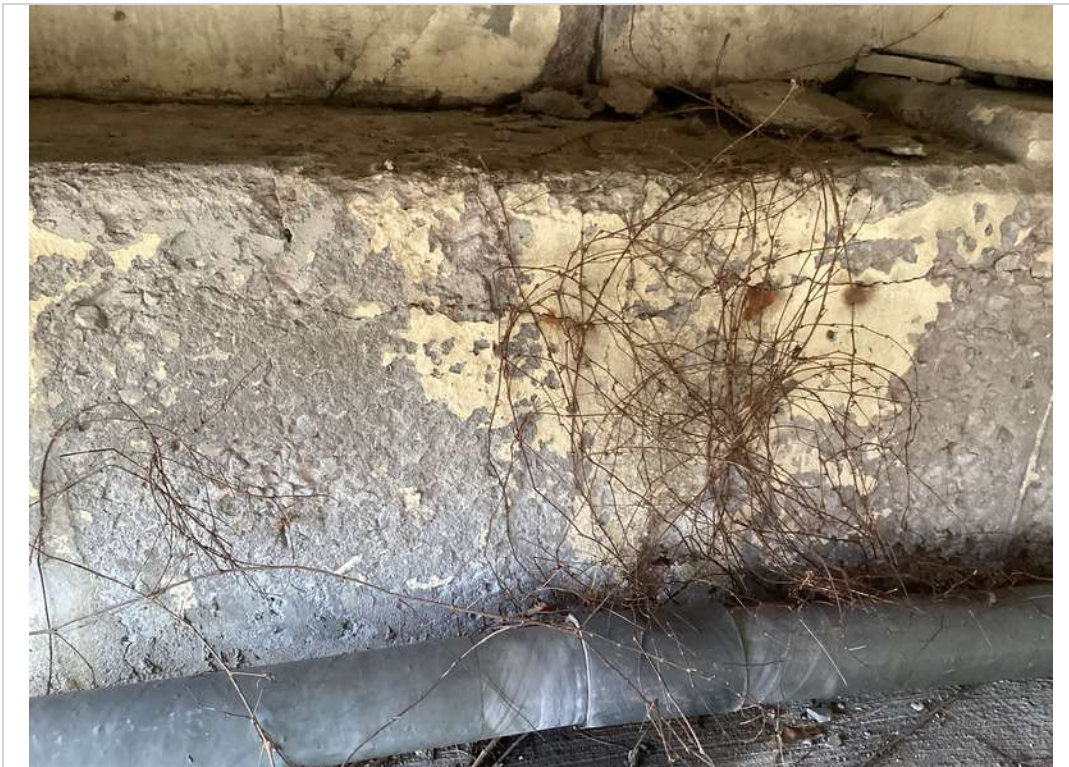
Abutment 2 deep honeycombing and 1/16" crack on cap under Bay A

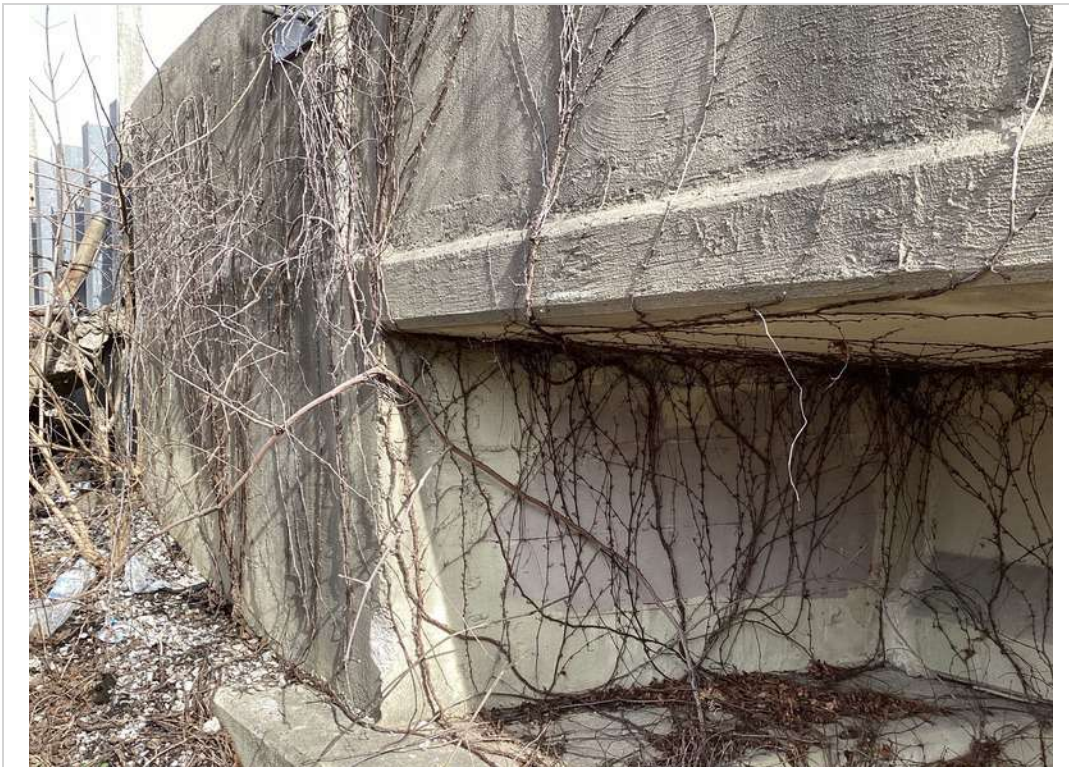
Abutment 2 vegetation growth on left wingwall and backwall

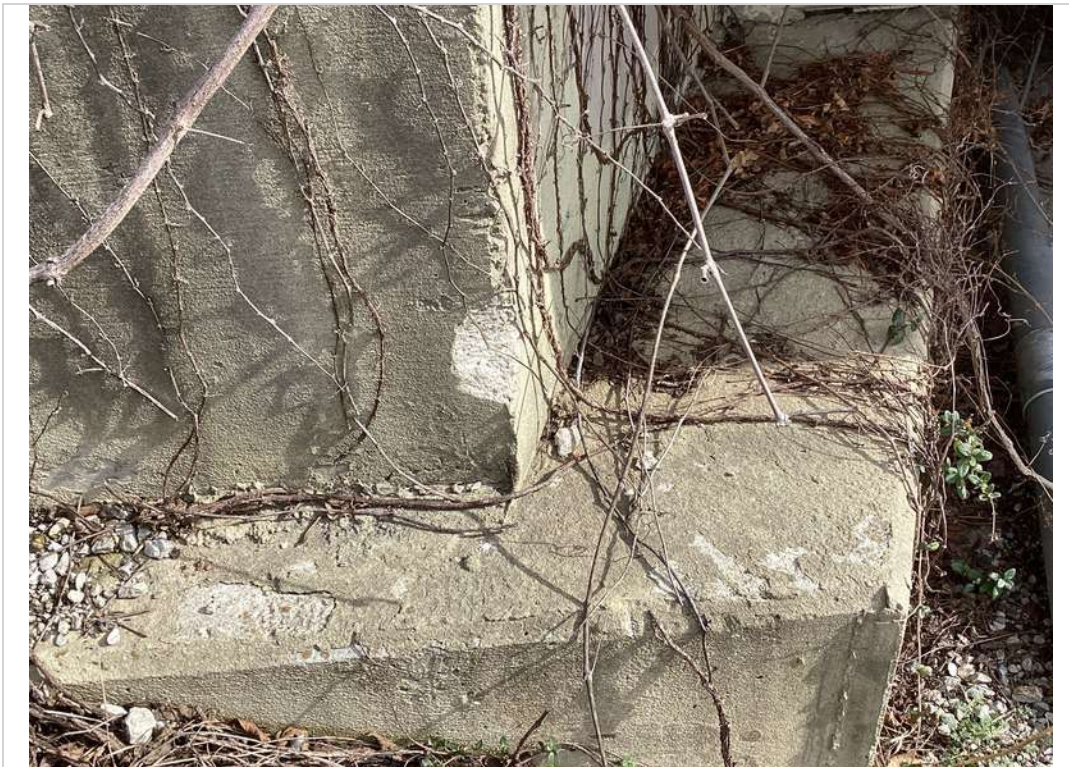
Abutment 2 spall on corner of left wingwall and backwall

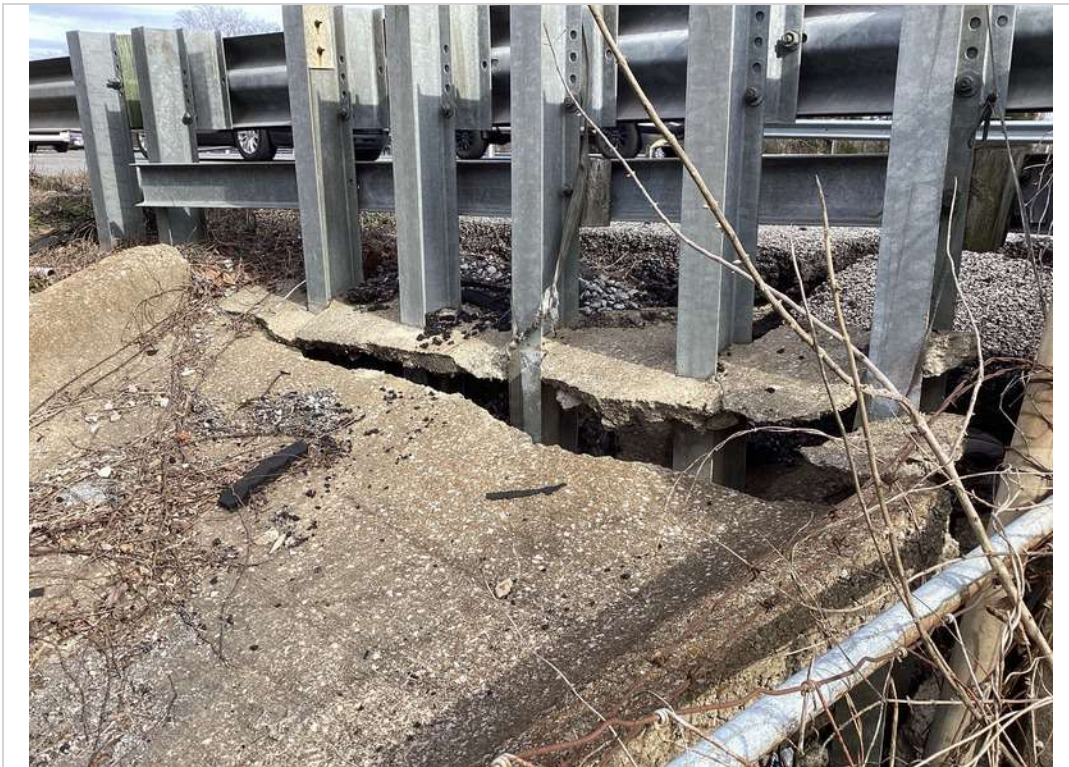
Abutment #2 failed left embankment drain

| Date Added | Recommendation | Priority |
|---|---|---|
| 02/21/2023 | REPAIR APPROACH DRAIN AT APPROACH NO. 2, LEFT SIDE | 3 |
