Hamilton County

Regular Inspection Report

Location: 33-I0075-02.68

3 Span Bridge

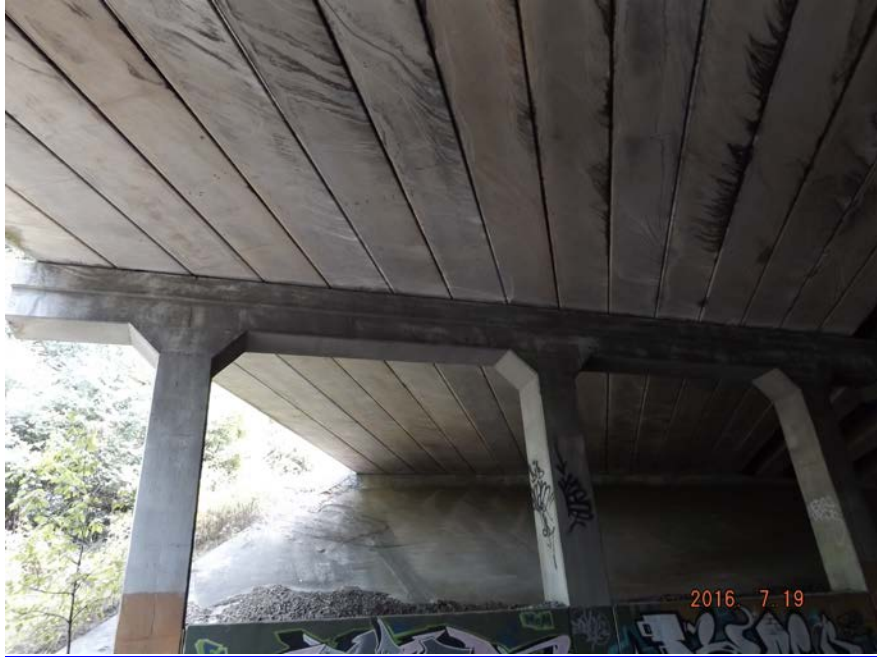
SUPER/SUB STRUCTURE - LEFT

Beams:	GOOD	HL CRACKS, DELAM, PATCHES, SPALL W/ CABLE EXPOSED. REBAR POPOUTS
Bearings:	GOOD	Abutments - None - Integral, Bents - Fixed

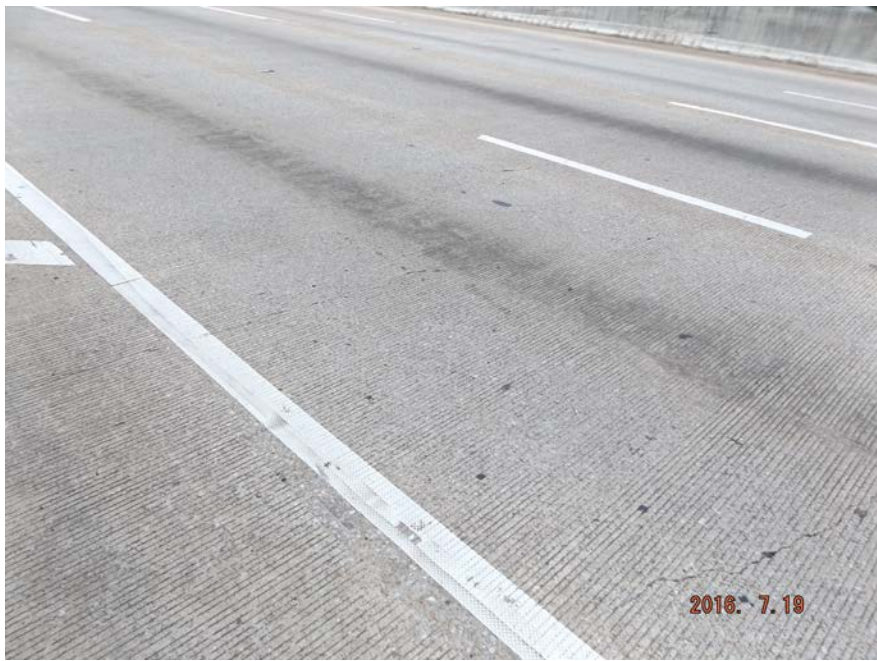
WEARING SURFACE - NB

Approach Pvm:	GOOD		
Deck - Wearing Surface:	GOOD	NUMEROUS SMALL-LARGE CRACKS

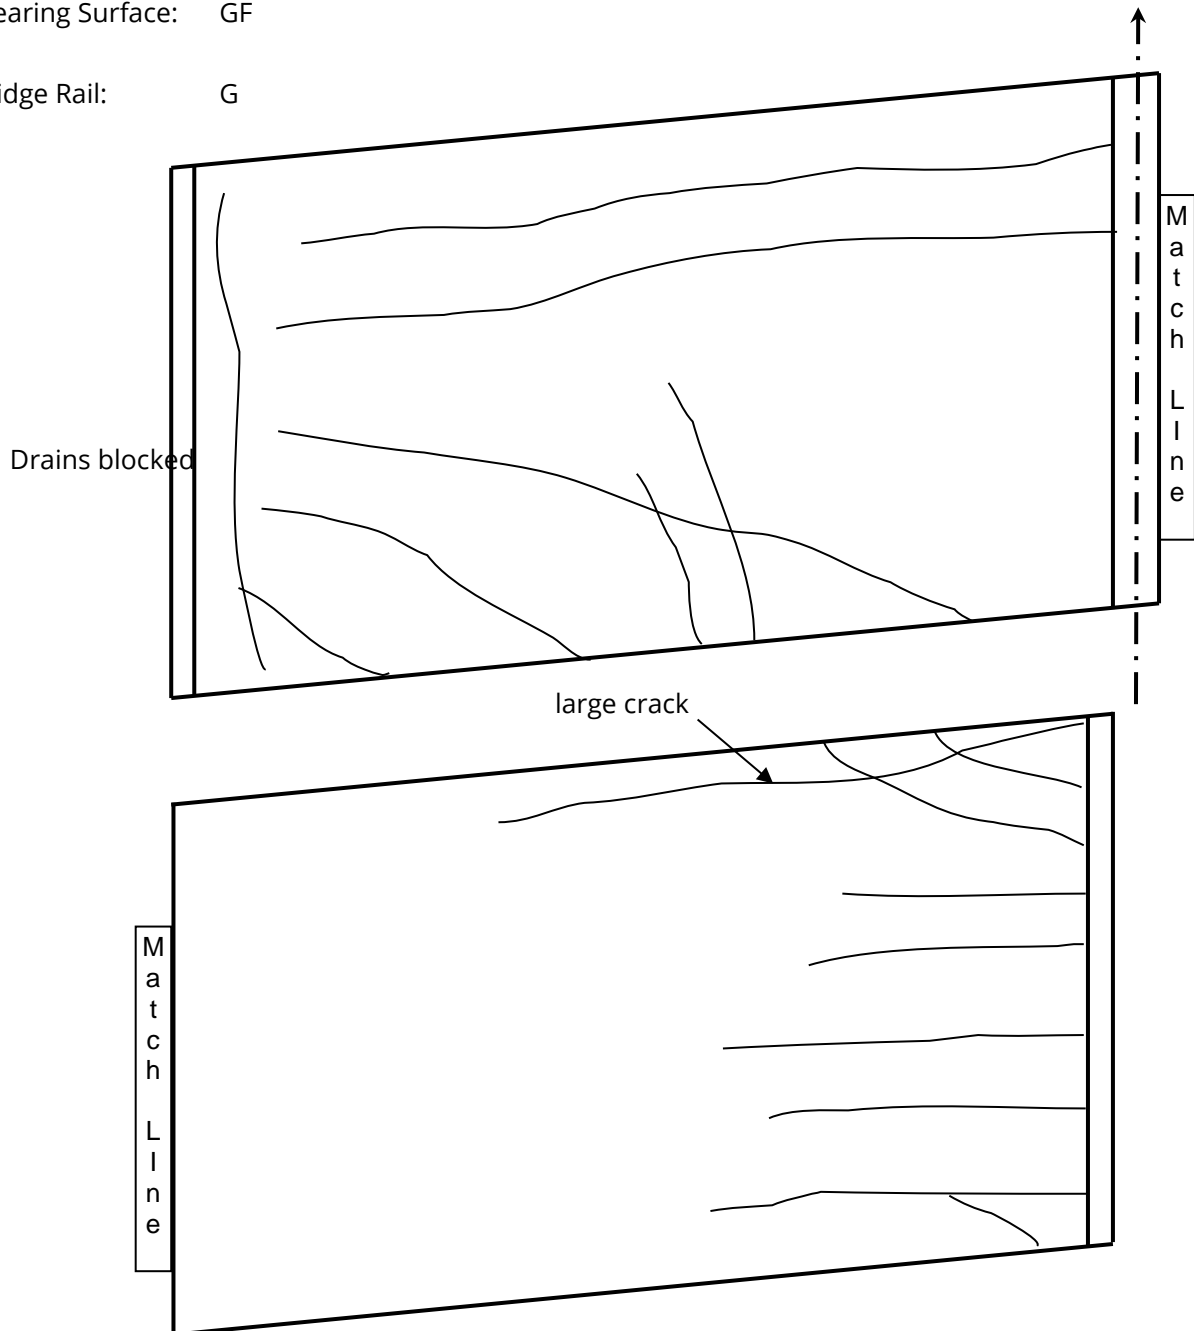
Wearing Surface: F

Bridge Rail: G

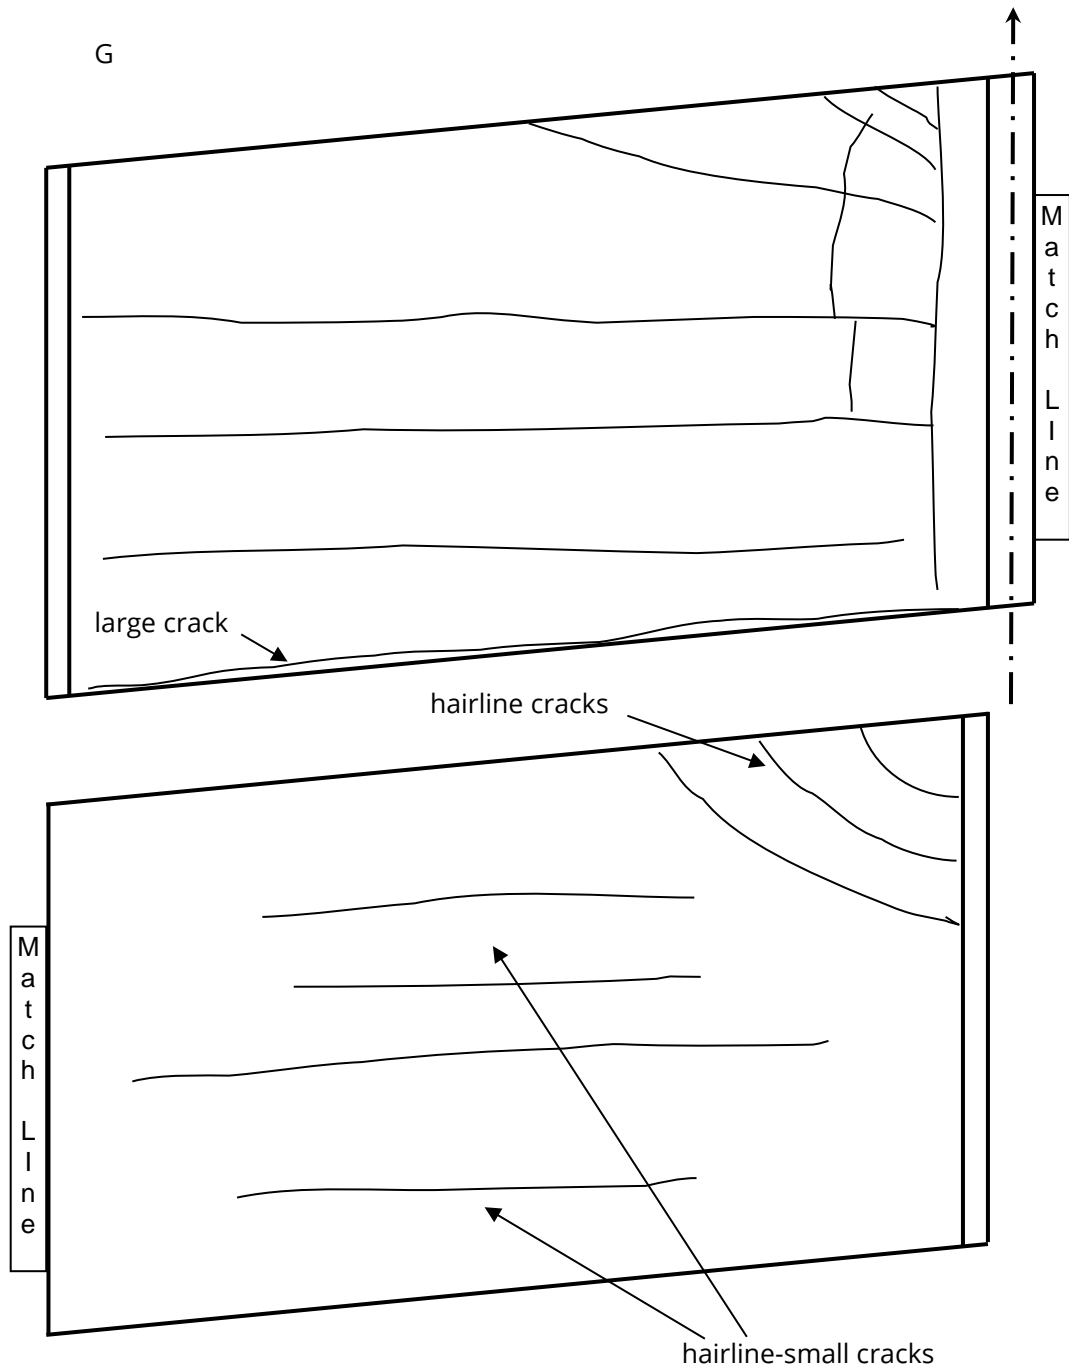
App Pvmt: F
App Rail: G
Wearing Surface: F
Bridge Rail: G

Beams: G 'A' - HL cracks w/ eff

Deck: GF 1C2 HL CRACK W/EFF

Beams: G 'N' - Rebar spall

Deck: GF 2B5, 2C4, 2D4, 2D5, 2E3, 2E4 - HL CRACKS

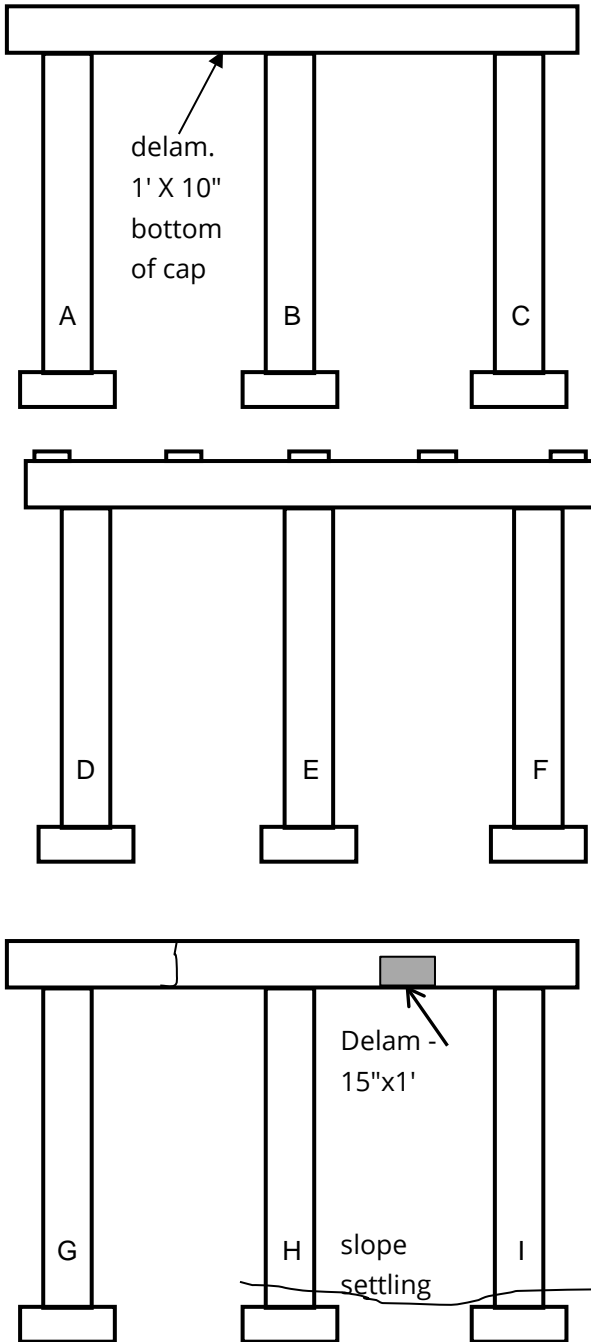
Looking Ahead

Columns: G Backside of Column 'I' - Wall has separated from column. **2016 Changes in RED**
 Gap between wall and column of 6" at top and 3" at bottom.
 Rebar being pulled is creating spalls in column.

Walls: GF

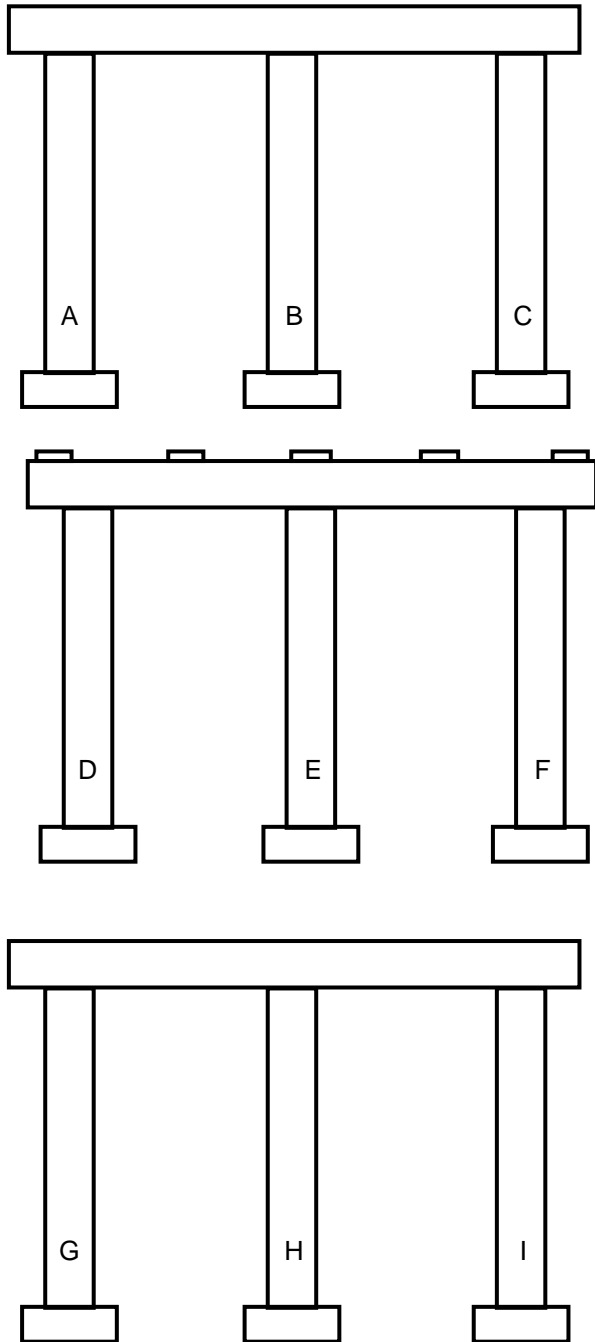
Looking Ahead

Walls: GF
